Contract No. HY/2010/02

Hong Kong – Zhuhai – Macao Bridge Hong Kong Boundary Crossing Facilities – Reclamation Works

Monthly EM&A Report for September 2013

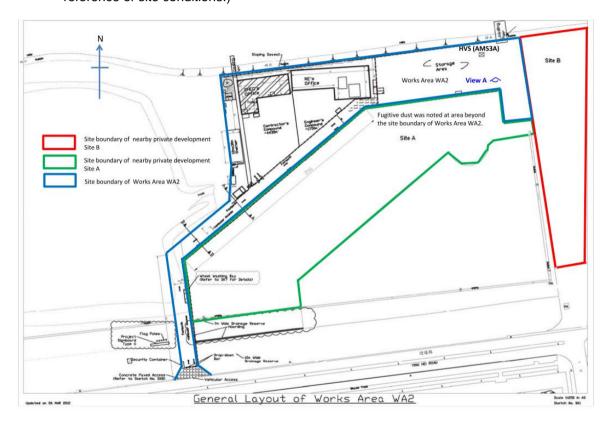
Conditions of the construction sites near Works Area WA2:

- 2.7.3.4 As refer to the wind data collected at wind station at Works Area WA2 during the monitoring period on 18 and 19 September 13, East South East winds was prevailing during the monitoring period.
- 2.7.3.5 Photo record shows that fugitive dust was emitted from the construction sites of nearby private development project located close to the monitoring station AMS3A but beyond the site boundary of Works Area WA2. With reference to the prevailing East South East wind direction, construction works carried out at construction sites of nearby private development project may contribute to the measured dust levels at the monitoring station AMS3A. (Please also see photo and layout map below for reference of site conditions.)

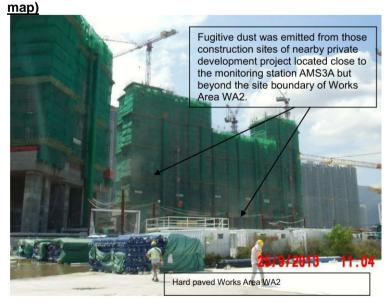
View of Works Area WA2 : the hard paved ground next to monitoring station AMS3A (View A on layout

- 2.7.3.6 Construction works carried out at construction sites of nearby private development project may contribute to the measured dust levels at the monitoring station AMS3A. The 1-hr TSP values recorded at AMS3A on 19 Sept 13, which are within the monitoring period of the 24-hr TSP, were 78 g/m³, 77 g/m³ and 77g/m³ respectively. All measured values are well below the Action and Limit Levels.

- 2.7.3.9 The dust exceedance was therefore considered not to be due to the Project works.
- 2.7.3.10 The Contractor was recommended to continue implementing existing dust mitigation measures.

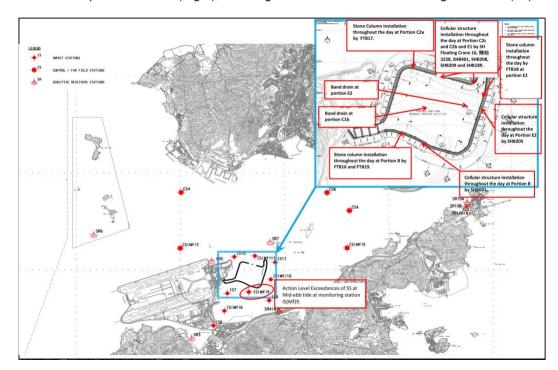
4.7.5 One (1) Action Level exceedance at measured Suspended Solids (mg/L) where recorded on 06 September 2013 during mid-flood tide at monitoring station IS(Mf)9. For Action Level exceedances at measured Suspended Solids (mg/L), 30.3 mg/L was recorded at Monitoring Station IS(Mf)9.

- 4.7.5.1 For locations and type of active works carried out on 6 Sept 13, please refer to the above layout map.
- 4.7.5.2 For action level exceedance of depth averaged SS (in mg/L) recorded at IS(Mf)9 during mid flood tide, active works were carried out at almost the same locations on 4, 6 and 9 Sept 13, but all depth averaged SS (in mg/L) results recorded at all monitoring location on 4 and 9 Sept 13 were all below the Action and Limit Level, which indicates that active works are unlikely to contribute to the action level exceedance recorded at IS(Mf)9.

- 4.7.5.5 When impact water quality monitoring was carried out during mid flood tide at monitoring location IS(Mf)9, no discoloration of sea water was observed and no silty plume were observed to flow from the inside to the outside of the site boundary.

- 4.7.5.6 The exceedance was likely due to local effects in the vicinity of IS(Mf)9.
- 4.7.5.7 The exceedance was considered as non-Project related.
- 4.7.5.8 Nevertheless, the Contractor was reminded to ensure provision of ongoing maintenance to the silt curtains and to carry out maintenance work once defects were found.

- 4.7.5.9 Maintenance work of the silt curtain was carried out by the Contractor on a daily basis except Sunday and public holiday.
- 4.7.6 One (1) Action Level exceedance at measured Suspended Solids (mg/L) where recorded on 16 September 2013 during mid-ebb tide at monitoring station IS(Mf)6. For Action Level exceedances at measured Suspended Solids (mg/L), 25 mg/L was recorded at Monitoring Station IS(Mf)6.

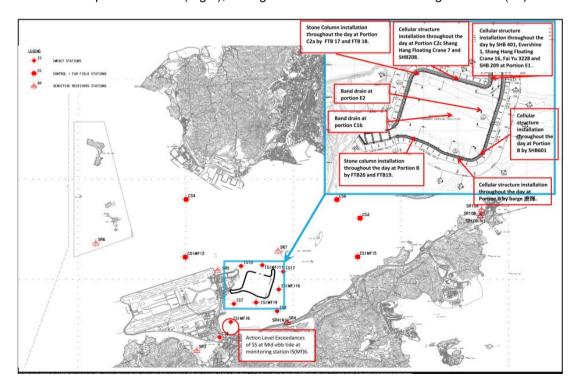
- 4.7.6.1 For locations and type of active works carried out on 16 Sept 13, please refer to the above layout map.
- 4.7.6.2 For action level exceedance of depth averaged SS (in mg/L) recorded at IS(Mf)6 during mid ebb tide, Suspended solids values recorded at Impact Station IS7, IS(Mf)9 and IS8 located downstream to and closer to active works than IS(Mf)6 during Mid-Ebb tide were below the Action and Limit Level during the same tide on the same day. This indicates project works is unlikely to contribute to the action level exceedance recorded at IS(Mf)6.

- 4.7.6.3 Same type of works was carried out at the same locations on 13 and 18 Sept 13 but Suspended Solids values recorded at IS(Mf)6 on 13 and 18 Sept 13 are all below the Action and Limit Level during the same tide on the these days. Turbidity level (NTU) results recorded at IS(Mf)9 is 11.8 NTU during flood tide on 6 Sept 13 which was well below the Action and Limit Level which indicates turbidity level was not adversely affected.

- 4.7.6.7 Nevertheless, the Contractor was reminded to ensure provision of ongoing maintenance to the silt curtains and to carry out maintenance work once defects were found.

- 4.7.6.8 Maintenance work of the silt curtain was carried out by the Contractor on a daily basis except Sunday and public holiday.
- 4.7.7 One (1) Action Level exceedance at measured Suspended Solids (mg/L) where recorded on 18 September 2013 during mid-flood tide at monitoring station SR4(N). For Action Level exceedance at measured Suspended Solids (mg/L), 24 mg/L was recorded at Monitoring Station SR4(N)

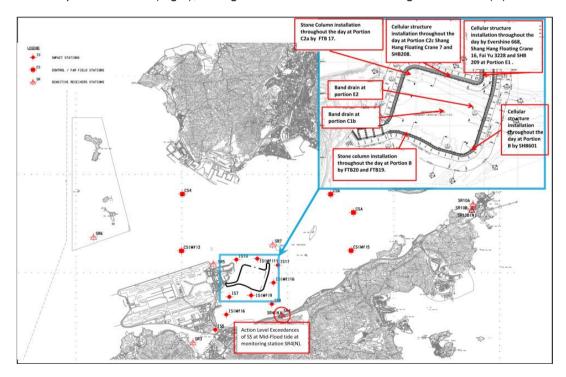
- 4.7.7.1 Please refer the above layout map for activity carried out on 18 Sept 13.
- 4.7.7.2 IS(Mf)9 and IS(Mf)16 are located closer to the active works than monitoring station SR4(N). Depth Averaged Suspended Solids (SS) values (in mg/L) recorded during the flood tide on the same day at

- 4.7.7.5 The exceedance was likely due to local effects in the vicinity of SR4(N).
- 4.7.7.6 Nevertheless, the Contractor was reminded to ensure provision of ongoing maintenance to the silt curtains and to carry out maintenance work once defects were found.

- 4.7.7.7 Maintenance work of the silt curtain was carried out by the Contractor on a daily basis except Sunday and public holiday.
- 4.7.8 Two (2) Action Level exceedance at measured Suspended Solids (mg/L) where recorded on 30 Sept 13 during mid-flood tide at monitoring station SR5 and IS (10). For Action Level exceedance at measured Suspended Solids (mg/L), 24.5 mg/L were recorded at Monitoring Station SR5 and IS(10).

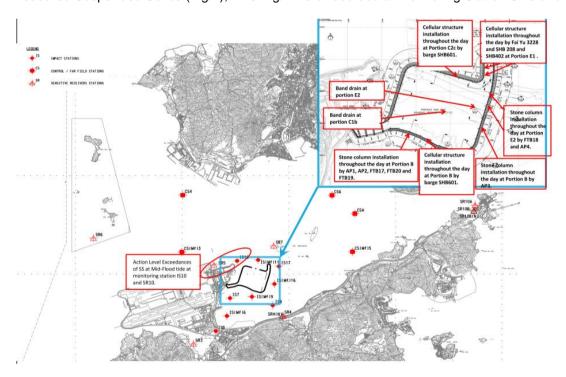
- 4.7.8.1 Please refer the above layout map for activity carried out on 30 Sept 13.
- 4.7.8.2 No active works were carried out portion C2a, Portion A and Portion C1a. Installation of band drain was carried out at Portion C1b and Cellular Structure installation was carried out at Portion C2c and E1 on 30 Sept 13. These works were unlikely to generate silt plumes or suspended solid. Stone column installation was conducted at Portion B and E2 which is far away from IS10 and SR5. (For location of each portion please refer to below Layout Portion of Marine Work)

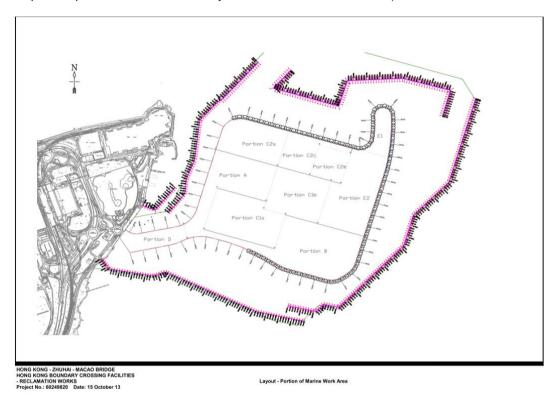
- 4.7.8.3 Suspended solids values recorded at Impact Stations IS(Mf)11 and IS7 which is closer to the active works at Portion E2 and Portion B respectively than monitoring station IS10 and SR5 were below the action and limit level which indicates that active works from portion E2 and B is unlikely to cause SS exceedance at monitoring station IS10 and SR5.

- 4.7.8.4 Turbidity level (NTU) results recorded at IS10 and SR5 were 14.2 NTU and 20.4 NTU respectively during flood tide on 30 Sept 13 which was below the Action and Limit Level which indicates turbidity level was not adversely affected.

- 4.7.8.5 When impact water quality monitoring was carried out during mid flood tide at monitoring location IS10 and SR5, no discoloration of sea water was observed and no silty plume were observed to flow from the inside to the outside of the site boundary.

- 4.7.8.6 The exceedance was likely due to local effects in the vicinity of IS10 and SR5.
- 4.7.8.7 Nevertheless, the Contractor was reminded to ensure provision of ongoing maintenance to the silt curtains and to carry out maintenance work once defects were found.
