Contract No. HY/2010/02

**Hong Kong – Zhuhai – Macao Bridge  
Hong Kong Boundary Crossing  
Facilities –  
Reclamation Works**

**Monthly EM&A Report for November 2013**

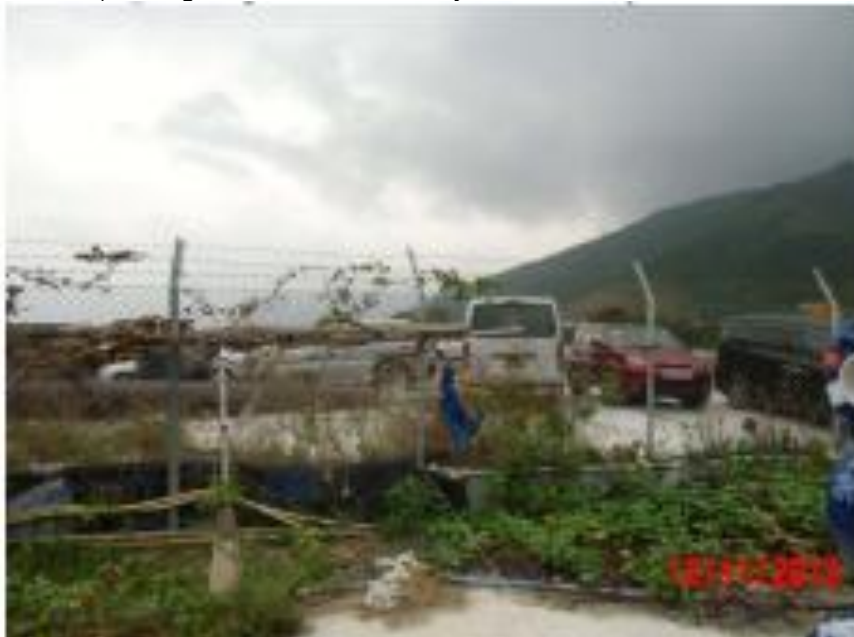
- 2.7.4.3 Photo records shows vehicle parking activities were observed inside an area at construction sites of nearby private development project which are close to the monitoring station AMS3A but beyond the site boundary of Works Area WA2. (Please also see photo and layout map attached for reference of site conditions (View A.))

View A: (Parking lot observed at nearby construction site which do not belongs to this Contract):

- 2.7.4.8 The dust exceedance was therefore considered not to be due to the Project works.
- 2.7.4.9 The Contractor was recommended to continue implementing existing dust mitigation measures.

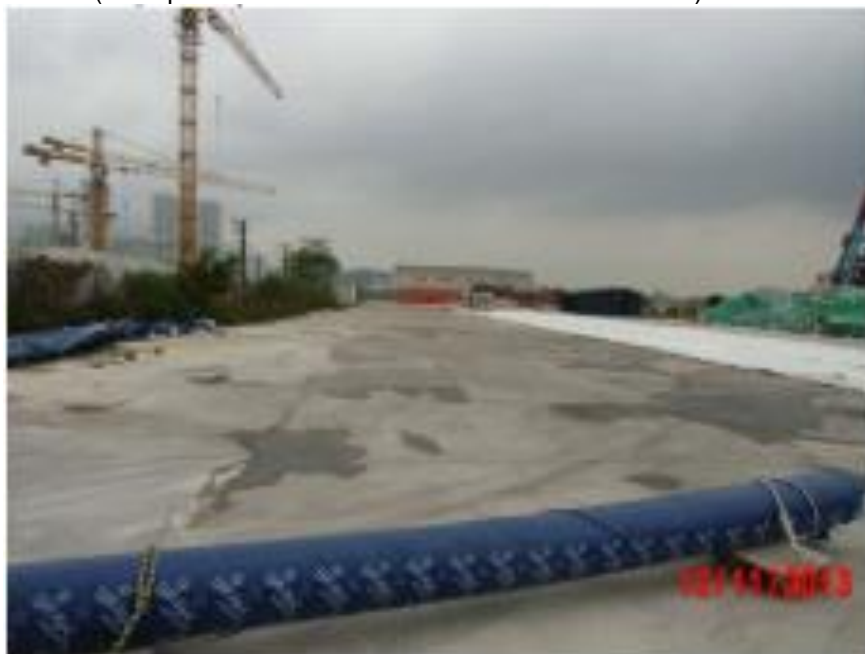
View B (Hard paved surface observed at Works Area WA2)

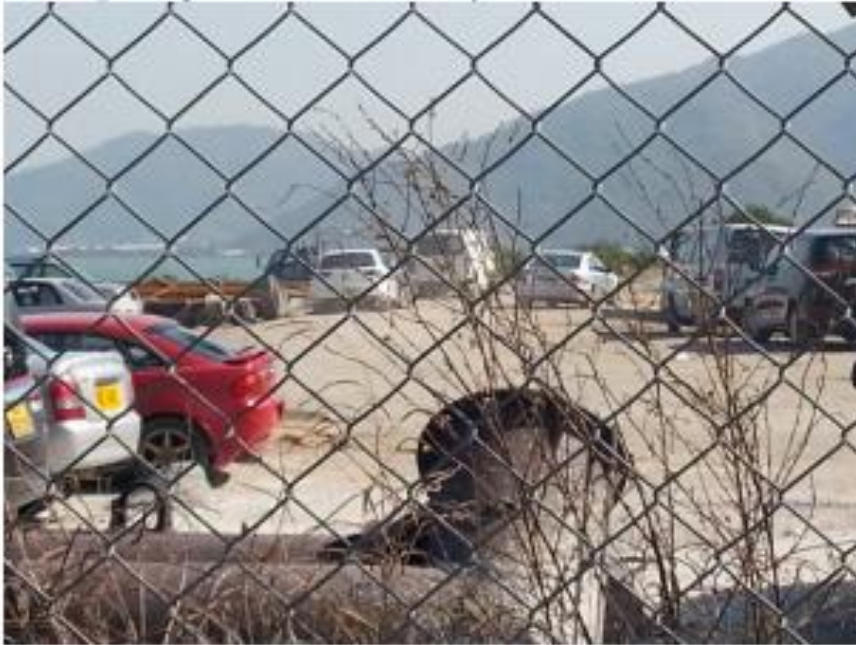
- 2.7.5.3 Photo records shows vehicle parking activities were observed inside an area at construction sites of nearby private development project which are close to the monitoring station AMS3A but beyond the site boundary of Works Area WA2. (Please also see photo and layout map attached for reference of site conditions (View A.))

View A (parking lot observed at nearby construction site which do not belongs to this Contract)

- 2.7.5.8 The dust exceedance was therefore considered not to be due to the Project works.
- 2.7.5.9 The Contractor was recommended to continue implementing existing dust mitigation measures.

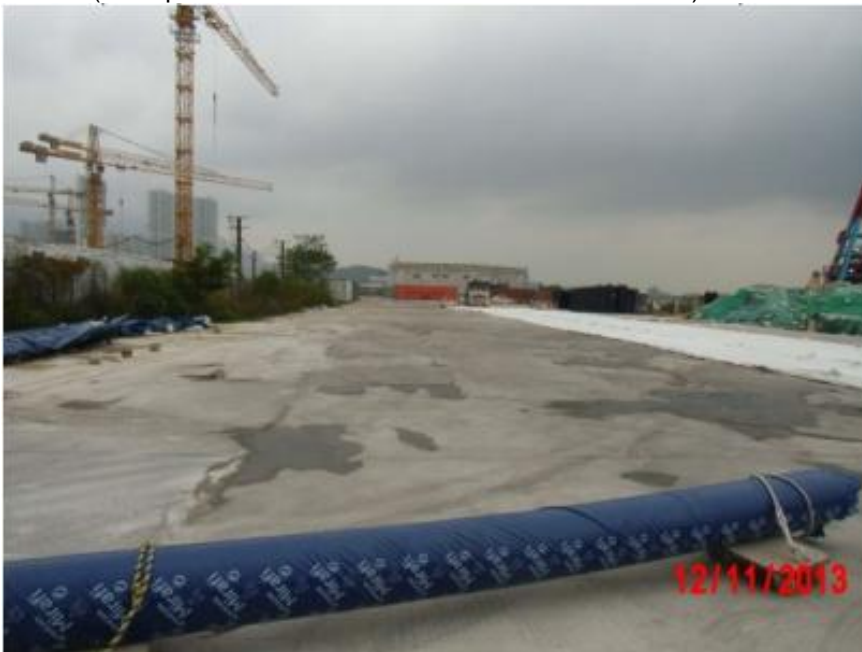
View B (Hard paved surface observed at Works Area WA2)

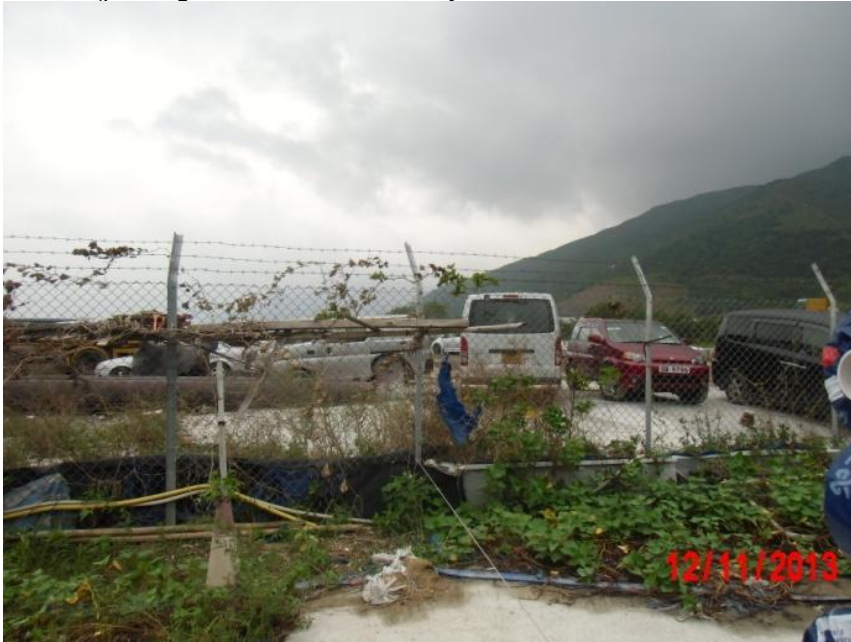
- 2.7.6.3 Photo records shows vehicle parking activities were observed inside an area at construction sites of nearby private development project which are close to the monitoring station AMS3A but beyond the site boundary of Works Area WA2. (Please also see photo and layout map attached for reference of site conditions (View A.))

View A (parking lot observed at nearby construction site which do not belongs to this Contract)

- 2.7.6.8 The dust exceedance was therefore considered not to be due to the Project works.
- 2.7.6.9 The Contractor was recommended to continue implementing existing dust mitigation measures.

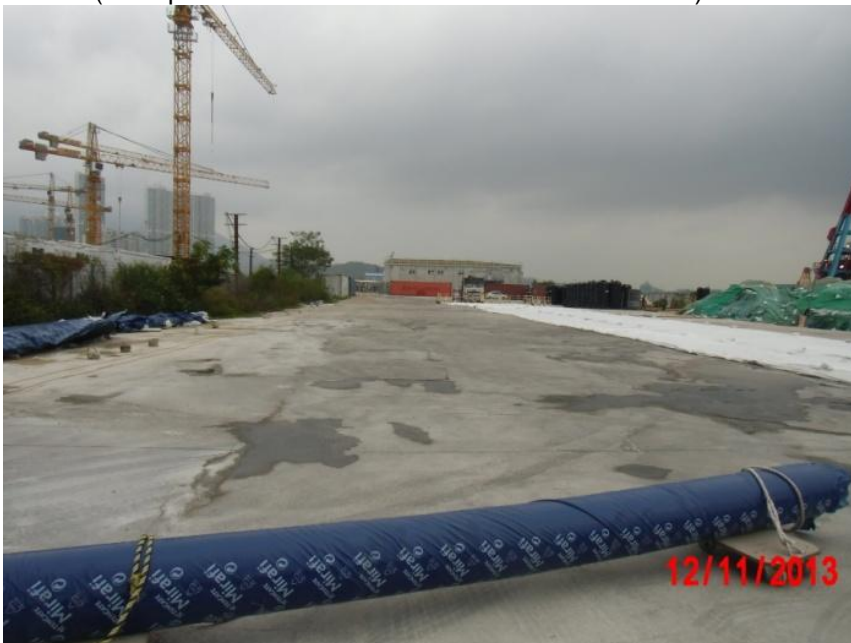
View B (Hard paved surface observed at Works Area WA2)

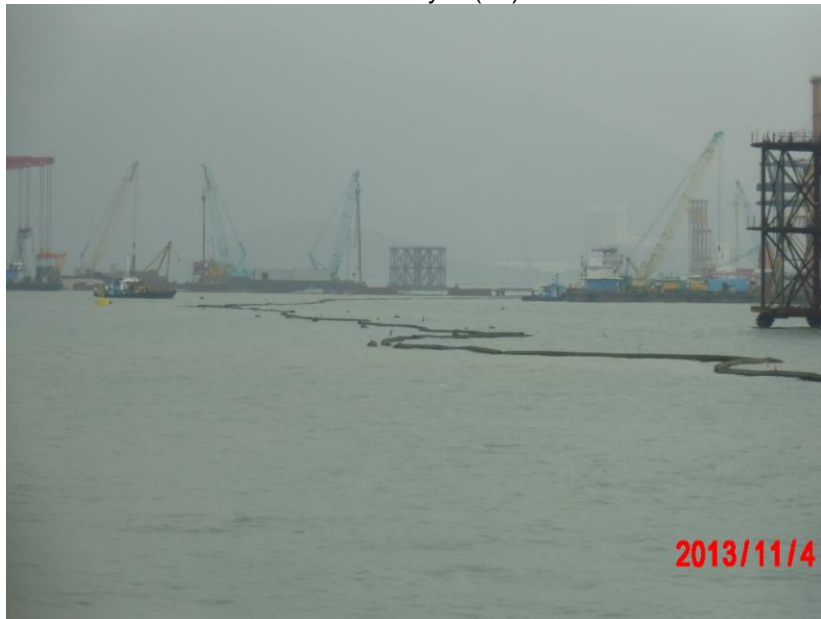
- 4.7.5.5 Photo record shows that no defect was observed on the perimeter silt curtain nearby IS(Mf)16 and IS17. (Please see attached photo record)
- 4.7.5.6 When impact water quality monitoring was carried out at IS(Mf)16 during mid ebb tide and at IS(Mf)9 during mid flood tide, no discoloration of sea water was observed and no silty plume were observed to flow from the inside to the outside of the site boundary.

Photo record of site condition nearby IS(Mf)6

4.7.5.9 Nevertheless, the Contractor was reminded to ensure provision of ongoing maintenance to the silt curtains and to carry out maintenance work once defects were found.

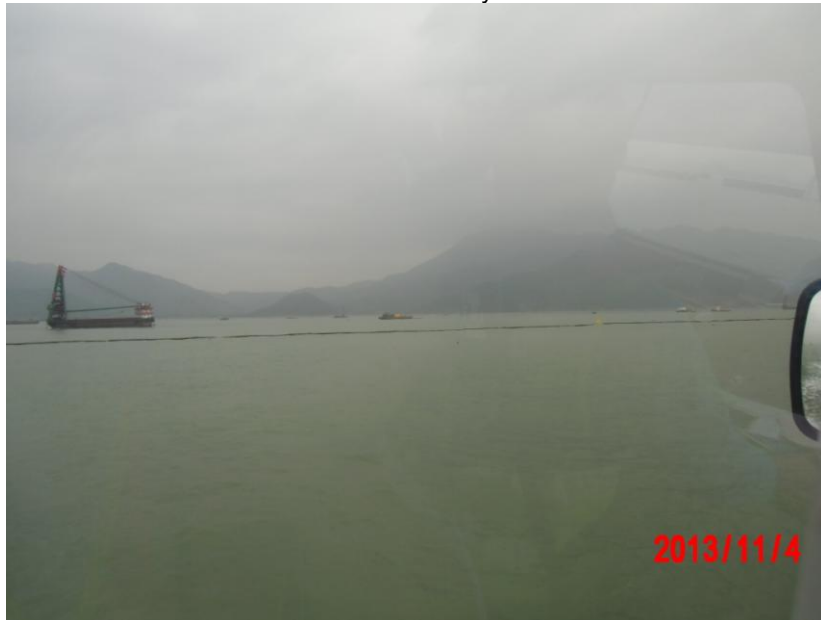
Photo record shows site condition nearby IS17

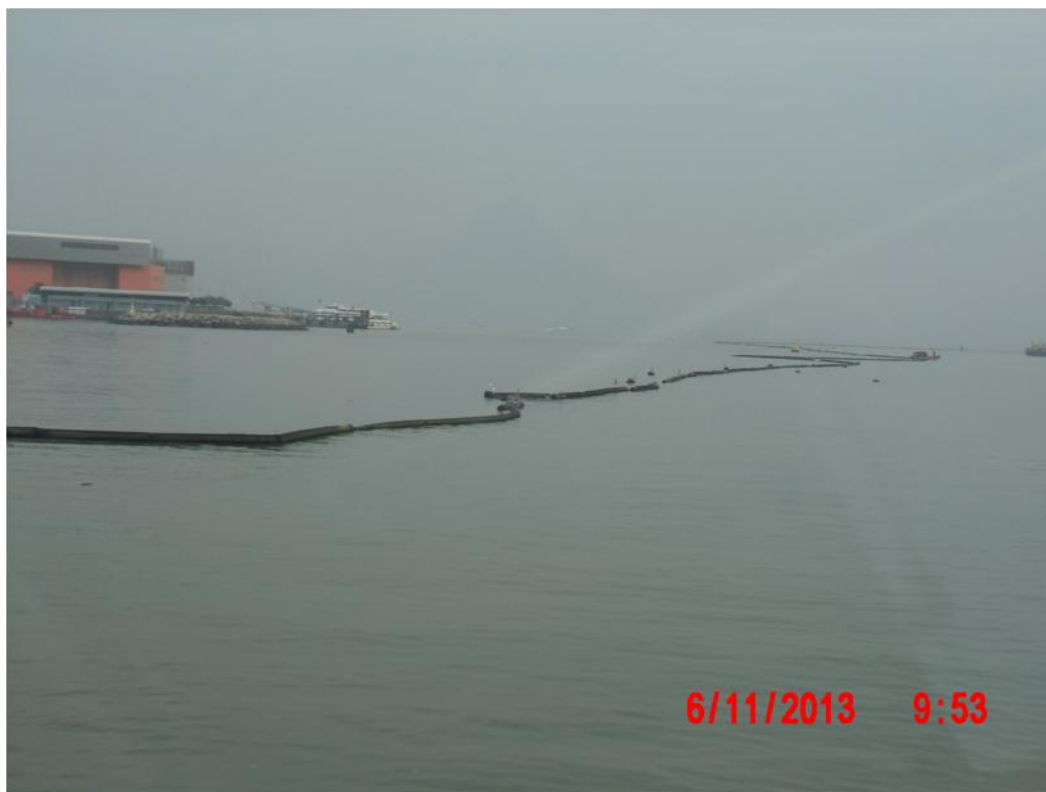
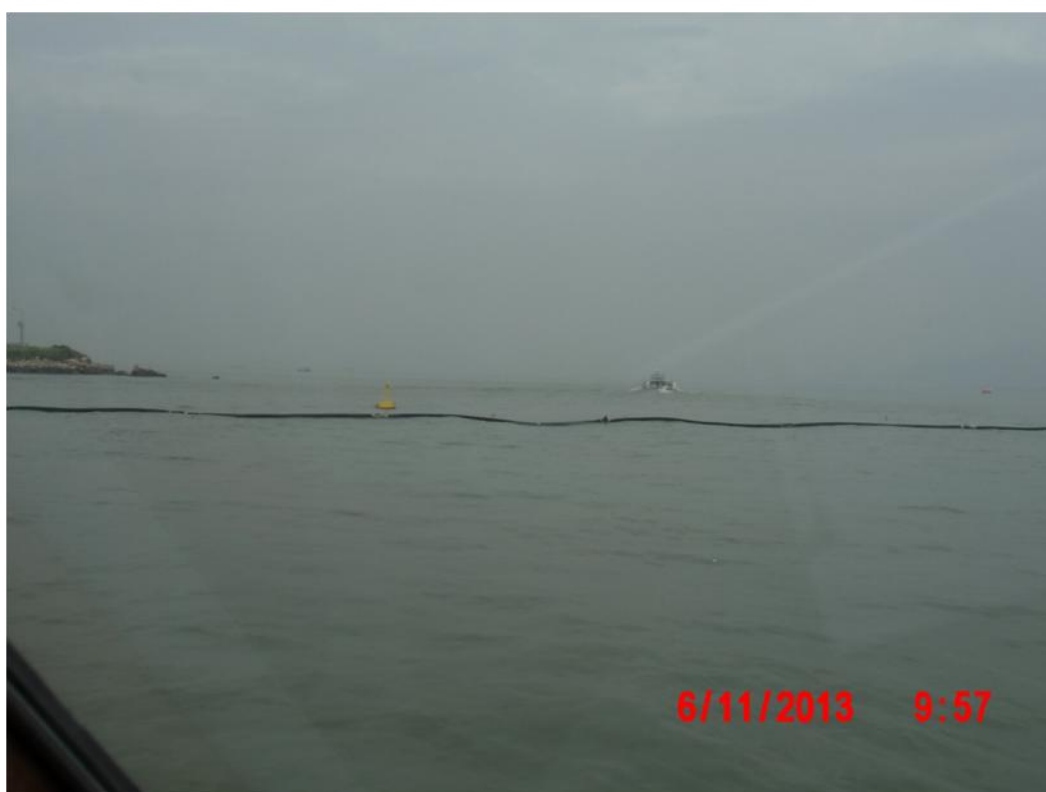
- 4.7.6.6 However, with refer to the silt curtain condition on 6 and 8 Nov 13, defects of the perimeter silt curtain was observed at southwest and northwest of the construction site but no exceedance was observed on 8 Nov 13 at IS10, SR5, SR6 and SR10B(N).

Condition of sea and silt curtain on 6 November 2013 (the northwest side of BCF)

- 4.7.6.10 As such, the exceedances recorded at IS10, SR5, SR6 and SR10B(N) were considered as non-Project related.
- 4.7.6.11 Nevertheless, the Contractor was reminded to ensure provision of ongoing maintenance to the silt curtains and to carry out maintenance work once defects were found.

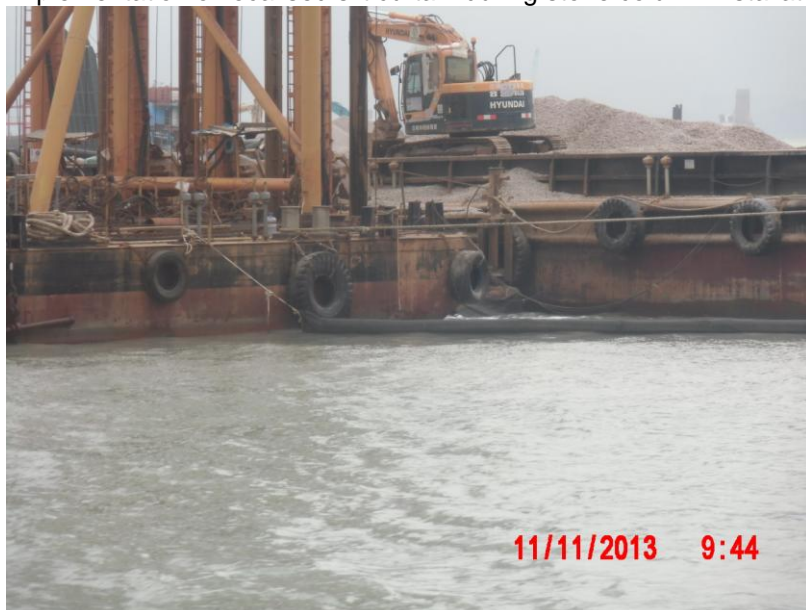
Implementation of localised silt curtain during stone column installation

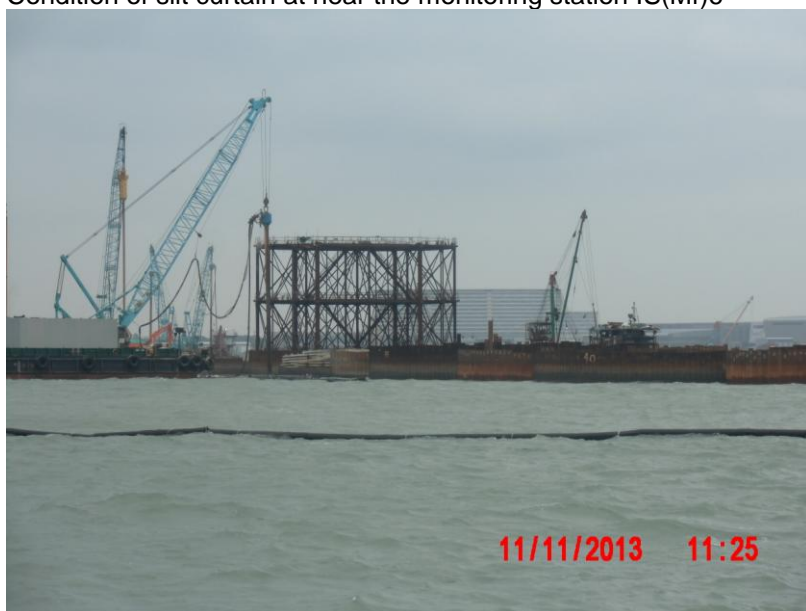
4.7.7.6 No defects of perimeter silt curtain was observed at the proximity of IS(Mf)6. (Please refer to the photo record attached)

Condition of silt curtain at near the monitoring station IS(Mf)6

4.7.7.9 Nevertheless, the Contractor was reminded to ensure provision of ongoing maintenance to the silt curtains and to carry out maintenance work once defects were found.

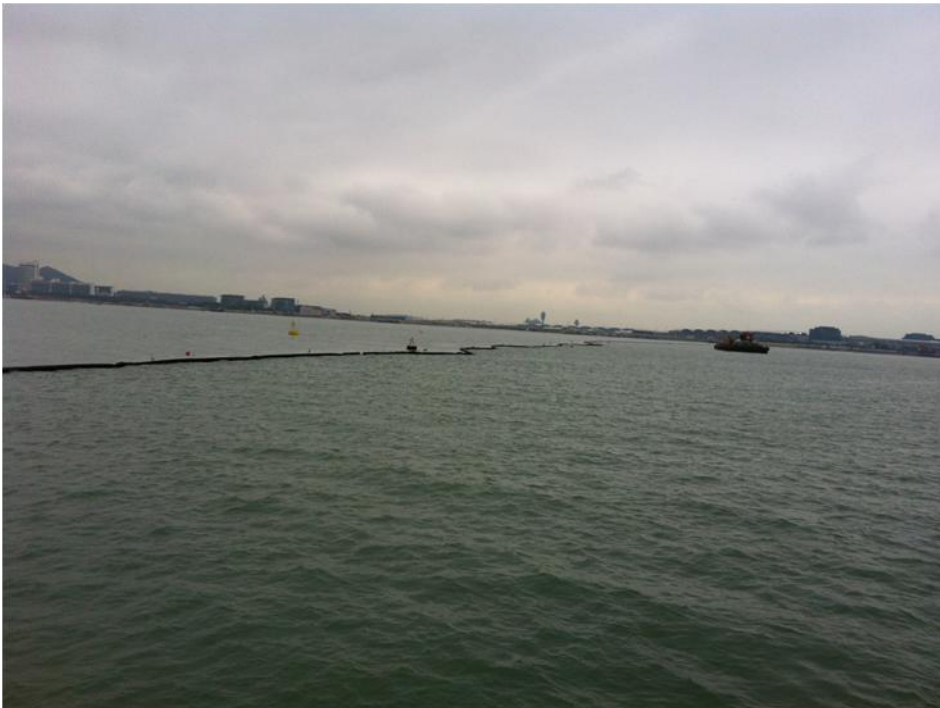
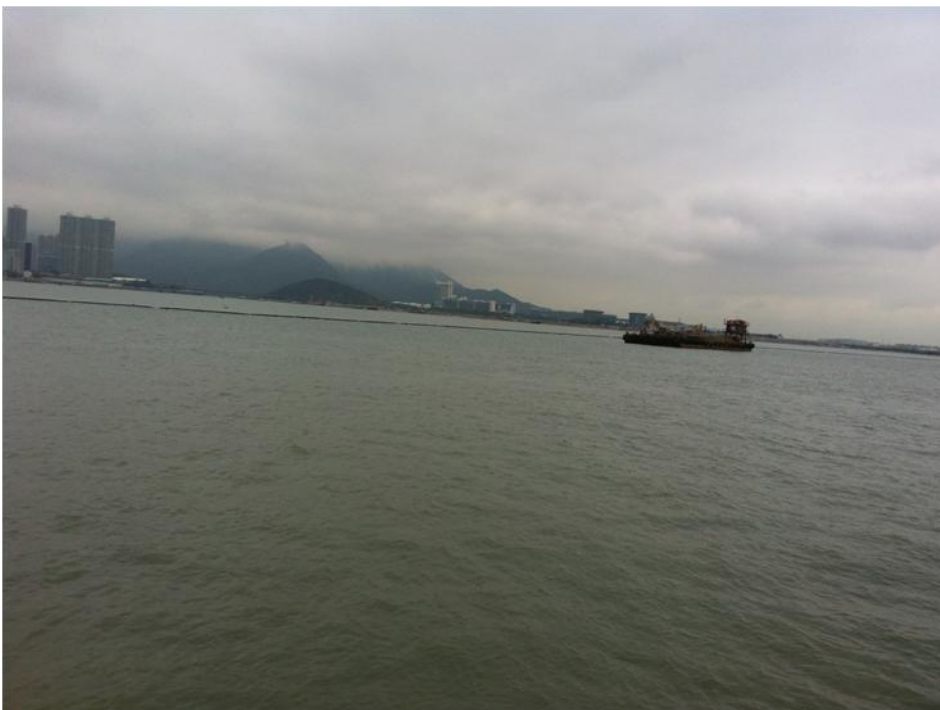
Condition of silt curtain near the monitoring station SR4(N).

- 4.7.8.4 The exceedance was likely due to local effects in the vicinity of SR4(N).
- 4.7.8.5 Nevertheless, the Contractor was reminded to ensure provision of ongoing maintenance to the silt curtains and to carry out maintenance work once defects were found.

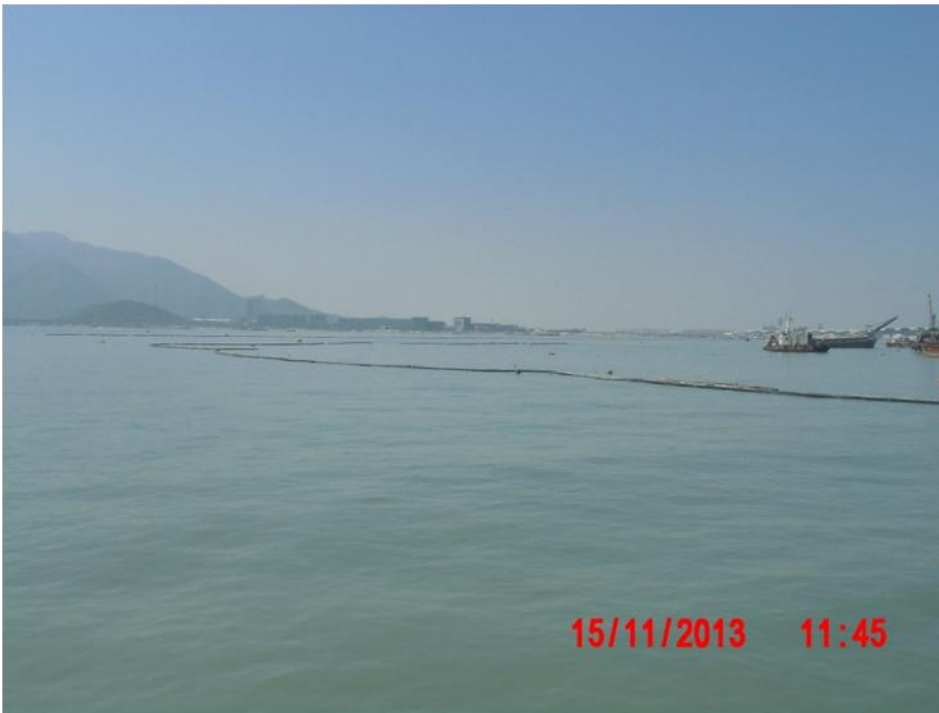
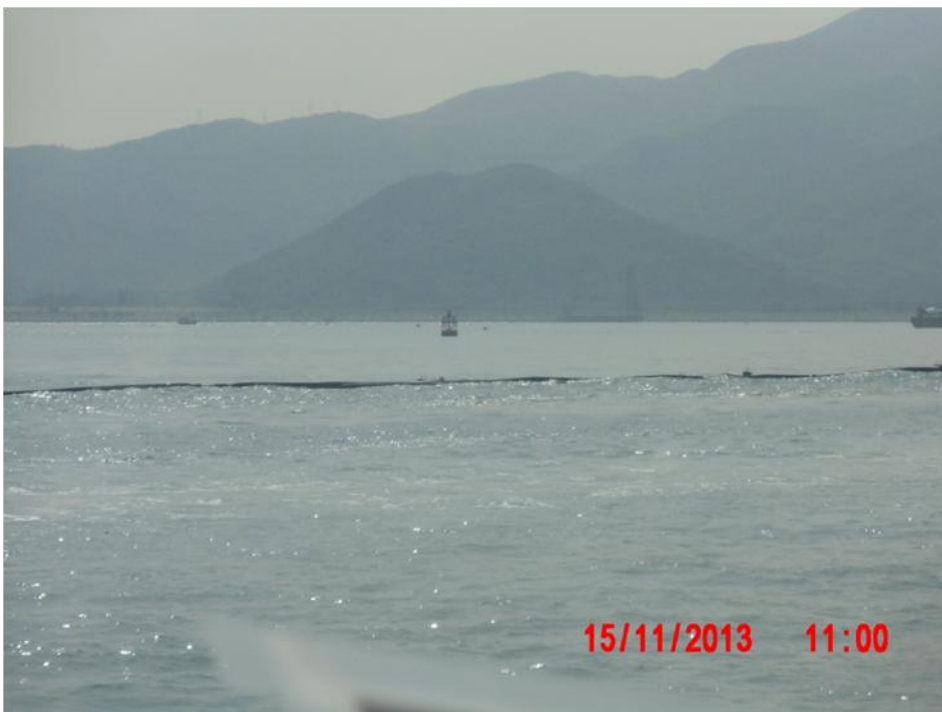
**Photo record of the sea condition taken on 15 Nov 13**

4.7.9.4 Refer to the attached layout map, active works were noted directly upstream to IS(Mf)9 during flood tide and IS17 during ebb tide, but no defects at south alignment (Nearby IS(Mf)9 and the northwest alignment of the perimeter silt curtain (nearby S117) when monitoring was conducted on 15 Nov 13.

4.7.9.7 Nevertheless, the Contractor was reminded to ensure provision of ongoing maintenance to the silt curtains and to carry out maintenance work once defects were found.

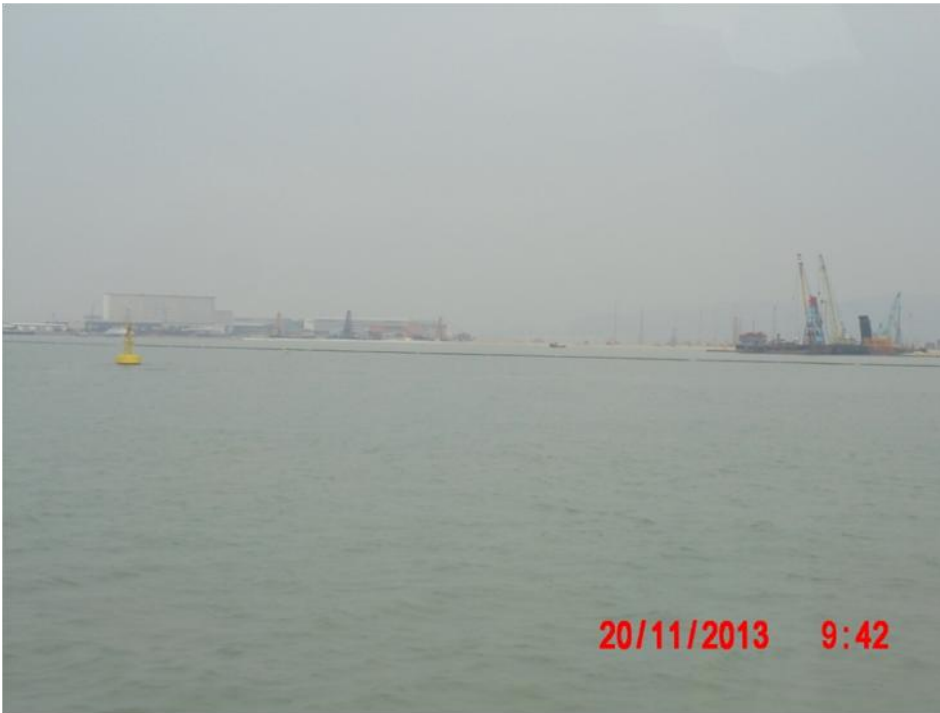
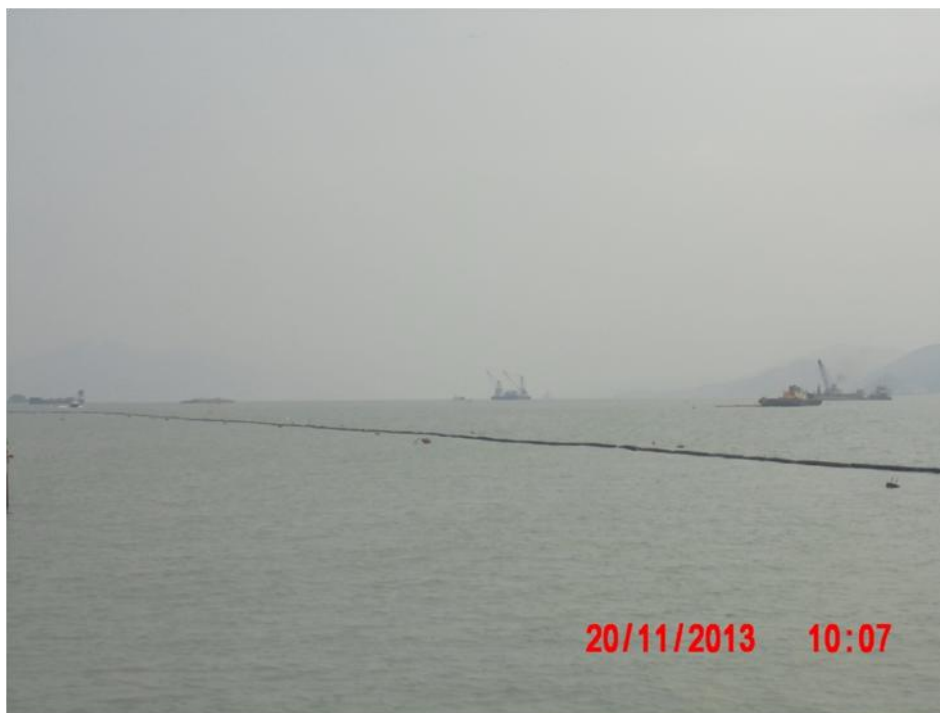
4.7.10.7 No defects of perimeter silt curtain was observed at the proximity of IS(Mf)6 and IS7. (Please refer to the photo record attached)

Condition of silt curtain near the monitoring station IS(Mf)6 and IS7.

4.7.10.10 Nevertheless, the Contractor was reminded to ensure provision of ongoing maintenance to the silt curtains and to carry out maintenance work once defects were found.

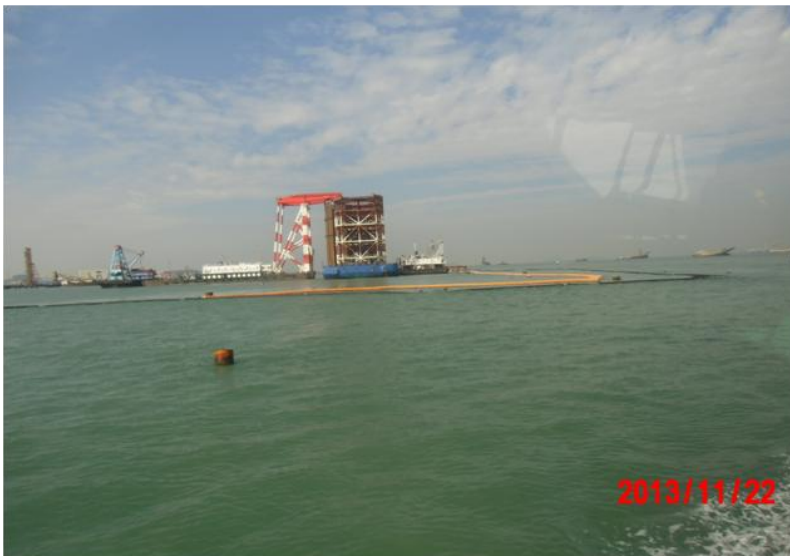
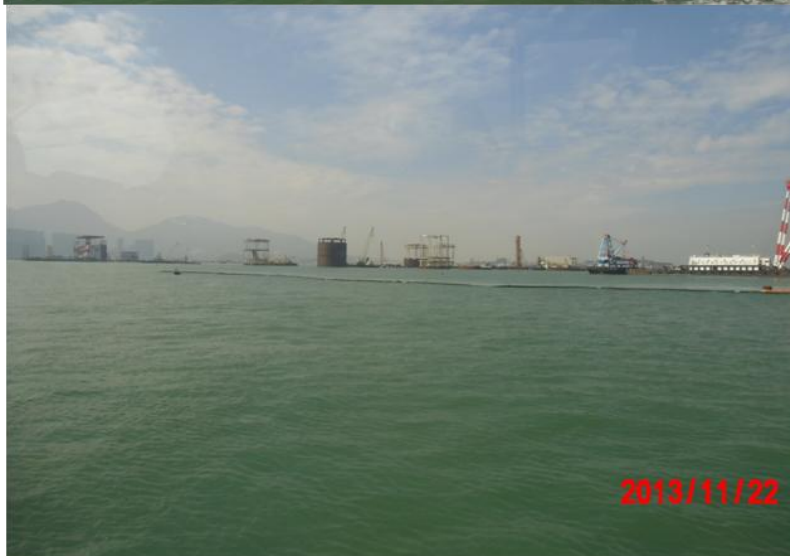
4.7.11.6 No defects of perimeter silt curtain was observed at the proximity of IS(Mf)16. (Please refer to the photo record attached)

Implementation of localised silt curtain during stone column installation near the monitoring station IS(Mf)16.

4.7.11.12 Nevertheless, the Contractor was reminded to ensure provision of ongoing maintenance to the silt curtains and to carry out maintenance work once defects were found.

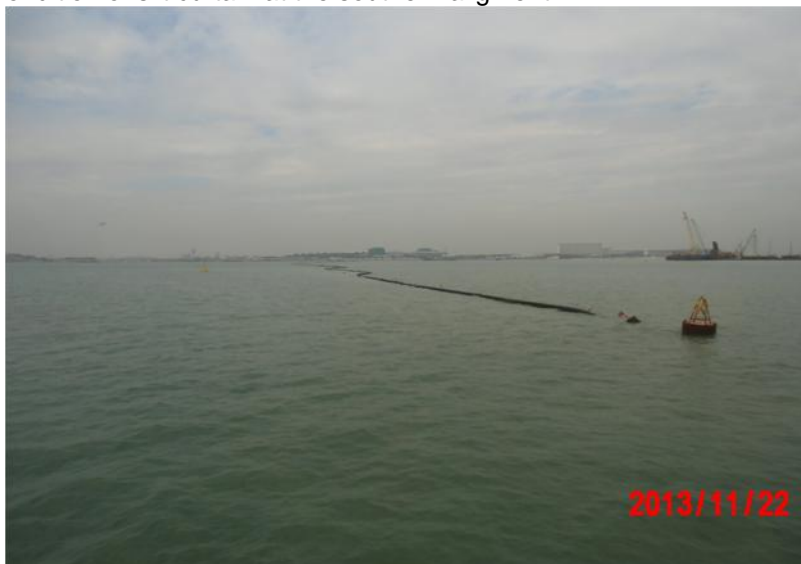
Condition of silt curtain at the southern alignment.
