Contract No. HY/2010/02

**Hong Kong – Zhuhai – Macao Bridge  
Hong Kong Boundary Crossing  
Facilities –  
Reclamation Works**

**Monthly EM&A Report for December 2013**

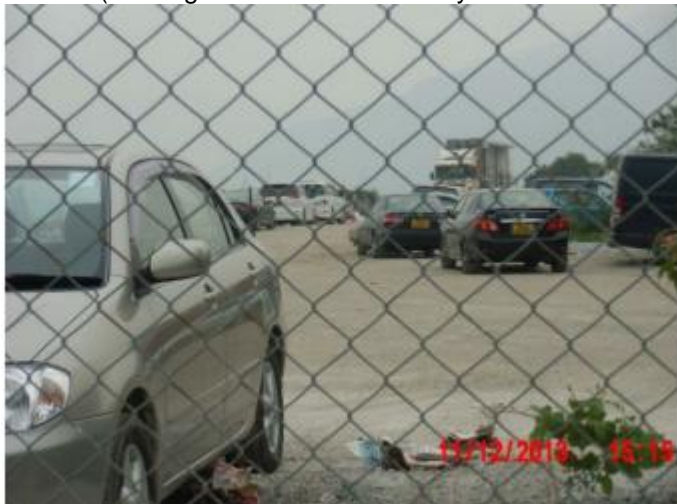
- 2.7.4.3 Photo records shows vehicle parking activities were observed inside an area at construction sites of nearby private development project which are close to the monitoring station AMS3A but beyond the site boundary of Works Area WA2. (Please also see photo and layout map attached for reference of site conditions (View A.))

View A: (Parking lot observed at nearby construction site which do not belongs to this Contract):

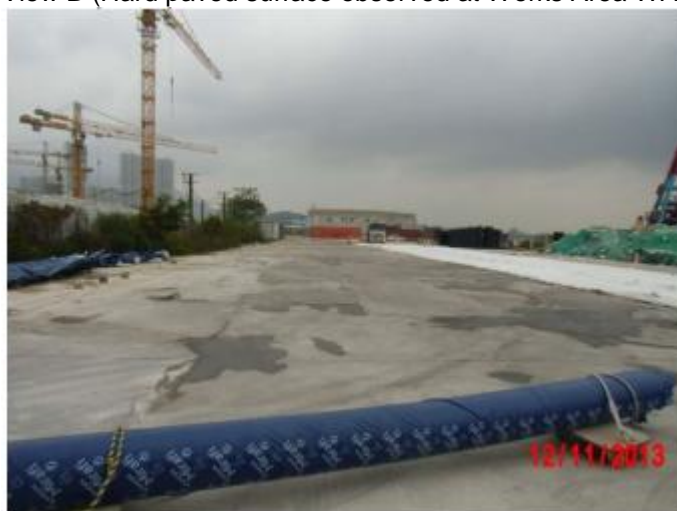
View B (Hard paved surface observed at Works Area WA2)

- 2.7.4.8 The dust exceedance was therefore considered not to be due to the Project works.
- 2.7.4.9 The Contractor was recommended to continue implementing existing dust mitigation measures.

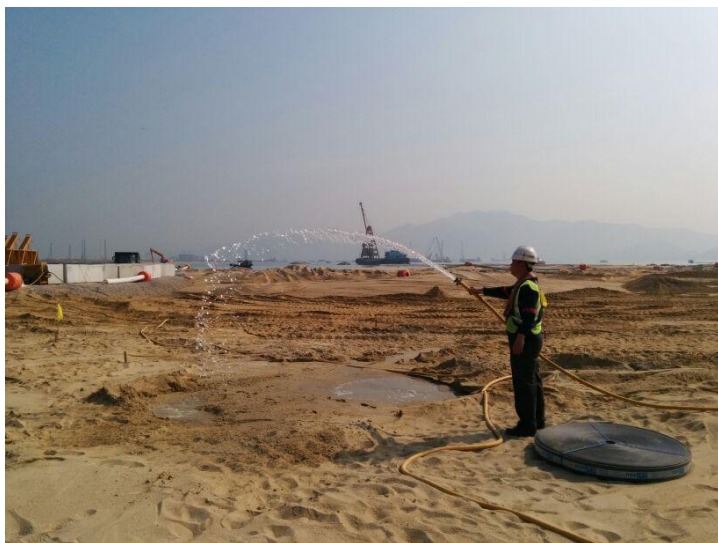
- 2.7.5.5 Photo record below shows that the Contractor implemented dust control measures on works area of Portion A:

- 2.7.5.11 The dust exceedance was therefore considered not to be due to the Project works.
- 2.7.5.12 The Contractor was recommended to continue implementing existing dust mitigation measures and the Contractor was reminded ensure to undertake watering at least 8 times per day on all exposed soil within the Project site and associated work areas throughout the construction phase.
- 2.7.6 The event action plan is annexed in Appendix L.
- 2.7.7 Meteorological information collected from the wind station during the monitoring periods on the monitoring dates, as shown in Figure 2, including wind speed and wind direction, is annexed in Appendix H.

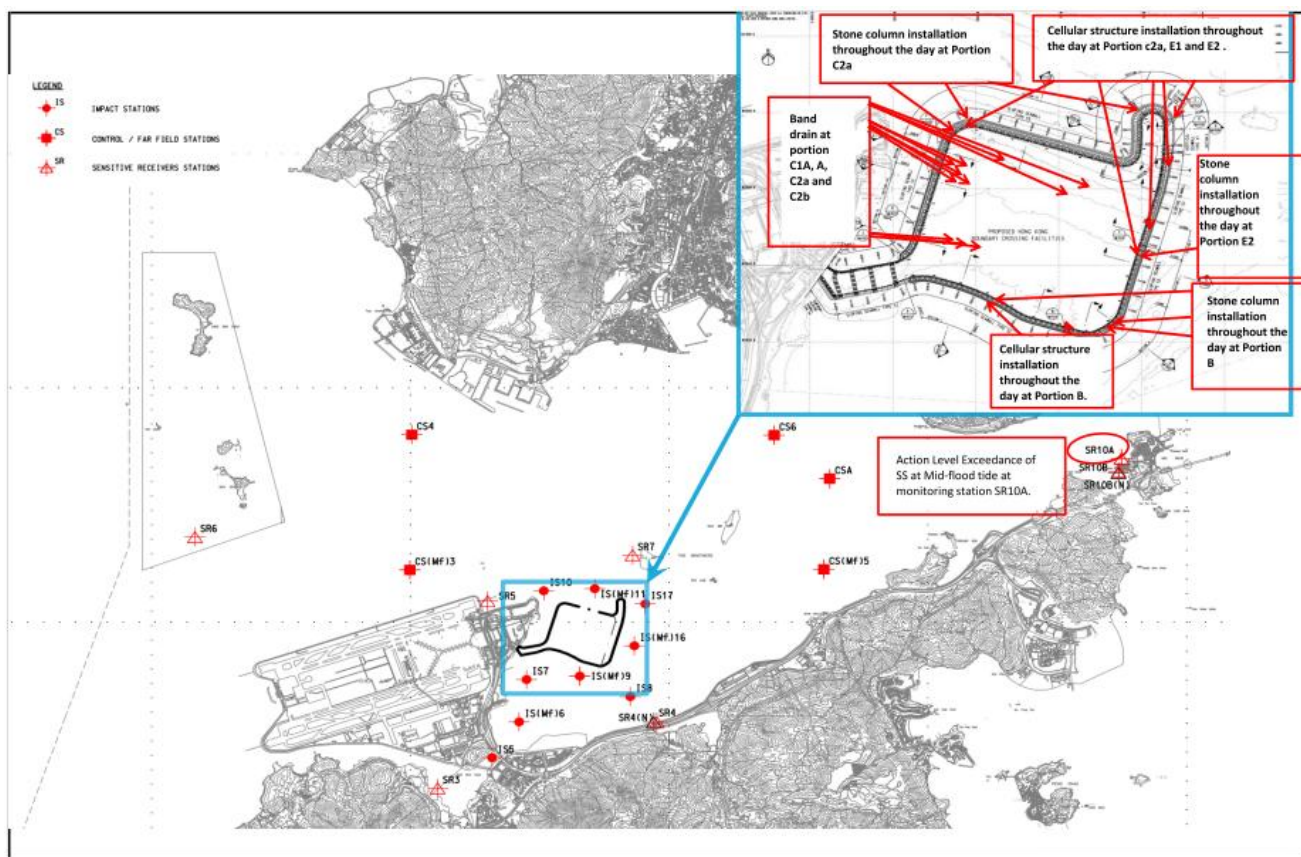
4.7.5 One (1) Action Level exceedance at measured Suspended Solids (mg/L) were recorded on 06 Dec 2013 at monitoring station SR10A at Mid-flood tide. For Action Level exceedances at measured Suspended Solids (mg/L), 28.2 mg/L was recorded at Monitoring Station SR10A.

4.7.5.1 For locations and type of active works carried out on 6 Dec 13, please refer to the above layout map.

4.7.5.2 IS(Mf)11 and IS10 are located downstream and closer to the active works than monitoring station SR10A during flood tide. Depth Averaged Suspended Solids (SS) values (in mg/L) recorded during flood tide on the same day at IS(Mf)11 and IS10 were below the Action and Limit Level which indicates project work is unlikely to contribute to the action level exceedance recorded at SR10A.

4.7.5.6 Nevertheless, the Contractor was reminded to ensure provision of ongoing maintenance to the silt curtains and to carry out maintenance work once defects were found.

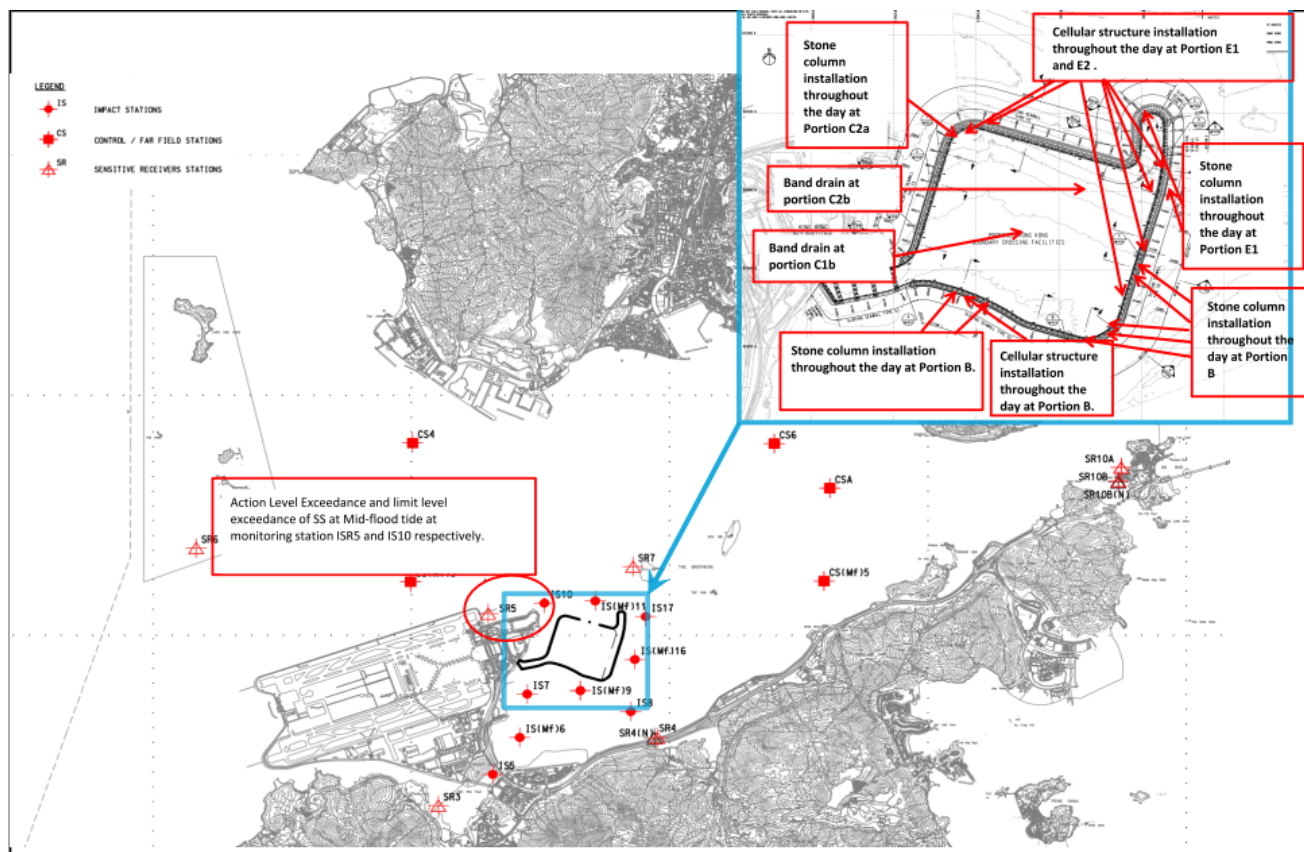
4.7.6 One (1) action level exceedances at measured Suspended Solids (mg/L) were recorded on 18 Dec 2013 at monitoring station SR5 at Mid-flood tide and one (1) limit level exceedance at measured Suspended Solids (mg/L) was recorded on 18 Dec 2013 at monitoring station IS10 at Mid-flood tide. For Action Level exceedance at measured Suspended Solids (mg/L), 33.2mg/L were recorded at Monitoring Station SR5. For limit level exceedance at measured Suspended Solids (mg/L), 34.9 mg/L was recorded at Monitoring Station IS10.

- 4.7.6.1 For locations and type of active works carried out on 18 Dec 13, please refer to the above layout map.
- 4.7.6.2 Exceedances recorded at SR5 and IS10 are likely due to marine based construction activities of the Project because:

- 4.7.6.3 With refer to monitoring record, appearance of water was not clear at IS10 and SR5 when compared with the appearance of water at IS(Mf)11 and IS17 during monitoring during Mid-flood tide on 18 Dec 13. This indicates the source of exceedance may not due to works activities at portion E1 and E2 which is directly upstream of IS(Mf)11 and IS17. The relatively turbid water observed at IS10 and SR5 may due to activities at Portion C2a during flood tide.

- 4.7.6.5 With refer to the silt curtain condition on 18 Dec 13, defects of the perimeter silt curtain was observed at northwest of the construction site.

- 5 The Contractor was reminded to ensure provision of ongoing maintenance to the silt curtains and to carry out maintenance work once defects were found.

- 6 As informed by the Contractor maintenance work for the defects of the northwest part of the perimeter silt curtain was conducted on 4 January 13.

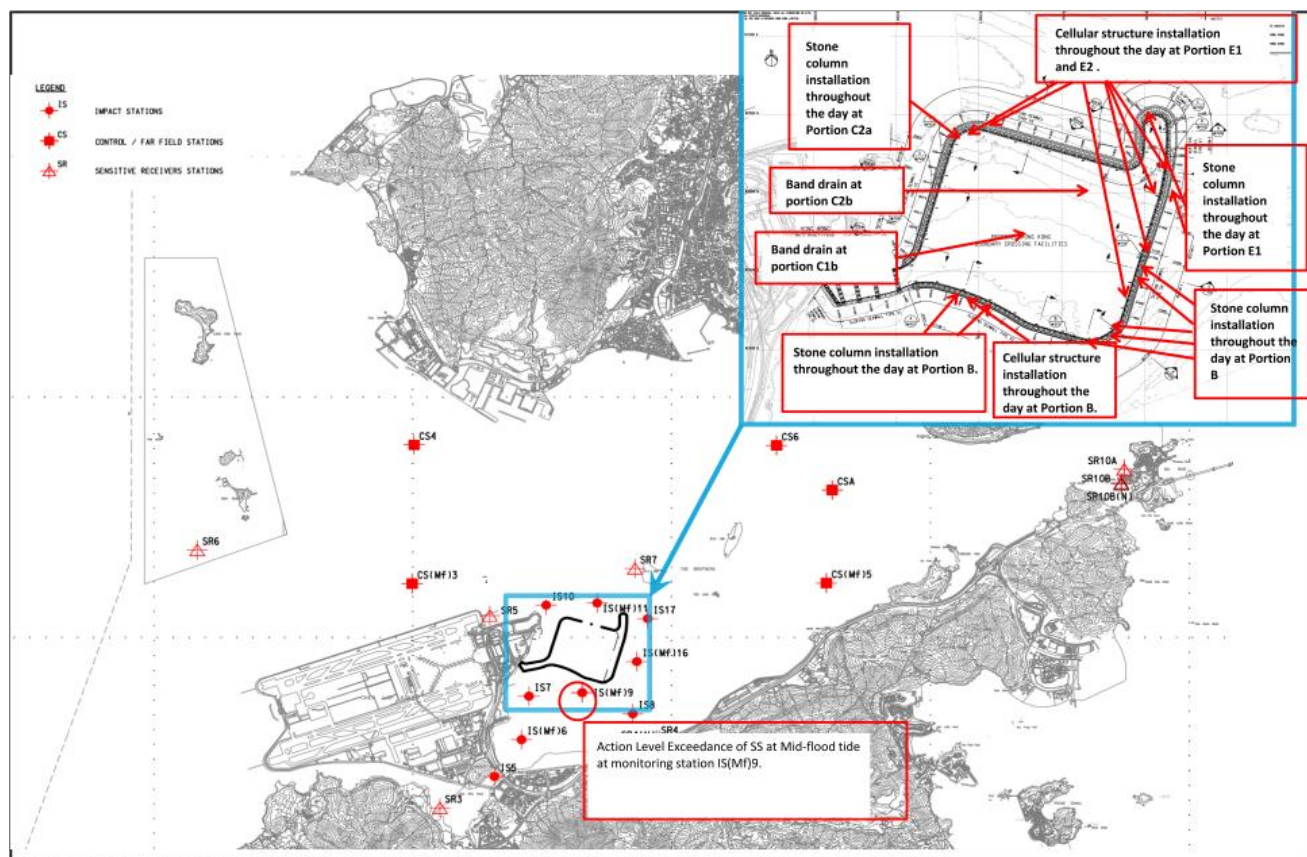
4.7.7 One (1) action level exceedances at measured Suspended Solids (mg/L) were recorded on 18 Dec 2013 at monitoring station IS(Mf)9 at Mid-flood tide. For Action Level exceedances at measured Suspended Solids (mg/L), 23.9 mg/L was recorded at Monitoring Station IS(Mf)9.

- 4.7.7.1 For locations and type of active works carried out on 18 Dec 13, please refer to the above layout map.
- 4.7.7.2 Exceedance recorded at IS(Mf)9 is unlikely due to marine based construction activities of the Project because:

- 4.7.7.3 With refer to the silt curtain condition on 18 Dec 13, no defects of the perimeter silt curtain was observed at south and southeast of the construction site.

- 4.7.7.6 As such, the exceedance recorded at IS(Mf)9 is considered non-project related.
- 4.7.7.7 The Contractor was reminded to ensure provision of ongoing maintenance to the silt curtains and to carry out maintenance work once defects were found.

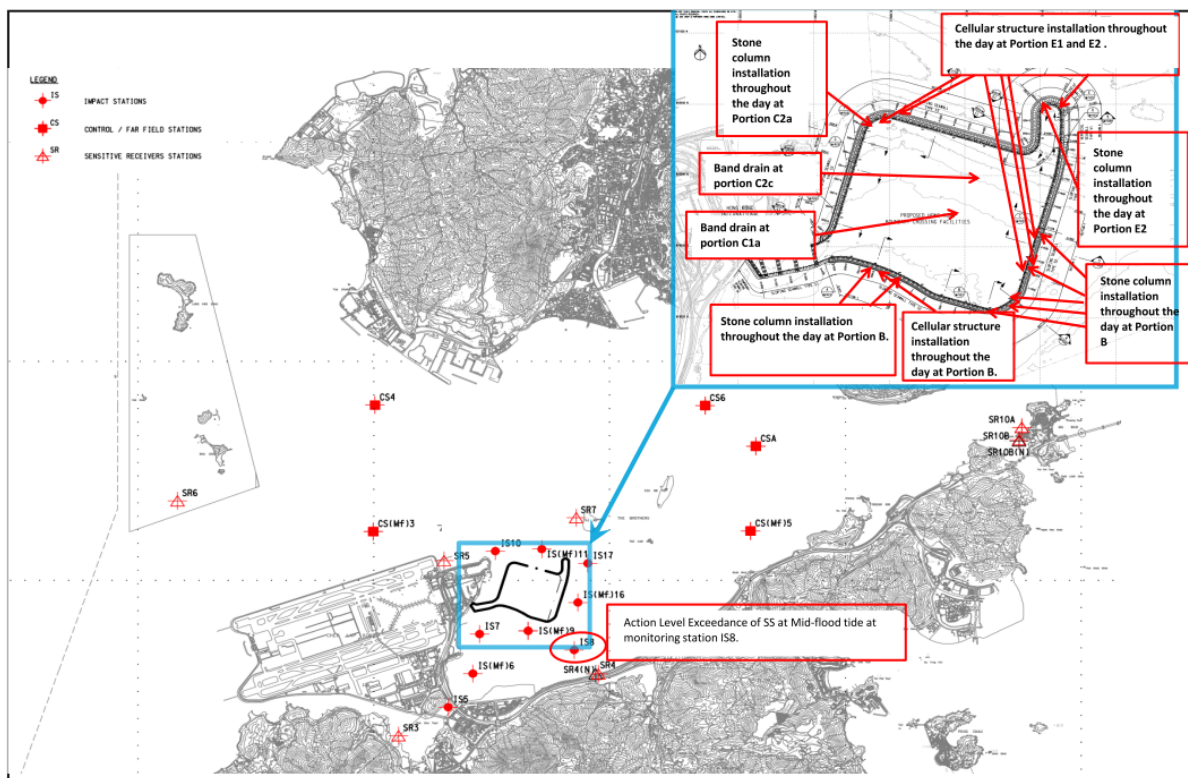
4.7.8 One (1) Limit Level exceedance at measured Suspended Solids (mg/L) was recorded on 20 Dec 2013 at monitoring station IS8 at Mid-flood tide. For limit exceedance at measured Suspended Solids (mg/L), 44.1 mg/L was recorded at Monitoring Station IS8.

4.7.8.1 For locations and type of active works carried out on 20 Dec 13, please refer to the above layout map.

4.7.8.2 IS(Mf)9 and IS(Mf)16 are located closer to the active works than monitoring station IS8. Depth Average Suspended Solids (SS) values (in mg/L) recorded during the flood tide on the same day at IS(Mf)9 and IS(Mf)16 were below the Action and Limit Level which shows that the water quality closer to active works were not adversely affected.

4.7.8.3 The monitoring location of monitoring station IS8 are considered located upstream to the active works of this project during flood tide. Therefore it was unlikely that the exceedances recorded at IS8 was due to active construction activities of this project.

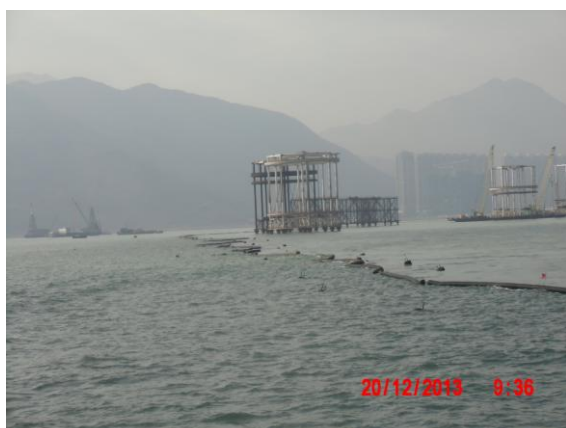
4.7.8.4 When impact water quality monitoring was carried out during mid flood tide at monitoring location IS8 on 20 Dec 13, no defects of the perimeter silt curtain was observed and no silty plume were observed to flow from the inside to the outside of the site boundary. (For reference, please see attached photo):
