Contract No. HY/2010/02

**Hong Kong – Zhuhai – Macao Bridge
Hong Kong Boundary Crossing
Facilities –
Reclamation Works**

Monthly EM&A Report for January 2014

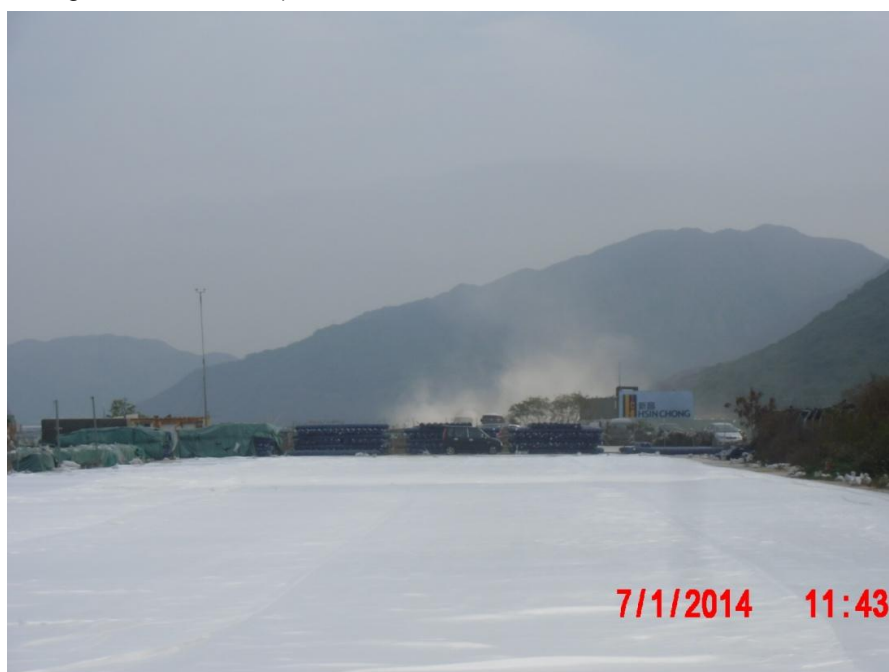
- 2.7.7.3 Photo records shows fugitive dust were generated by vehicle activities observed inside an area at construction sites of nearby private development project which are close to the monitoring station AMS3A but beyond the site boundary of Works Area WA2. (Please also see photo and layout map attached for reference of site conditions (View A.))

View A (fugitive dust were observed at the parking lot of the nearby construction site which do not belongs to this Contract)

2.7.7.9 The Contractor was recommended to continue implementing existing dust mitigation measures.

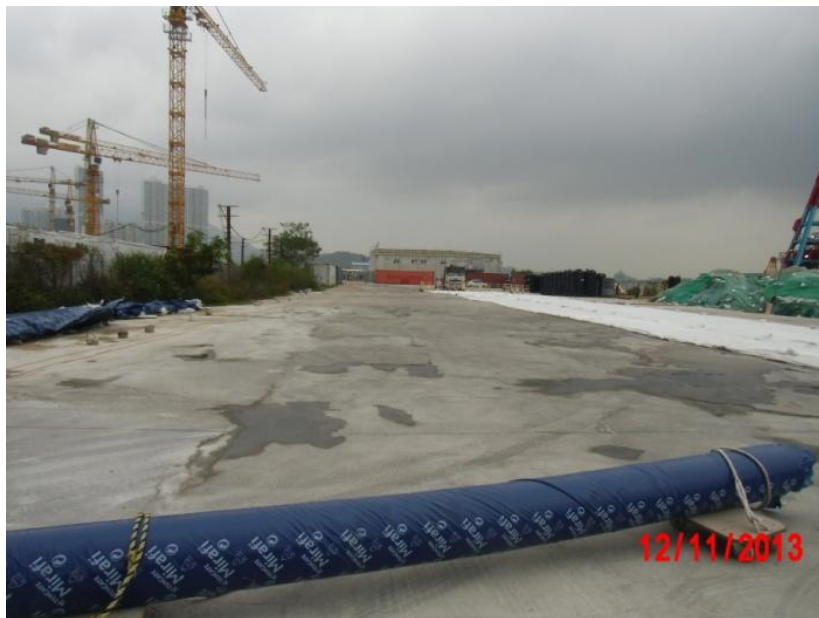
View B (Hard paved surface observed at Works Area WA2)

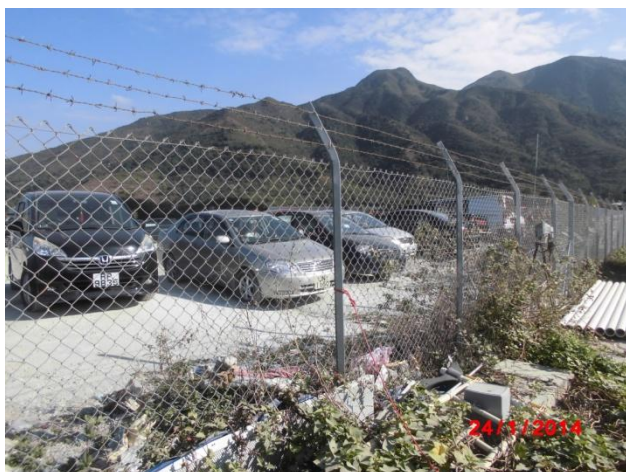
- 2.7.6.3 Photo records shows vehicle parking activities were observed inside an area at construction sites of nearby private development project which are close to the monitoring station AMS3A but beyond the site boundary of Works Area WA2. (Please also see photo and layout map attached for reference of site conditions (View A.))

View A (parking lot observed at nearby construction site which do not belongs to this Contract)

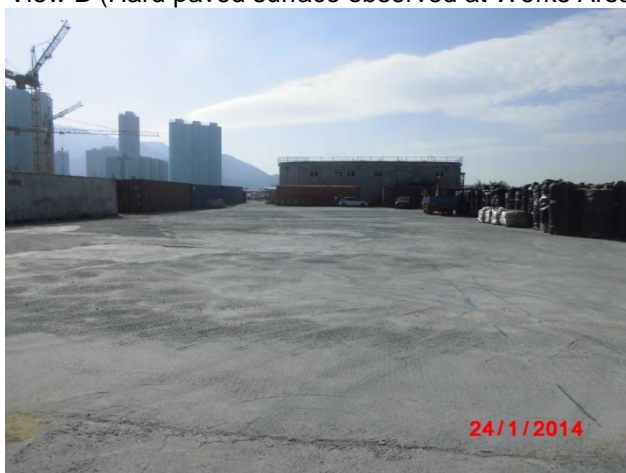
View B (Hard paved surface observed at Works Area WA2)

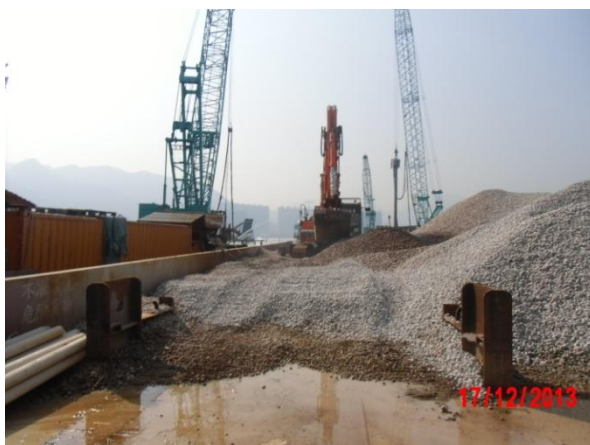
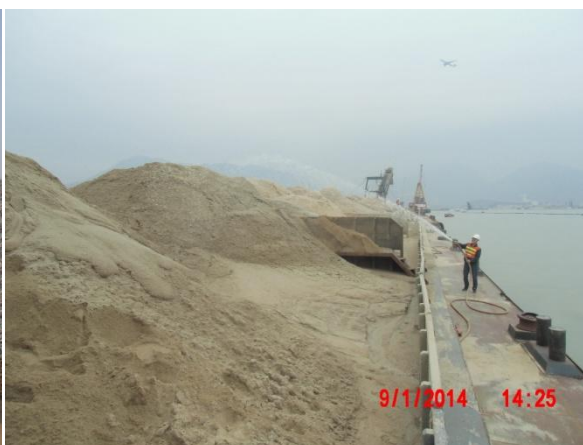
Photo record showed that the Contractor implemented dust control measures on pelican barge loaded with rock/sand. The Contractor was reminded to continue to provide dust control measures on pelican barge loaded with rock/sand.

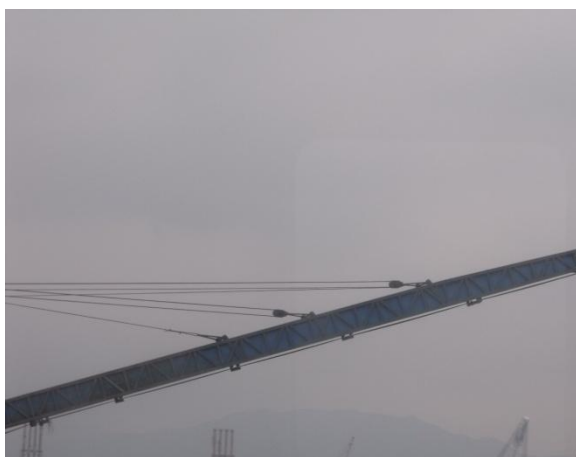
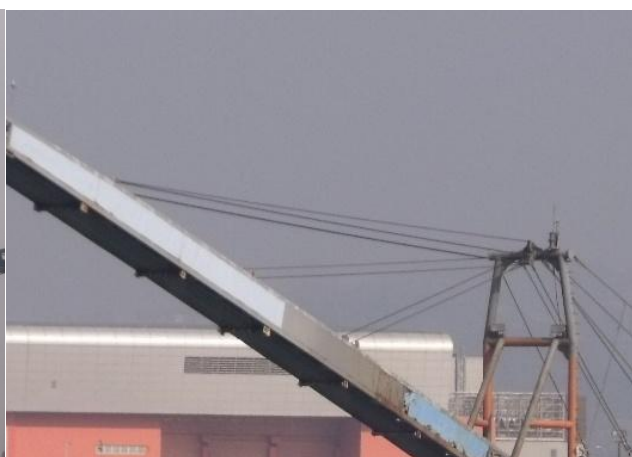
Photo record showed that the Contractor implemented dust control measures such as wind-board installed on pelican barge. The Contractor was reminded to continue to provide such dust control measure.

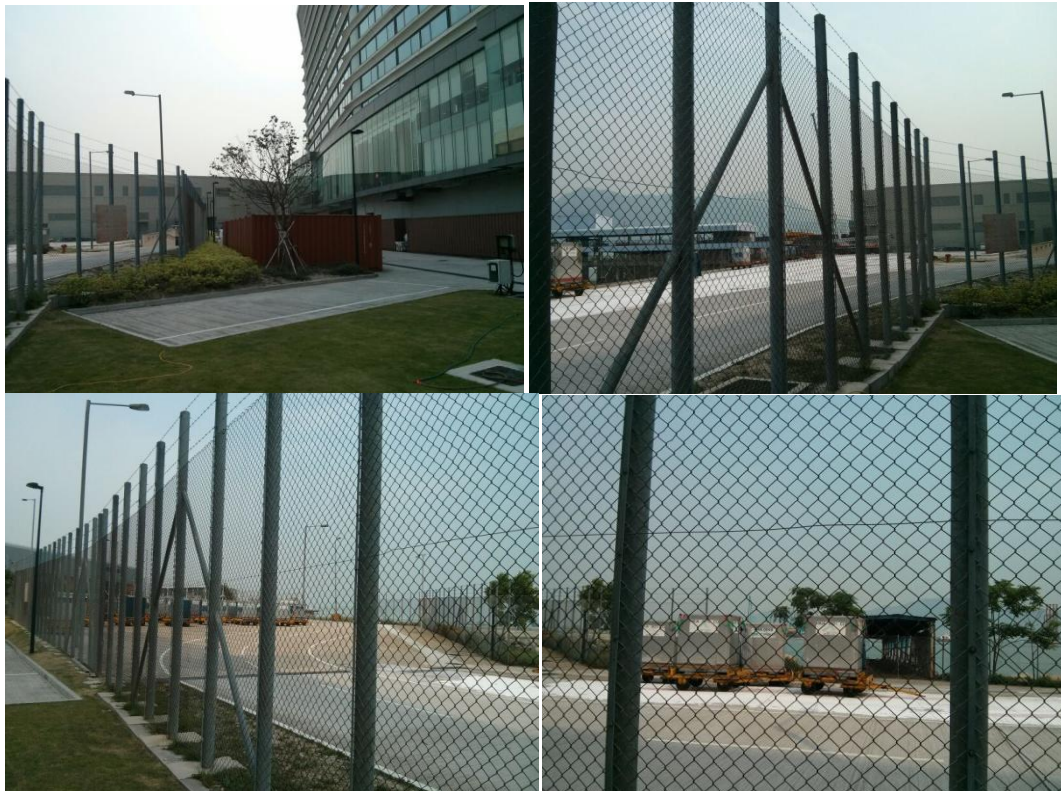
- 2.7.7.11 On the other hand, according to observation made at the monitoring station AMS7, there was no non-project potential cause/activity at the surrounding of monitoring station AMS7 which might potentially contribute to the dust action level exceedance.

Photo shows the conditions of the surrounding near the monitoring station AMS7:

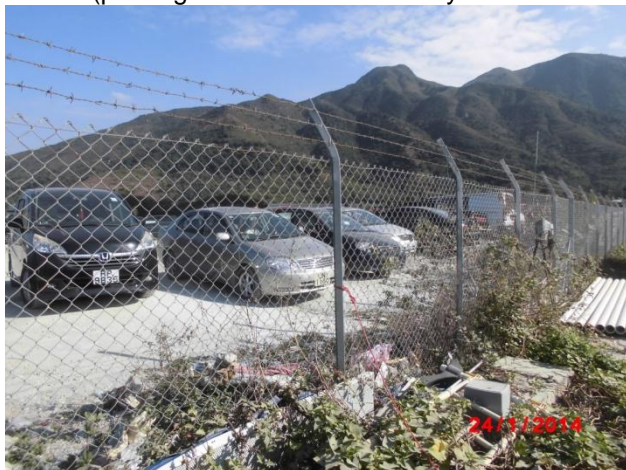
- 2.7.8.3 Photo records shows vehicle parking activities were observed inside an area at construction sites of nearby private development project which are close to the monitoring station AMS3A but beyond the site boundary of Works Area WA2. (Please also see photo and layout map attached for reference of site conditions (View A.))

View A (parking lot observed at nearby construction site which do not belongs to this Contract)

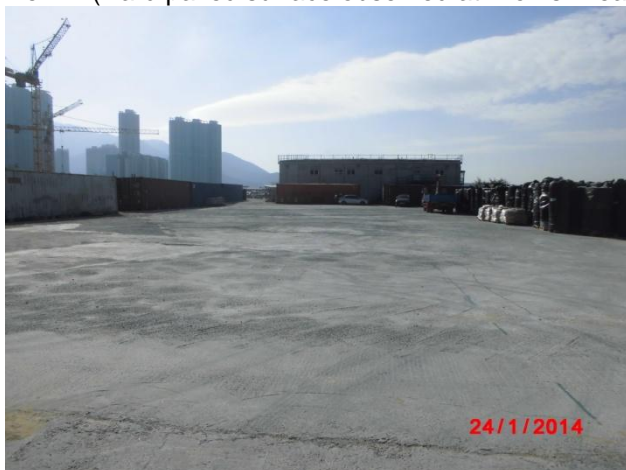
View B (Hard paved surface observed at Works Area WA2)

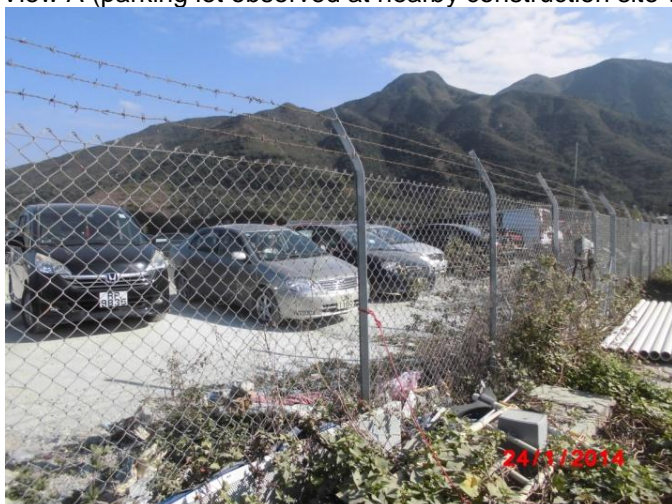
- 2.7.9.3 Photo records shows vehicle parking activities were observed inside an area at construction sites of nearby private development project which are close to the monitoring station AMS3A but beyond the site boundary of Works Area WA2. (Please also see photo and layout map attached for reference of site conditions (View A.))

View A (parking lot observed at nearby construction site which do not belongs to this Contract)

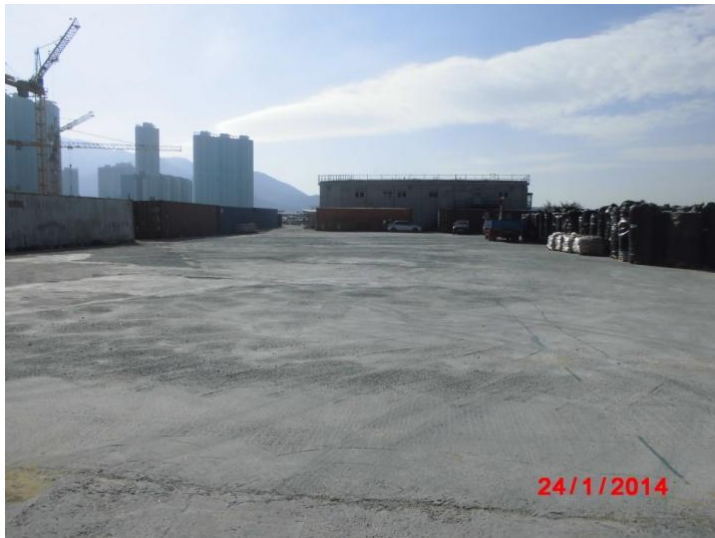
View B (Hard paved surface observed at Works Area WA2)
