Contract No. HY/2010/02

**Hong Kong – Zhuhai – Macao Bridge
Hong Kong Boundary Crossing
Facilities –
Reclamation Works**

Monthly EM&A Report for March 2014

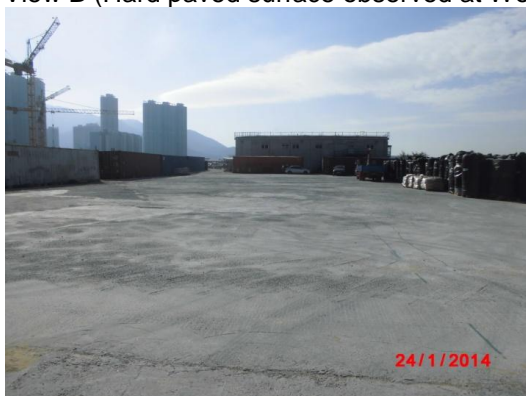
View B (Hard paved surface observed at Works Area WA2)

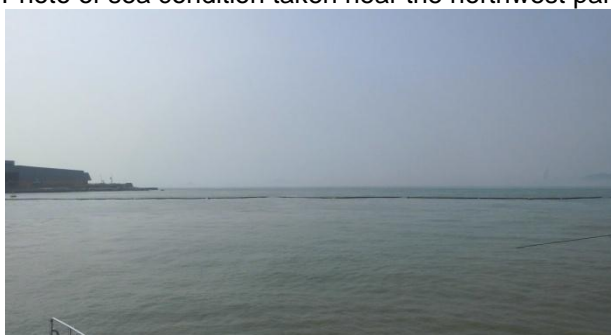
4.7.6.4 With reference to monitoring record and photo record taken on 19 and 20 March 2014, no silt plume was observed on sea near the northwest part of the site which is close to IS10. (Please see attached photo record)

4.7.6.5 Photo of sea condition taken near the northwest part of the site (Near IS10) on 19 March 14.

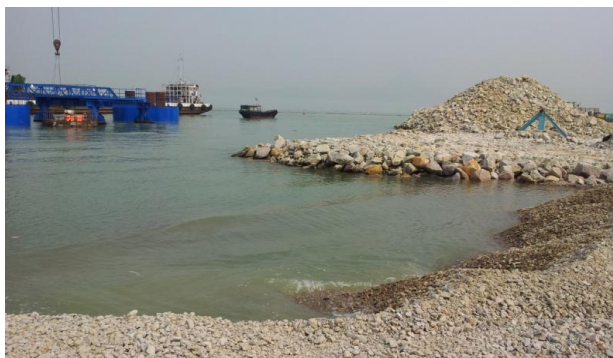
4.7.6.6 Photo of sea condition taken near the northwest part of the site (Near IS10) on 20 March 14.

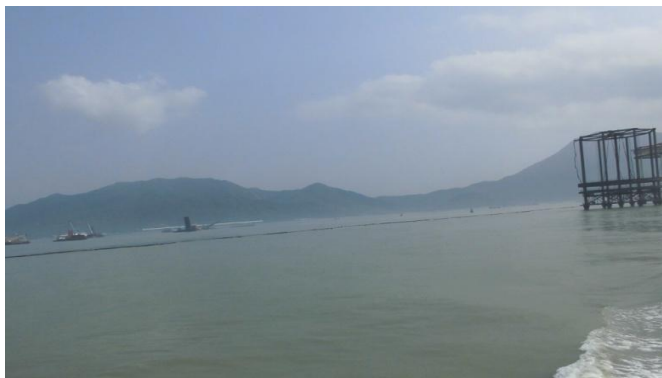
- 4.7.6.37 With reference to monitoring record and photo record taken on 19 and 20 March 2014, no silt plume was observed on sea near the northeast part of the site which is close to IS17. (Please see attached photo record)

- 4.7.6.38 Photo of sea condition taken near the northeast part of the site (Near IS17) on 19 March 14.

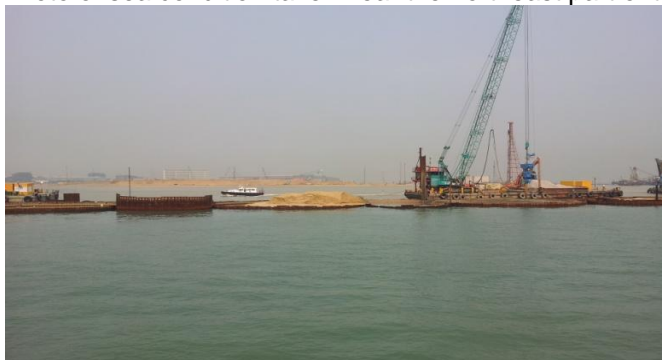
4.7.6.39 Photo of sea condition taken near the northeast part of the site (Near IS17) on 20 March 14.

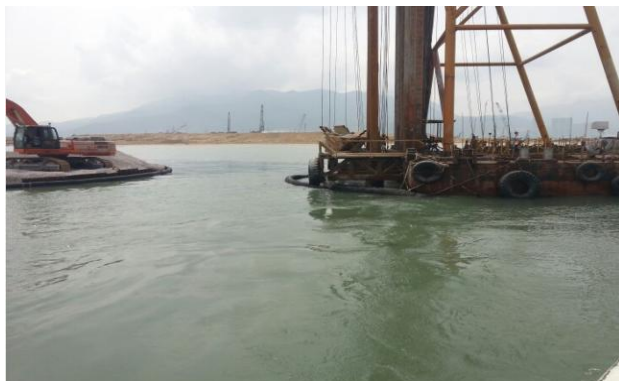
4.7.7.5 Mitigation measures such as localised silt curtain was implemented for stone column installation. (Please refer to the photo record)

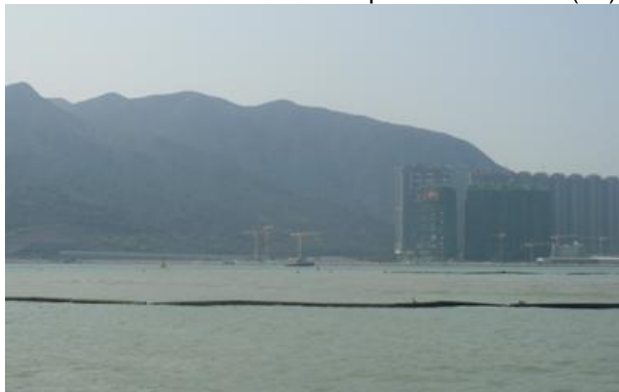
4.7.7.2 In accordance with the silt curtain integrity checking record, deficiency such as missing segments at one end of the perimeter silt curtain at the southern marine access was noted. This part of the perimeter silt curtain is close to IS(Mf)9. The Contractor was reminded to ensure provision of ongoing maintenance to the silt curtains and to carry out maintenance work once defects were found and maintenance work of the silt curtain was carried out by the Contractor on a daily basis except Sunday and public holiday.

4.7.7.6 Also, in accordance with the monitoring record, no silt plume was observed to flow from the inside of the perimeter silt curtain to the outside of the perimeter silt curtain during impact water quality monitoring on 24 March 2014. (Please refer to the photo attached which shows the sea condition near IS(Mf)9 on 24 March 2014.)

4.7.7.7 Photo of silt curtain near south part of the site IS(Mf)9 on 24 March 2014.

4.7.7.12 Nonetheless, the Contractor was reminded to ensure provision of ongoing maintenance to the silt curtains and to carry out maintenance work once defects were found.

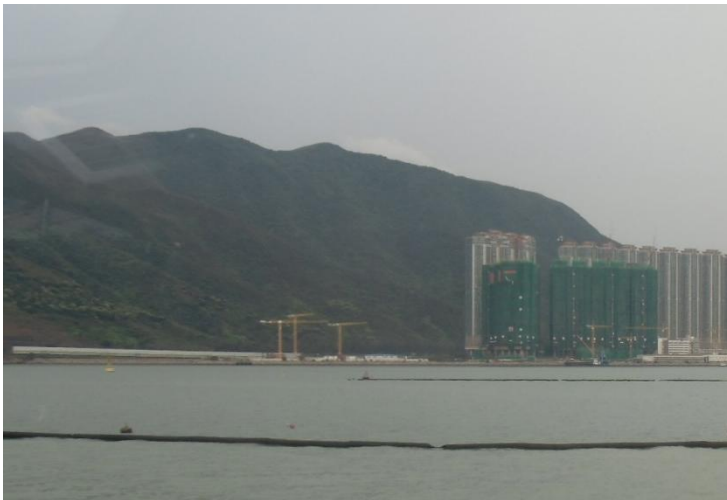
4.7.8.5 In accordance with the silt curtain integrity checking record, defects such as missing segments at southern marine access at one end of the perimeter silt curtain was noted. This part of the perimeter silt curtain is close to IS(Mf)9. The Contractor was reminded to ensure provision of ongoing maintenance to the silt curtains and to carry out maintenance work once defects were found and maintenance work of the silt curtain was carried out by the Contractor on a daily basis except Sunday and public holiday.

4.7.8.6 However, in accordance with the monitoring record, no silt plume was observed outside the perimeter silt curtain near IS(Mf)9 and IS7 on 31 March 2014. (Please refer to the photo below which shows the sea condition near IS(Mf)9 on 31 March 2014.)

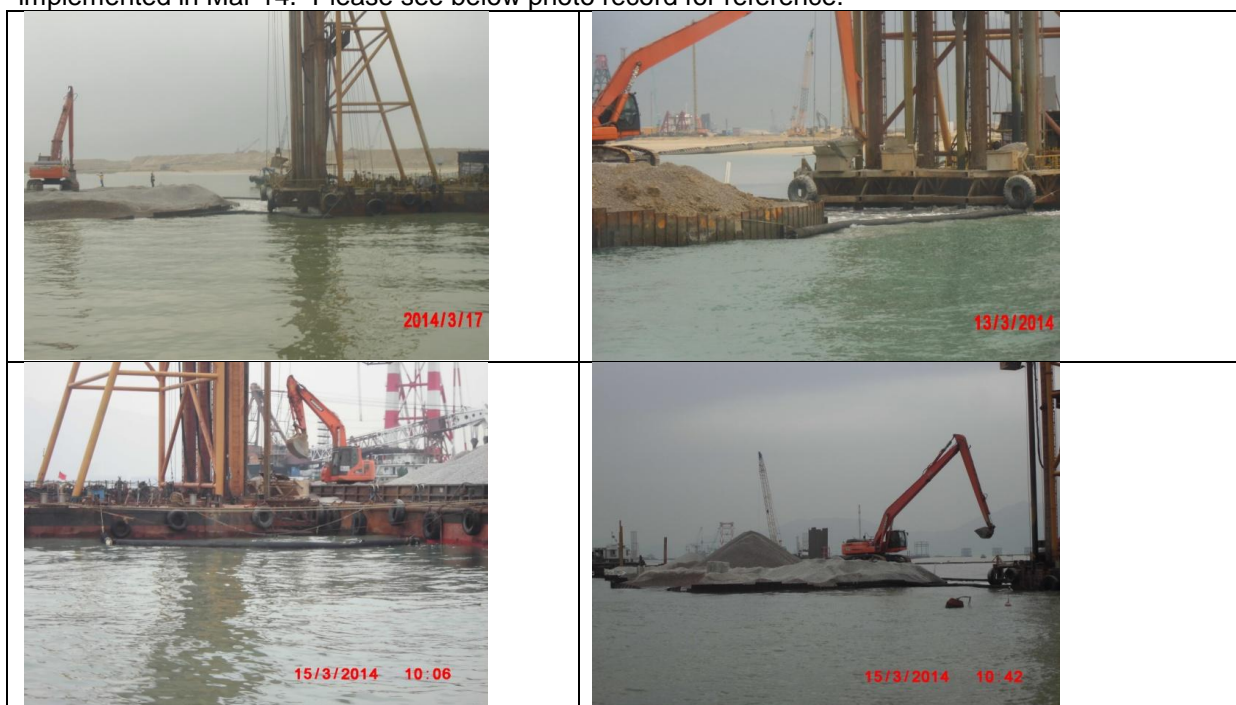
6.6.2.3 In addition, mitigation measure for active stone column installation such as localised silt curtain was implemented in Mar 14. Please see below photo record for reference.

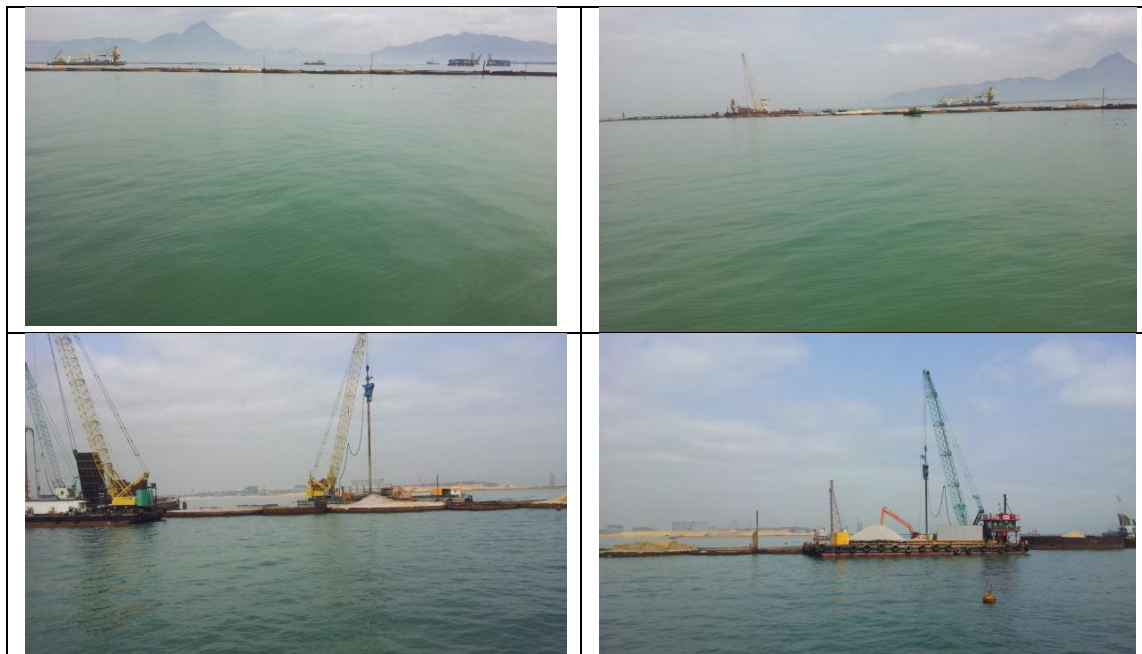
6.6.3.1 No silt plume or muddy water was observed being discharged from HKBCF – Reclamation Works during a follow-up site inspection audit conducted with the representatives of the Contractor and Residential Engineer 27 March 2014. Please see below photo record for reference.

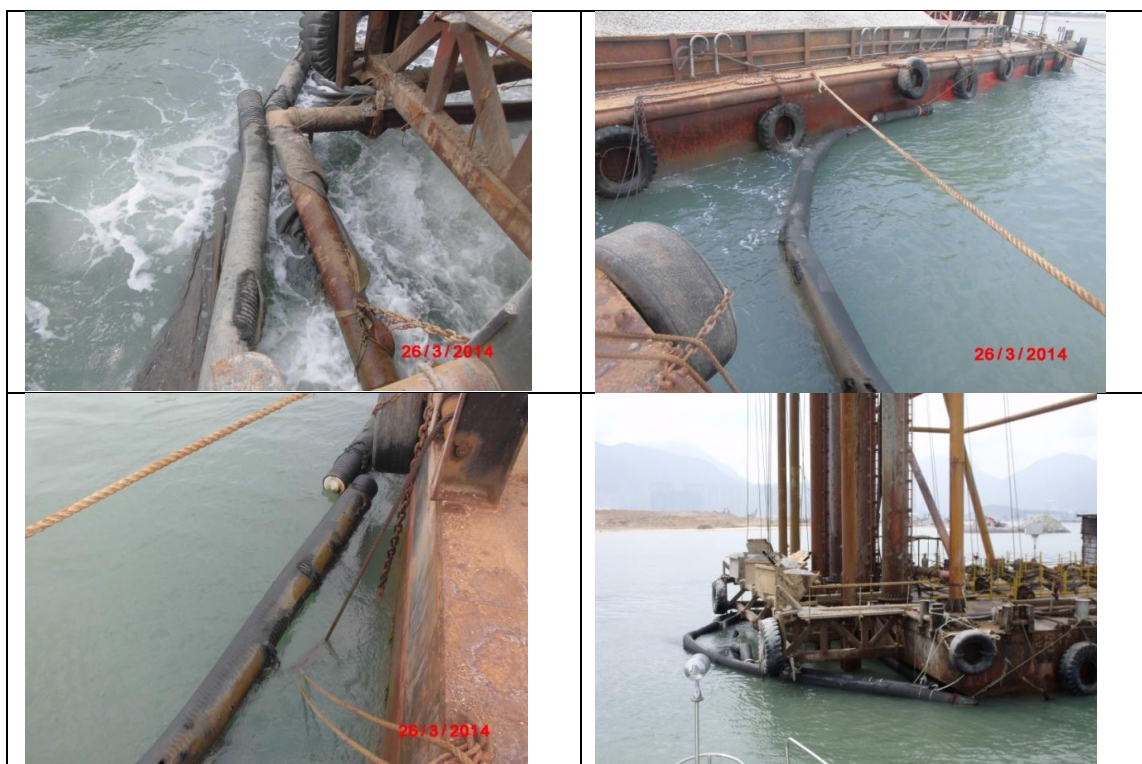
6.6.3.3 In addition, with referred to the photo record attached, mitigation measure for active stone column installation such as localised silt curtain was implemented in March 2014. Please see below photo record for reference.

6.6.3.5 Nevertheless, the Contractor was recommended to continue implementing existing water quality mitigation measures.

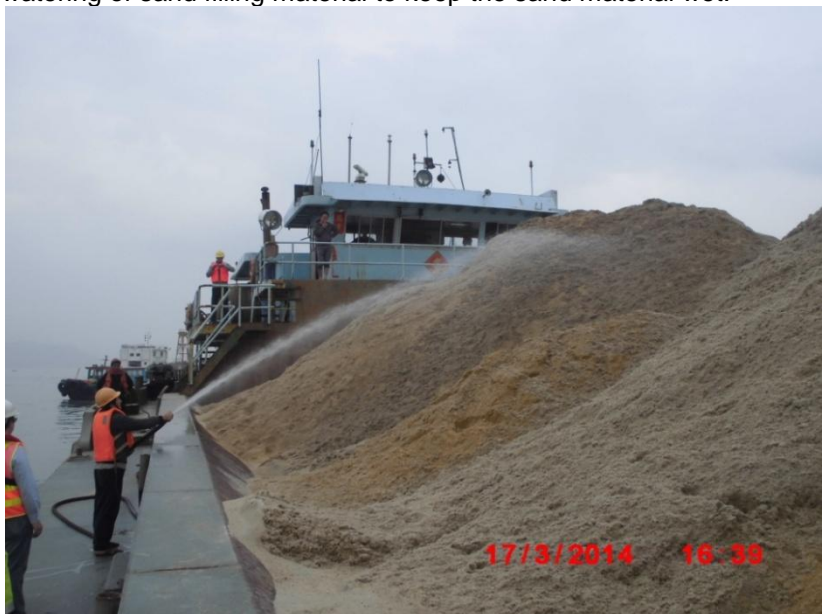
6.6.4.3 Photo record shows that watering equipment was provided on pelican barge loaded with sand for watering of sand filling material to keep the sand material wet:

6.6.4.4 Nevertheless, the Contractor was reminded to continue to properly implement all dust mitigation measures.

6.6.4.5 The Contractor was advised to ensure to continue the provision of fugitive dust mitigation measures to barges loaded with filling material such as watering to sand filling material on sand barges to keep the surface of stockpile of filling material wet.
