Contract No. HY/2010/02

**Hong Kong – Zhuhai – Macao Bridge
Hong Kong Boundary Crossing
Facilities –
Reclamation Works**

Monthly EM&A Report for August 2014

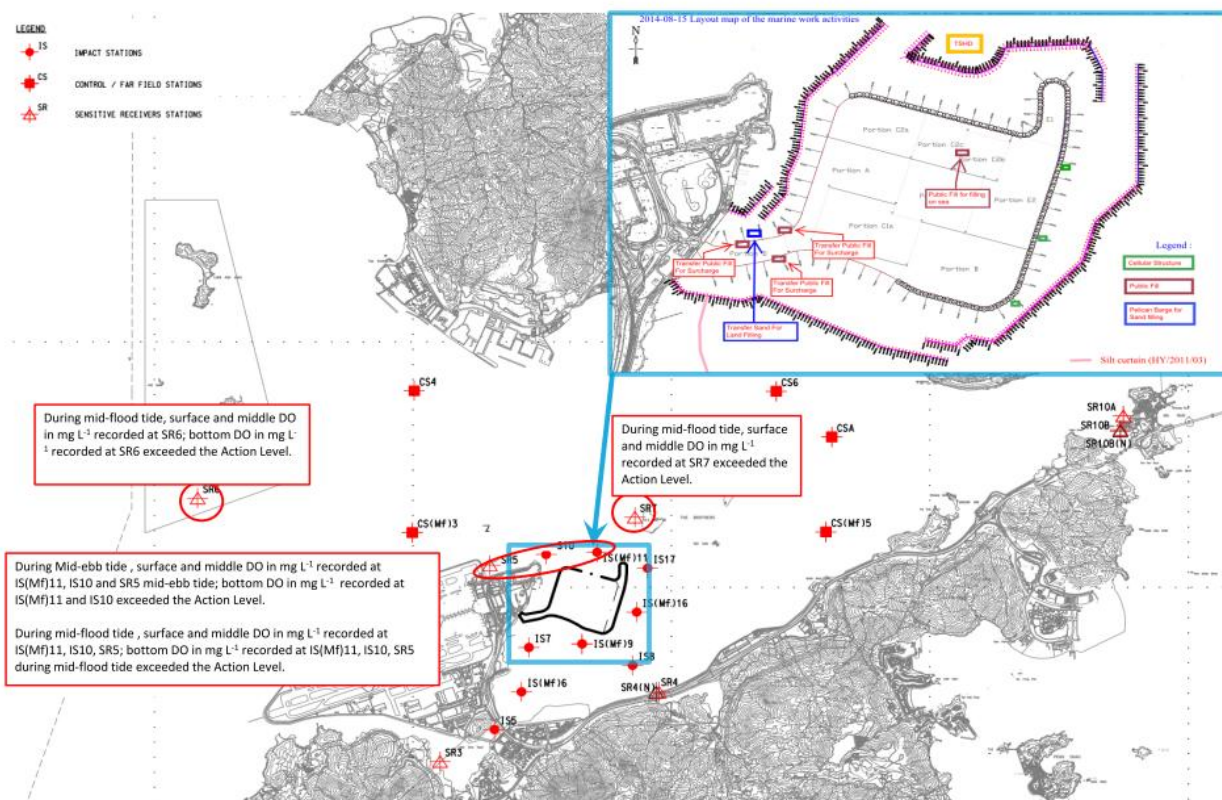
4.7.3 During Mid-ebb tide on 15 August 2014, surface and middle DO in mg L^{-1} recorded at IS(Mf)11, IS10 and SR5 mid-ebb tide; bottom DO in mg L^{-1} recorded at IS(Mf)11 and IS10 exceeded the Action Level. During mid-flood tide on 15 August 2014, surface and middle DO in mg L^{-1} recorded at IS(Mf)11, IS10, SR5, SR6 and SR7 during mid-flood tide; bottom DO in mg L^{-1} recorded at IS(Mf)11, IS10, SR5 and SR6 during mid-flood tide exceeded the Action Level.

4.7.3.1 For marine works, marine filling was conducted at portion C2b during flood and ebb tide at area behind cellular structures on 15 Aug 2014. Also refer to above layout map.

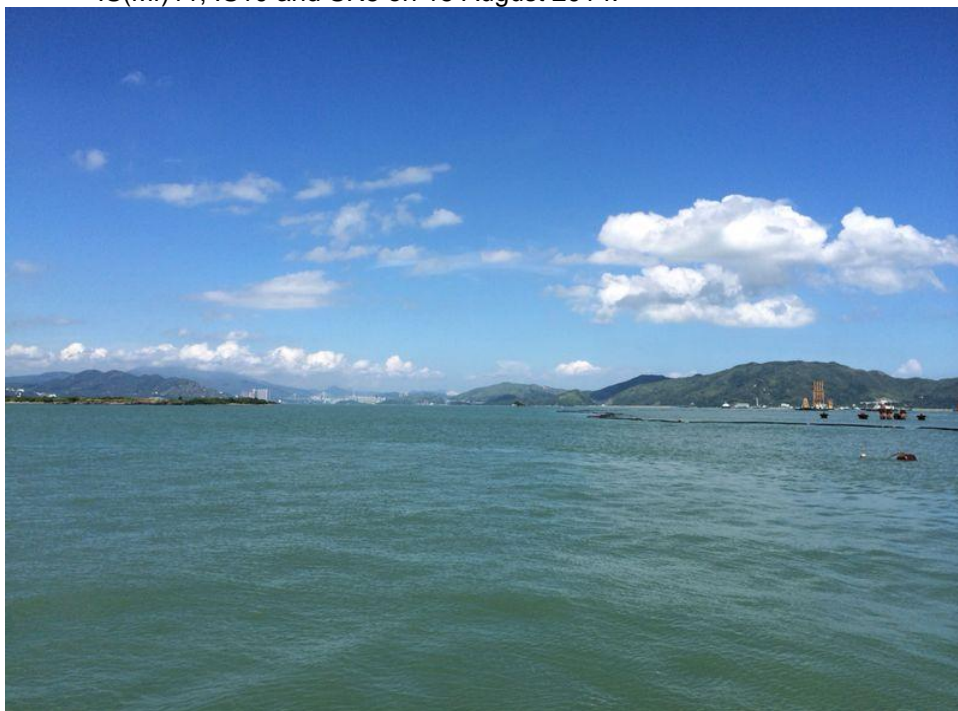
4.7.3.3 With reference to the silt curtain checking record defects was observed at north parts of the perimeter silt curtain and at southwest entrance of the perimeter silt curtain.

4.7.3.4 As informed by the Contractor, filling was conducted on 13, 15 and 18 August 2014 at Portion C2b, but with referred to monitoring record and photo record attached, no sediment plume has been observed to flow from the inside of the perimeter silt curtain to the outside of the perimeter silt curtain and no discoloration of sea water has been observed. Please refer to the photo attached for reference of the sea condition during ebb tide and flood tide on 15 August 2014.

4.7.3.5 Photo record of sea condition taken during ebb tide at north of HKBCF Reclamation Works near IS(Mf)11, IS10 and SR5 on 15 August 2014.

4.7.3.12 Nevertheless, the Contractor was reminded to ensure provision of ongoing maintenance to the silt curtains and to carry out maintenance work once defects were found.

4.7.3.13 With reference to the silt curtain checking record on 27 August 2014, the defect observed on 15 August 2014 at north part of the perimeter silt curtain has been repaired. As informed by the Contractor, maintenance work of the silt curtain is on-going and carried out by the Contractor on a daily basis.

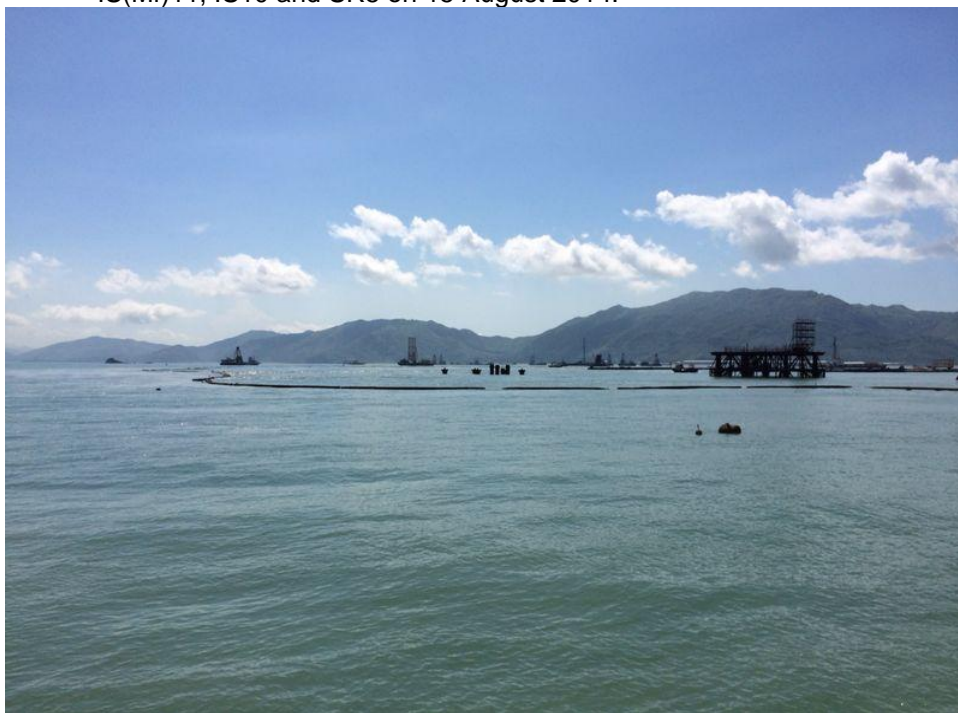
4.7.3.6 Photo record of sea condition taken during flood tide at north of HKBCF Reclamation Works near IS(Mf)11, IS10 and SR5 on 15 August 2014.

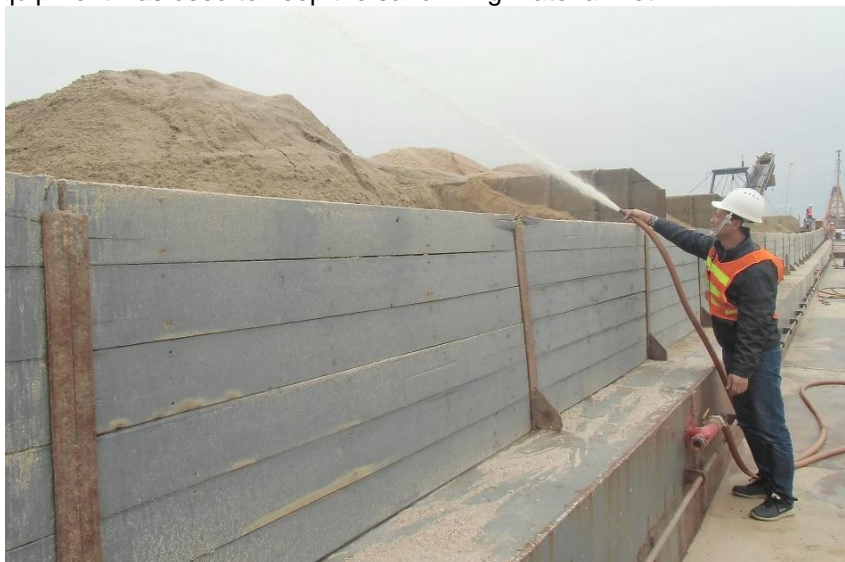
- Photo record below shows that Sand barges are equipped with watering equipments. And watering equipment was used to keep the sand filling material wet.

- In addition, site inspection has been jointly conducted with the Contractor and RSS on 28 August 2014, but no generation of fugitive dust was observed to be caused by barges loaded with filling material.

6.6.3.4 After investigation, there is no adequate information to conclude the observed impact is related to this Contract.
