Contract No. HY/2010/02

## Hong Kong – Zhuhai – Macao Bridge Hong Kong Boundary Crossing Facilities – Reclamation Works

Monthly EM&A Report for October 2014

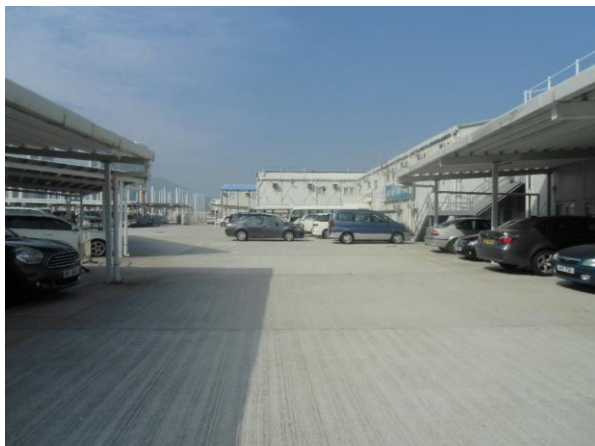
- 1 Works Area WA2's surface was hard-paved, compacted or hydro-seeded (Please refer to above layout map and photo records below (View A))

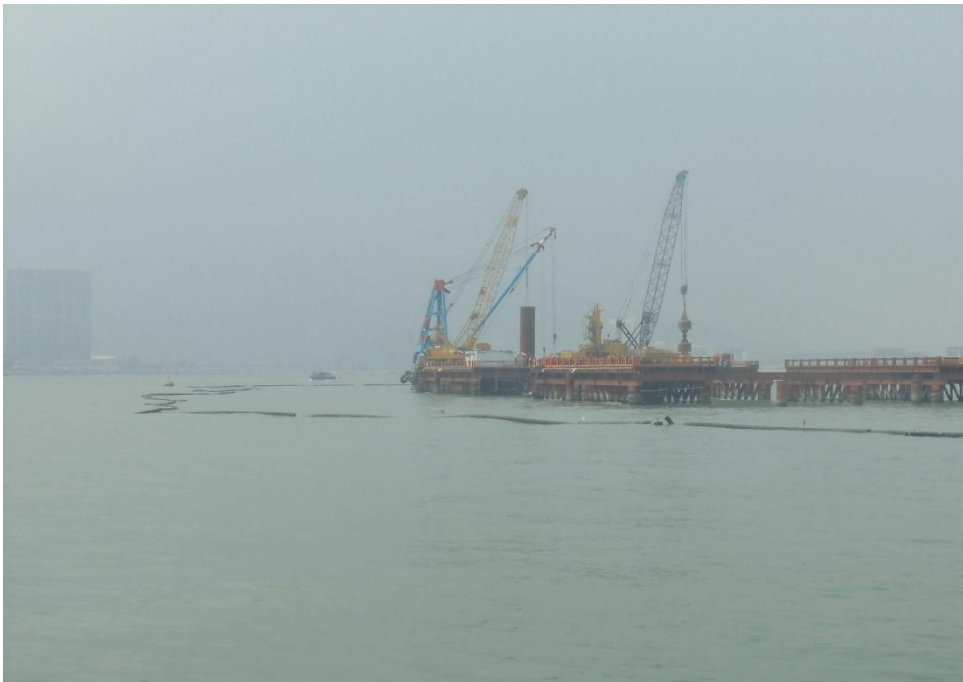
4.7.5.5 In accordance with the silt curtain integrity checking record of 3 October 2014, disconnection of the perimeter silt curtain was observed at the southeast part of HKBCF Reclamation Works, but with referred to monitoring record and photo record below, no sediment plume has been observed to flow from the inside of the perimeter silt curtain to the outside of the perimeter silt curtain and no discoloration of sea water has been observed. (Please refer to below photo). In accordance with the silt curtain integrity checking record, the observed disconnection was rectified on 6 October 2014

4.7.5.6 Photo record above shows the sea condition taken during flood tide at HKBCF Reclamation Works near IS8 on 3 October 2014.

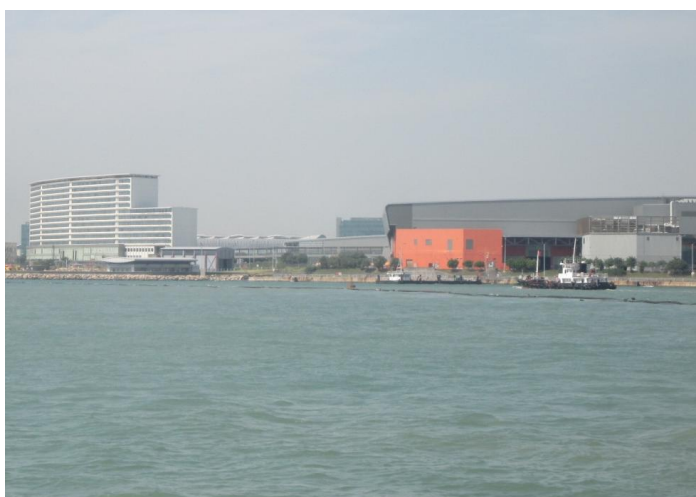
- 4.7.6.17 ET's conclusions and recommendations for mitigation: Mitigation measures such as perimeter silt curtain was implemented by the Contractor, however defects of the perimeter silt curtain was observed, the Contractor was reminded to ensure swift provision of maintenance to the silt curtains once defects were found.

- 4.7.6.19 Photo shows sea condition at northwest part of HKBCF reclamation works on 6 Oct 2014 during ebb tide

- 4.7.6.18 Contractor's actions to implement the mitigation: With refer to the maintenance record provided by the Contractor, maintenance work for the defects of the northwest part of the perimeter silt curtain was conducted on 28 October 2014.

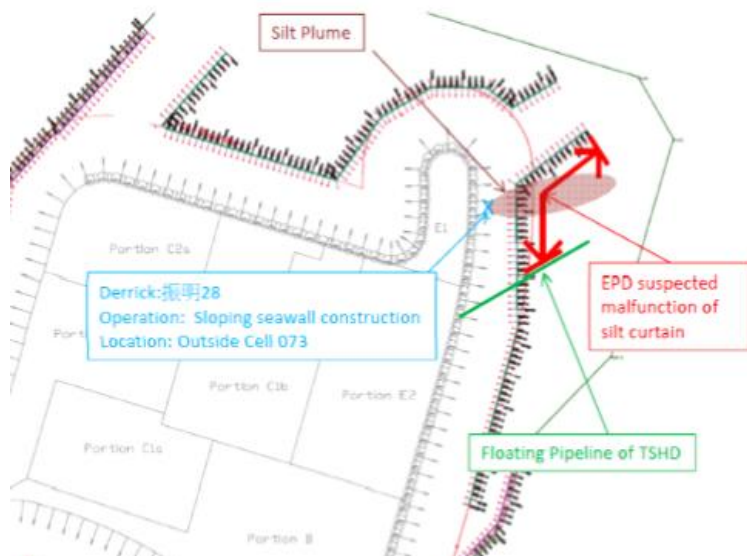
- Diver checking and rectification record for integrity of silt curtain has been checked and it shows that the part of the silt curtain which was suspected to be malfunction (showed by red arrow in the diagram below) has been rectified by the Contractor.

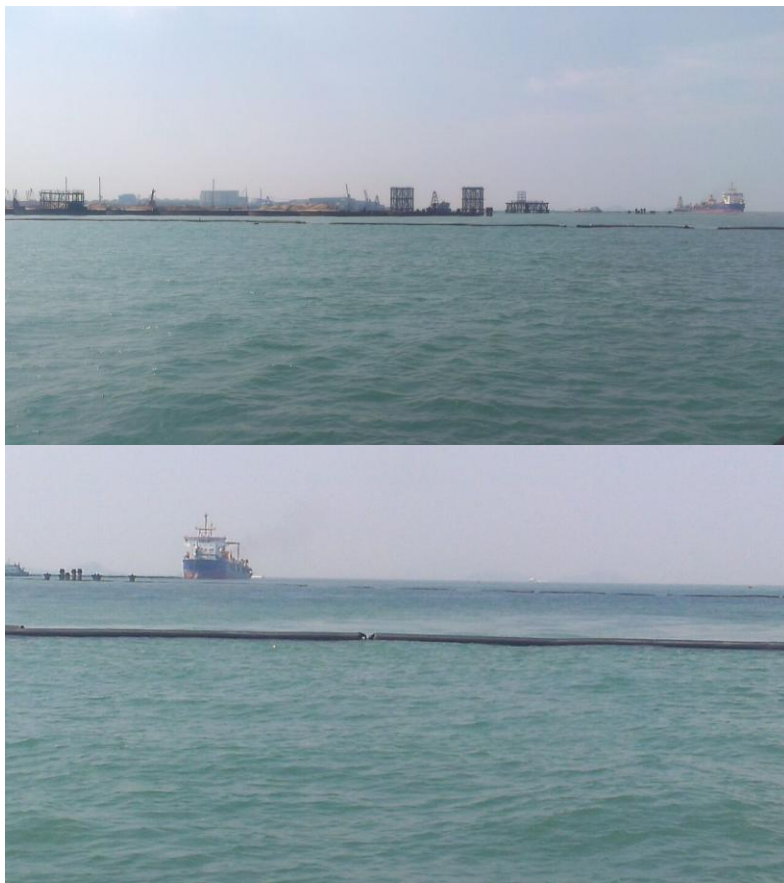
- Subsequently, a rock placement trial was conducted by the Contractor on 28 October 2014. Silt plume was observed during the process but Figure 3.8 of the investigation report shows that spreading to the outside of the silt curtain was prevented by the silt curtain.
- Photo records taken on 31 October 2014 shows the sea condition at sea area near the northeast side of the HKBCF Reclamation Works and no silt plume was observed spreading out from Portion E1 of the construction site through the silt curtain:

- 6.4.7.6 As informed by the Contractor, rockfill materials would be placed more slowly by the derrick as well as the lowest dropping point to minimize the generation of silt plume. Daily site inspection in the area would be conducted so that any damaged parts of silt curtain can be observed and repaired promptly.

- 6.4.7.7 The Contractor was further reminded to ensure swift provision of maintenance to the perimeter silt curtains once defects of the perimeter silt curtain were observed and continue the preventive measures during rock filling and keep the site inspected at least daily to ensure compliance with respect to the recommendations in the EIA Report and EM&A Manual in particular on EIA Ref. Section 9.11.1.1

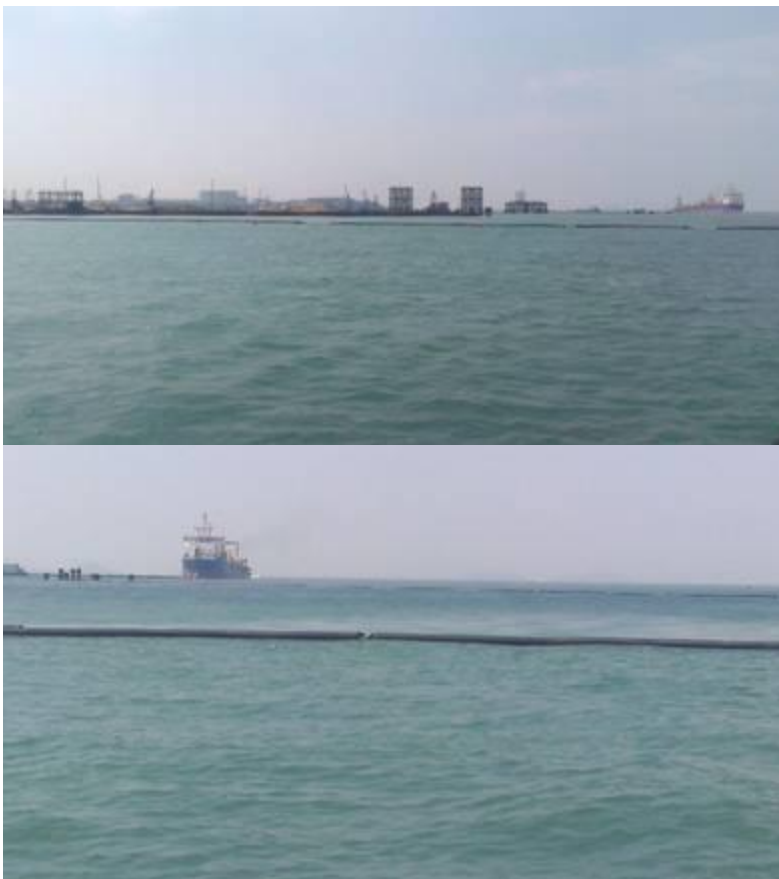
- IWQM data obtained on 27 and 29 October 2014 were reviewed; no water quality monitoring exceedance was noted on 27 and 29 October 2014.
- Ad hoc site inspection was subsequently conducted on 31 October 2014 but no silt plume or turbid water was observed on 31 October 2014. Photo records taken on 31 October 2014 at around 01:00pm which shows the sea condition at sea area near Portion E1 of the HKBCF Reclamation Works:

6.4.8.4 The Contractor was reminded that all water quality mitigation measures with respect to the recommendations in the EIA Report and EM&A Manual in particular on EIA Ref. Section 9.11.1.6 should be fully and properly implemented.

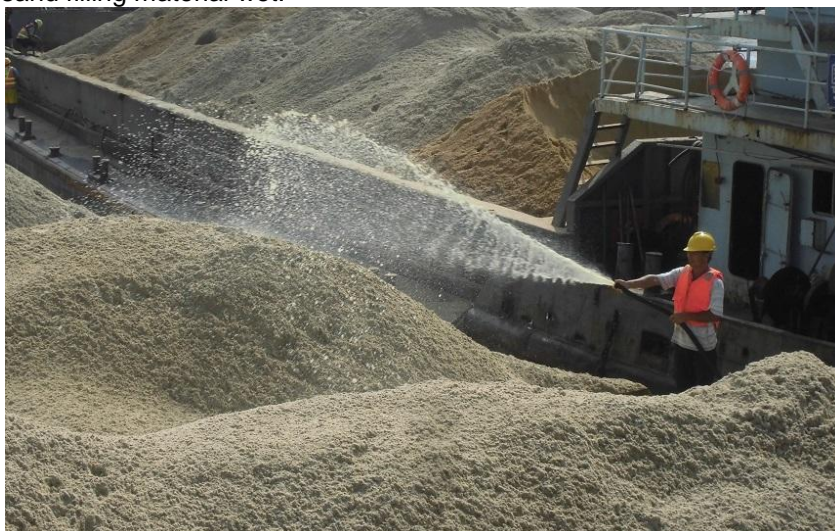
- As informed by the Contractor, the Contractor would continue to provide watering to stockpile of sand on sand delivery barges.
- Photo record below shows that sand barges were not covered but they are equipped with watering equipment and in order to prevent generation of fugitive dust, watering equipment was used to keep the sand filling material wet.

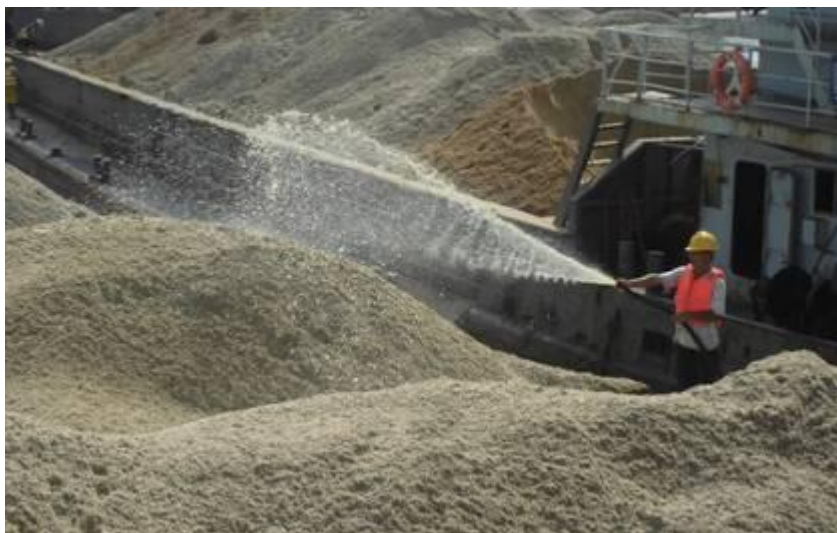
- In addition, sand delivery barges are equipped with watering equipment and in order to prevent generation of fugitive dust, watering equipment was used to keep the sand filling material wet.

- Nonetheless, as informed by the Contractor, the Contractor would study the feasibility of covering stockpile of sand on sand delivery barges.
