Contract No. HY/2010/02

**Hong Kong – Zhuhai – Macao Bridge
Hong Kong Boundary Crossing
Facilities –
Reclamation Works**

Monthly EM&A Report for January 2015

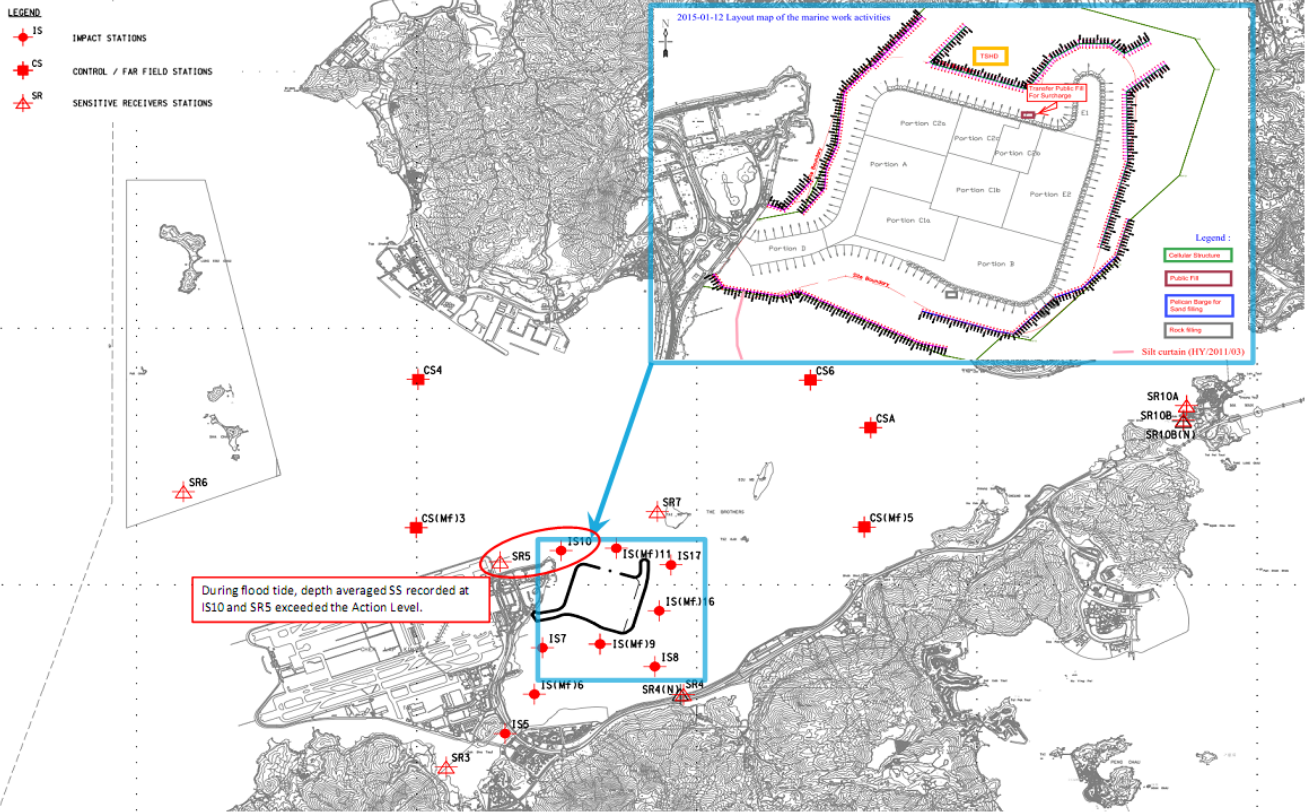
4.7.2 For water quality, one (1) action level exceedance was recorded at IS10 and one (1) action level exceedance was recorded at SR5 respectively on 12 January 2015 during flood tide.

4.7.2.1 Attached layout map shows active works conducted on 12 January 2015. No marine based construction works such as filling were conducted at northwest part of the HKBCF Reclamation Works.

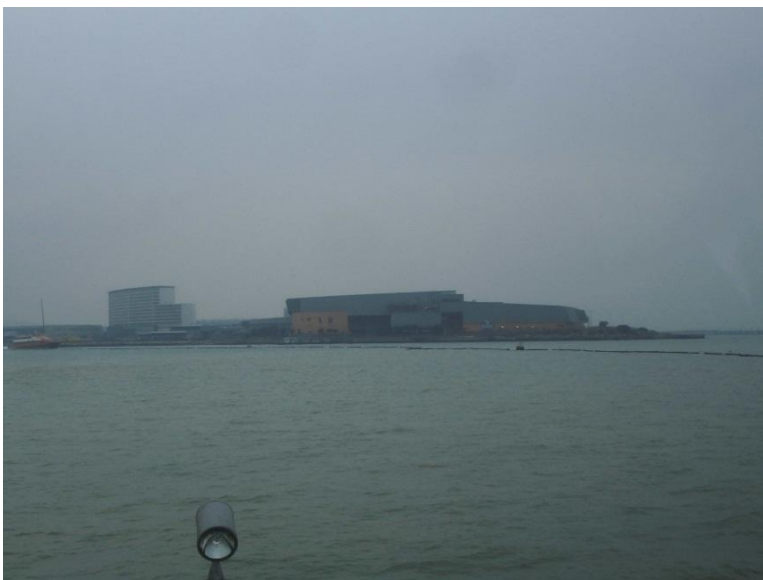
4.7.2.3 With reference to the silt curtain checking record, defects was not observed at northwest part of the perimeter silt curtain which are close to the IS10 and SR5.

4.7.2.4 No filling activities was observed in progress and no silt plume was observed to flow from the inside of the perimeter silt curtain to the outside of the perimeter silt curtain when monitoring was conducted at IS10 and SR5. (Also see attached for sea condition observed on 12 January 2015 during flood tide.)

4.7.2.5 Photo record which shows the sea condition near Portion C2a, the northwest part of the HKBCF

4.7.2.10 Nevertheless, the Contractor was reminded to ensure provision of ongoing maintenance to the silt curtains and to carry out maintenance work once defects were found.

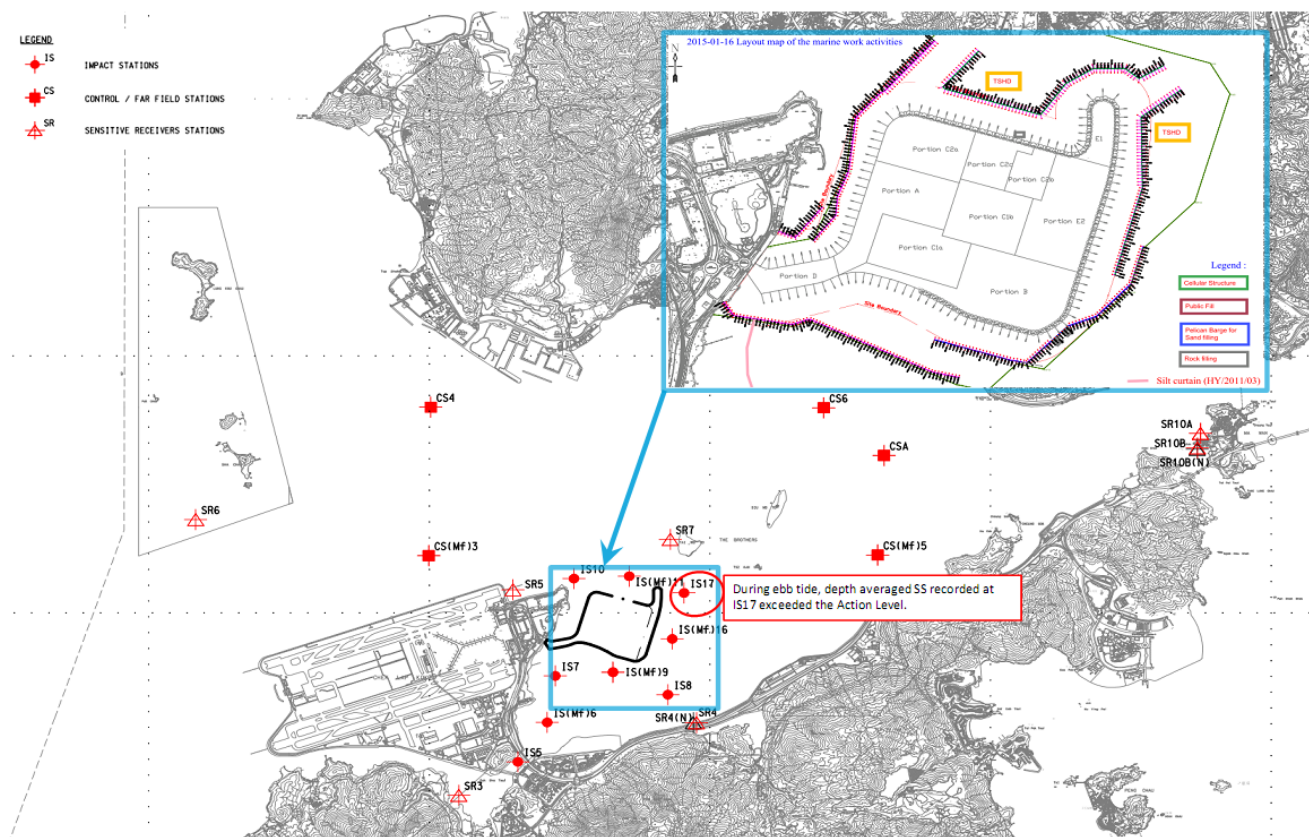
4.7.3.1 Attached layout map shows active works conducted on 16 January 2015. Marine based construction activities such as rock filling was conducted at north part of the HKBCF Reclamation Works.

4.7.3.4 With refer to the layout map attached, rock filling is the only marine based construction works conducted during ebb tide on 16 January 2015 at portion C2C which relatively far away from IS17, as such, it is unlikely to cause the exceedance of SS at IS17.

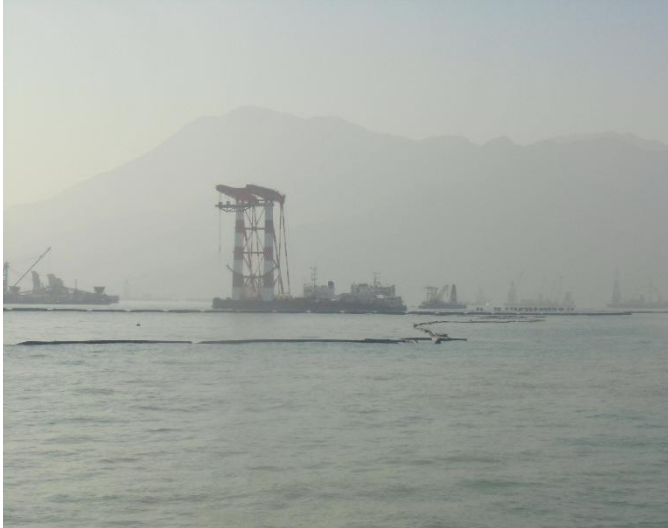
4.7.3.6 In addition, with referred to monitoring record, no sediment plume has been observed to flow from the inside of the perimeter silt curtain to the outside of the perimeter silt curtain during ebb tide on 16 January 2015. (Please refer to photo record taken during ebb tide on 16 January 2015)

4.7.3.7 Photo record which shows the sea condition near Portion E1, the northeast part of the HKBCF reclamation works at ebb tide on 16 January 2015.

4.7.3.11 Nevertheless, the Contractor was reminded to ensure provision of ongoing maintenance to the silt curtains and to carry out maintenance work once defects were found.

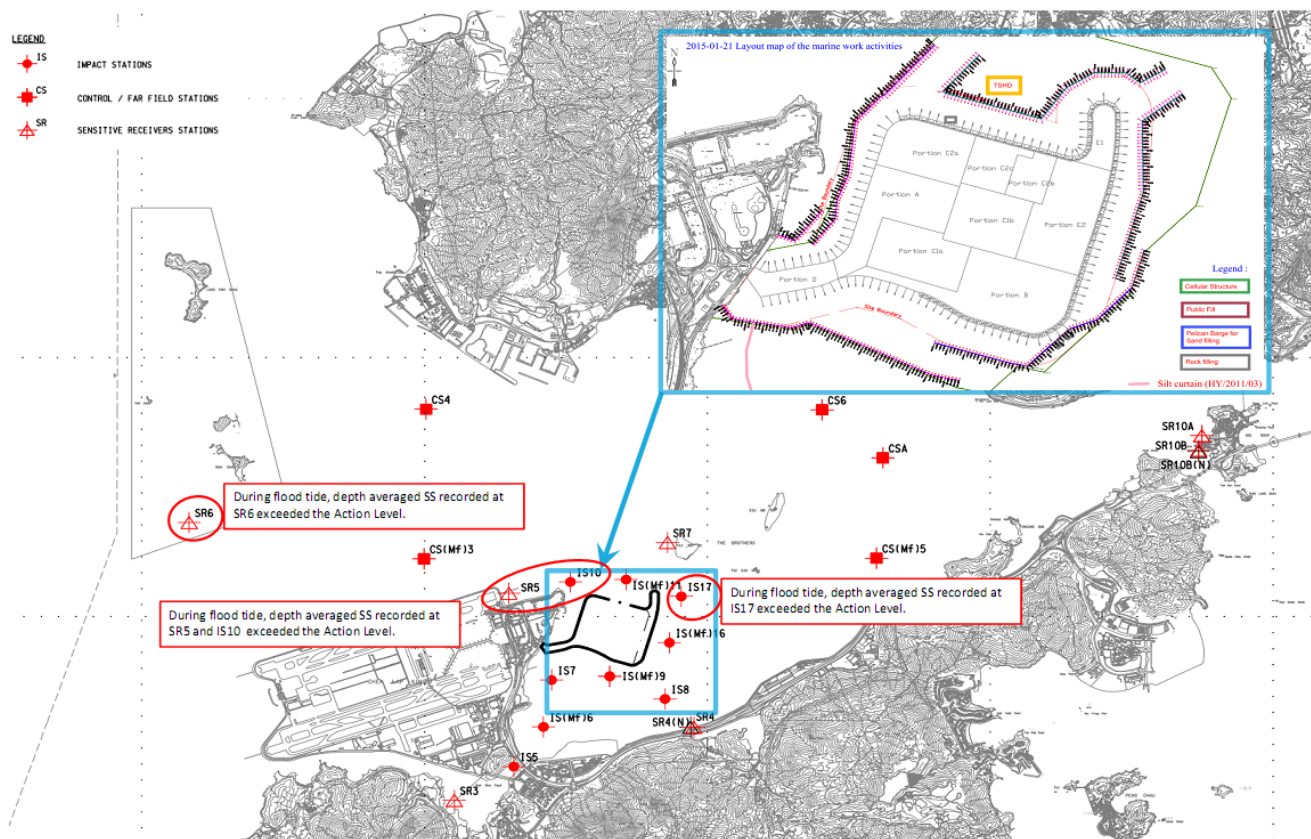
4.7.4.1 Attached layout map shows active works conducted on 21 January 2015. Construction works such as rock filling was conducted near portion C2a of the HKBCF Reclamation Works on 21 January 2015.

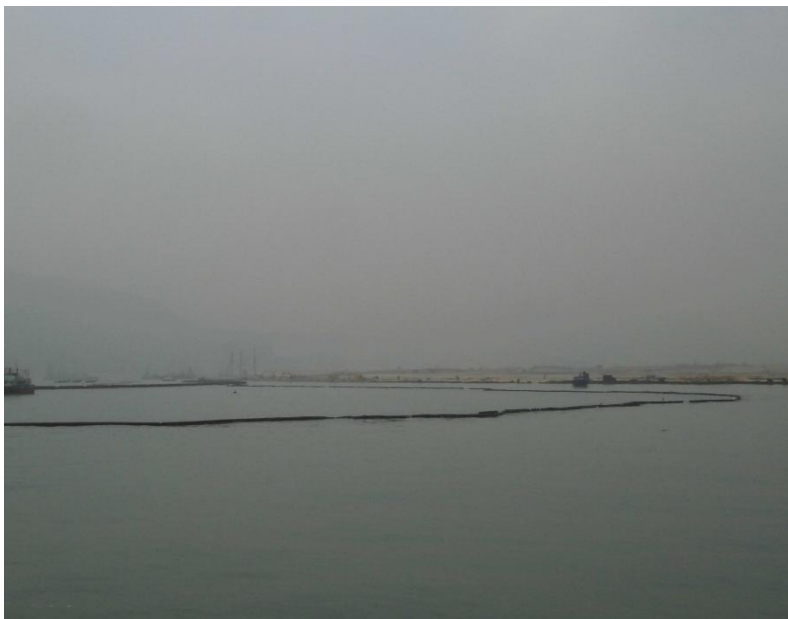
4.7.4.8 With reference to the silt curtain checking record, defects were observed at northeast part of the silt curtain.

4.7.4.9 Although rock filling was conducted near portion C2a during flood tide, no silt plume was observed to flow from the inside of the perimeter silt curtain to the outside of the perimeter silt curtain when monitoring was conducted. (Also see attached photo record for sea condition on 21 January 2015 during northwest side of the HKBCF Reclamation Works during flood tide.)

4.7.4.10 Photo record which shows the sea condition near at northeast side of HKBCF Reclamation Works at flood tide on 21 January 2015.

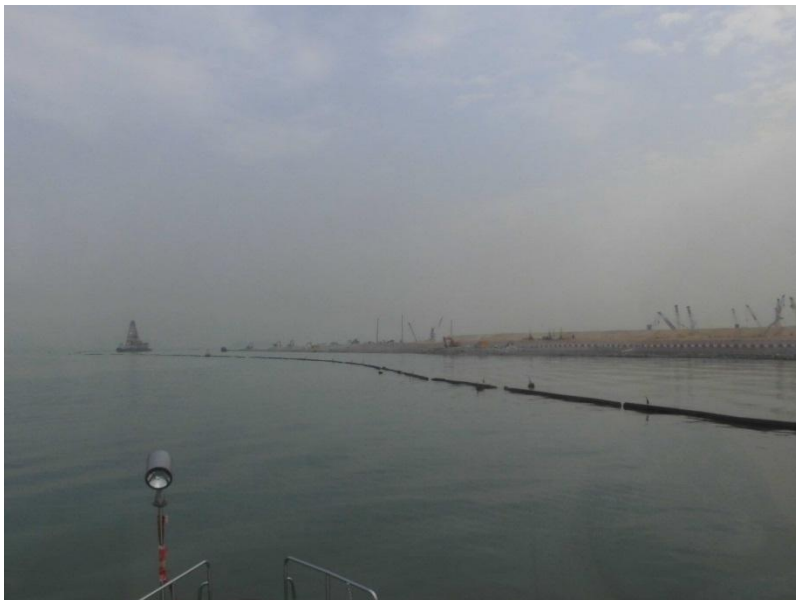
4.7.4.4 Rock filling was conducted near portion C2a during flood tide, but no silt plume was observed to flow from the inside of the perimeter silt curtain to the outside of the perimeter silt curtain when monitoring was conducted. (Also see attached photo record for sea condition taken at west side of the HKBCF Reclamation Works on 21 January 2015 during flood tide.)

4.7.4.11 Photo record which shows the sea condition near at west side of HKBCF Reclamation Works at flood tide on 21 January 2015.

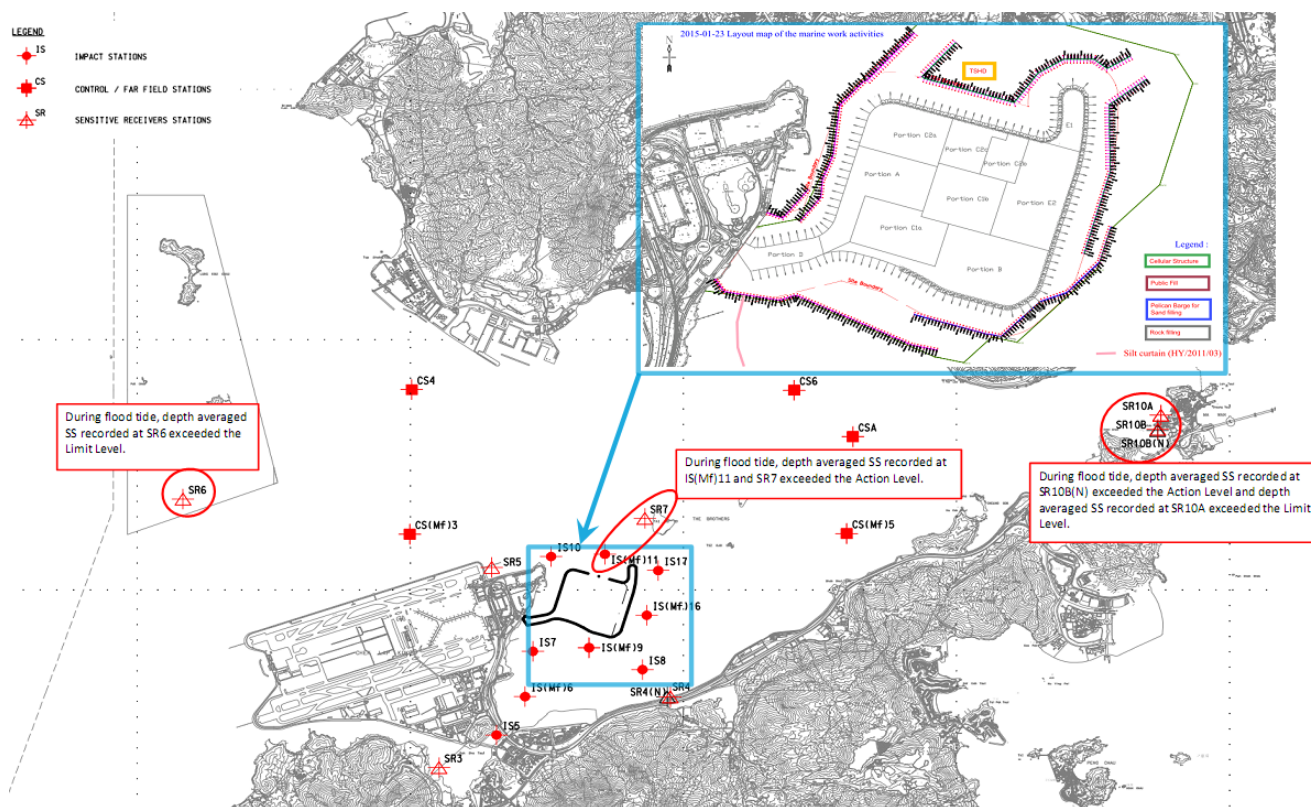
4.7.5.1 Attached layout map shows active works conducted on 23 January 2015. Marine based construction works such rock filling were conducted at southeast part of HKBCF Reclamation Works.

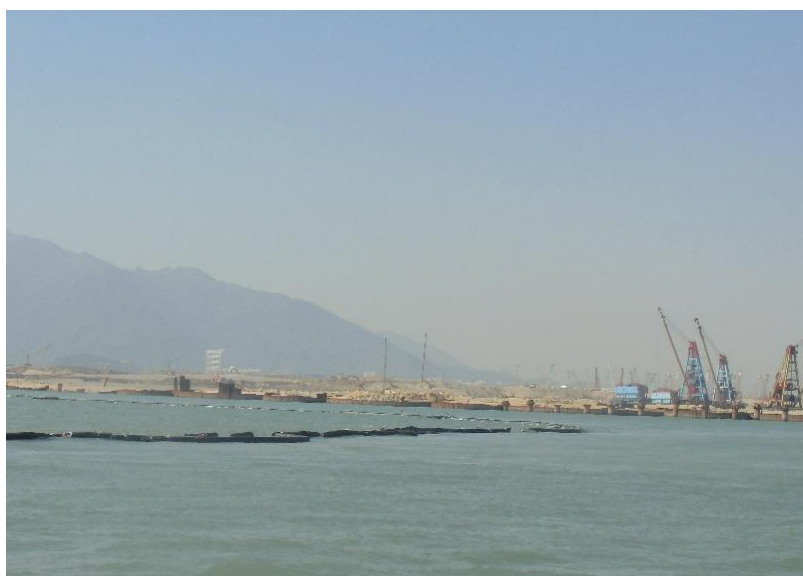
- 4.7.5.11 With reference to the silt curtain checking record, defects were observed at north and northwest part of the perimeter silt curtain which are close IS11.

- 4.7.5.12 With referred to the attached layout map, marine based construction works such rock filling were conducted at southeast part of the site, however no silt plume was observed to flow from the inside of the perimeter silt curtain to the outside of the perimeter silt curtain when monitoring was conducted during flood tide. (Also see attached for sea condition observed on 23 January 2015 during flood tide.)

- 4.7.5.13 Photo record which shows the sea condition at northeast part of the HKBCF reclamation works during flood tide on 23 January 2015.

4.7.5.19 Nevertheless, the Contractor was reminded to ensure provision of ongoing maintenance to the silt curtains and to carry out maintenance work once defects were found.

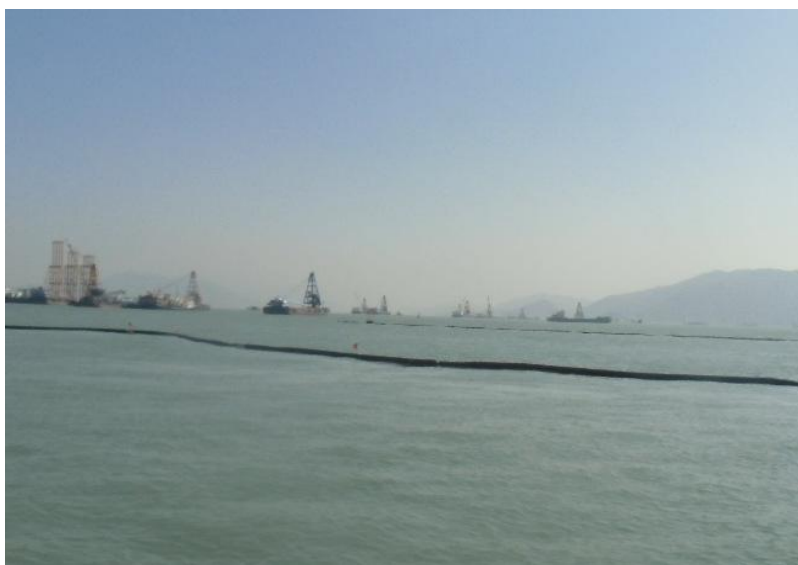
- 4.7.5.14 Photo record which shows the sea condition at east part of the HKBCF reclamation works during flood tide on 23 January 2015.

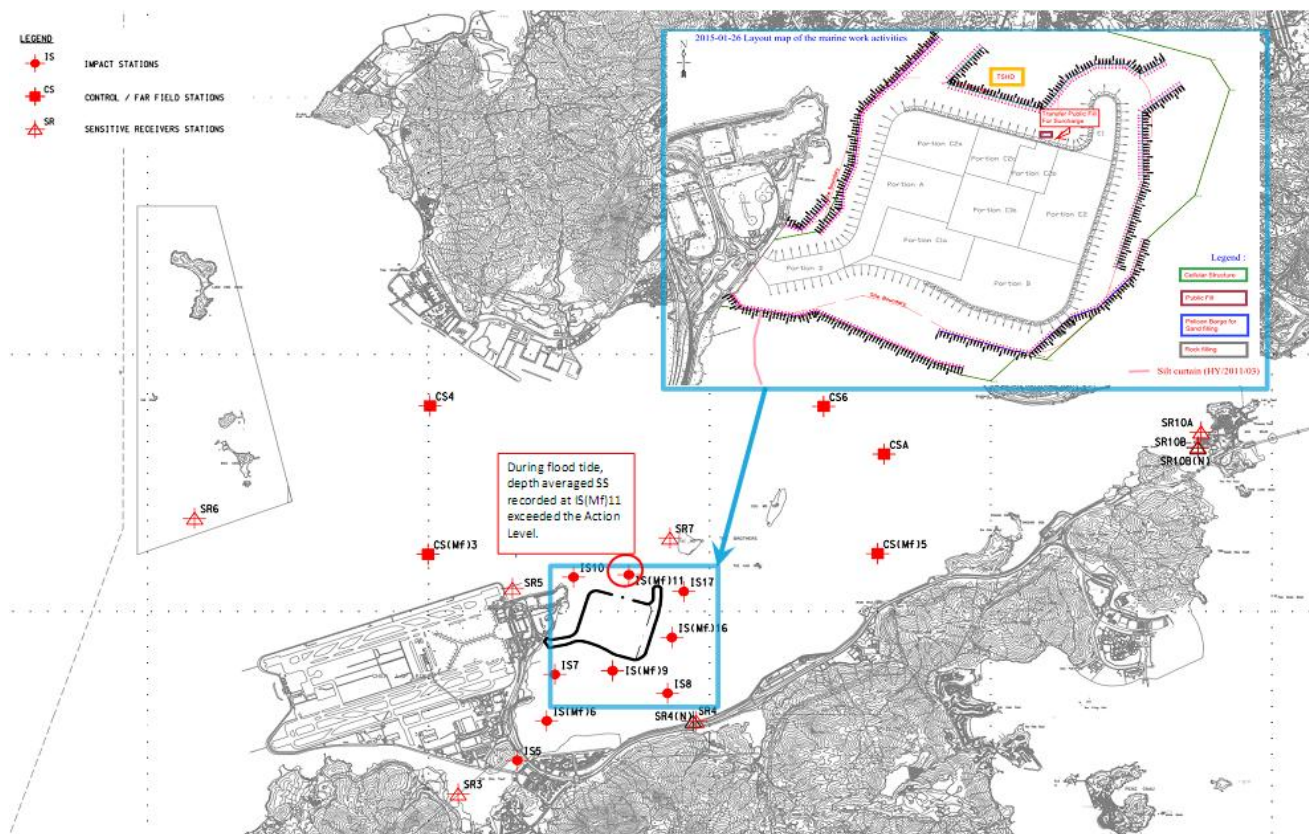
4.7.6.1 Attached layout map shows active works conducted on 26 January 2015. No marine based construction works such as marine filling were conducted at the HKBCF Reclamation Works.

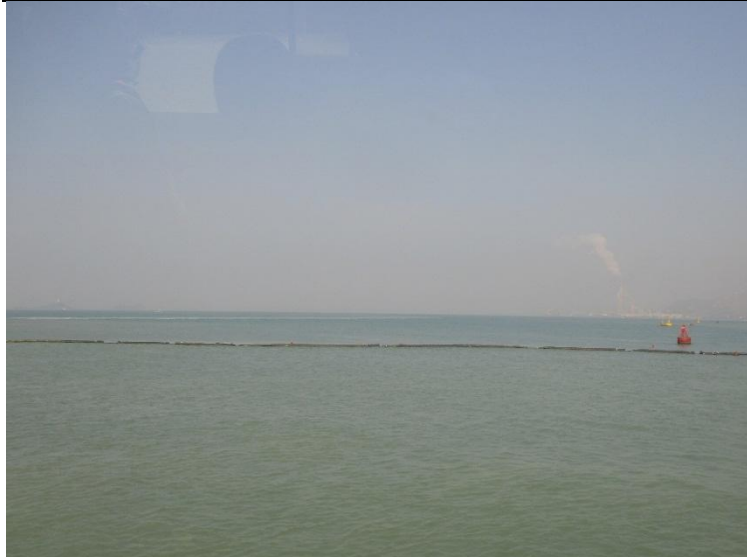
4.7.6.3 With reference to the silt curtain checking record, defect was observed at north part of the perimeter silt curtain which are close to the IS(Mf)11.

4.7.6.4 No filling activities was observed in progress and no silt plume was observed to flow from the inside of the perimeter silt curtain to the outside of the perimeter silt curtain when monitoring was conducted at IS(Mf)11. (Also see attached for sea condition observed on 26 January 2015 during flood tide.

4.7.6.5 Photo record which shows the sea condition at north part of the HKBCF reclamation works during flood tide on 26 January 2015.

- 4.7.6.10 Nevertheless, the Contractor was reminded to ensure provision of ongoing maintenance to the silt curtains and to carry out maintenance work once defects were found.
