Contract No. HY/2010/02

Hong Kong – Zhuhai – Macao Bridge Hong Kong Boundary Crossing Facilities – Reclamation Works

Monthly EM&A Report for December 2016

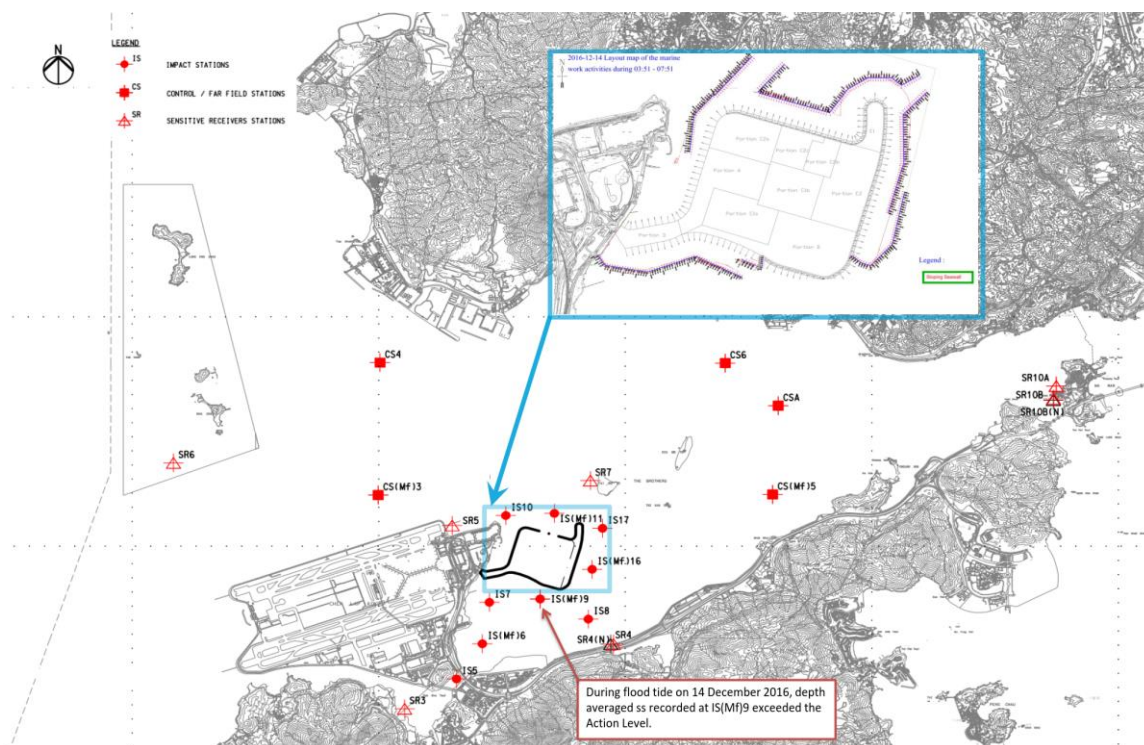
4.7.2.1 Below layout map shows that no marine based construction works were carried out at HKBCF Reclamation Works:

4.7.2.3 Exceedance was recorded at 07:51 on 14 December 2016, with referred to the layout map attached, no marine based construction works were conducted during flood tide, between 03:51 to 07:51, on 14 December 2016, as such, it is unlikely to cause the exceedance of SS at IS(Mf)9 on 14 December 2016. In addition, with referred to silt curtain checking record of 14 December 2016, no defects of the silt curtain was observed.

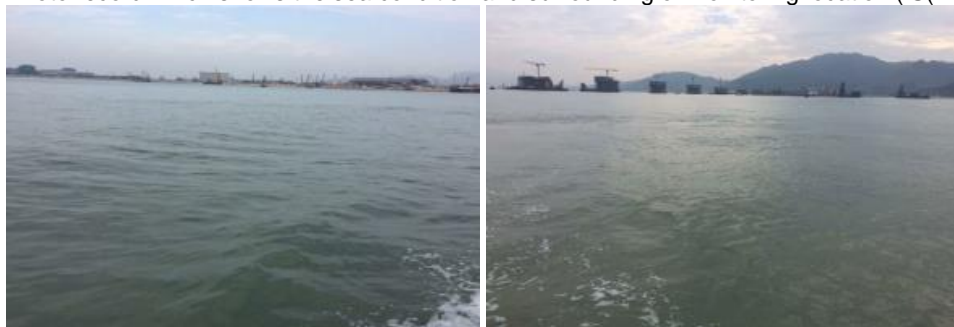
4.7.2.5 With referred photo record taken near IS(Mf)9 on 14 December 2016, no adverse water quality impact was indirectly caused by vessel traffic. For sea condition and surrounding of IS(Mf)9, also see below photo record.

4.7.2.6 The exceedance was likely due to local effects in the vicinity of IS(Mf)9.

4.7.2.7 After investigation, there is no adequate information to conclude the recorded exceedances are related to this Contract.

4.7.2.9 Nevertheless, the Contractor was reminded to ensure provision of ongoing maintenance to the silt curtains and to carry out maintenance work once defects were found.

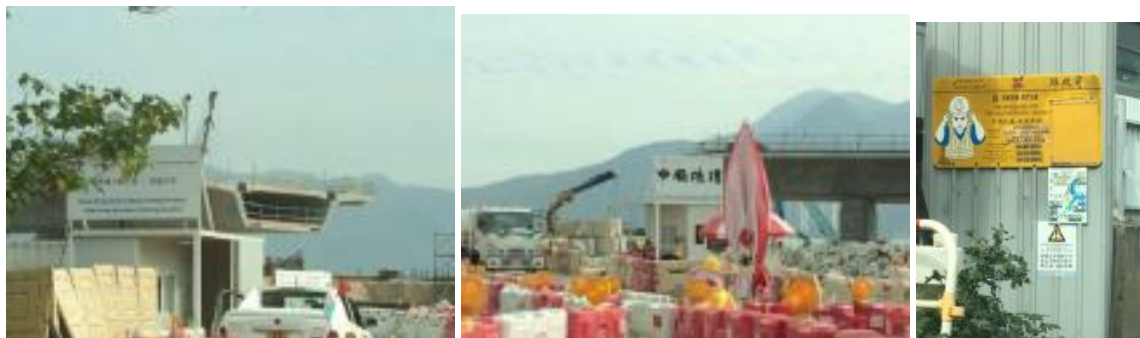
6.6.3 RSS received a complaint received an environmental complaint referred Government's hotline (1823) on 2 December 2016. The Complainant complained that, "the whole stretch of East Coast Road & Tung Fai Road is truly disgusting. The stone debris big and small and the mud is a nuisance to those who use the road every day. When dry there is a lot of dust and when it rains or when the road washing trucks are out it becomes a muddy mess. Cars and pedestrians are covered in dust or mud, cars are hit by stones is a daily hazard. Washing of construction vehicles is inadequate as the sand and soil is carried out onto the roads. Oversight of road conditions is not carried out by the Airport Authority. An alternative route should be created for the large number of construction vehicles as they drive fast."

6.6.3.1 The photo record provide by the Complainant are presented as follows:

6.6.3.4 Portion D of HKBCF Reclamation Works is the closest works area to the East Coast Road (東岸道) and is located near site entrance of HKBCF Reclamation Works. With referred to the information provided by the Contactor, works at Portion D under this Contract has been completed and no activities was conducted under this Contract at Portion D after October 2016. In addition, weekly inspection was jointly conducted by ET, RSS and the Contractor on 1 and 8 December 2016, and slurry was not observed near the East Coast Road (東岸道) or Portion D during the site inspection on 1 December 2016.

6.6.3.5 Large dump trucks loaded with stone or mud loads leaving the site at East Coast Road were not observed during site inspection jointly conducted by RSS, ET and Contractor in December 2016. In addition, Contract HY/2010/02 has no construction site entrance or exit at Tung Fai Road.
