Contract No. HY/2010/02

**Hong Kong – Zhuhai – Macao Bridge  
Hong Kong Boundary Crossing  
Facilities –  
Reclamation Works****Quarterly EM&A Report for  
December 2012- February 2013**

[05/2013]

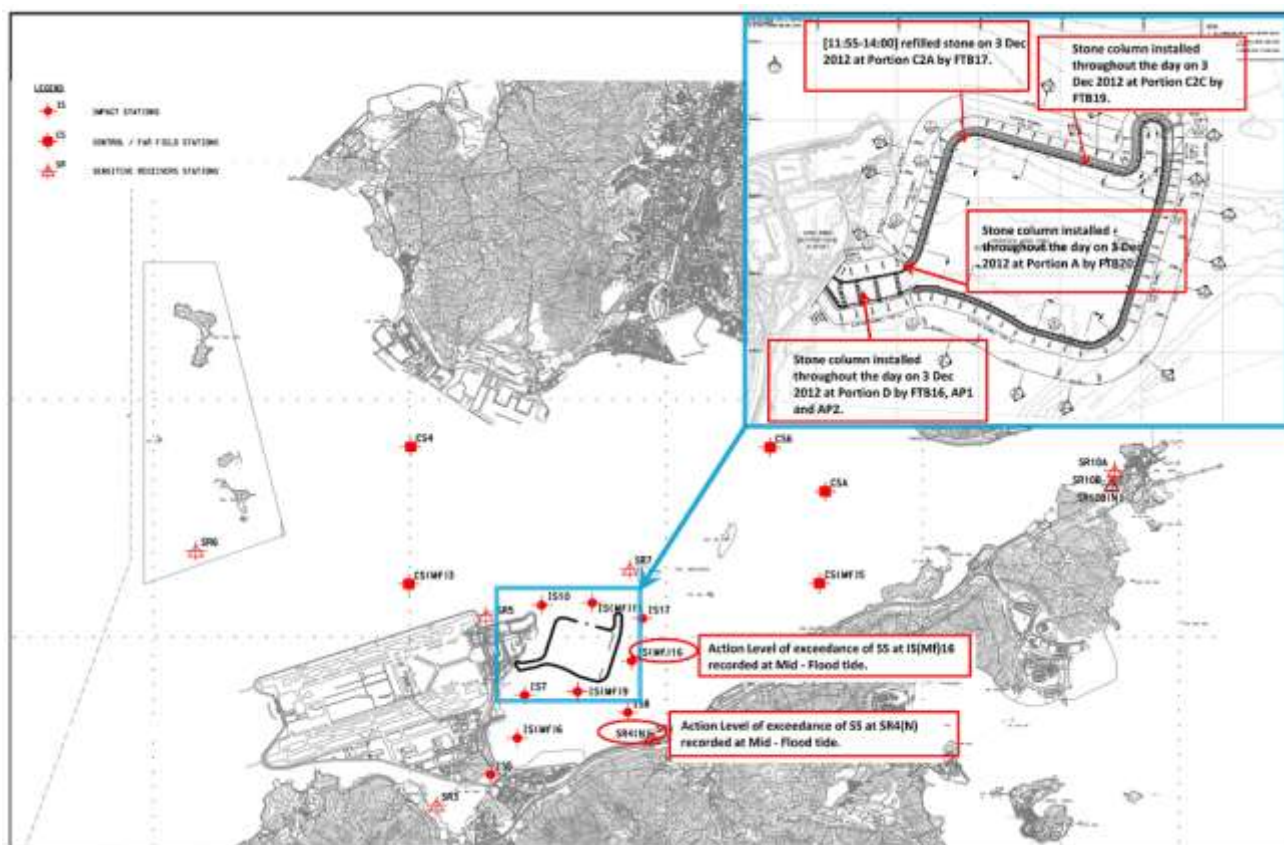
3.3.4 Two (2) Action Level exceedances at measured Suspended Solids (mg/L) were recorded on 3 Dec 2012 during mid-flood tide at monitoring station IS(Mf)16 and SR4 (N). For Action Level exceedances at measured Suspended Solids (mg/L), 26.1 mg/L and 26.7 mg/L were recorded at Monitoring Station IS(Mf)16 and SR4 (N) respectively.

3.3.4.1 For the exceedances recorded at IS(Mf)16 and SR4 (N), it was found that Stone column installation was carried out throughout the day at Portion D by FTB 16, AP1 and AP2, at Portion A by FTB20, at Portion C2A by FTB17 and Portion C2C by FTB19 on 3 Dec 2012. Location plan showing the locations of the mentioned works is shown below:

3.3.4.2 Suspended solids values recorded at Impact Stations closer to the works are (e.g. IS(Mf)9, IS7 and IS8) all below the Action and Limit Level during the same tide on the same day.

3.3.4.6 The exceedances were considered as non-Project related.

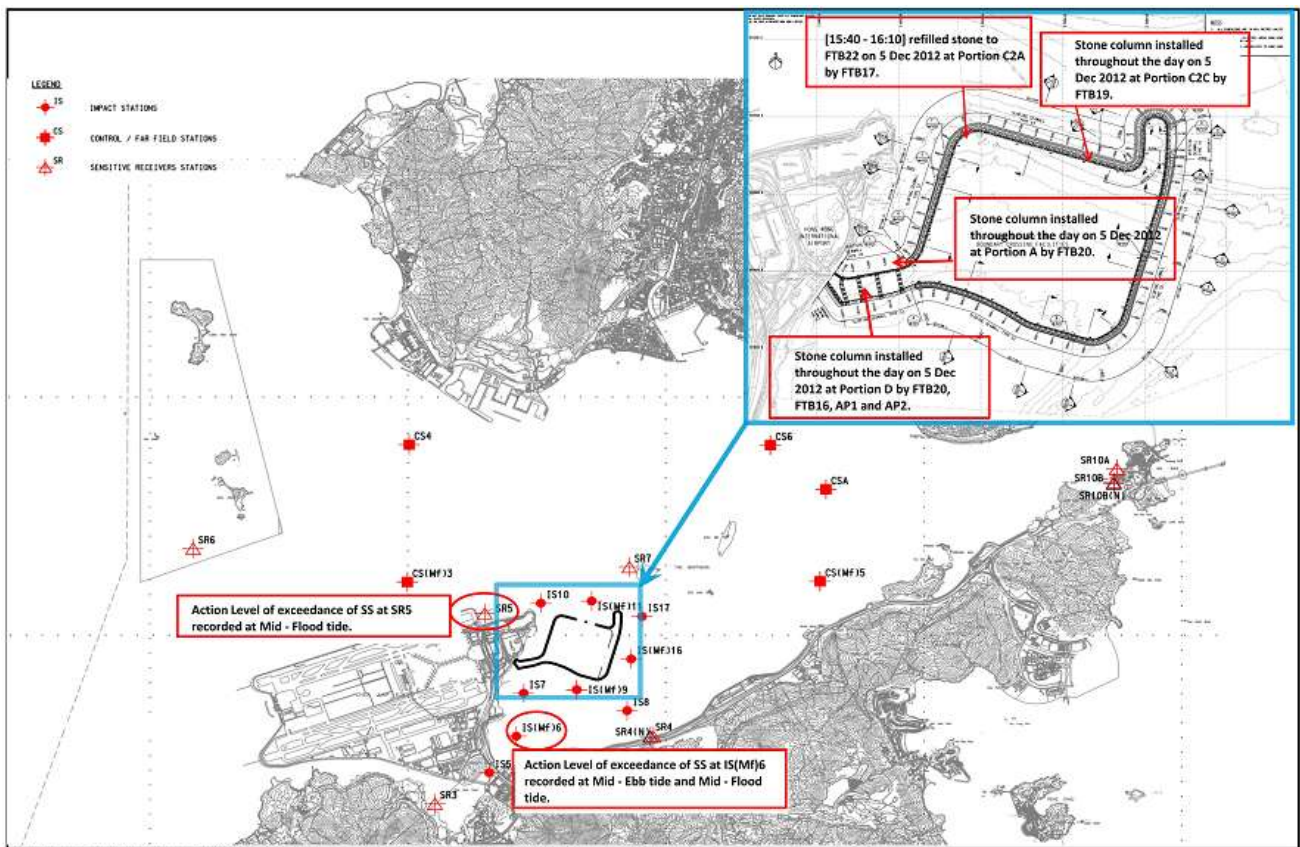
3.3.5 Three (3) were recorded on 05 Dec 2012 during mid-ebb tide at Impact Station IS(Mf)6 and during mid-flood tide at monitoring station IS(Mf)6 and SR5. For Action Level exceedances at measured Suspended Solids (mg/L), 26.6 mg/L, 25.4 mg/L and 24.3 mg/L were recorded at Impact Station IS(Mf)6 during mid-ebb tide, IS(Mf)6 during mid-flood tide and SR5 during mid-flood respectively.

- 3.3.5.1 For Action Level Exceedances recorded at Impact Station IS(Mf)6 during mid-ebb tide, IS(Mf)6 during mid-flood tide and SR5 during mid-flood on 5 Dec 2012, stone column installation was carried out throughout the day at Portion D by FTB 16, AP1 and AP2, at Portion A by FTB20, at Portion C2A by FTB17 and Portion C2C by FTB19.

- 3.3.5.2 Suspended Solids values recorded at Impact Station IS(Mf)9 and IS7 which are closer to the works than monitoring station IS(Mf)6 are all below the Action and Limit Level during the same tide on the same day.

- 3.3.5.5 The exceedances were likely due to local effects in the vicinity of IS(Mf)6 & SR5.
- 3.3.5.6 The exceedances were considered as Non-Project Related.

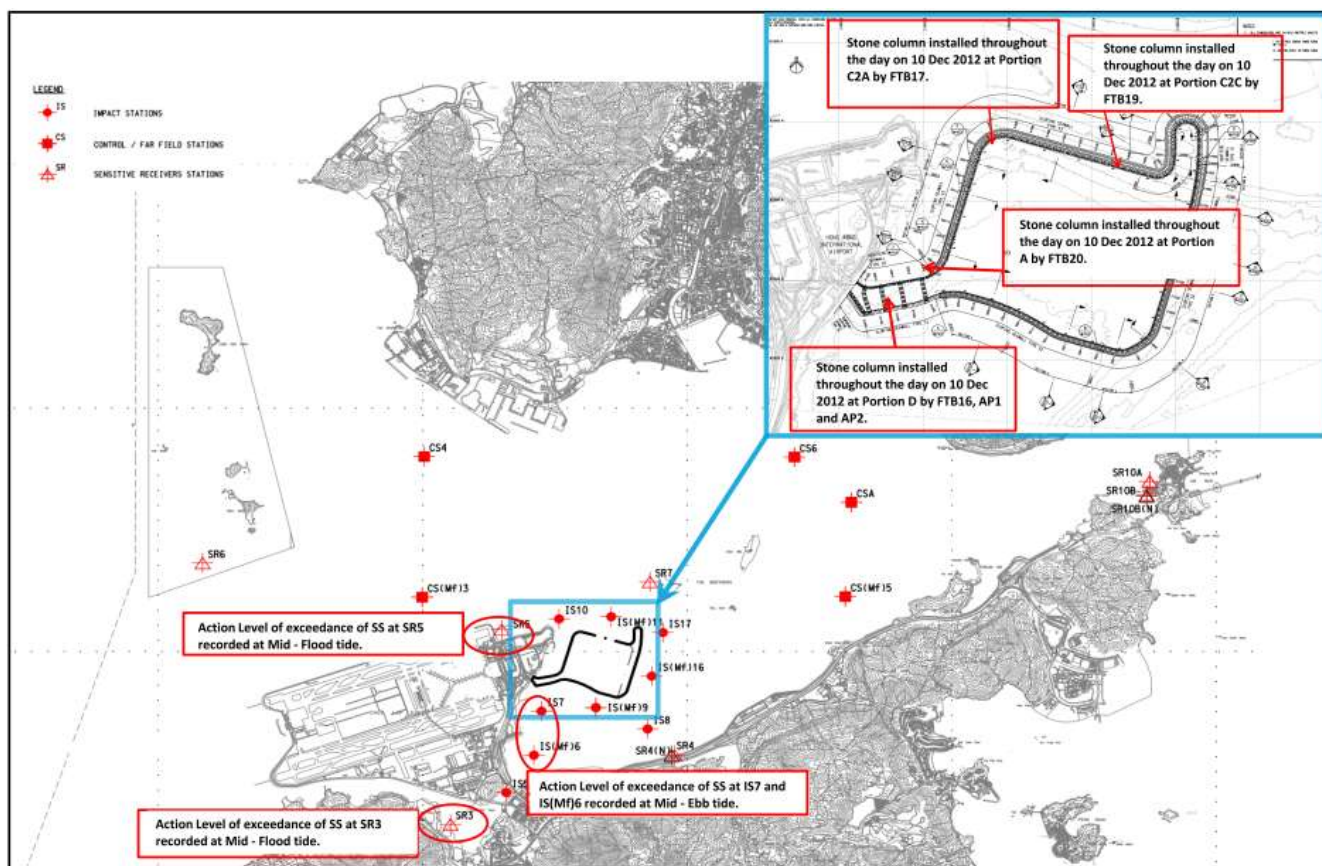
- 3.3.6 Four (4) were recorded on 10th Dec 2012 during mid-ebb tide at Impact Station IS(Mf)6 and IS7 and during mid-flood tide at monitoring station SR3 and SR5. For Action Level exceedances at measured Suspended Solids (mg/L), 31mg/L, 31.8mg/L, 27.3mg/L and 32.2 mg/L were recorded during mid-ebb tide at Impact Station IS(Mf)6 and IS7 and during mid-flood tide at monitoring station SR3 and SR5.

- 3.3.6.1 For Action Level Exceedances of SS at during mid-ebb tide at Impact Station IS(Mf)6 and IS7 and during mid-flood tide at monitoring station SR3 and SR5 recorded on 10 Dec 2012, Stone column installation was carried out throughout the day at Portion D by FTB 16, AP1 and AP2, at Portion A by FTB20, at Portion C2A by FTB17 and Portion C2C by FTB19 .

- 3.3.6.2 Suspended solids values recorded at Impact Station IS(Mf) 9 and IS 8 located downstream of IS7 and IS(Mf)6 during Mid-Ebb tide were below the Action and Limit Level during the same tide on the same day.

- 3.3.6.6 The exceedances were likely due to local effects in the vicinity of IS(Mf)6, IS7, SR3 and SR5.
- 3.3.6.7 The exceedances were considered as Non-Project Related.

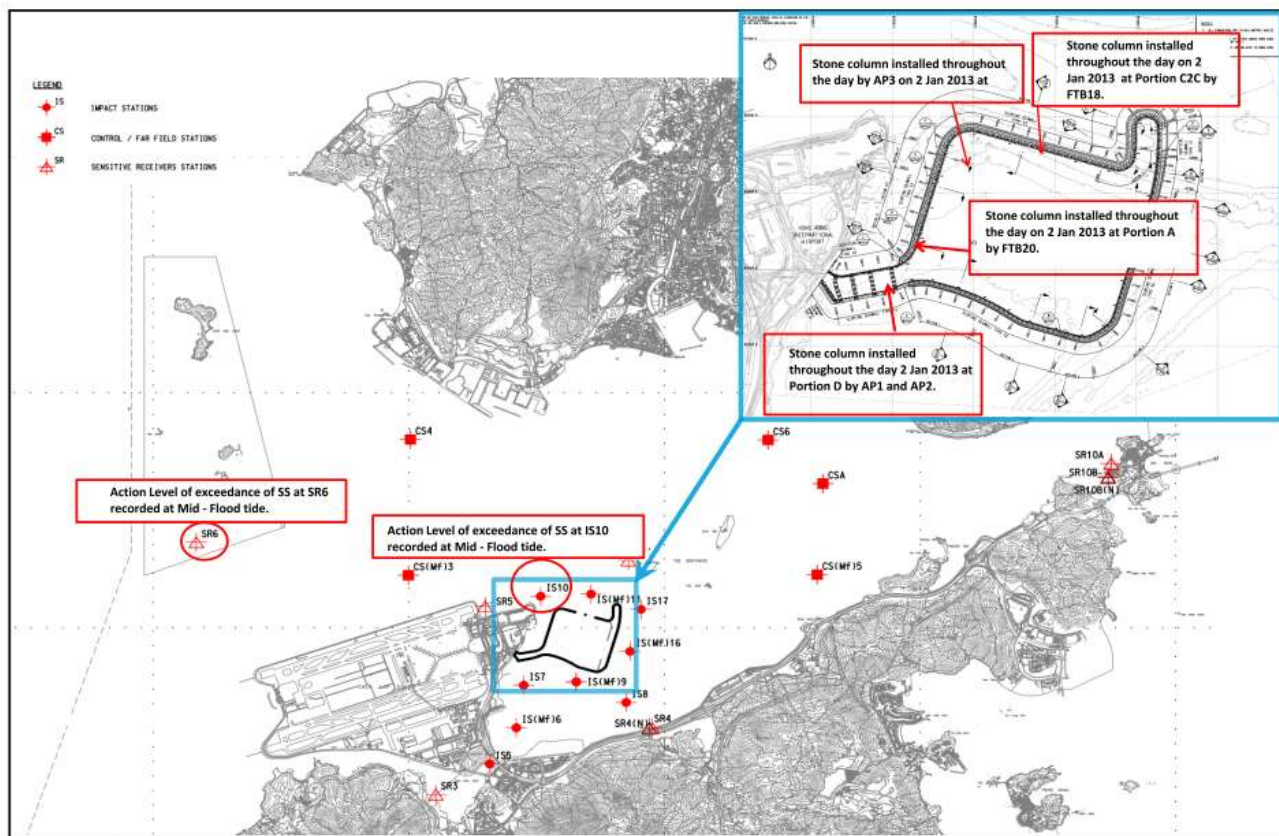
- 3.3.7 One (1) where recorded on 14 Dec 2012 during mid-ebb tide at Impact Station IS(Mf) 6. For Action Level exceedances at measured Suspended Solids (mg/L), 27.7mg/L was recorded at Impact Station IS(Mf)6.

- 3.3.8.1 For the exceedances recorded at IS10 and SR6, it was found that Stone column installation was carried out throughout the day at Portion D by AP1 and AP2, at Portion A by FTB20, at Portion A by AP3 and Portion C2C by FTB18.

- 3.3.8.2 Same type of works were carried out at the same location on 31 Dec 12 and 4 Jan 13 but Suspended Solids values recorded at IS10 and SR6 on 31 Dec 12 and 4 Jan 13 are all below the Action and Limit Level during the same tide on the same day.

- 3.3.8.6 The exceedances were likely due to local effects in the vicinity of IS10 and SR6.
- 3.3.8.7 The exceedances were considered as non-Project related.

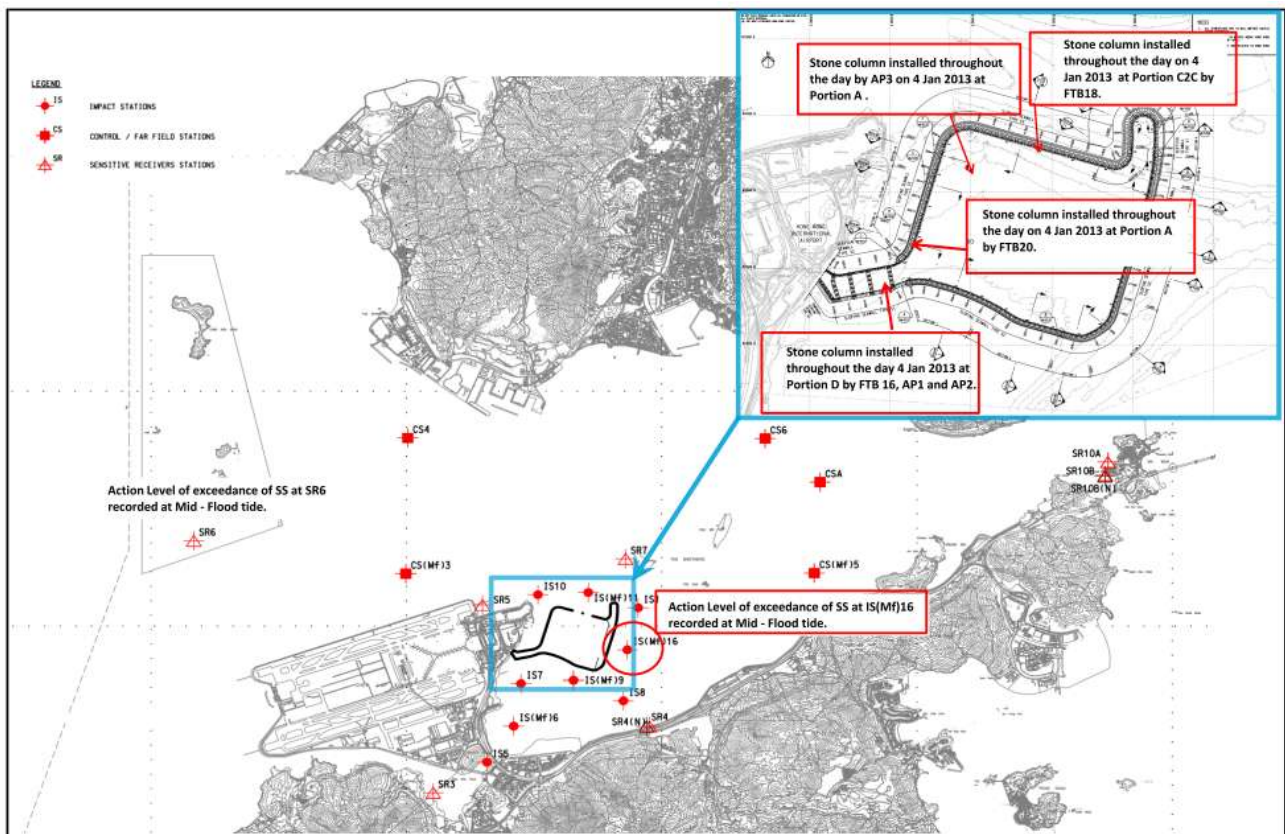
- 3.3.9 One (1) Acton Level exceedance at measured Suspended Solids (mg/L) was recorded on 04 Jan 2013 during mid-flood tide at Impact Station IS(Mf)16. For the Action Level exceedance of measured Suspended Solids (mg/L), 23.9 mg/L was recorded at Impact Station IS(Mf)16 during mid-flood tide.

- 3.3.9.1 For Action Level Exceedance recorded at Impact Station IS(Mf)16 during mid-flood tide, stone column installation was carried out throughout the day at Portion D by FTB 16, AP1 and AP2, at Portion A by FTB20, at Portion A by AP3 and Portion C2C by FTB18.

- 3.3.9.2 Suspended Solids values recorded at Impact Station IS(Mf)9 and IS7 which are closer to the works than monitoring station IS(Mf)6 are all below the Action and Limit Level during the same tide on the same day.

- 3.3.9.3 Impact Stations IS10 and IS(Mf)11 which are considered downstream and closer to the works than Impact Station IS(Mf)16. Since the Suspended Solids values recorded at IS10 and IS(Mf)11 are all below the Action and Limit Level during same tide on the same day. The water quality noted at downstream of active works were not adversely affected by active works. Hence it is considered that the exceedance recorded at IS(Mf)16 located upstream of active works are not related to the Project.

- 3.3.9.4 IS(Mf)16 is considered upstream of Partion D, A and C2C where work was carried out during mid flood tide.
- 3.3.9.5 The exceedance was likely due to local effects in the vicinity of IS(Mf)16.

- 3.3.9.6 The exceedance was considered as Non-Project Related.
- 3.3.10 One (1) Acton Level exceedance at measured Suspended Solids (mg/L) was recorded on 11 Jan 2013 at monitoring station SR5 during mid-flood tide. For Action Level exceedance of measured Suspended Solids (mg/L), 30.1 mg/L were recorded at monitoring station SR5 during mid-flood tide.

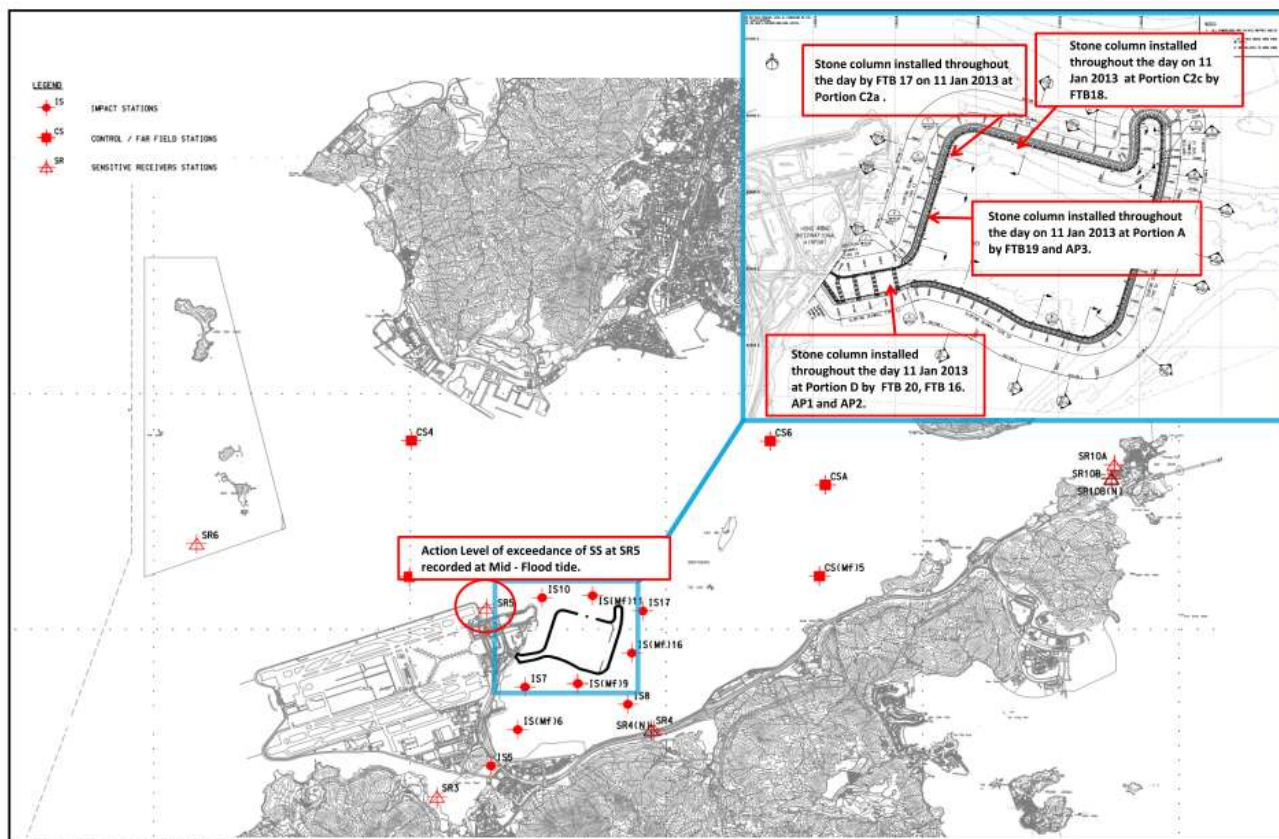
- 3.3.10.1 For Action Level Exceedance of SS recorded at monitoring station SR5 during mid-flood tide at monitoring station SR5 recorded on 11 Jan 2013, stone column installation was carried out throughout the day at Portion D by FTB16, FTB20, AP1 and AP2, at Portion A by FTB19 and AP3, at Portion C2A by FTB17 and Portion C2c by FTB18.

- 3.3.10.2 Impact Stations IS10 and IS(Mf)11 which are considered downstream and closer to the works than Impact Station SR5. Since the Suspended Solids values recorded at IS10 and IS(Mf)11 are all below the Action and Limit Level during same tide on the same day. The water quality noted at downstream of and closer to active works were not adversely affected by active works. Hence it is considered that the exceedance recorded at SR5 are not related to the Project.

- 3.3.10.3 Same type of works was carried out at almost the same location on 9 and 14 January13 but Suspended Solids values recorded at SR5 on 9 and 14 January 13 are all below the Action and Limit Level during the same tide on the same day.

- 3.3.10.4 The exceedance was likely due to local effects in the vicinity of SR5.
- 3.3.10.5 The exceedance was considered as Non-Project Related.
- 3.3.11 One (1) action Level exceedance at measured Suspended Solids (mg/L) was recorded on 14 Jan 2013 at monitoring station SR6 during mid-flood tide. For Action Level exceedance of measured Suspended Solids (mg/L), 33.8 mg/L were recorded at monitoring station SR5 during mid-flood tide.

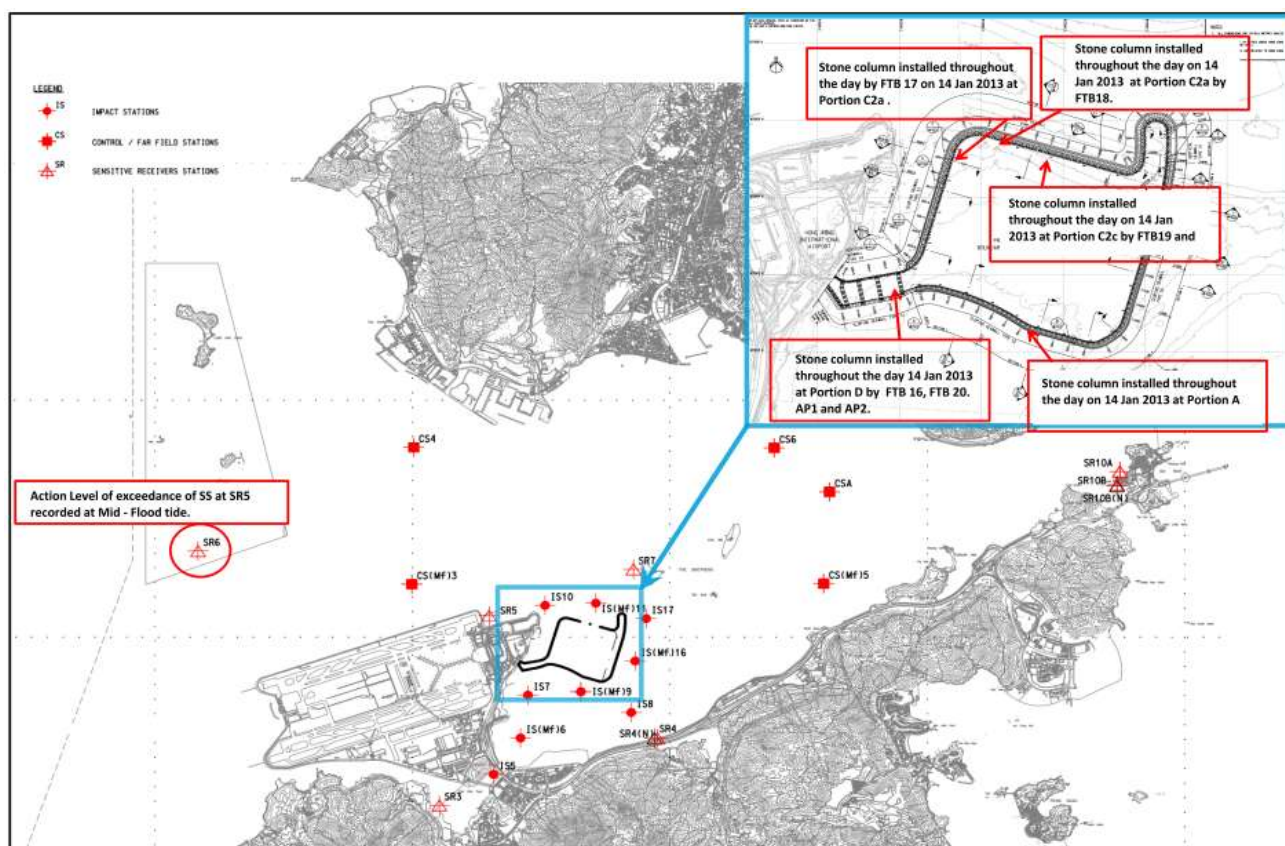
- 3.3.11.1 For Action Level Exceedance of SS at IS(Mf)6 at Mid-Flood tide recorded on 14 Jan 2013 at monitoring station SR6 during mid-flood tide, stone column installation was carried out throughout the day at Portion D by FTB 16, FTB20, AP1 and AP2, at Portion A by FTB19 and AP3, at Portion C2A by FTB17 and Portion C2c by FTB18.

- 3.3.11.2 Impact Stations IS10, IS(Mf)11, SR5 and CS(Mf)3 which are considered downstream and closer to active works than Monitoring Station SR6. Since the Suspended Solids values recorded at IS10, IS(Mf)11, SR5 and CS(Mf)3 are all below the Action and Limit Level during same tide on the same day. The water quality noted at downstream of and closer to active works were not adversely affected by active works. Hence it is considered that the exceedance recorded at SR6 is not related to the Project.

- 3.3.11.3 Same type of works was carried out at almost the same location on 11 and 16 January13 but Suspended Solids values recorded at SR6 on 11 and 16 January 13 are all below the Action and Limit Level during the same tide on the same day.

- 3.3.11.4 The exceedance was likely due to local effects in the vicinity of SR6.
- 3.3.11.5 The exceedance was considered as Non-Project Related.
- 3.3.12 One (1) action Level exceedance at measured Suspended Solids (mg/L) was recorded on 30 Jan 2013 at monitoring station SR5 during mid-flood tide. For Action Level exceedance of measured Suspended Solids (mg/L), 30.1 mg/L were recorded at monitoring station SR5 during mid-flood tide.

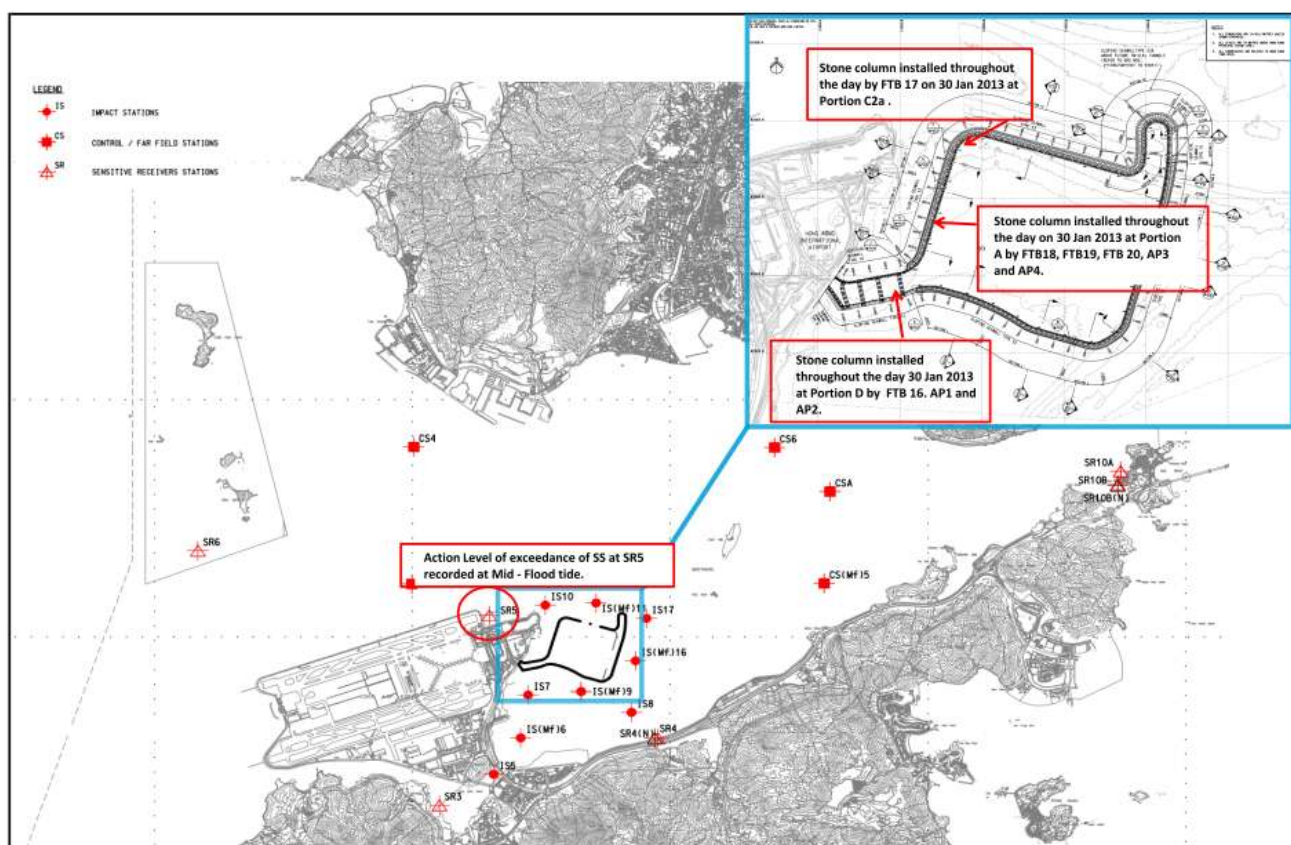
- 3.3.12.1 For Action Level Exceedance of SS recorded at Mid-Flood tide on 30 Jan 2013 at monitoring station SR5, Stone column installation was carried out throughout the day at Portion D by FTB 16, AP1 and AP2, at Portion A by FTB 18, FTB19, FTB20, AP3 and AP4, at Portion C2A by FTB17.

- 3.3.12.2 Impact Stations IS10 and IS(Mf)11 which are considered downstream and closer to the works than Impact Station SR5. Since the Suspended Solids values recorded at IS10 and IS(Mf)11 are all below the Action and Limit Level during same tide on the same day. The water quality noted at downstream of and closer to active works were not adversely affected by active works. Hence it is considered that the exceedance recorded at SR5 is not related to the Project.

- 3.3.12.4 The exceedance was likely due to local effects in the vicinity of SR5.
- 3.3.12.5 The exceedance was considered as Non-Project Related.
- 3.3.12.6 The floating type silt curtains were provided around the whole works area. However, integrity checking record of 30 Jan 13 shows that defects were found at parts of the floating type silt curtains. The Contractor was reminded to swiftly rectify the perimeter silt curtain in particular the portions which defects were observed to ensure the sediment plume generated by construction activities could be prevented from discharging to areas outside the site boundary.

- 3.3.12.7 As informed by the Contractor, maintenance work of the silt curtain was carried out on a daily basis except Sunday.
- 3.3.13 The graphical plots of the trends of the monitoring results are provided in Appendix G. No specific trend of the monitoring results or existence of persistent pollution source was noted.
