Contract No. HY/2010/02

**Hong Kong – Zhuhai – Macao Bridge
Hong Kong Boundary Crossing
Facilities –
Reclamation Works**

**Quarterly EM&A Report for
June 2013- August 2013**

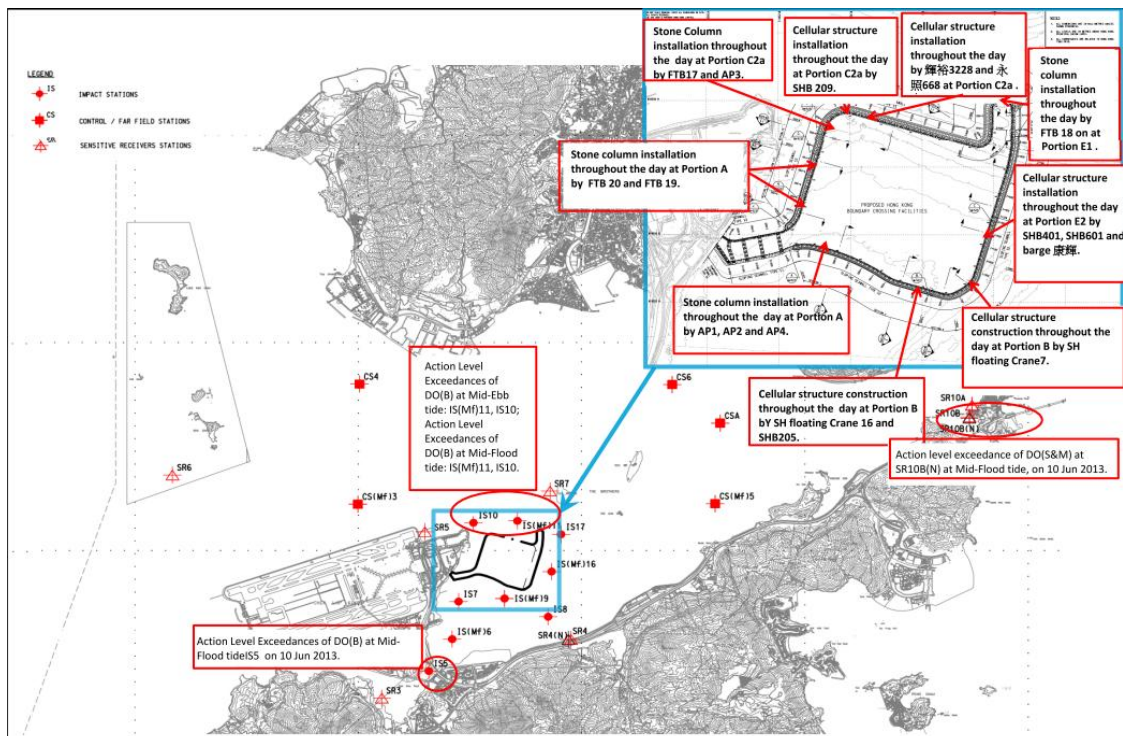
3.3.4 For the one (1) Limit Level Exceedance record at SR10(B)N during flood tide, two (2) Action Level Exceedances of DO recorded IS10 and IS(Mf)11 during ebb tide, (4) Action Level Exceedance of DO recorded at IS5, IS10, SR10B(N) and IS(Mf)11 during mid flood tide on 10 Jun 13.

3.3.3.1 For type, location and duration of works carried out on 10 June 2013 please refer to the above layout map.

- 3.3.3.4 During ebb tide, low DO (Bottom) - 4.8mg/L was noted at control station CS(Mf)3 which is considered upstream to monitoring station IS(Mf)11 and IS10, indicating DO (Bottom) at location upstream to active construction works was adversely affected by local effects in the vicinity. As such, the exceedances recorded were likely due to local effects in the vicinity at IS(Mf)11 and IS10 .

- 3.3.3.5 Low DO (Bottom) - 4.4mg/L, 4.2mg/L, 4.0mg/L and 4.0mg/L were noted at monitoring station SR10B(N), CS6, CSA and CS(Mf)5 respectively which are considered upstream to monitoring stations IS(Mf)11 and IS10 during mid flood tide indicating DO (Bottom) at locations upstream to active construction works were adversely affected by local effects in the vicinity. As such, the exceedances recorded were likely due to local effects in the vicinity at IS(Mf)11, IS10 and IS5 during mid flood tide.

- 3.3.3.9 Maintenance work of the silt curtain was carried out by the Contractor on a daily basis except Sunday and public holiday.

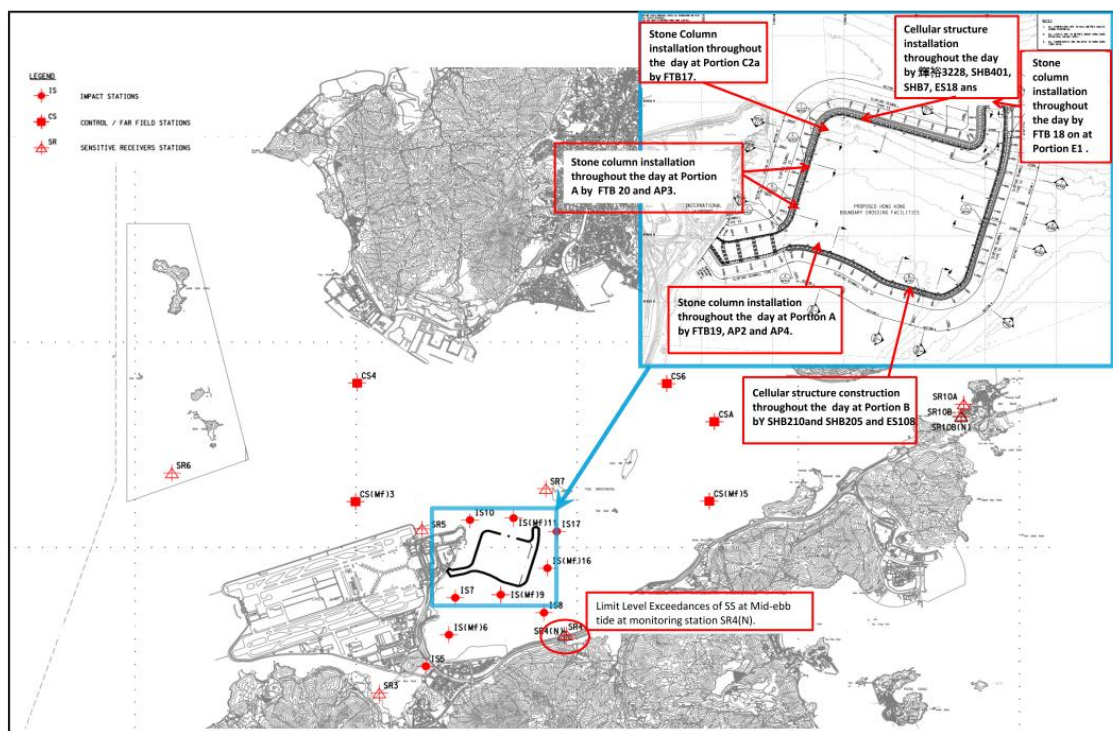
3.3.5 For the one (1) Limit Level Exceedance of SS was recorded at SR4(N) during mid ebb tide on 24 June 2013.

- 3.3.4.1 For type, location and duration of works carried out on 10 June 2013 please refer to the above layout map.
- 3.3.4.2 Exceedance was not due to marine based construction works of the Project because:

- 3.3.4.3 Red rain storm signal was hoisted between 10:20am - 11:35am by Hong Kong Observatory during flood tide and adverse weather condition e.g. heavy rainfall in the monitoring area was noted before the limit level exceedance recorded at SR4(N) at 12:53pm on 24 June 2013. As such, the water quality at SR4(N) was likely to be affected.

- 3.3.4.6 The exceedance was likely due to local effects in the vicinity SR4(N).
- 3.3.4.7 The exceedance was considered as Non-Project Related.
- 3.3.4.8 Nevertheless, the Contractor was reminded to ensure provision of ongoing maintenance to the silt curtains and to carry out maintenance work once defects were found.

- 3.3.4.9 Maintenance work of the silt curtain was carried out by the Contractor on a daily basis except Sunday and public holiday.

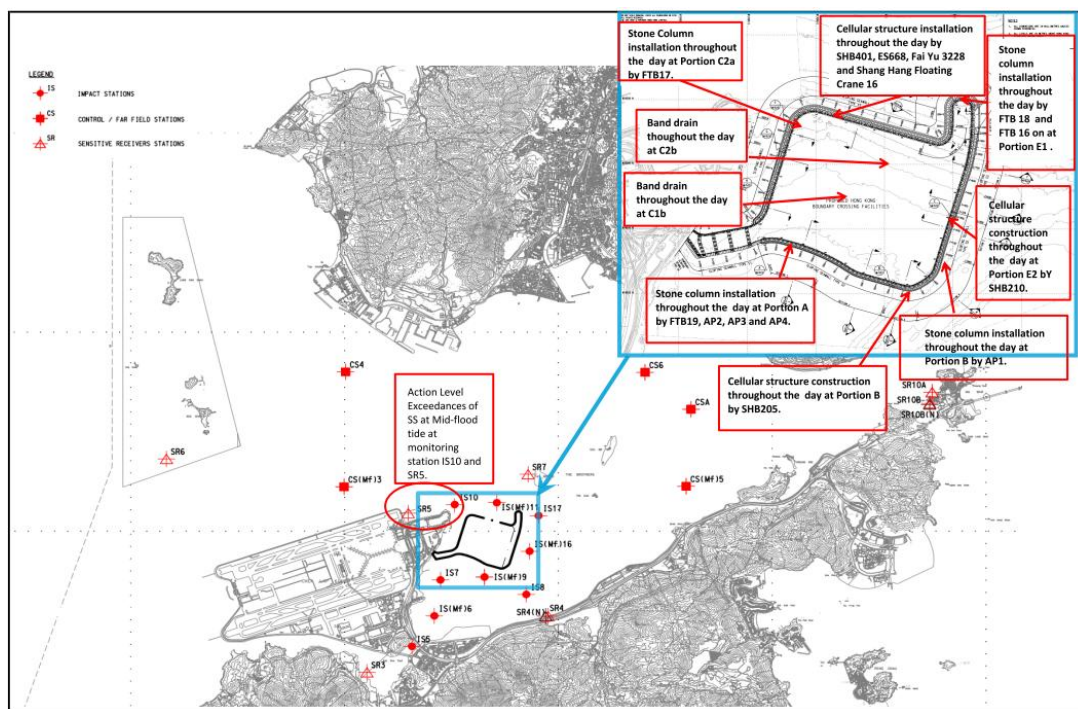
3.3.6 Two (2) Action Level exceedances at measured Suspended Solids (mg/L) were recorded on 26 Jul 2013 during mid-flood tide at monitoring station IS10 and SR5. For Action Level exceedances at measured Suspended Solids (mg/L), 23.9 mg/L and 23.8 mg/L were recorded at Monitoring Station IS10 and SR5 respectively.

3.3.5.1 For works activities carried out on 26 July 2013, please refer to above layout map which shows the locations active works.

3.3.5.5 No silt plume was observed flowing from the inside of the perimeter silt curtain to the outside of the perimeter silt curtain when monitoring works were conducted IS10 on 26 July 13 during mid flood tide.

3.3.5.9 Nevertheless, the Contractor was reminded to ensure provision of ongoing maintenance to the silt curtains and to carry out maintenance work once defects were found.

3.3.5.10 Maintenance work of the silt curtain was carried out by the Contractor on a daily basis except Sunday and public holiday.

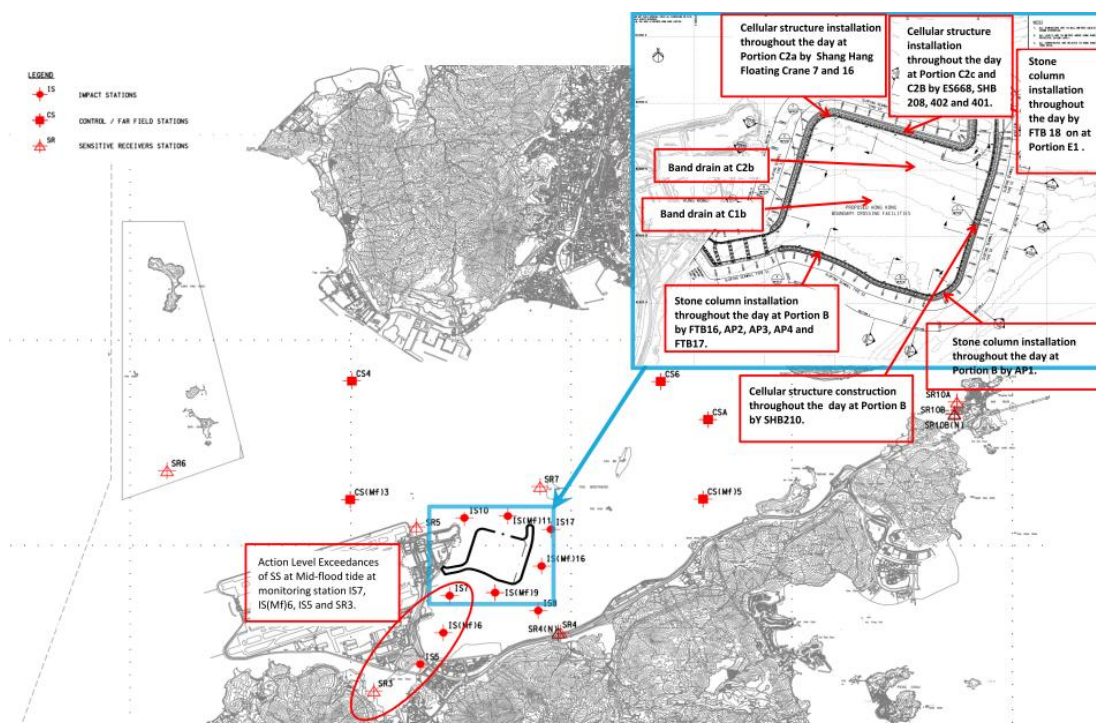
3.3.8 Four (4) Action Level exceedances at measured Suspended Solids (mg/L) were recorded on 07 August 2013 during mid-flood tide at monitoring station IS(Mf)6, IS5, IS7 and SR3. For Action Level exceedances at measured Suspended Solids (mg/L), 24.7 mg/L, 29.8mg/L, 24.9 and 28.1 were recorded at Monitoring Station IS(Mf)6, IS5, IS7 and SR3 respectively.

- 3.3.7.1 For locations and type of active works carried out on 7 Aug 13, please refer to the above layout map.
- 3.3.7.2 Exceedances were not due to marine based construction works of the Project because:

- 3.3.7.3 Same type of works were carried out at the same locations on 5 and 9 Aug 13 but Suspended Solids values recorded at IS(Mf)6, IS5, IS7 and SR3 on 5 and 9 Aug 13 are below the Action and Limit Level during the same tide which indicates project works is unlikely to contribute to the action level exceedances recorded at IS(Mf)6, IS5, IS7 and SR3.

- 3.3.7.4 Monitoring Stations IS10 and IS(Mf)11 which are considered downstream to the active works of during mid flood tide. The Suspended Solids values recorded at IS10 and IS(Mf)11 are all below the Action and Limit Level during same tide on the same day which shows that the water quality noted downstream of active works during flood tide were not adversely affected by active works. Hence it is considered that the action level exceedances recorded at IS(Mf)6, IS5, IS7 and SR3 are unlikely contributed by project works.

- 3.3.7.10 Maintenance work of the silt curtain was carried out by the Contractor on a daily basis except Sunday and public holiday.

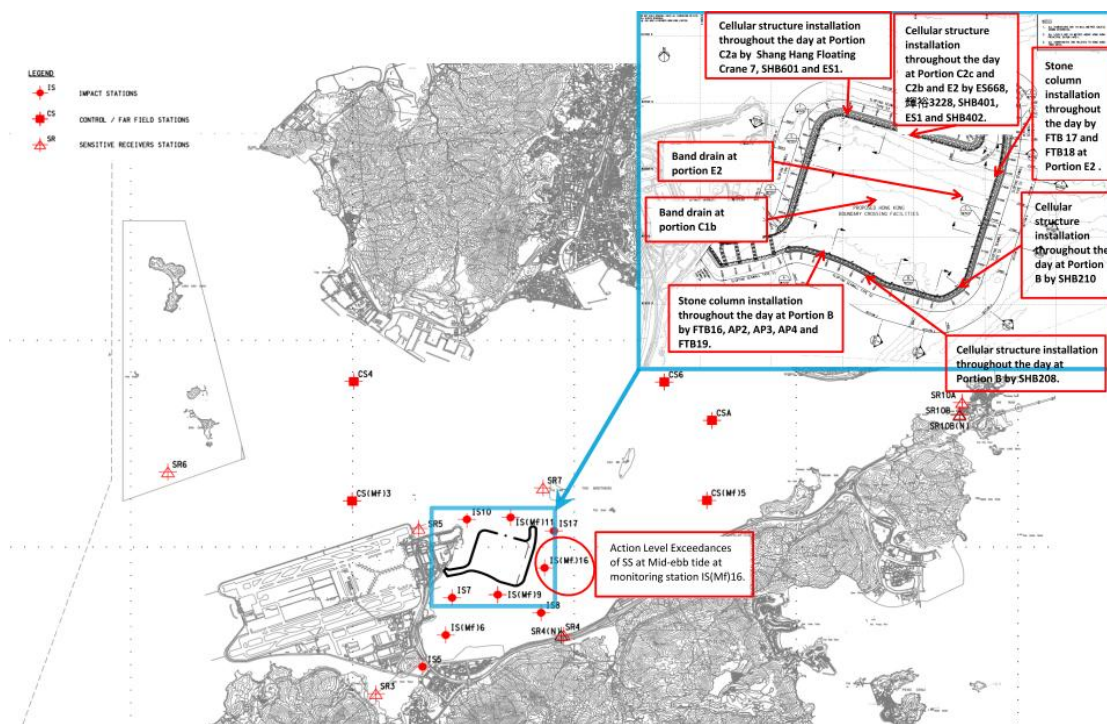
3.3.9 One (1) Action Level exceedance at measured Suspended Solids (mg/L) were recorded on 23 August 2013 during mid-Ebb tide at monitoring station IS(Mf)16. For Action Level exceedance at measured Suspended Solids (mg/L), 24.1 mg/L was recorded.

- 3.3.8.1 For locations and type of active works carried out on 23 Aug 13, please refer to the above layout map.
- 3.3.8.2 Exceedance was not due to marine based construction works of the Project because:

- 3.3.8.3 Same type of works were carried out at the same locations on 21 and 26 Aug 13 but Suspended Solids values recorded at IS(Mf)16 on 21 and 26 Aug 13 are below the Action and Limit Level during the same tide which indicates project works is unlikely to contribute to the action level exceedances recorded at IS(Mf)16.

- 3.3.8.5 No silt plume was observed flowing from the inside of the perimeter silt curtain to the outside of the perimeter silt curtain when water quality monitoring was conducted at IS(Mf)16.

- 3.3.8.6 In view of there is no damage can be observed from the perimeter silt curtain which deployed in the works area at Portion D and E2.
- 3.3.8.7 The exceedance was likely due to local effects in the vicinity of IS(Mf)16 and considered non-project related.

- 3.3.8.8 Nevertheless, the Contractor was reminded to ensure provision of ongoing maintenance to the silt curtains and to carry out maintenance work once defects were found.
