Contract No. HY/2010/02

**Hong Kong – Zhuhai – Macao Bridge
Hong Kong Boundary Crossing
Facilities –
Reclamation Works**

**Quarterly EM&A Report for
September 2013- November 2013**

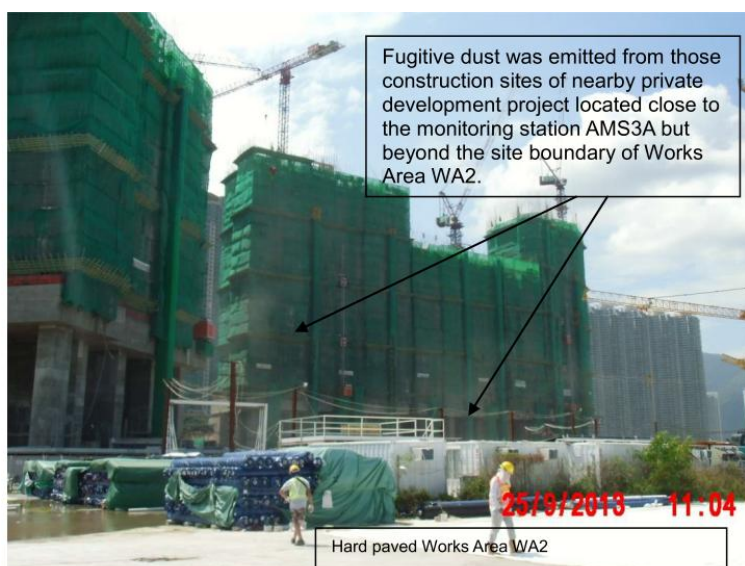
View of Works Area WA2 : the hard paved ground next to monitoring station AMS3A (View A on layout map)

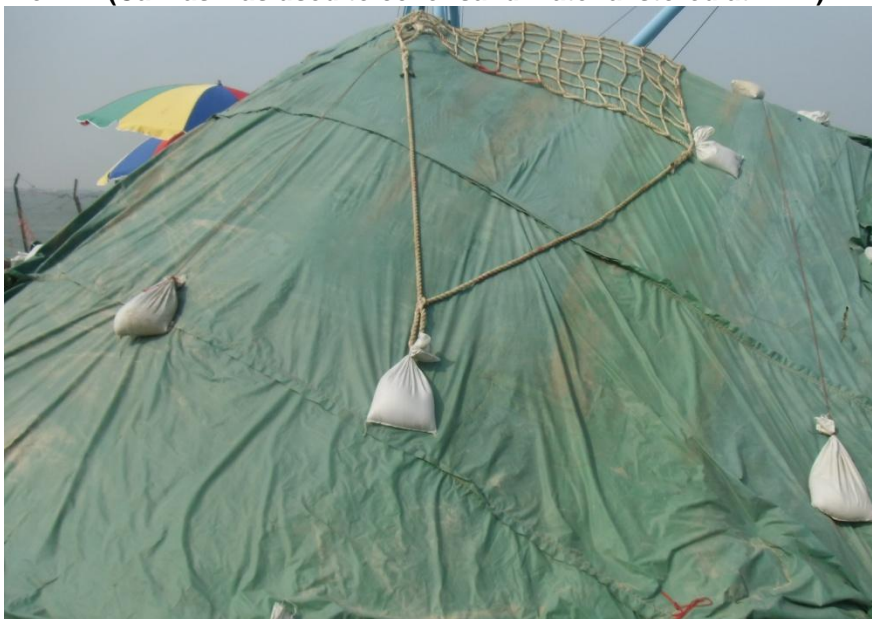
View A: (Canvas was used to cover sand material stored at WA2):

1. Canvas/tarpaulin sheet was used to cover sand material stored at WA2 (please refer to photo record – View A above)
 2. Works Area WA2's surface was hard-paved, compacted or hydro-seeded
 3. Vehicle washing facility was provided at vehicle exit points,
- 3.1.9.8 The dust exceedance was therefore considered not to be due to the Project works.
- 3.1.9.9 The Contractor was recommended to continue implementing existing dust mitigation measures.

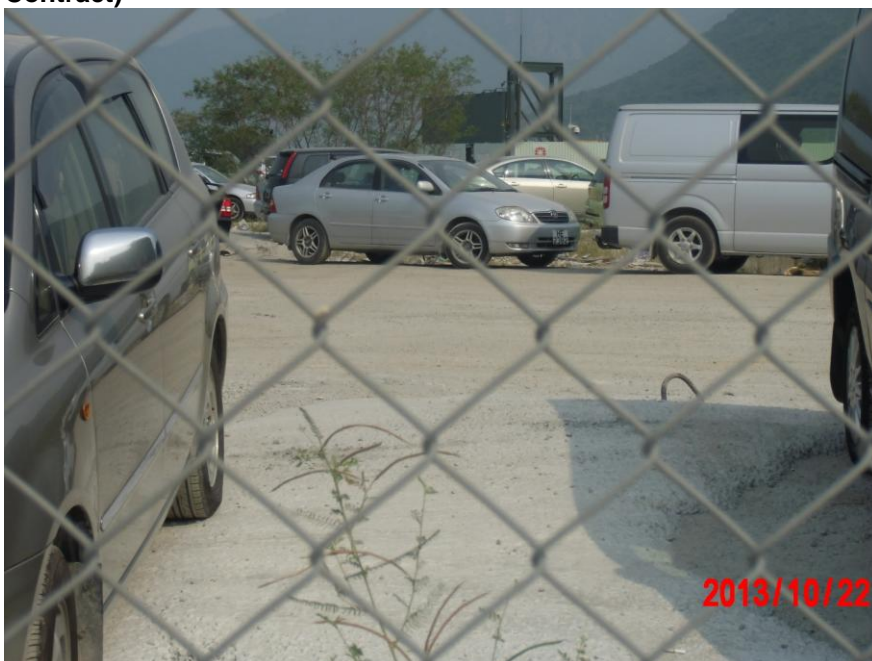
- 3.1.9.3 Photo records shows that vehicle would travel on exposed soil surfaces at those construction sites of nearby private development project which are close to the monitoring station AMS3A but beyond the site boundary of Works Area WA2. (Please also see photo and layout map attached for reference of site conditions.)

View B: (Traffic on dusty surface observed at nearby construction site which do not belongs to this Contract)

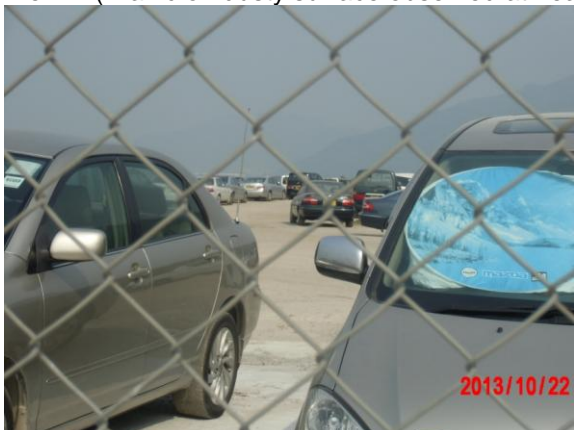
- 3.1.8.3 Photo records shows that vehicle would travel on exposed soil surfaces at those construction sites of nearby private development project which are close to the monitoring station AMS3A but beyond the site boundary of Works Area WA2. (Please also see photo and layout map attached for reference of site conditions (View A.)

View A (Traffic on dusty surface observed at nearby construction site which do not belongs to this Contract)

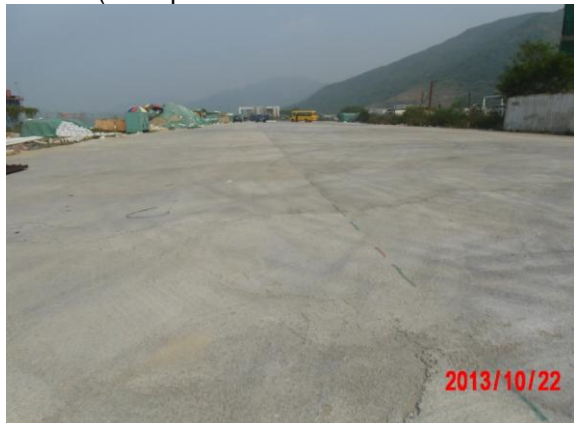
View B (Hard paved surface observed at Works Area WA2)

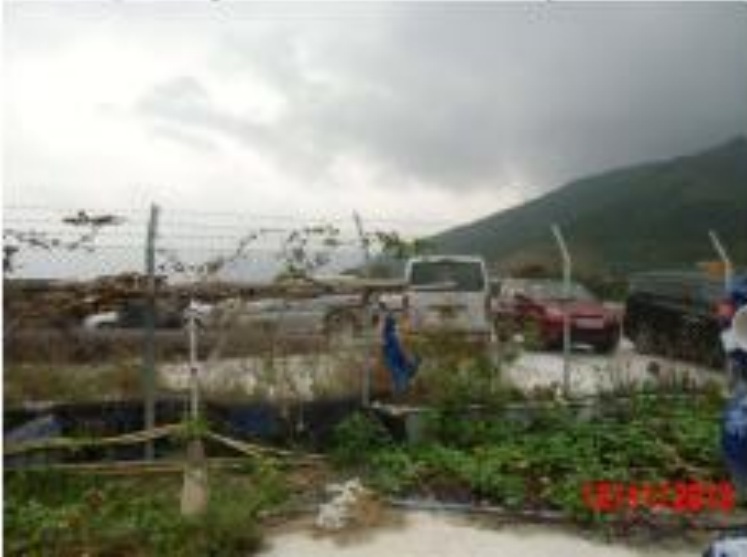
- 3.1.9.3 Photo records shows vehicle parking activities were observed inside an area at construction sites of nearby private development project which are close to the monitoring station AMS3A but beyond the site boundary of Works Area WA2. (Please also see photo and layout map attached for reference of site conditions (View A.))

View A: (Parking lot observed at nearby construction site which do not belongs to this Contract):

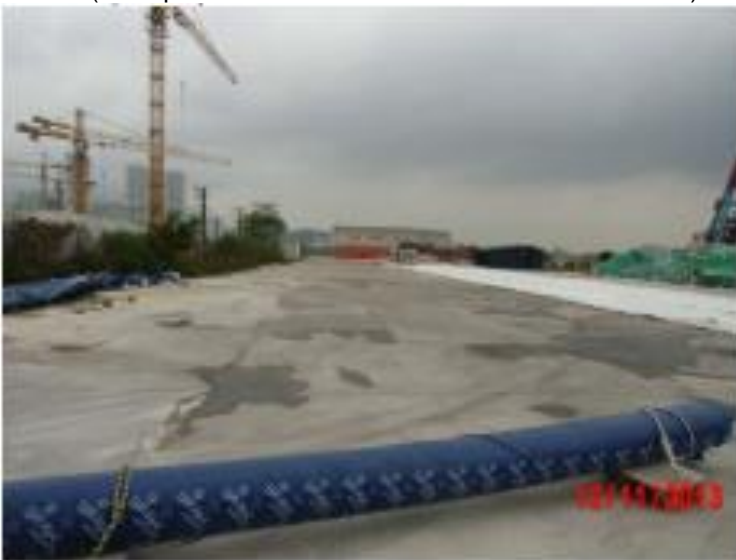
View B (Hard paved surface observed at Works Area WA2)

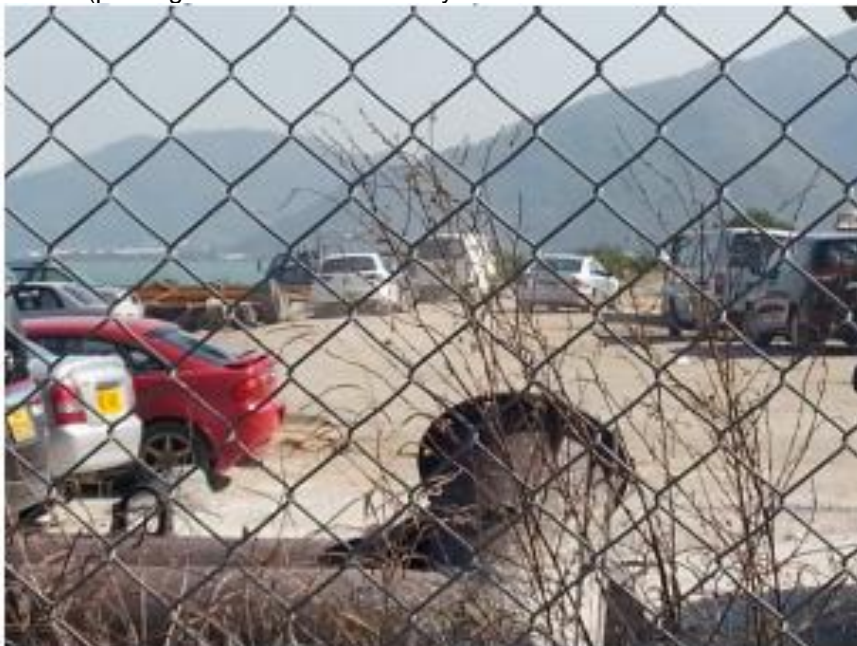
- 3.1.10.3 Photo records shows vehicle parking activities were observed inside an area at construction sites of nearby private development project which are close to the monitoring station AMS3A but beyond the site boundary of Works Area WA2. (Please also see photo and layout map attached for reference of site conditions (View A.))

View A (parking lot observed at nearby construction site which do not belongs to this Contract)

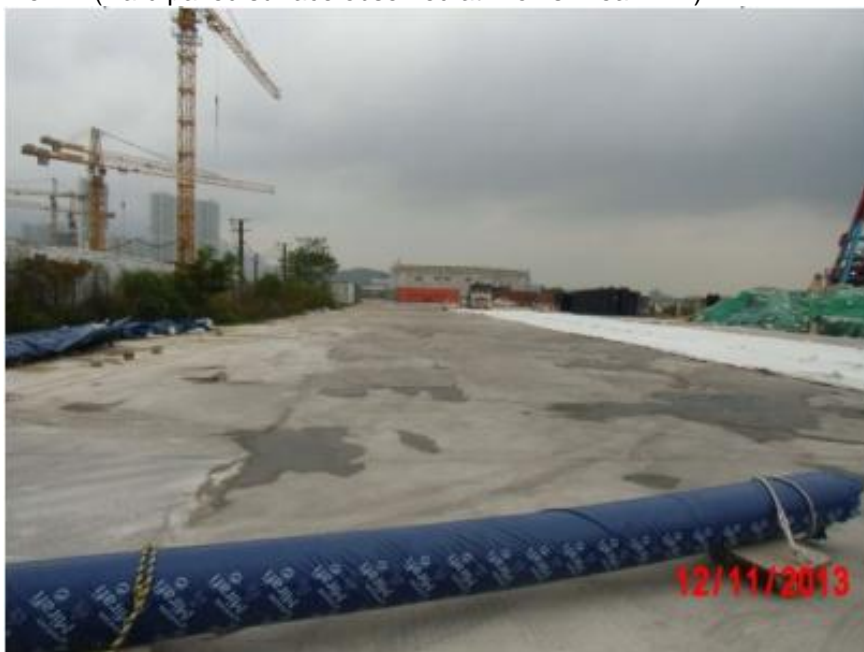
View B (Hard paved surface observed at Works Area WA2)

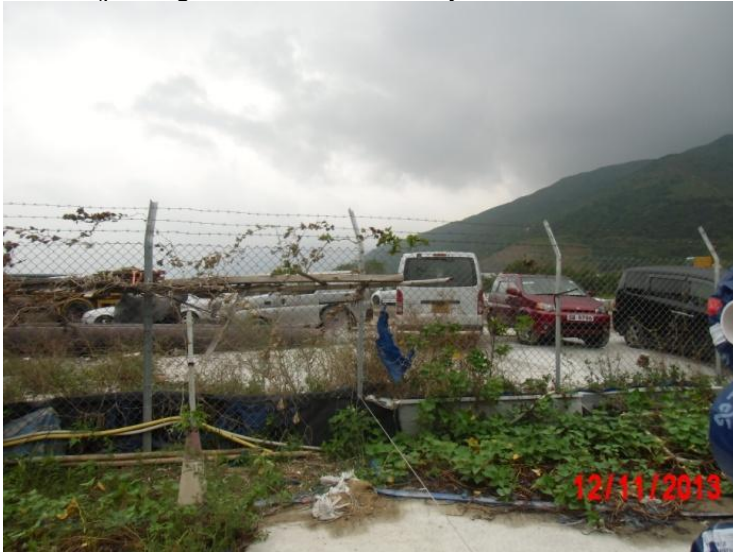
- 3.1.11.3 Photo records shows vehicle parking activities were observed inside an area at construction sites of nearby private development project which are close to the monitoring station AMS3A but beyond the site boundary of Works Area WA2. (Please also see photo and layout map attached for reference of site conditions (View A.))

View A (parking lot observed at nearby construction site which do not belongs to this Contract)

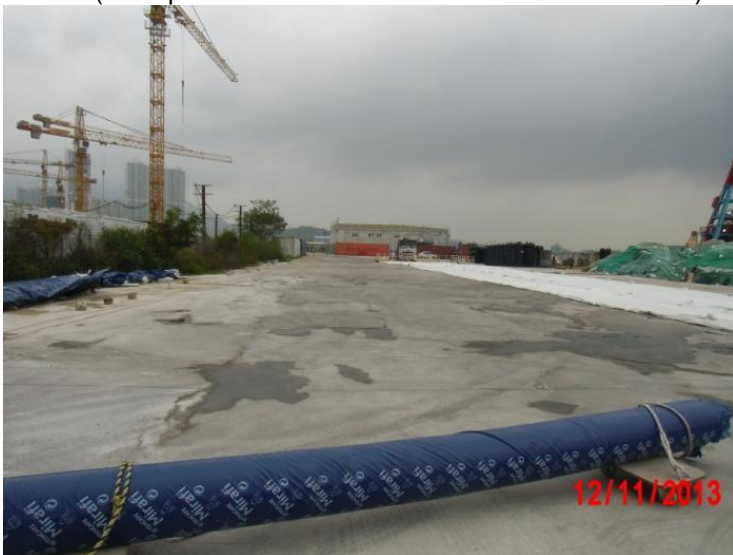
View B (Hard paved surface observed at Works Area WA2)

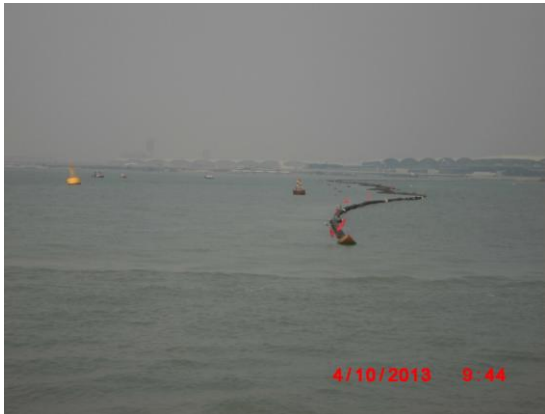
Photo record shows that no defect was observed on the perimeter silt curtain nearby IS(Mf)9.

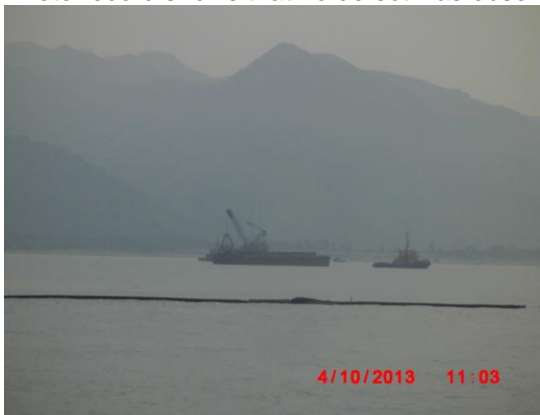
Photo record shows that no defect was observed on the perimeter silt curtain nearby IS(Mf)16.

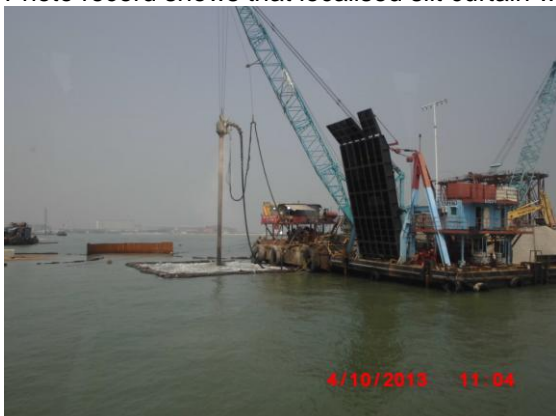
Photo record shows that localised silt curtain was implemented during stone column installation.

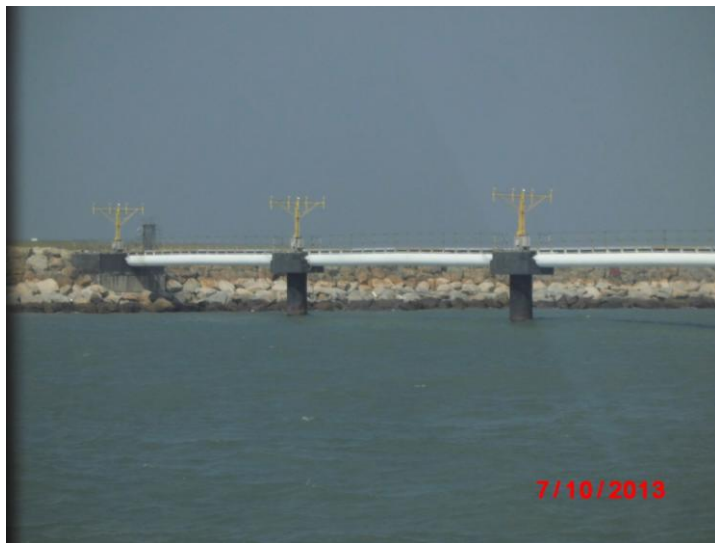
3.3.8.7 Strong wind and rough sea condition were experienced during impact water quality monitoring conducted during mid flood tide at monitoring. (Please see photo record which shows the sea condition recorded on 7 Oct 13.)

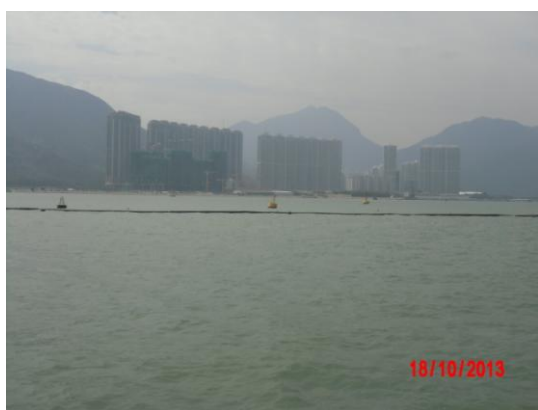
- 3.3.10.5 Photo record shows that no defect was observed on the perimeter silt curtain nearby IS7 on 18 Oct 13.

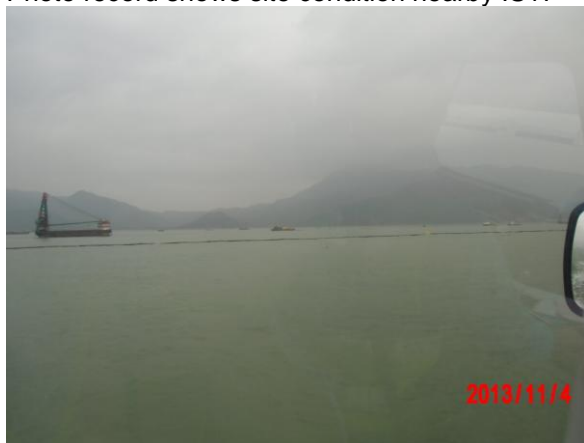
Photo record shows site condition nearby IS17

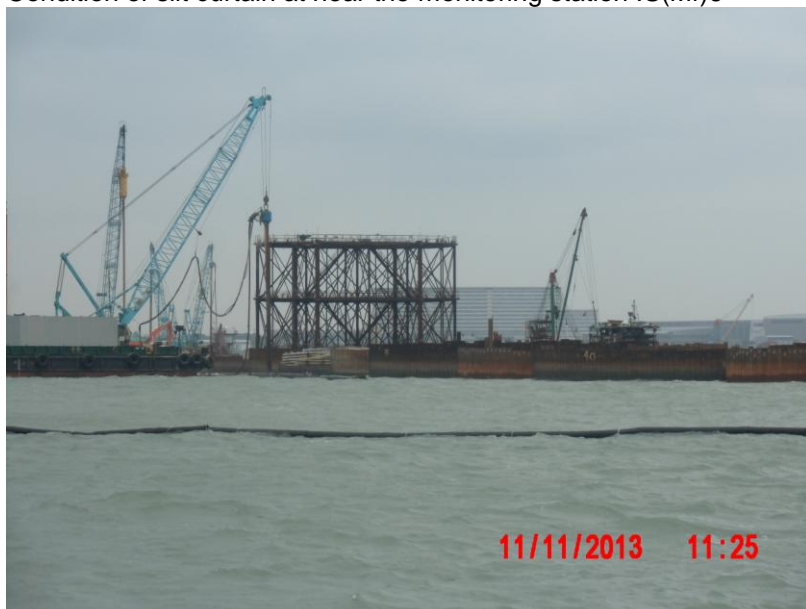
Condition of silt curtain at near the monitoring station IS(Mf)6
