Contract No. HY/2010/02

**Hong Kong – Zhuhai – Macao Bridge
Hong Kong Boundary Crossing
Facilities –
Reclamation Works**

**Quarterly EM&A Report for
June 2014- August 2014**

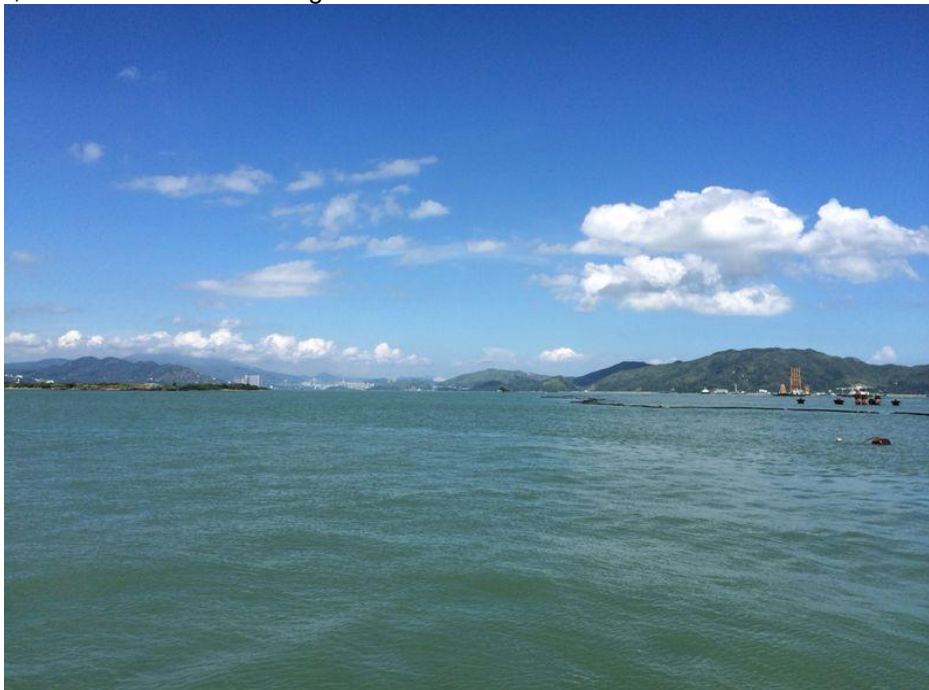
3.3.3.4 As informed by the Contractor, filling was conducted on 13, 15 and 18 August 2014 at Portion C2b, but with referred to monitoring record and photo record attached, no sediment plume has been observed to flow from the inside of the perimeter silt curtain to the outside of the perimeter silt curtain and no discoloration of sea water has been observed. Please refer to the photo attached for reference of the sea condition during ebb tide and flood tide on 15 August 2014.

- 3.3.3.5 Photo record of sea condition taken during ebb tide at north of HKBCF Reclamation Works near IS(Mf)11, IS10 and SR5 on 15 August 2014.

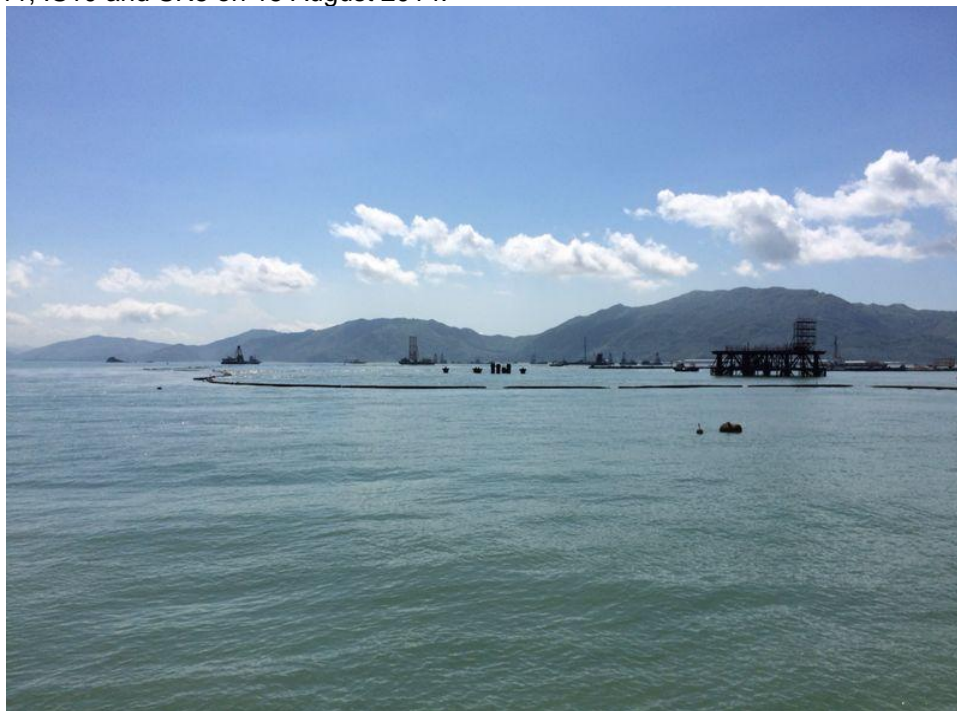
- 3.3.3.6 Photo record of sea condition taken during flood tide at north of HKBCF Reclamation Works near IS(Mf)11, IS10 and SR5 on 15 August 2014.

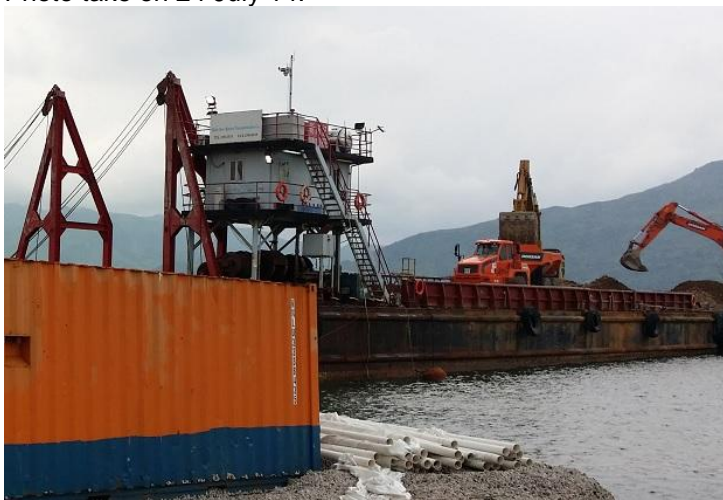
- There is no sufficient information provided by the complainant to make sure that the concerned barges are related to this project.
- Date of the observed impact was not specified by the complainant so the IWQM results available for July 14 for monitoring stations close to the concerned area - IS12, IS13, IS14, IS15 have been reviewed and there were no impact water quality monitoring result that shows the turbidity or suspended solid of sea water were adversely affected.
- In addition, site inspection has been jointly conducted with the Contractor and RSS on 24 and 31 July 2014, but no leakage of soil/sand material from barges causing discoloration of sea water was observed inside or outside the perimeter silt curtain of HKBCF reclamation works. Please see below the photos taken during site inspection for reference.
- Photo take on 24 July 14.

7.1.4.3 In addition, site inspection has been jointly conducted with RSS and the Contractor, but no leakage of soil/sand material from barges causing discoloration of sea water was observed inside or outside the perimeter silt curtain of HKBCF reclamation works.

7.1.4.5 Recommendations: The Contractor was advised to ensure the provision of routine maintenance and prohibit overloading of sand material on delivery barges to prevent potential leakage of soil from sand delivery barges causing discoloration of sea water

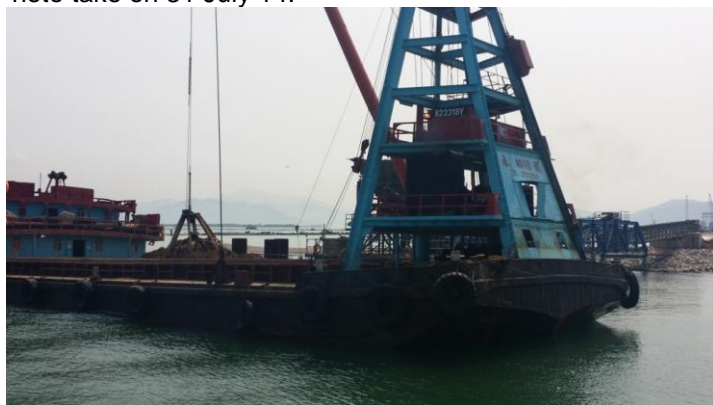
- Photo take on 31 July 14.

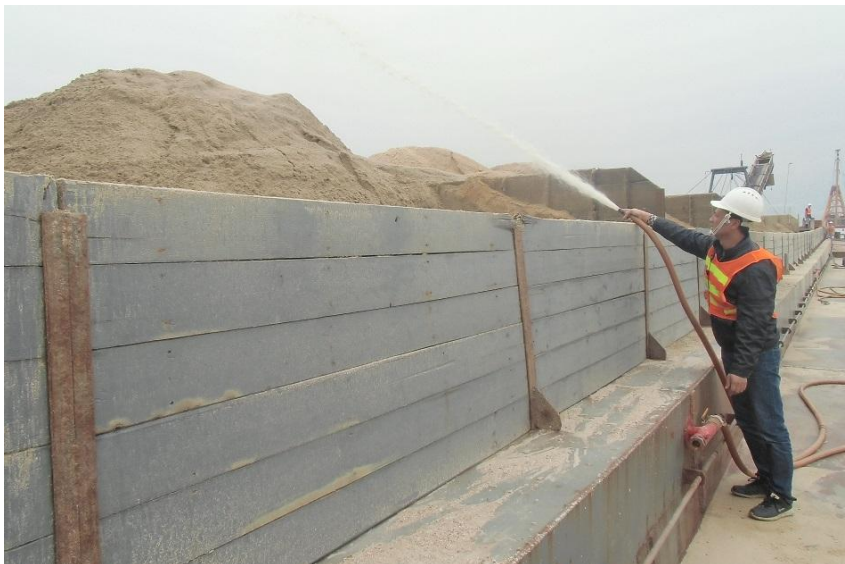
- There is no sufficient information provided by the complainant to make sure that the concerned barges are related to this project.
- Date of the observed impact was not specified by the complainant so the impact air quality monitoring (IAQM) results available for August 2014 for monitoring stations close to the concerned area – AQMS1, ASR1, ASR5, ASR6 and ASR10 have been reviewed and there was no impact air quality monitoring result that shows 1-hour TSP or 24-hour TSP exceeded the action (AL)/limit level (LL).
- Photo record below shows that Sand barges are equipped with watering equipments. And watering equipment was used to keep the sand filling material wet.

- In addition, site inspection has been jointly conducted with the Contractor and RSS on 28 August 2014, but no generation of fugitive dust was observed to be caused by barges loaded with filling material.
