Contract No. HY/2010/02

**Hong Kong – Zhuhai – Macao Bridge  
Hong Kong Boundary Crossing  
Facilities –  
Reclamation Works**

**Quarterly EM&A Report for  
September 2014- November 2014**

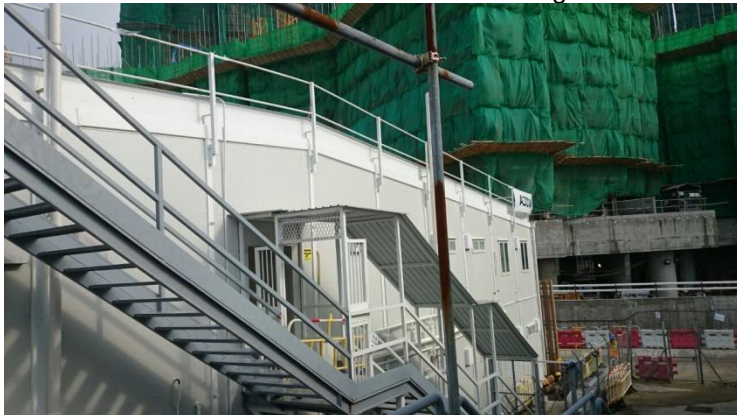
- 3.1.5.3 Site inspection has been conducted on 7 November 2014 to review works activities of adjacent construction site(s) for identifying the possible source(s), construction site was observed and the source of impact may be contributed by adjacent construction site which do not belongs to this contract. Please see below photo record for reference.

- Photo record taken on 7 November 2014 during ad hoc site inspection: View B on layout map

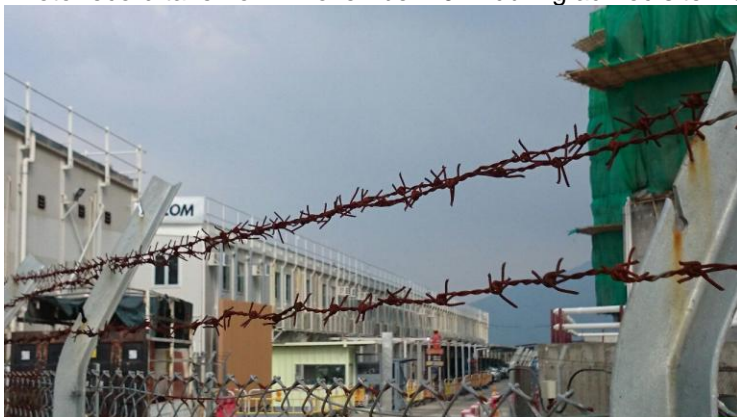
- Photo record taken on 7 November 2014 during ad hoc site inspection: View C on layout map

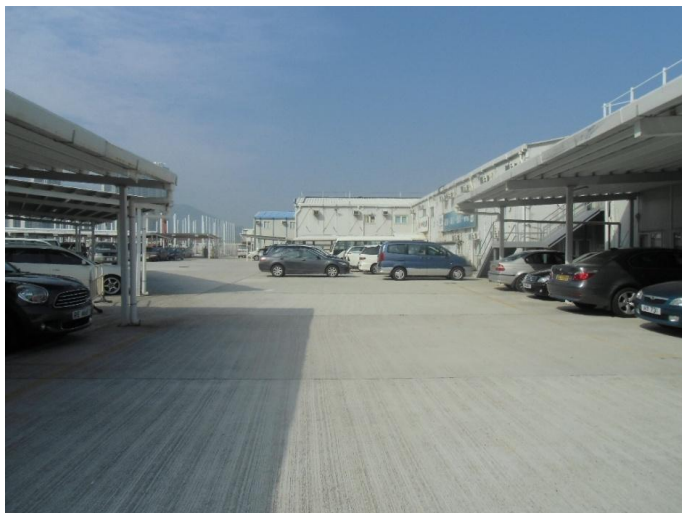
- 1 Works Area WA2's surface was hard-paved, compacted or hydro-seeded (Please refer to above layout map and photo records below (View A))

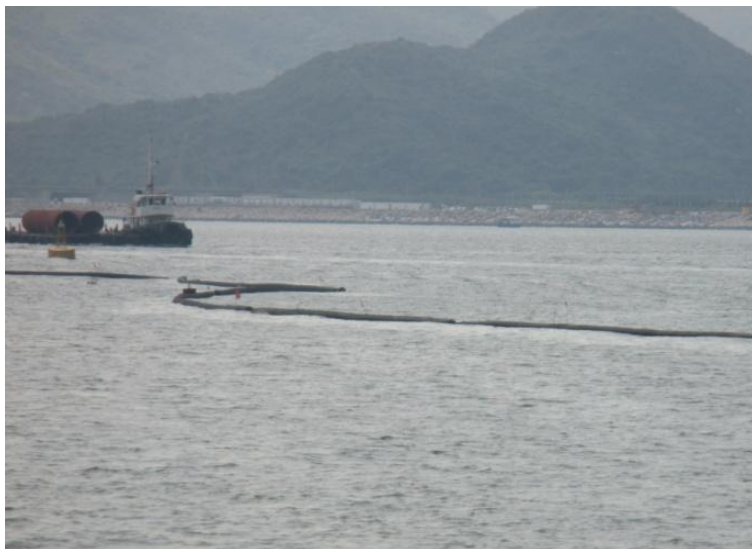
3.3.4.3 As informed by the Contractor, filling was conducted on 3, 5 and 8 September 2014 at Portion E2, but with referred to monitoring record and photo record attached, no sediment plume has been observed to flow from the inside of the perimeter silt curtain to the outside of the perimeter silt curtain and no discoloration of sea water has been observed.

3.3.4.4 Photo record of sea condition taken during flood tide at the North of HKBCF Reclamation Works near IS8 on 5 September 2014.

- 3.3.4.12 Nevertheless, the Contractor was reminded to ensure provision of ongoing maintenance to the silt curtains and to carry out maintenance work once defects were found.

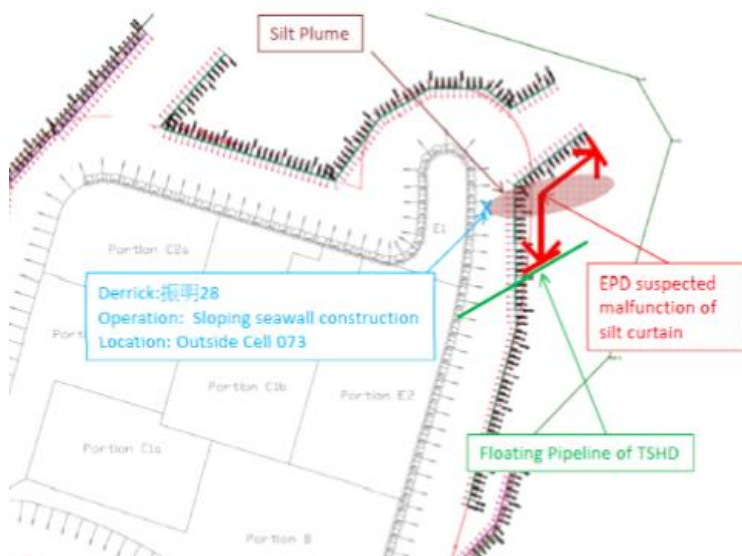
- Diver checking and rectification record for integrity of silt curtain has been checked and it shows that the part of the silt curtain which was suspected to be malfunction (showed by red arrow in the diagram below) has been rectified by the Contractor.

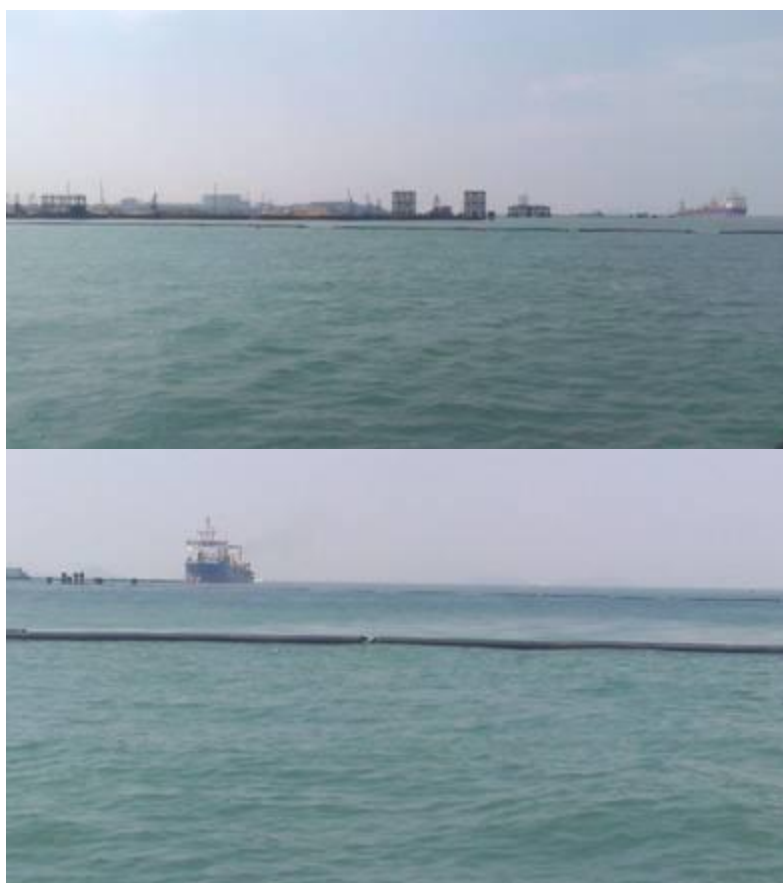
- IWQM data obtained on 27 and 29 October 2014 were reviewed; no water quality monitoring exceedance was noted on 27 and 29 October 2014.
- Ad hoc site inspection was subsequently conducted on 31 October 2014 but no silt plume or turbid water was observed on 31 October 2014. Photo records taken on 31 October 2014 at around 01:00pm which shows the sea condition at sea area near Portion E1 of the HKBCF Reclamation Works:

5.1.8.3 The water quality will be closely monitored through IWQM works of this Contract, should any water quality exceedance is recorded, investigation will be conducted following the EAP for IWQM. Furthermore, joint site inspection will be conducted regularly to check whether the water quality at monitoring stations of HKBCF reclamation works is adversely affected.

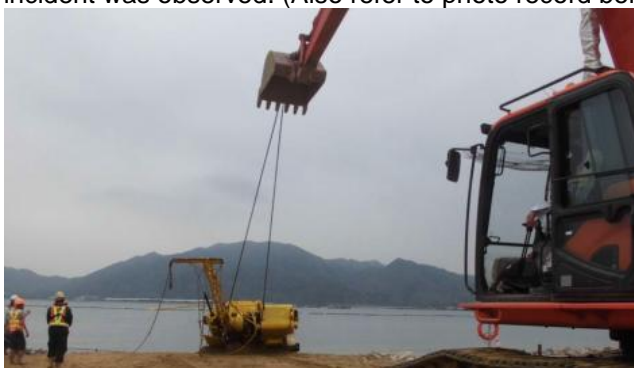
5.1.9.2 The oil spillage was caused by a drilling machine fell into the water near steel cell 51. The drilling machine which caused the oil spillage was lifted up and as informed by the Contractor, the machine was lifted and removed from the water on 12 November 2014 soon after the oil spillage incident was observed. (Also refer to photo record below).

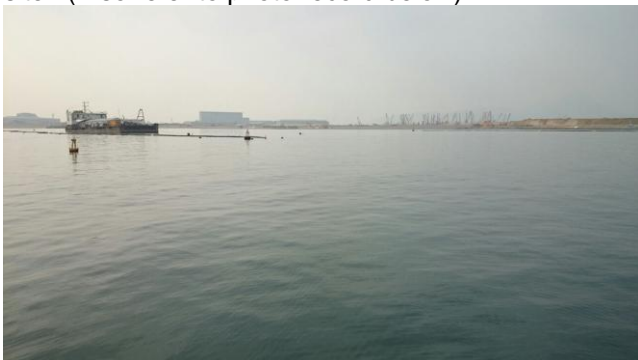
5.1.9.5 Ad hoc site inspection was conducted on 14 November 2014 and no oil spillage was observed on site. (Also refer to photo record below).

5.1.9.6 The contractor was reminded to continue to follow the spill response plan in the event of accidental oil spillage.

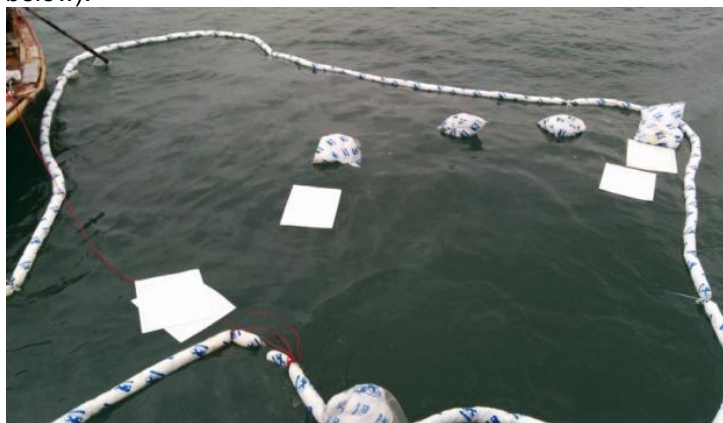
5.1.10.4 The Contractor used absorption booms as secondary oil container to contain and remove the floating oil from water and absorption booms used was collected using disposal bags as part of the spill kits item. The used absorption booms were disposed of as chemical waste. (Also refer to photo record below).

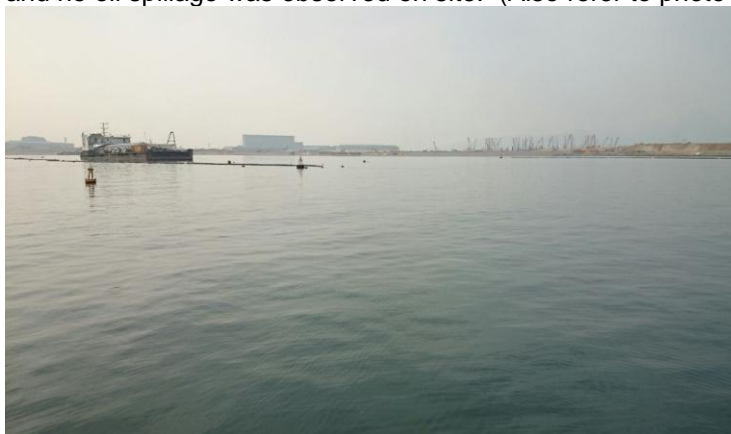
5.1.10.6 An independent site inspection was conducted on 14 November 2014 at sea area next to steel cell 51 and no oil spillage was observed on site. (Also refer to photo record below).

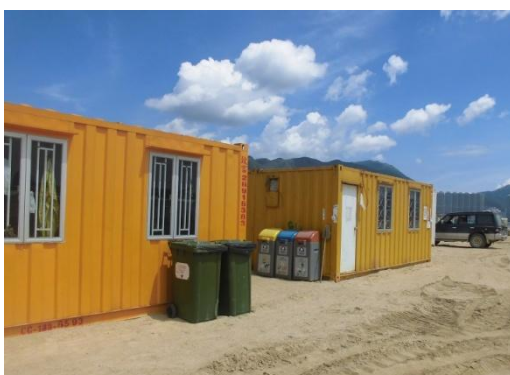
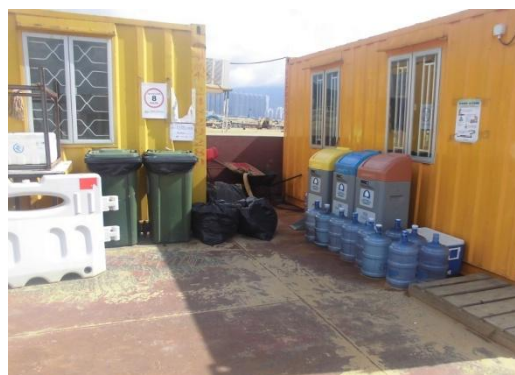
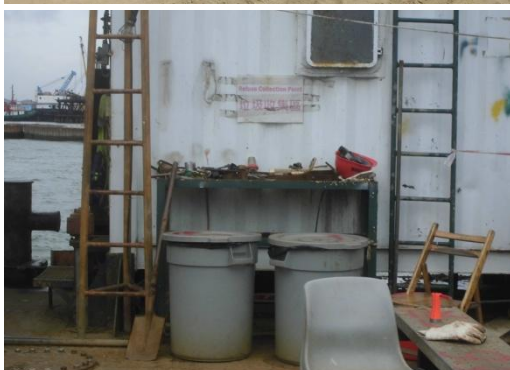
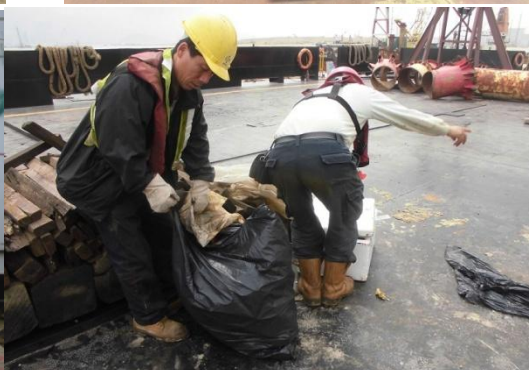
- There is no sufficient information provided by the complainant to make sure that the general refuse such as food container and plastic bottles are related to this project.
- Photo of site condition was reviewed, temporary refuse collection facility/ appropriate containers such as rubbish bins were provided by the Contractor on reclamation and vessel to collect general refuses, please refer to the photo below:

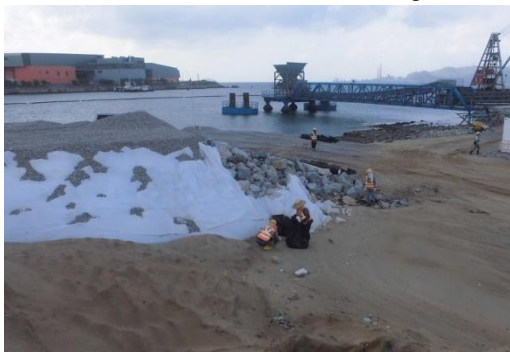
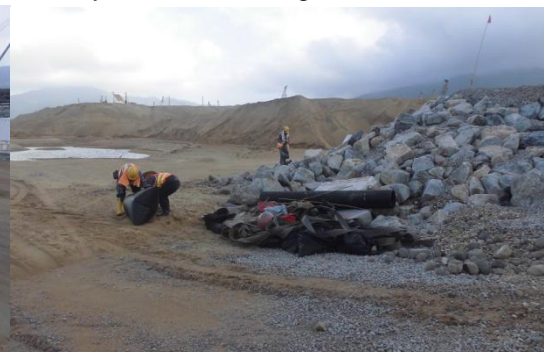
- Photo records shows collection of general refuse by workers on a regular basis:

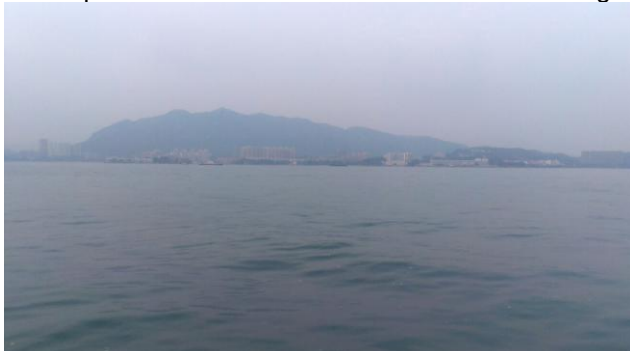
7.1.4.3 Below photo shows condition of the sea area facing Tuen Mun on 22 September 14.
