Contract No. HY/2010/02

## Hong Kong – Zhuhai – Macao Bridge Hong Kong Boundary Crossing Facilities – Reclamation Works

Quarterly EM&A Report for  
December 2014- February 2015

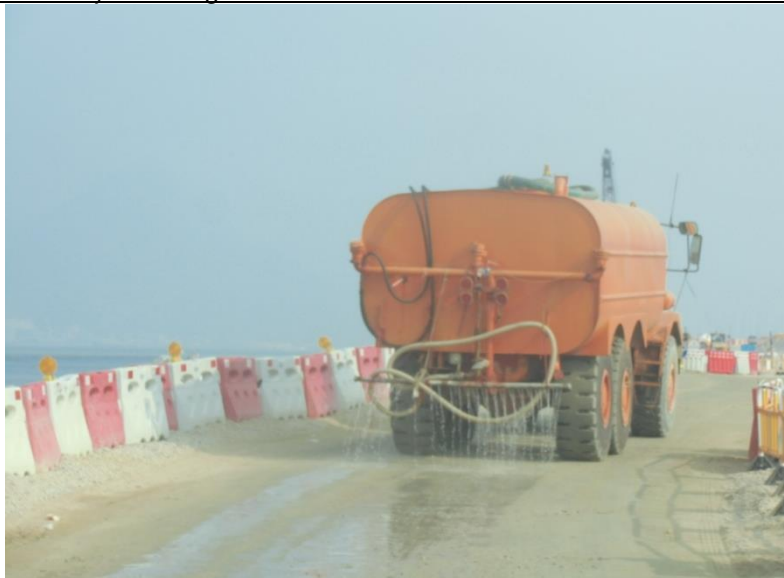
3.1.7.5 Photo record taken on 5 February 2015 below showed that the Contractor implemented dust control measures at HKBCF reclamation works such as watering on exposed soil. The Contractor was reminded to continue to provide such dust control measure.

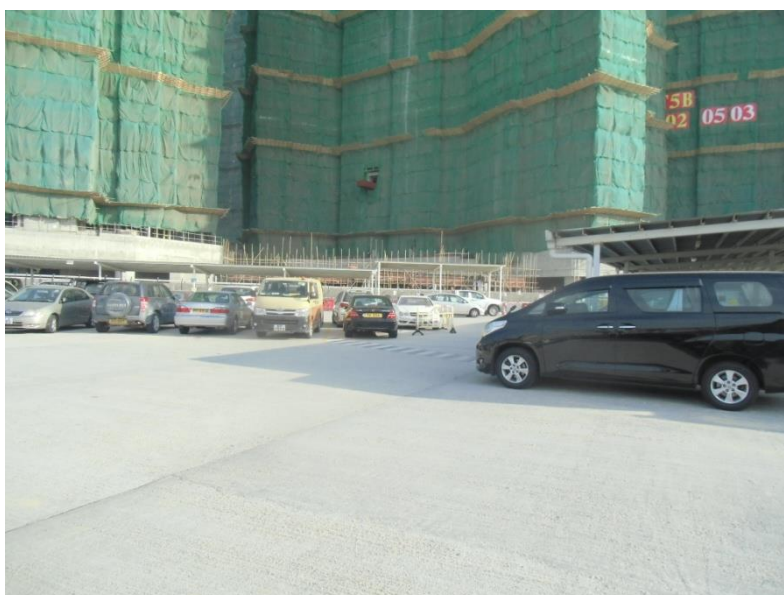
- 3.1.7.6 Photo record taken on 12 February 2015 showed that the Contractor implemented dust control measures such as hard paved roads at WA2. The Contractor was reminded to continue to provide such dust control measure.

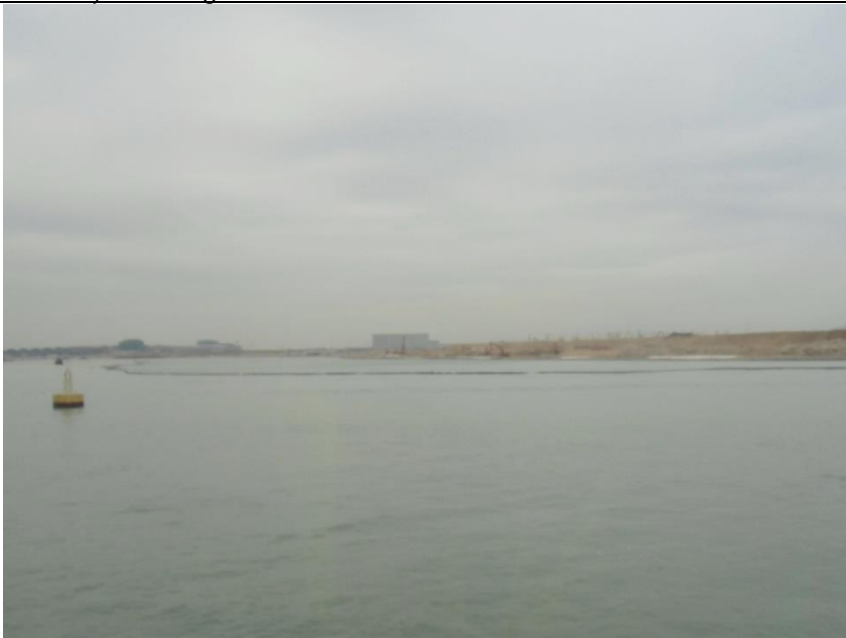
3.3.4.7 Photo record which shows the sea condition near Portion B, the southeast part of the HKBCF reclamation works at ebb tide on 5 December 2014.

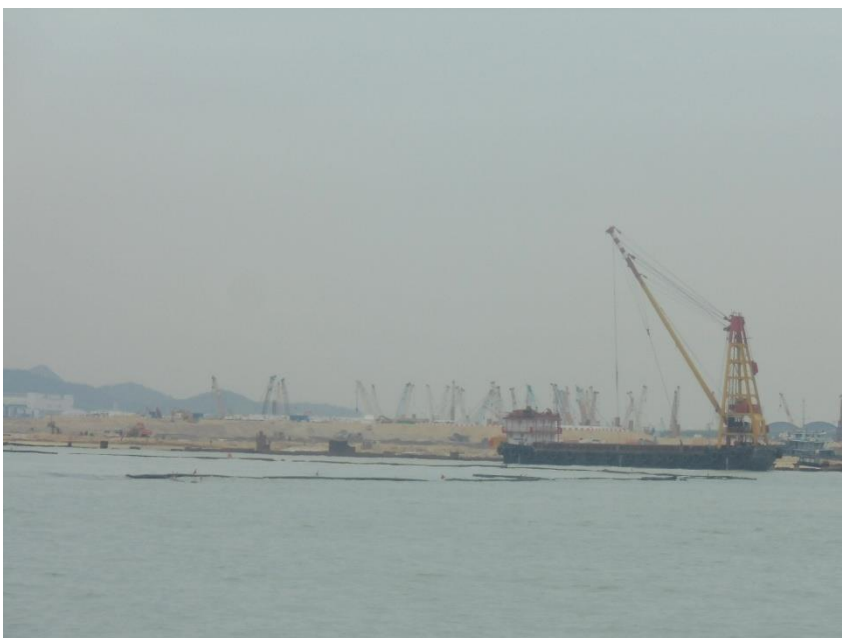
- 3.3.4.8 Photo record which shows the sea condition near Portion E, the northeast part of the HKBCF reclamation works at ebb tide on 5 December 2014

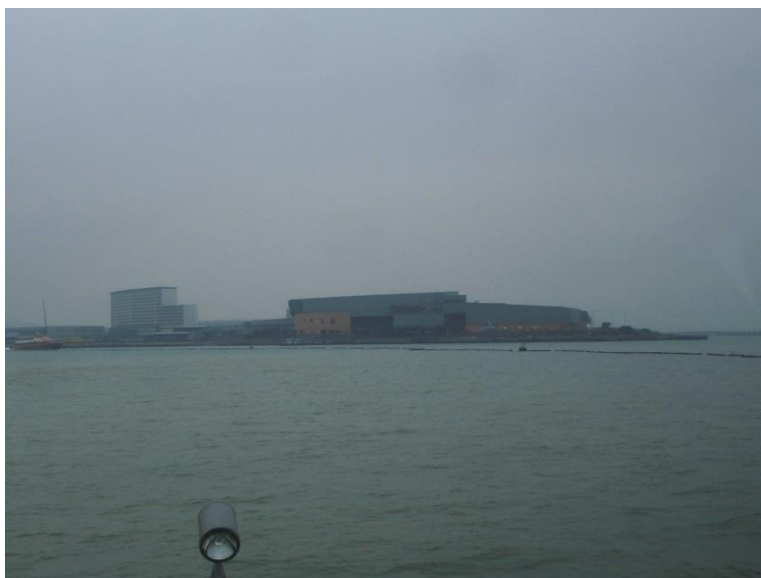
3.3.5.4 No filling activities was observed in progress and no silt plume was observed to flow from the inside of the perimeter silt curtain to the outside of the perimeter silt curtain when monitoring was conducted at IS10 and SR5. (Also see attached for sea condition observed on 12 January 2015 during flood tide.)

3.3.5.5 Photo record which shows the sea condition near Portion C2a, the northwest part of the HKBCF

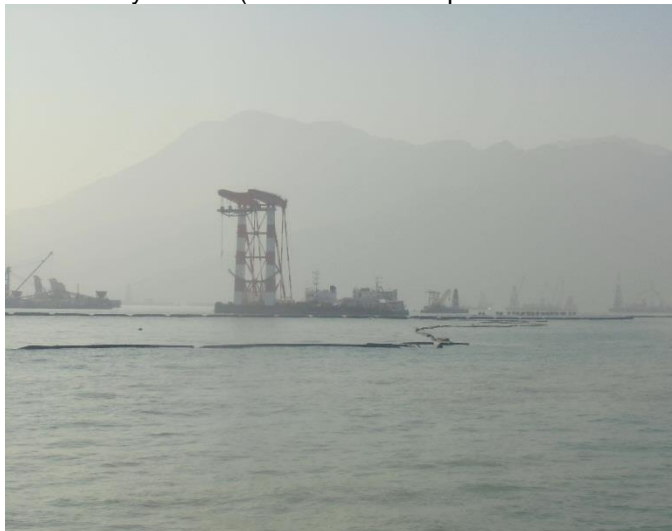
- 3.3.6.6 In addition, with referred to monitoring record, no sediment plume has been observed to flow from the inside of the perimeter silt curtain to the outside of the perimeter silt curtain during ebb tide on 16 January 2015. (Please refer to photo record taken during ebb tide on 16 January 2015)

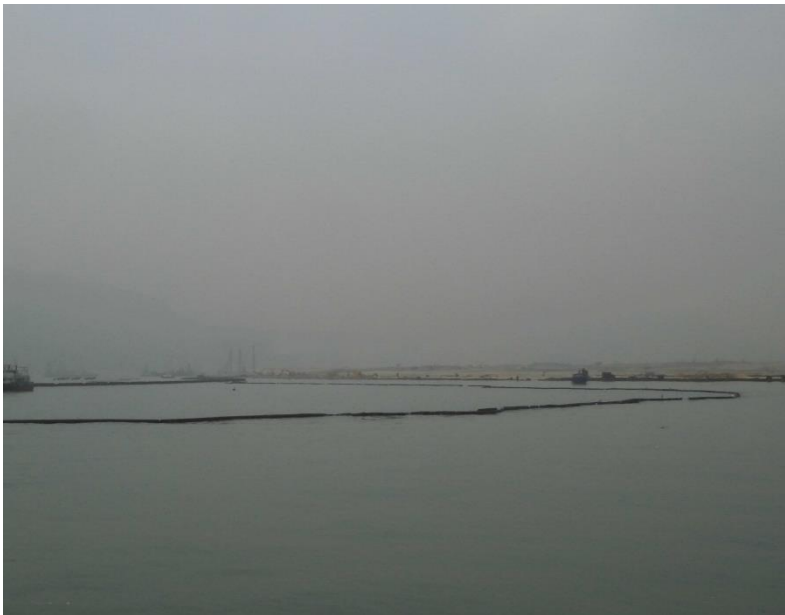
- 3.3.7.10 Photo record which shows the sea condition near at northeast side of HKBCF Reclamation Works at flood tide on 21 January 2015.

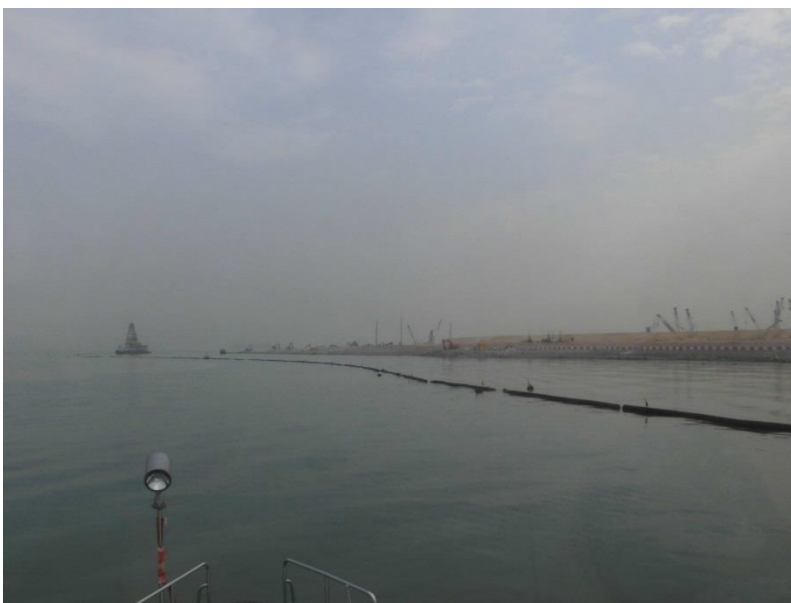
- 3.3.7.11 Photo record which shows the sea condition near at west side of HKBCF Reclamation Works at flood tide on 21 January 2015.

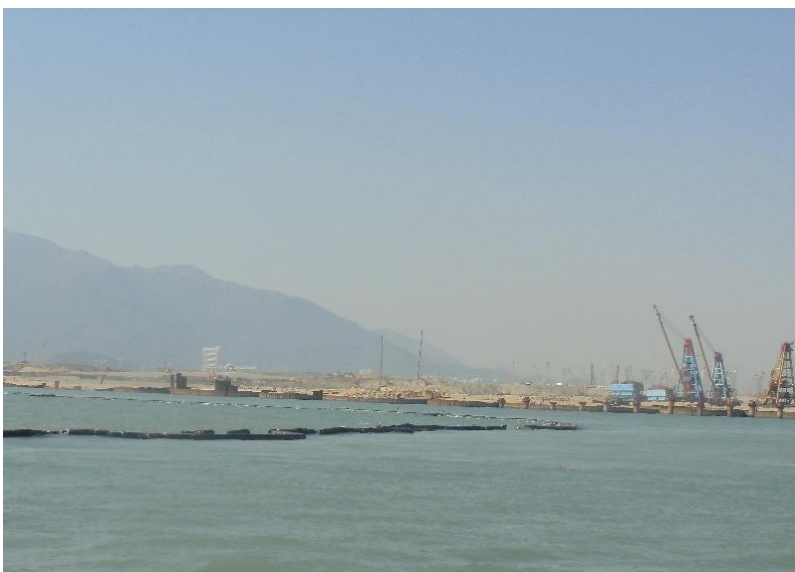
- 3.3.8.13 Photo record which shows the sea condition at northeast part of the HKBCF reclamation works during flood tide on 23 January 2015.

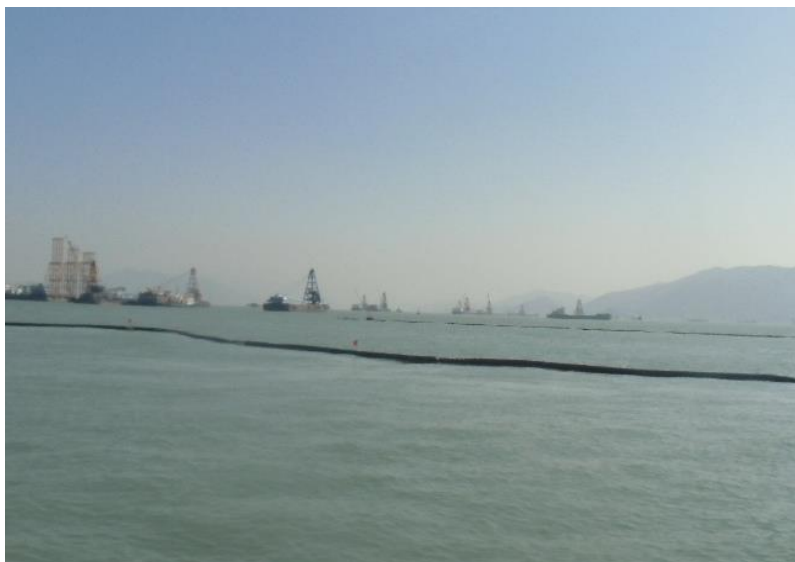
- 3.3.8.14 Photo record which shows the sea condition at the east part of the HKBCF reclamation works during flood tide on 23 January 2015.

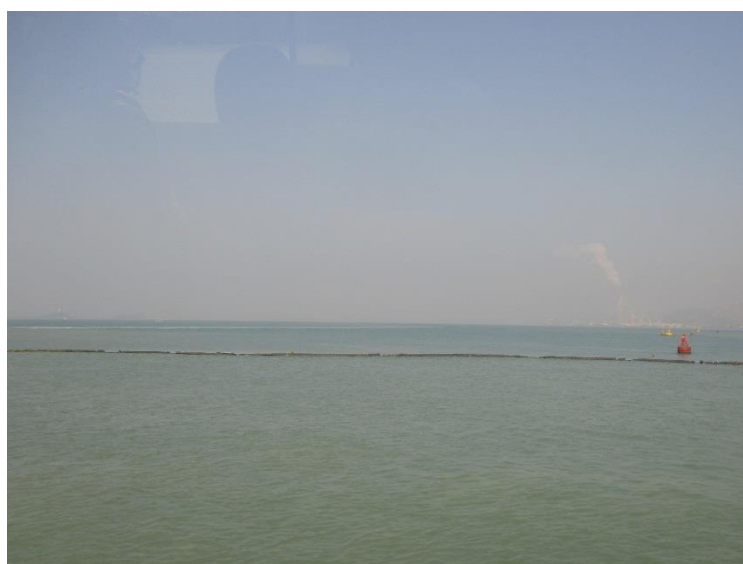
3.3.9.4 No filling activities was observed in progress and no silt plume was observed to flow from the inside of the perimeter silt curtain to the outside of the perimeter silt curtain when monitoring was conducted at IS(Mf)11. (Also see attached for sea condition observed on 26 January 2015 during flood tide.

3.3.9.5 Photo record which shows the sea condition at north part of the HKBCF reclamation works during flood tide on 26 January 2015.

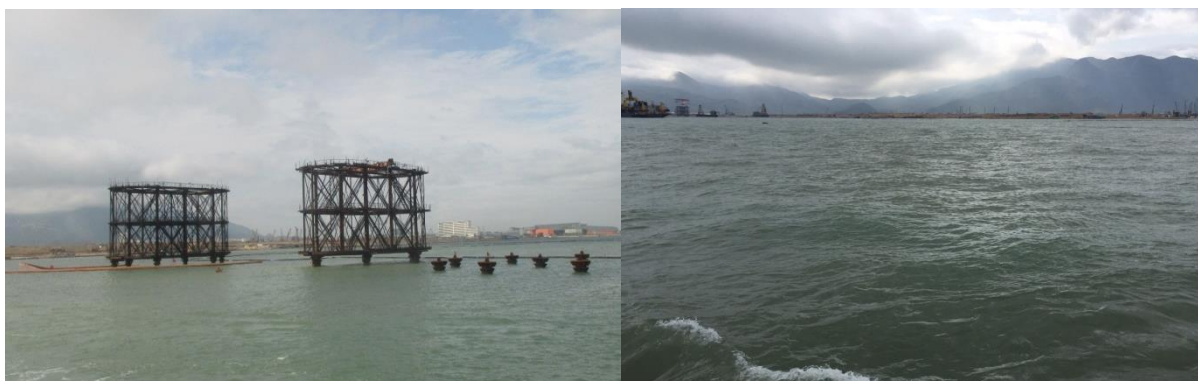
3.3.10.4 Photo record which shows the sea condition at north part of the HKBCF reclamation works during flood tide on 23 February 2015:

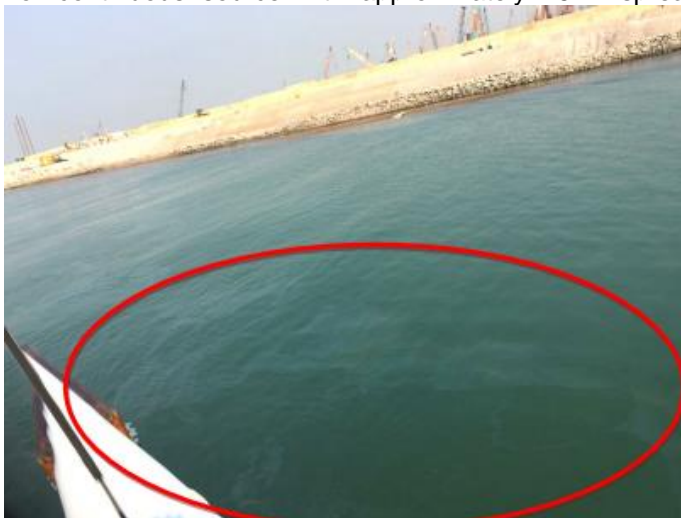
5.1.7.2 The oil spill was visually identified by the Contractor and RSS on 8 December 2014 as discrete, non-continuous source with approximately 25m<sup>2</sup> spread. (Also refer to photo record below)

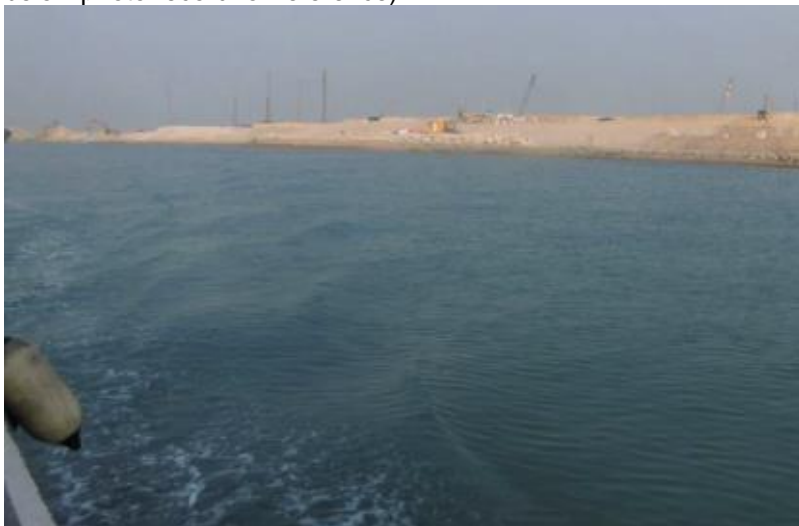
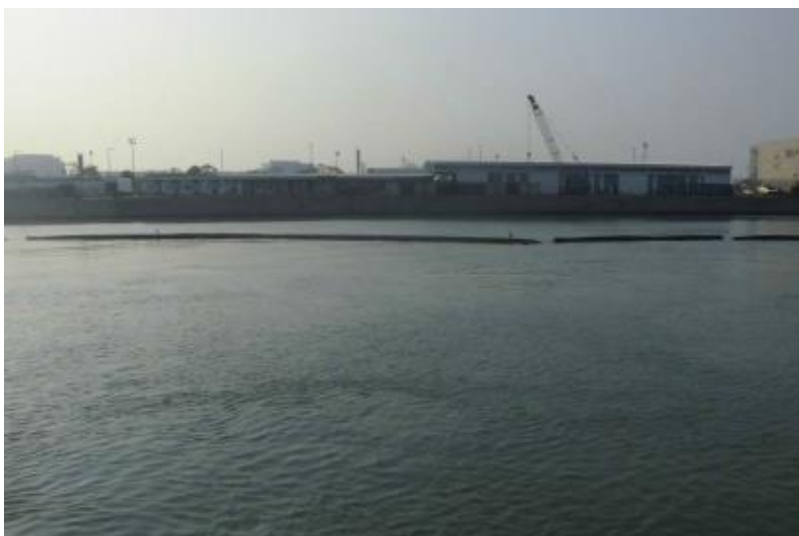
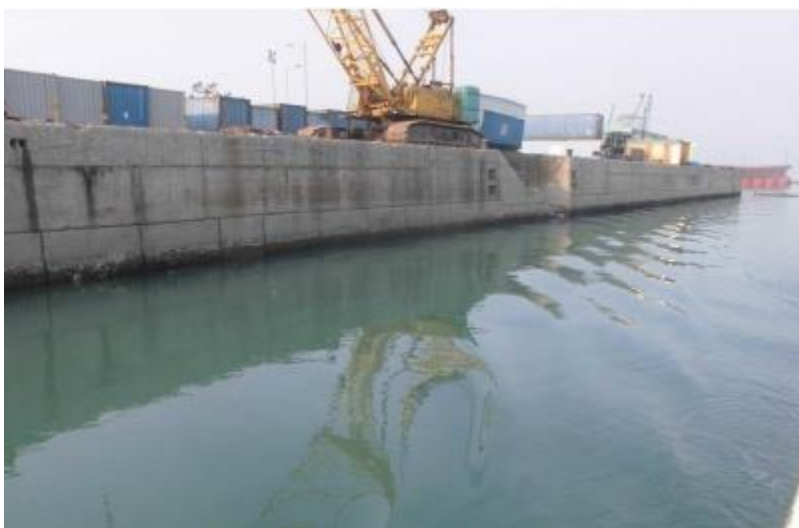
5.1.7.3 The oil stain was no longer found when the emergency boat arrived the area about 15mins after the observation. And no sign of oil spillage was found on the nearby waters after. (Please see below photo record for reference).

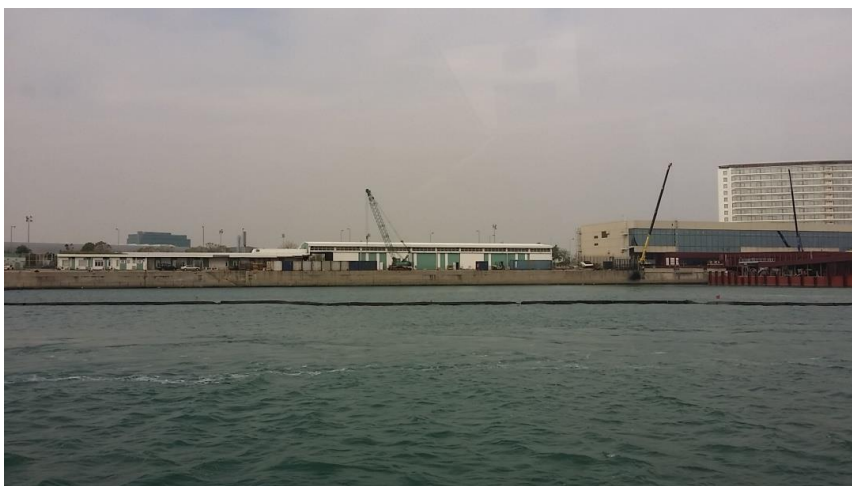
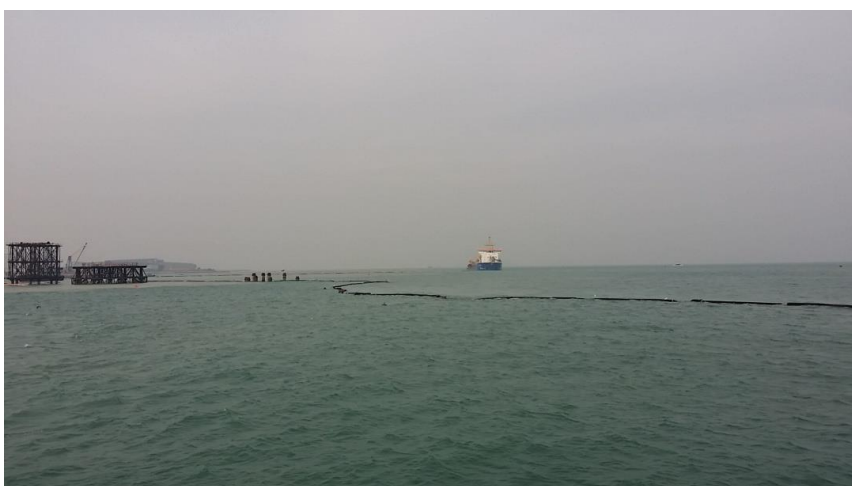
- 5.1.7.4 The oil stain observed was limited at nearby western sea area within the silt curtain.
- 5.1.7.5 An joint site inspection was conducted with ET, Contractor and RSS on 11 December 2014 at perimeter of HKBCF Reclamation Works and no oil spillage was observed on site. (Also refer to photo record below).
