Contract No. HY/2010/02

**Hong Kong – Zhuhai – Macao Bridge
Hong Kong Boundary Crossing
Facilities –
Reclamation Works**

**Quarterly EM&A Report for
March 2015- May 2015**

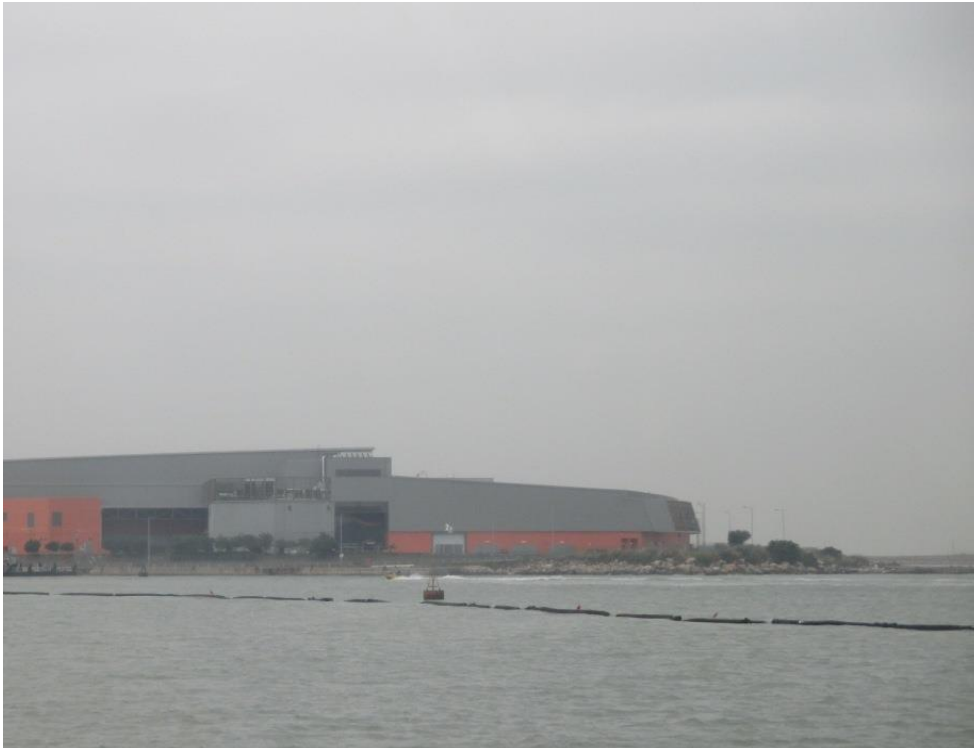
- 3.3.4.3 Photo record which shows the sea condition near IS10 at northwest part of the HKBCF during flood tide on 23 March 2015

- 3.3.4.8 Furthermore, no filling activities were observed in progress and no silt plume was observed to flow from the inside of the perimeter silt curtain to the outside of the perimeter silt curtain when monitoring was conducted at IS10 and SR5. (Also see attached for sea condition observed on 23 March 2015 during flood tide.)

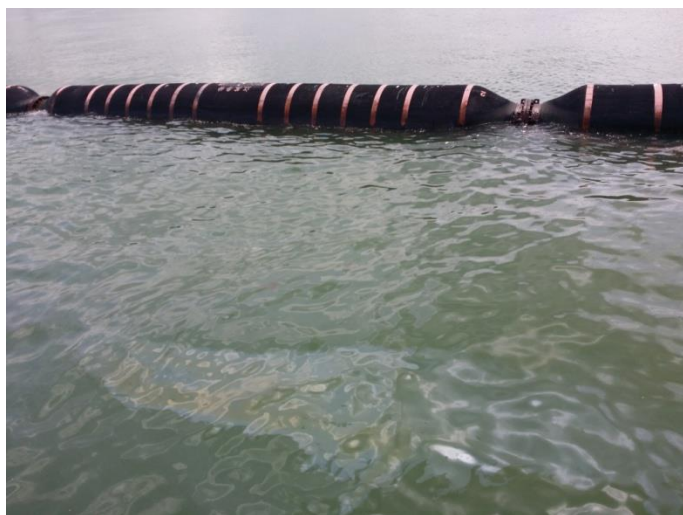
- Oil was observed on sea next to Northeastern of Portion C2c within silt curtain at 10:45 a.m. on 14 May 2015 during joint inspection conducted by Contractor, ET, ESS and the RSS. The following actions was taken by the Contractor:
- The Contractor organised manpower to identify the spill source, the vessel (Evershin no.8) located close to the oil spill was inspected but the source of oil spill was not identified.
- The oil spill was identified during join site inspection conducted by the Contractor, ET, ESS and RSS on 14 May 2015 as discrete, non-continuous source with approximately 10m² spread. Also refer to photo below:

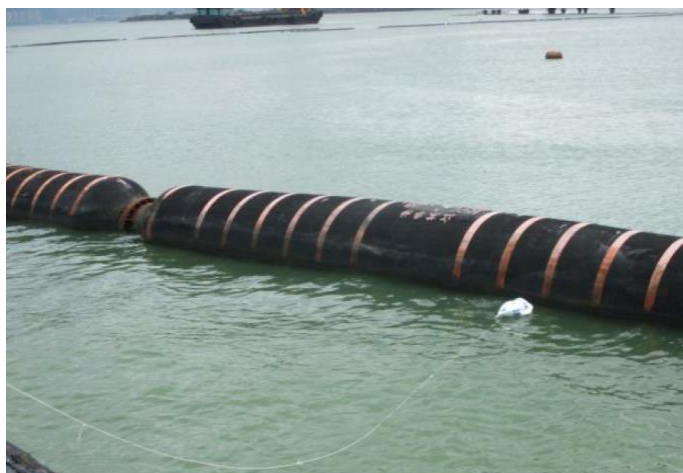
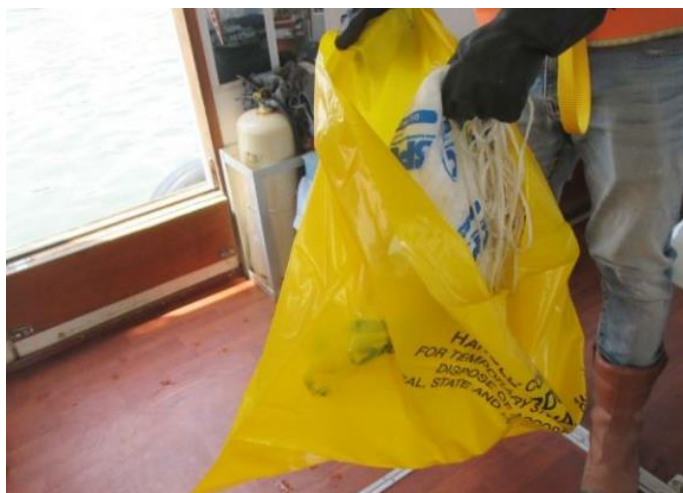
- The Contractor deployed absorption booms to remove the floating oil from water and the used absorption booms were collected using disposal bags as part of the spill kits item. The used absorption booms were disposed of as chemical waste by the Contractor. (Also refer to photo record below).

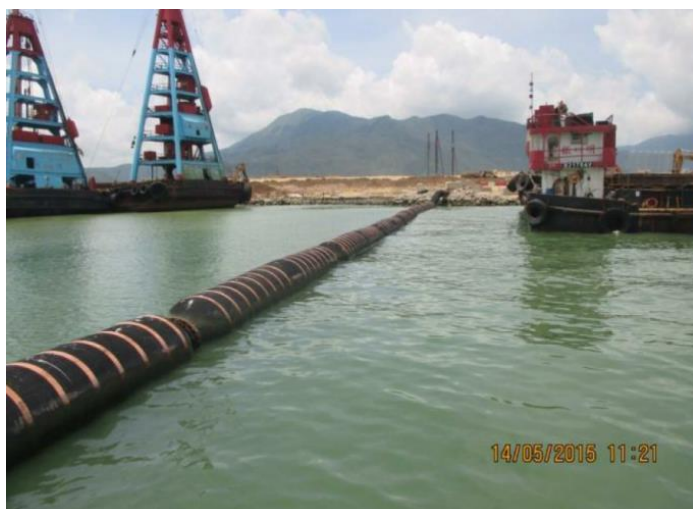
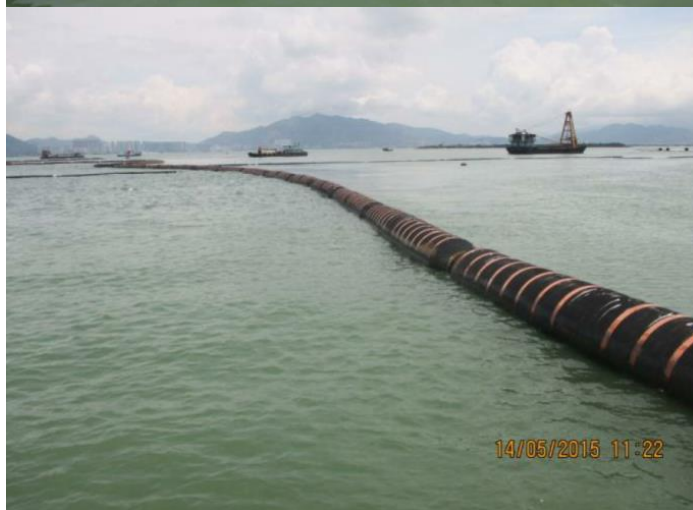
- The oil stain observed was limited at nearby Northeastern sea area within the silt curtain.
- Photo record shows that oil on sea was no longer observed at sea area near Northeastern of Portion C2c. (Also refer to photo record below)

- 5.1.6.3 The contractor was reminded to continue to follow the spill response plan when oil is observed on sea.
- 5.1.6.4 Frequency of watering per day on exposed soil was checked; with reference to the record provided by the Contract, watering was conducted at least 8 times per day on reclaimed land. The frequency of watering is the mainly refer to water truck. Sprinklers are only served to strengthen dust control measure for busy traffic at the entrance of Portion D. As informed by the Contractor, during the mal-function period of sprinkler, water truck will enhance watering at such area. The Contractor was reminded to ensure provision of watering of at least 8 times per day on all exposed soil within the

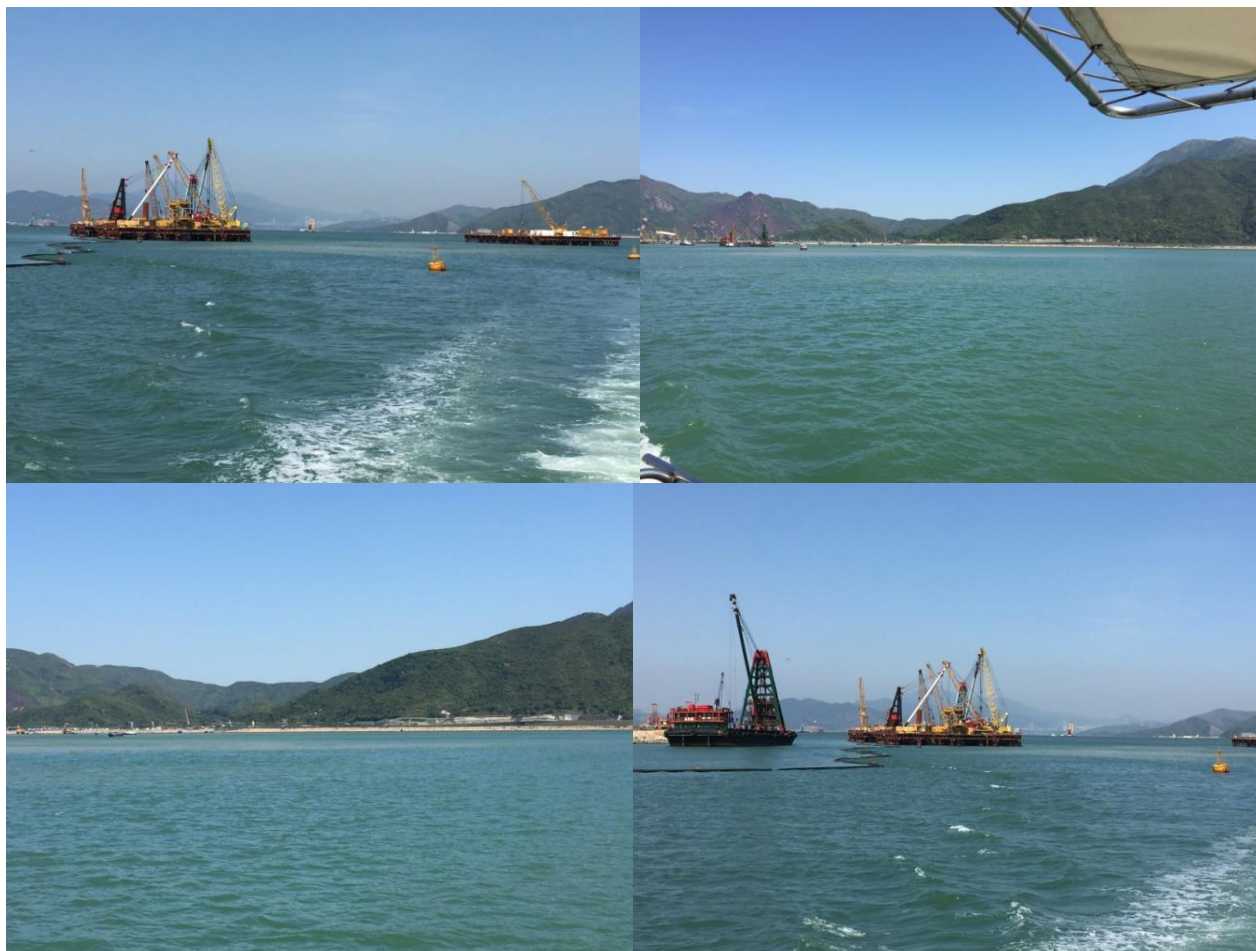
- 8.2.3 There is a report of silt plume observed near the silt curtain for HZMB HKBCF Project maintained by Contract No. HY/2010/02 during site visit conducted by HyD on 15 April 2015. Silt plume was observed Near the eastern part of HKBCF reclamation works (portion B and E), near the silt curtain for HZMB HKBCF Project maintained by Contract No. HY/2010/02.

8.2.3.1 Photo record taken on 15 April 2015 shows that silt plume was observed near the silt curtain for HZMB HKBCF Project maintained by Contract No. HY/2010/02 during a site visit conducted by HyD on 15 April 2015:

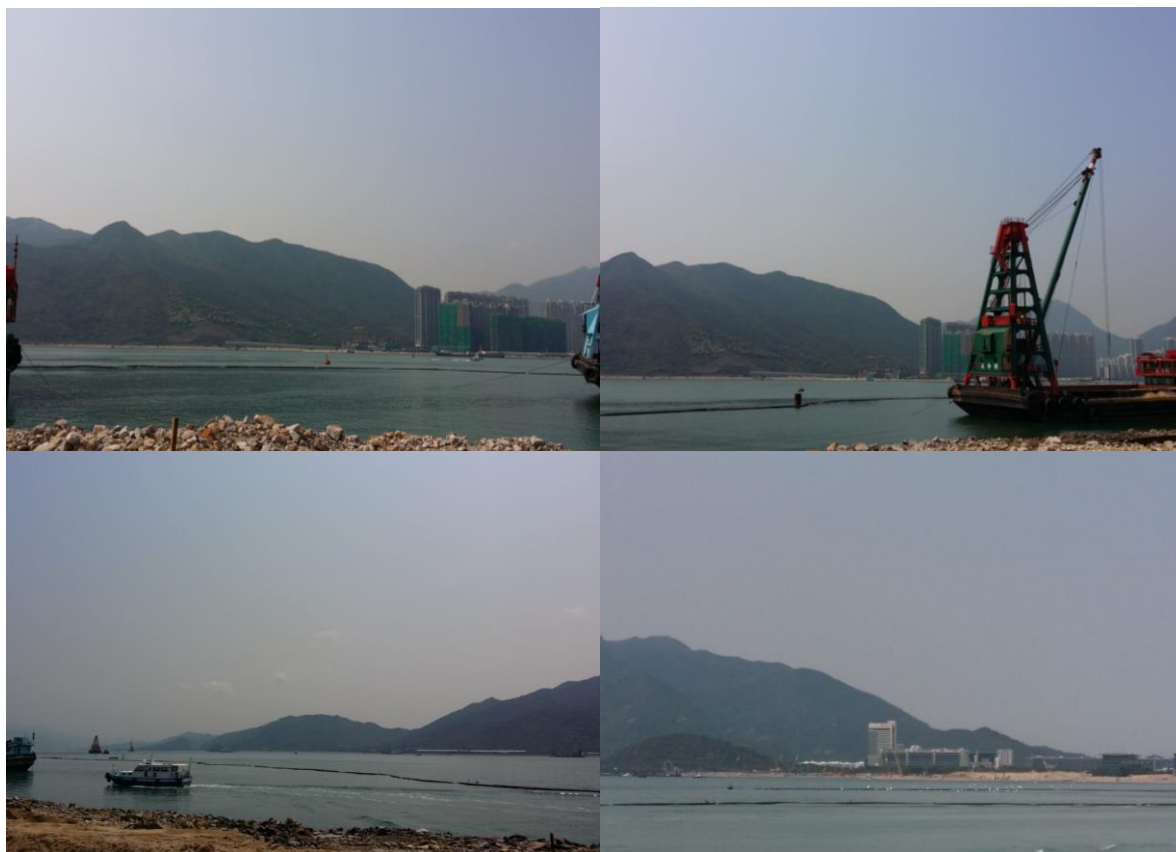
- No silt plume around the Portion B and Portion E2 of HKBCF reclamation works were observed during the joint site inspection conducted jointly with the Contractor, RSS and ESS on 16 April 2015. Photos were taken and please see attached photo record for reference

8.2.3.4 Photo record taken on 16 April 2015 shows that no silt plume around the Portion B and Portion E2 of HKBCF reclamation works were observed during the joint site inspection conducted jointly with the Contractor, RSS and ESS on 16 April 2015.
