EXECUTIVE SUMMARY

Ove Arup & Partners Hong Kong Limited (Arup) was appointed by Highways Department (HyD) as the consultants for the design and construction assignment for the Contract’s reclamation works (i.e. the Engineer for the Contract).

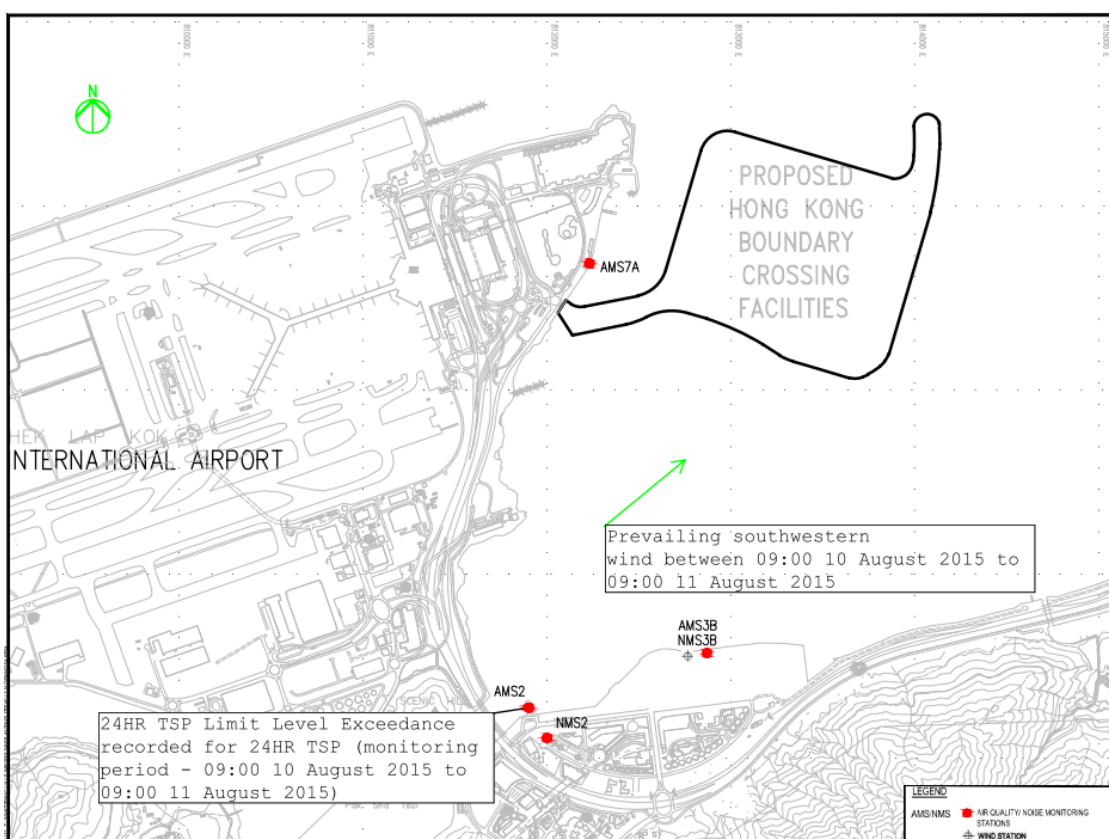
- 3.1.7.6 Box-culvert being installed at Portion D which is relatively far away from monitoring station AMS2 where the limit exceedance of 24-hr TSP was recorded. As refer to the wind direction data collected at Chek Lap Kok by Hong Kong Observatory during the monitoring period on 10 and 11 August 2015 (also see attached), Southwestern winds were prevailing during the monitoring period. Construction works carried out by this Contract are unlikely to cause dust exceedance at AMS2 under the abovementioned prevailing wind directions. (Also see below layout map for reference.)

- 3.1.7.7 In addition, no fugitive dust was expected to be generated in the process of box-culvert installation, as such, works activities from this Contract is unlikely to contribute to the recorded 24hr-TSP limit level exceedance.

- 3.1.7.10 As such, the dust exceedance was therefore considered not to be due to works of this Contract
- 3.1.7.11 The Contractor was recommended to continue implementing existing dust mitigation measures and the Contractor was reminded ensure to undertake watering at least 8 times per day on all exposed soil within the Contract site and associated work areas throughout the construction phase.

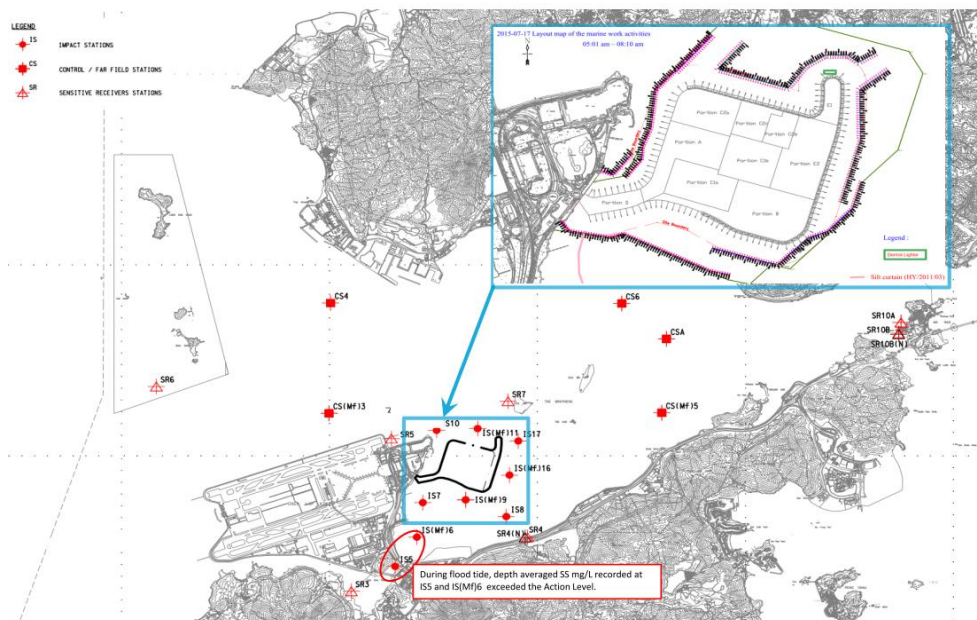
3.3.4.1 Below layout map shows no marine work was conducted at south and southwestern part of the HKBCF Reclamation Works during flood tide on 17 July 2015:

- 3.3.4.2 Exceedances recorded at IS5 and IS(Mf)6 during flood tide are unlikely due to marine based construction activities of the Contract because:
- 3.3.4.3 Attached layout map shows no marine work was conducted at south and southwestern part of the HKBCF Reclamation Works during flood tide on 17 July 2015, therefore it is unlikely that the SS exceedances recorded at IS5 and IS(Mf)6 during flood tide are caused by HKBCF Reclamation Works.

- 3.3.4.10 Nevertheless, the Contractor was reminded to ensure provision of ongoing maintenance to the silt curtains and to carry out maintenance work once defects were found.

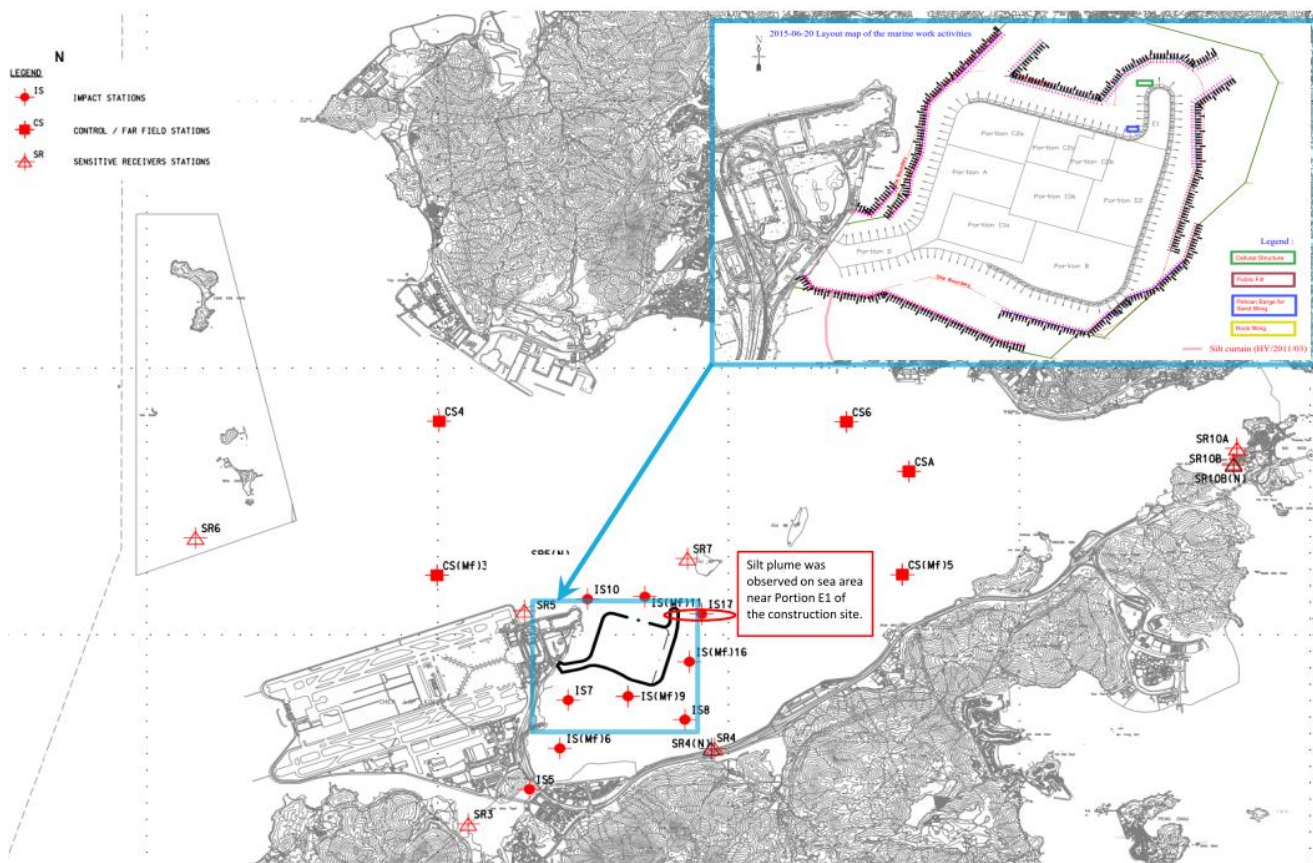
5.1.8 IEC/ENPO notified ET via email on 22 June 2015 that silt plume was observed being dispersed from Portion E1 to the open waters outside the silt curtain for the HZMB HKBCF Contract maintained by Contract No. HY/2010/02 at about 3:00 pm on 20 June 2015. For location of sea area near Portion E1 of the construction site, also see layout map below:

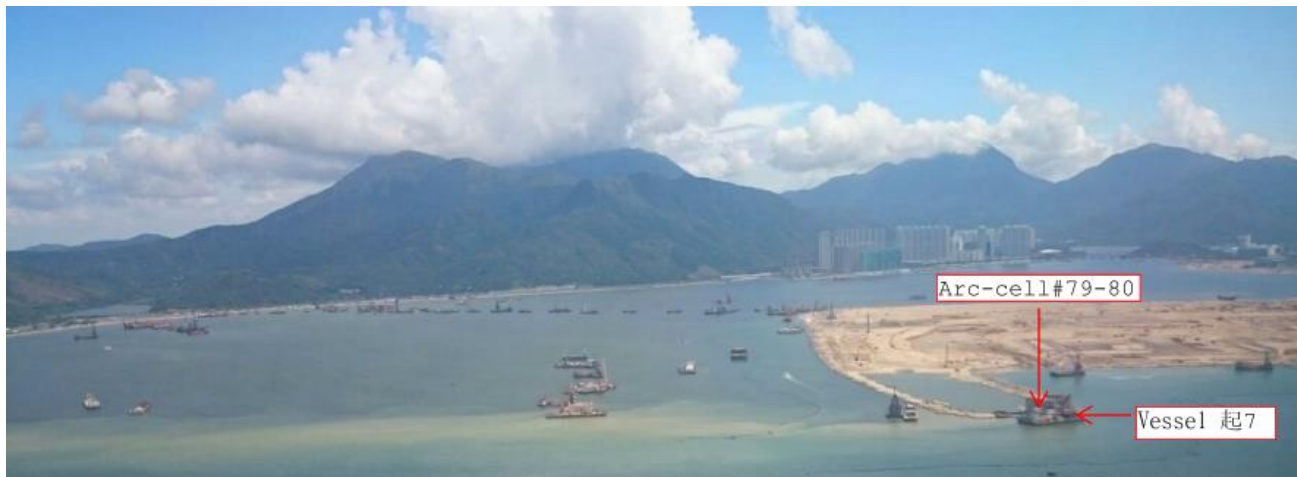
- 5.1.8.15 Photo record taken on 20 June 2015 at about 15:00 shows that silt plume was observed near the silt curtain for HZMB HKBCF Contract maintained by Contract No. HY/2010/02.

- 5.1.8.14 Nevertheless, the Contractor was reminded to regularly check the performance of the silt curtain and ensure swift provision of maintenance to the perimeter silt curtains once defects of the perimeter silt curtain were observed.

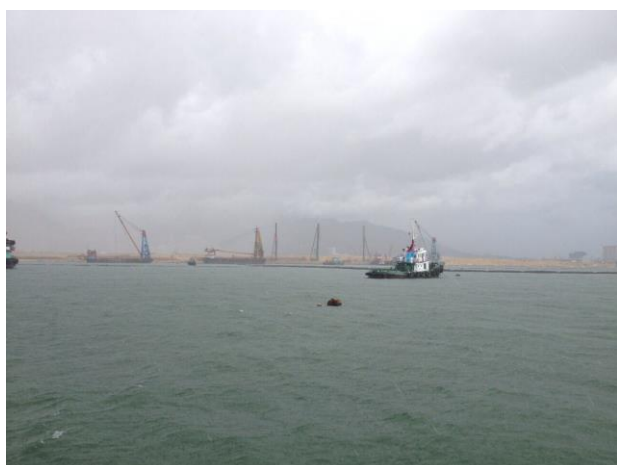
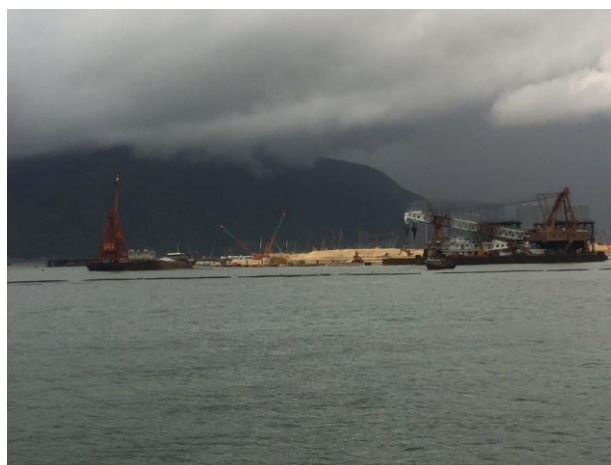
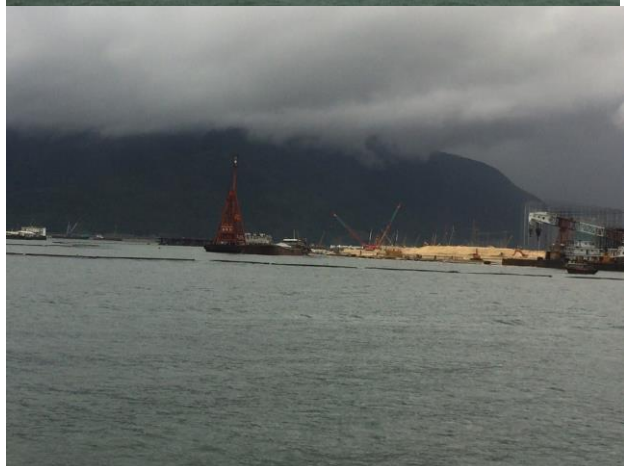
5.1.8.16 Photo record taken on 22 June 2015 shows that no silt plume around Portion E1 of HKBCF reclamation works were observed during the site inspection conducted on 22 June 2015.

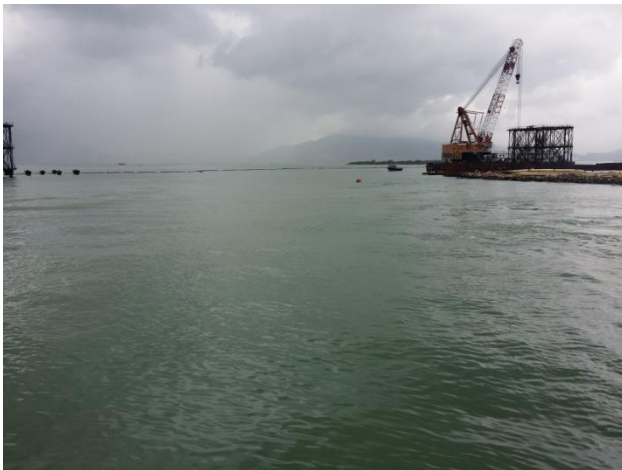
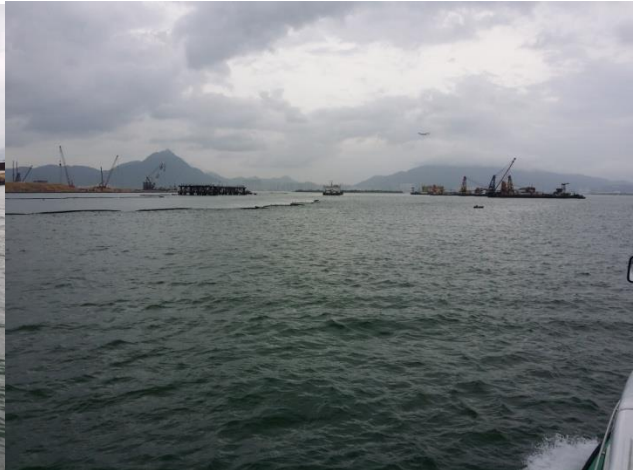
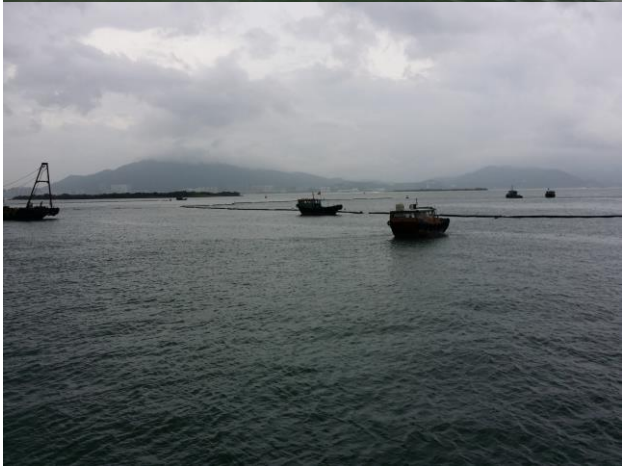
5.1.8.17 Photo record taken on 25 June 2015 shows that no silt plume around Portion E1 of HKBCF reclamation works were observed during the site inspection conducted on 25 June 2015.

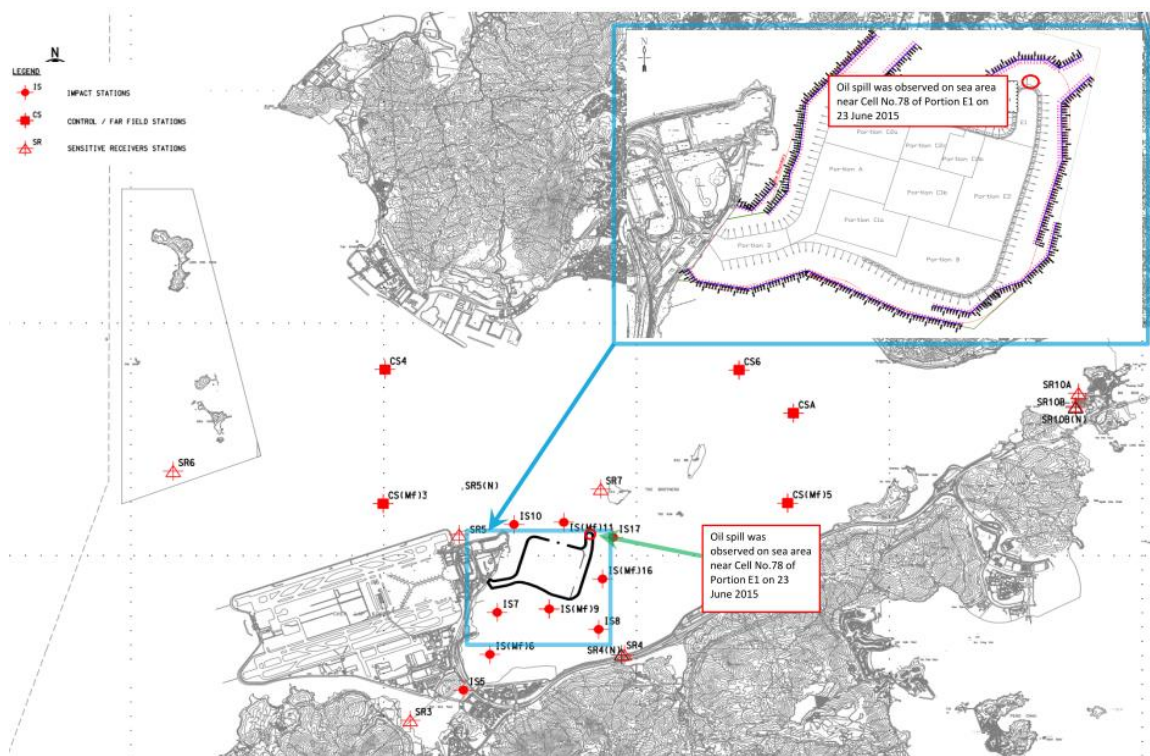
5.1.9 Oil spillage incident was observed at Sea area near Cell No. 78 on 23 June 2015 (also refer to attached layout map).

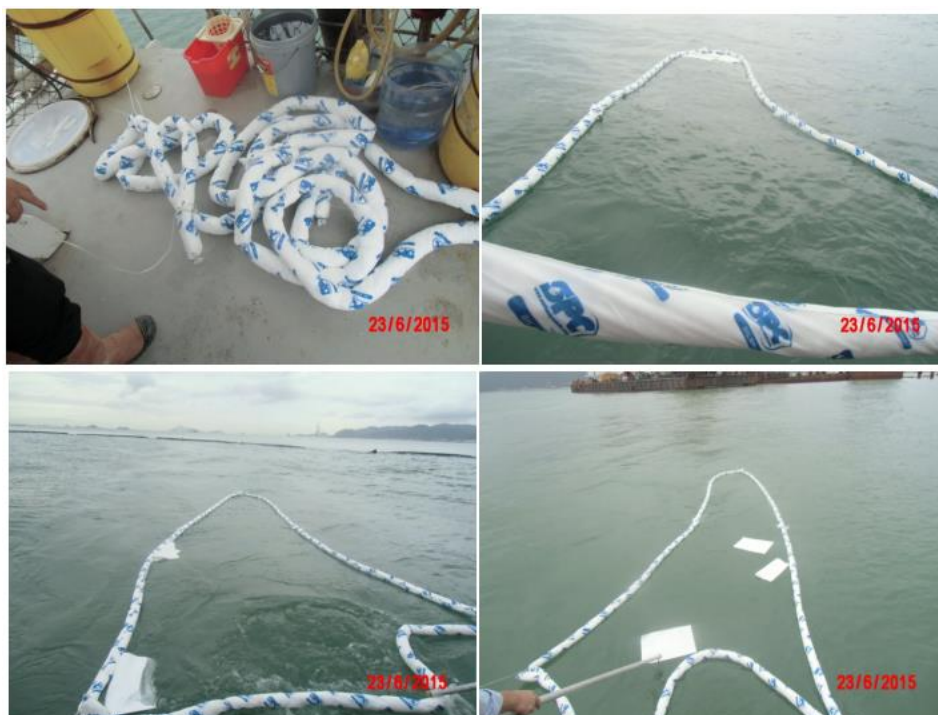
- 5.1.9.2 Oil observed on sea area near Cell No. 78 on 23 June 2015 at 09:45 a.m. on 23 June 2015 by Contractor and RSS. The following actions was taken by the Contractor:
- 5.1.9.3 The Contractor organized manpower to identify the spill source, the vessel (三航起 7) located close to the oil spill was inspected but the source of oil spill was not identified.
- 5.1.9.4 The oil spill was identified during join site inspection conducted by the Contractor and RSS on 23 June 2015 as discrete, non-continuous source with approximately 10m² spread. Also refer to photo below:
- 5.1.9.5 The oil spill was identified during join site inspection conducted by the Contractor and RSS on 23 June 2015 as discrete, non-continuous source with approximately 10m² spread. The below photo shows that the Contractor deployed absorption booms to remove the floating oil from water.

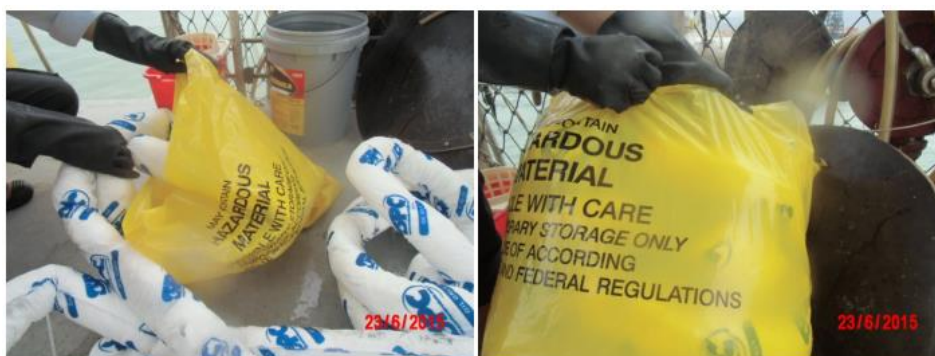
- 5.1.9.6 The used absorption booms were collected using disposal bags as part of the spill kits item. The used absorption booms were disposed of as chemical waste by the Contractor. (Also refer to photo record below)

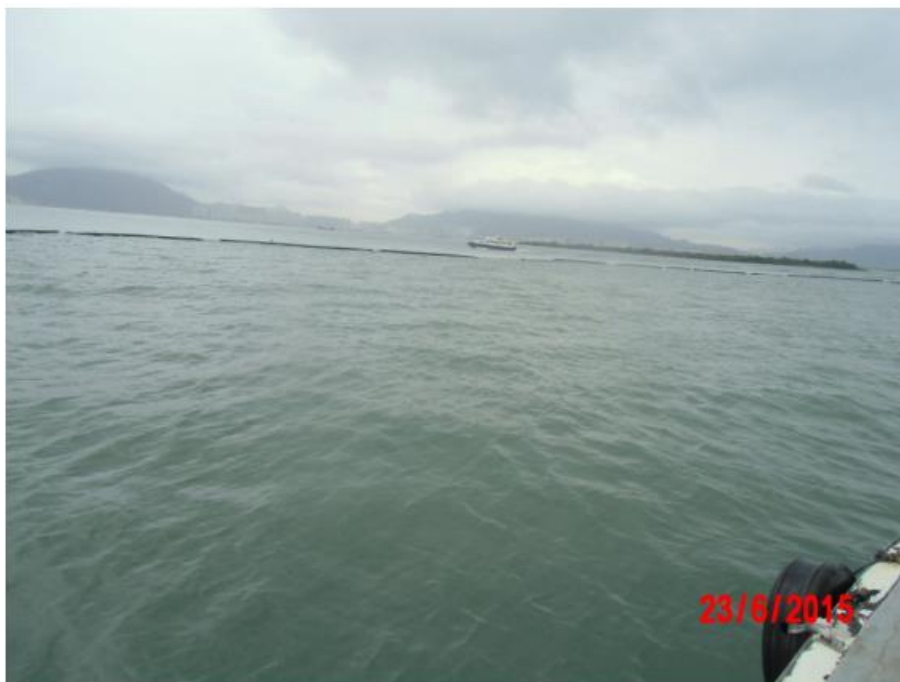
- 5.1.9.7 The oil stain observed was limited at nearby Northeastern sea area within the silt curtain.
- 5.1.9.8 Photo record shows that oil on sea was no longer on sea area near Cell No. 78. (Also refer to photo record below)

- 5.1.9.10 The Contractor was reminded to enhance environmental toolbox talk on chemical waste handling and to continue to follow the spill response plan when oil is observed on sea.
