Contract No. HY/2010/02

Hong Kong – Zhuhai – Macao Bridge Hong Kong Boundary Crossing Facilities – Reclamation Works

Quarterly EM&A Summary Report for September 2015 – November 2015

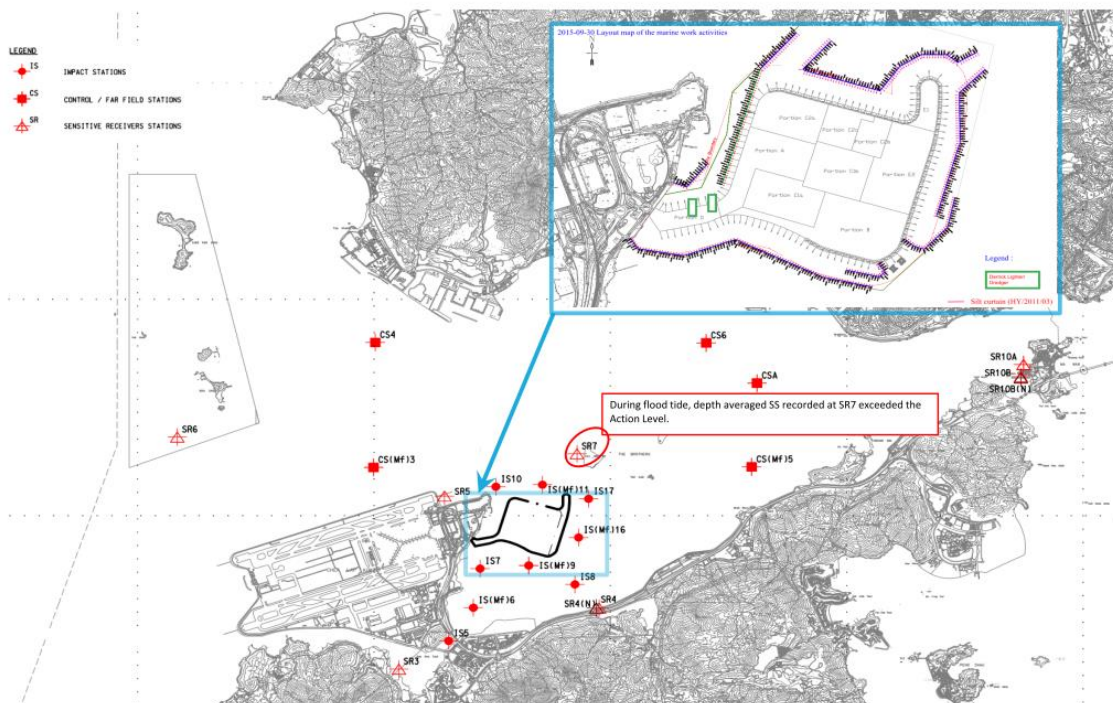
3.3.2 For water quality, one (1) Action Level Exceedance of SS at SR7 during flood tide was recorded on 30 September 2015.

3.3.2.1 Layout map below shows that vessel activities were carried out at Portion D by vessels during flood tide but no marine based construction work was conducted at north part of the HKBCF reclamation works on 30 September 2015:

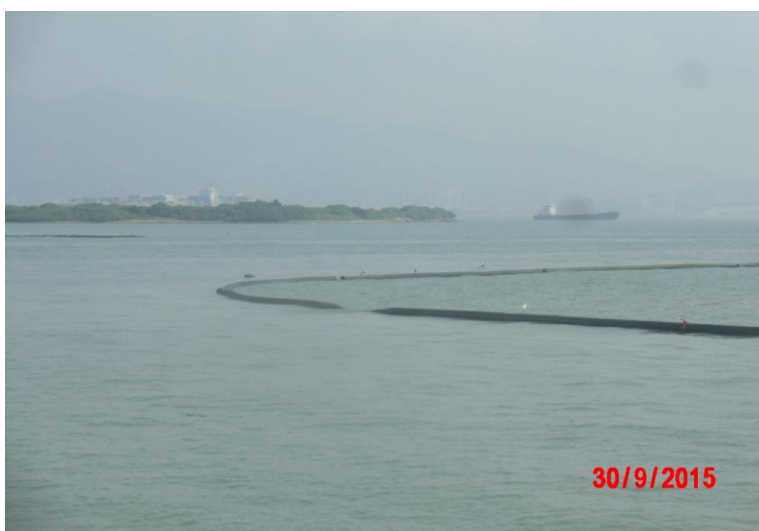
- 3.3.2.2 Exceedance recorded at SR7 during mid-flood tide is unlikely due to marine based construction activities of the Project:
- 3.3.2.3 With reference to the silt curtain checking record of 30 September 2015, defects such as missing segment or disconnection of the perimeter silt curtain were not observed at north part of the perimeter silt curtain.
- 3.3.2.4 With referred to the attached layout map, no marine based construction work was conducted at north part of the HKBCF reclamation works on 30 September 2015 and no silt plume was observed to flow from the inside of the perimeter silt curtain to the outside of the perimeter silt curtain when monitoring was conducted during flood tide.
- 3.3.2.5 Photo record which shows the sea condition at north part of the HKBCF reclamation works during flood tide on 30 September 2015.

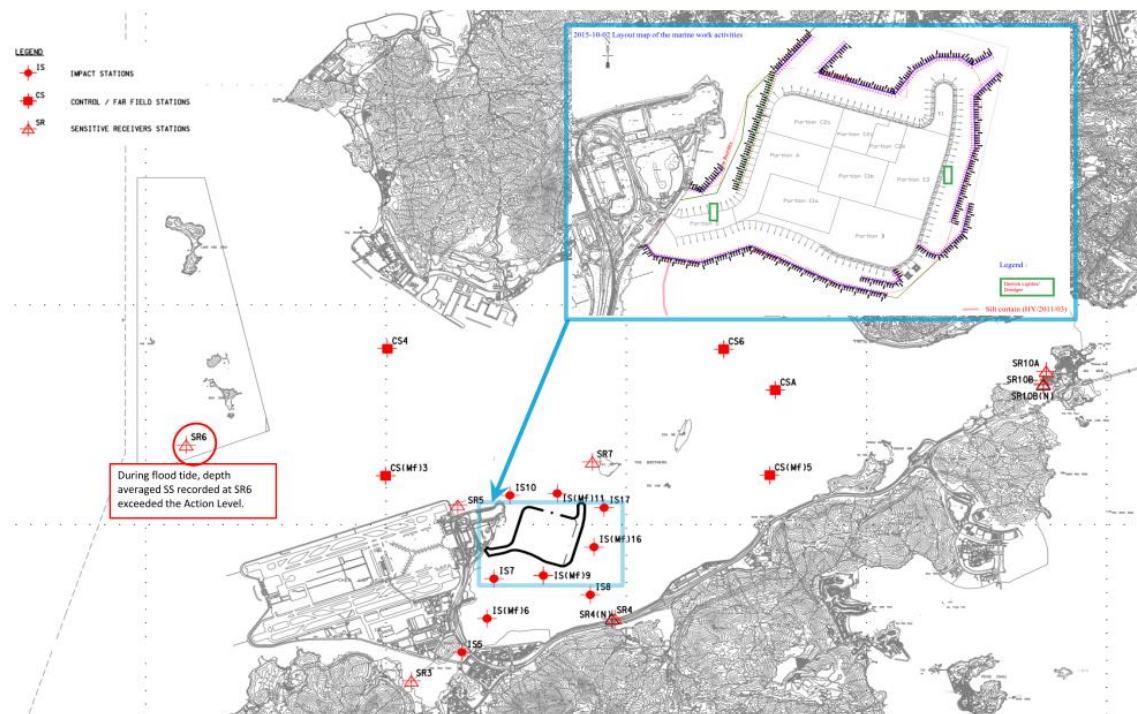
3.3.3 For water quality, one (1) Action Level Exceedance of SS at SR6 during flood tide was recorded on 02 October 2015.

3.3.3.1 Layout map below shows that vessel activities were carried out out on 2 October 2015. One derrick/dredger was at Portion D and one derrick/dredger was outside Portion E2 during flood tide on 2 October 2015.

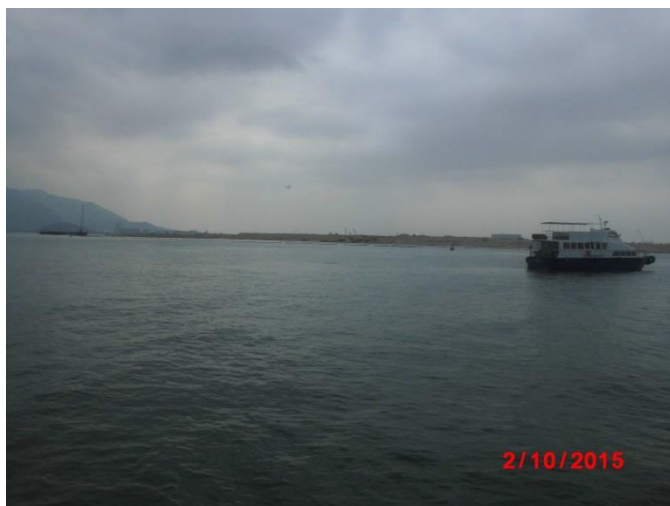
3.3.3.4 With referred to the above layout map, no marine based construction work was conducted at north part of the HKBCF reclamation works on 02 October 2015 and no silt plume was observed to flow from the inside of the perimeter silt curtain to the outside of the perimeter silt curtain when monitoring was conducted during flood tide.

3.3.3.5 Photo record which shows the sea condition at north part of the HKBCF reclamation works during flood tide on 02 October 2015

- 3.3.3.11 Nevertheless, the Contractor was reminded to ensure provision of ongoing maintenance to the silt curtains and to carry out maintenance work once defects were found.

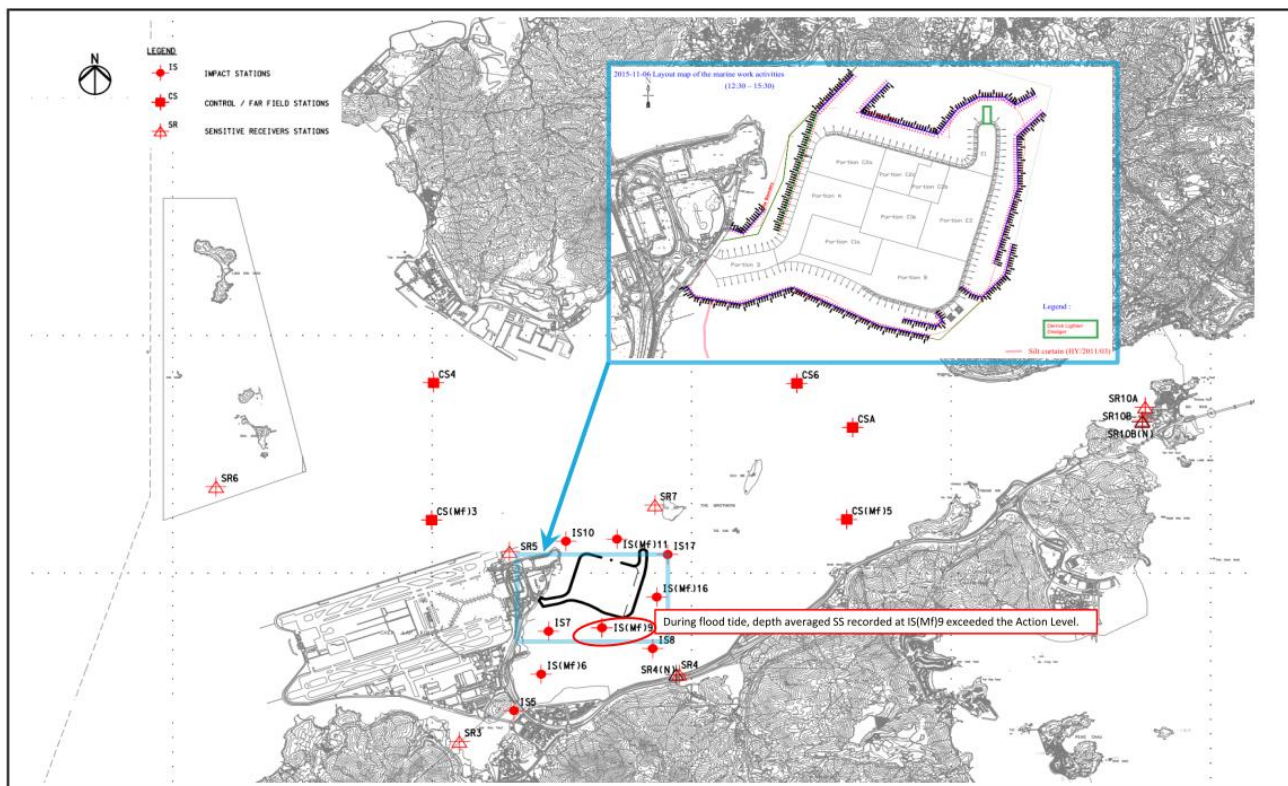
3.3.4 For water quality, one (1) Action Level Exceedance of SS at IS(Mf)9 during flood tide was recorded on 6 November 2015.

3.3.4.1 Layout map below shows that the construction activities conducted during flood tide on 6 November 2015, derrick lighter or dredger was working at north of HKBCF reclamation works which was far away from where IS(Mf)9 is located, therefore the construction activities was considered unlikely to cause the SS exceedances recorded at IS(Mf)9 during mid-flood tide.

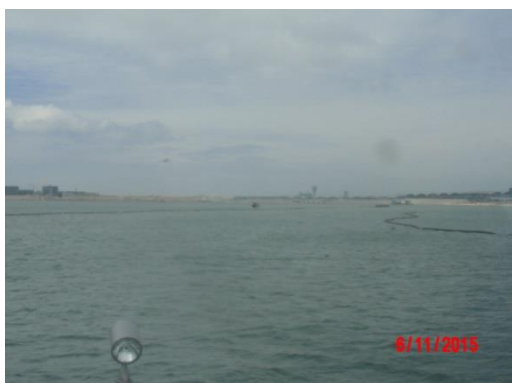
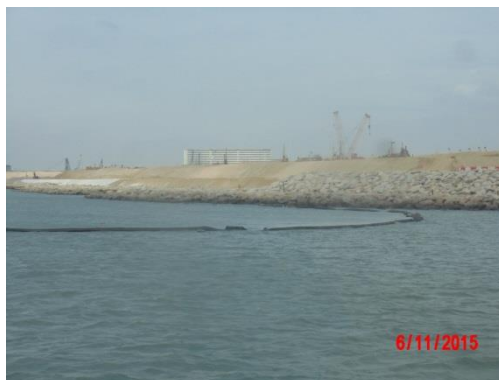
3.3.4.4 Furthermore, no filling activities was observed in progress at the sea area south to HKBCF reclamation works and no silt plume was observed to flow from the inside of the perimeter silt curtain to the outside of the perimeter silt curtain when monitoring was conducted at IS(Mf)9. Also refer to the attached photo record taken at sea area located south of HKBCF reclamation works on 6 November 2015 for reference of sea condition on 6 November 2015, which shows that no silt plume was observed.

3.3.4.5 Photo record which shows the sea condition at southern part of the HKBCF reclamation works on 06 November 2015. No silt plume was observed.

3.3.4.9 Nevertheless, the Contractor was reminded to ensure provision of ongoing maintenance to the silt curtains and to carry out maintenance work once defects were found.
