Contract No. HY/2010/02

Hong Kong – Zhuhai – Macao Bridge Hong Kong Boundary Crossing Facilities – Reclamation Works

Quarterly EM&A Summary Report for December 2015 to February 2016

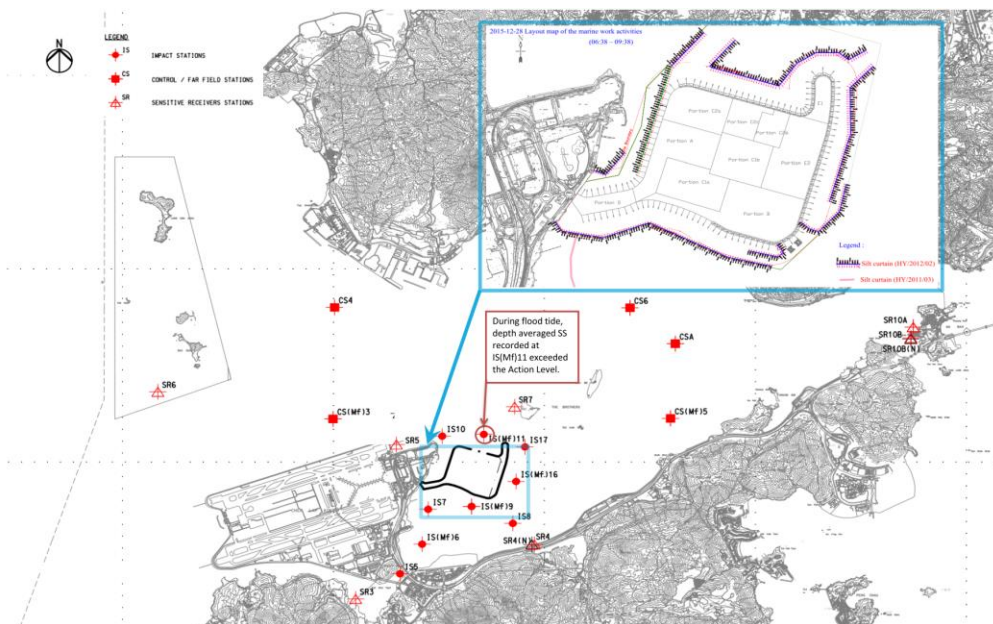
3.3.2 One action level impact water quality monitoring exceedance has been recorded on 28 December 2015.

3.3.2.1 Layout map below shows the construction activities conducted during flood tide on 28 December 2015, no marine work or barge was working at north of HKBCF reclamation works near the sea area or area where IS(Mf)11 is located, therefore the construction activities was considered unlikely to cause the SS exceedances recorded at IS(Mf)11 during mid-flood tide on 28 December 2015.

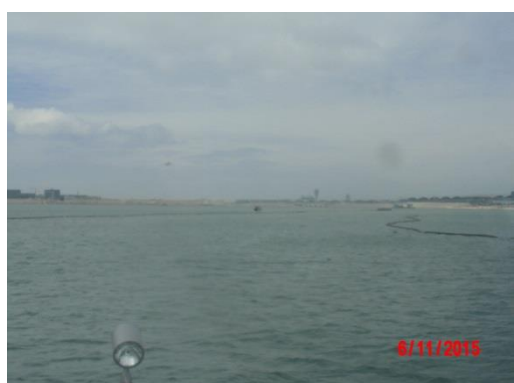
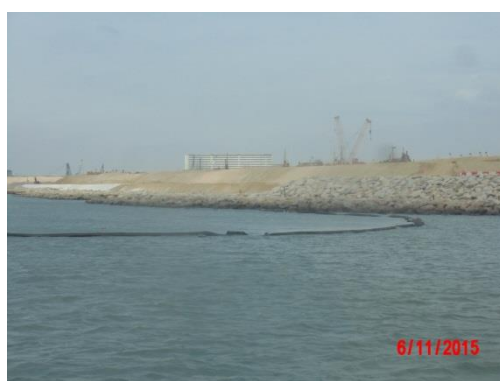
3.3.2.4 Furthermore, no filling activities was observed in progress at the sea area north to HKBCF reclamation works and no silt plume was observed to flow from the inside of the perimeter silt curtain to the outside of the perimeter silt curtain when monitoring was conducted at IS(Mf)11. Also refer to the below photo record taken at sea area located north of HKBCF reclamation works on 28 December 2015 for reference of sea condition on 28 December 2015, which shows that no silt plume was observed.

3.3.2.5 Photo record which shows the sea condition at southern part of the HKBCF reclamation works on 28 December 2015. No silt plume was observed.

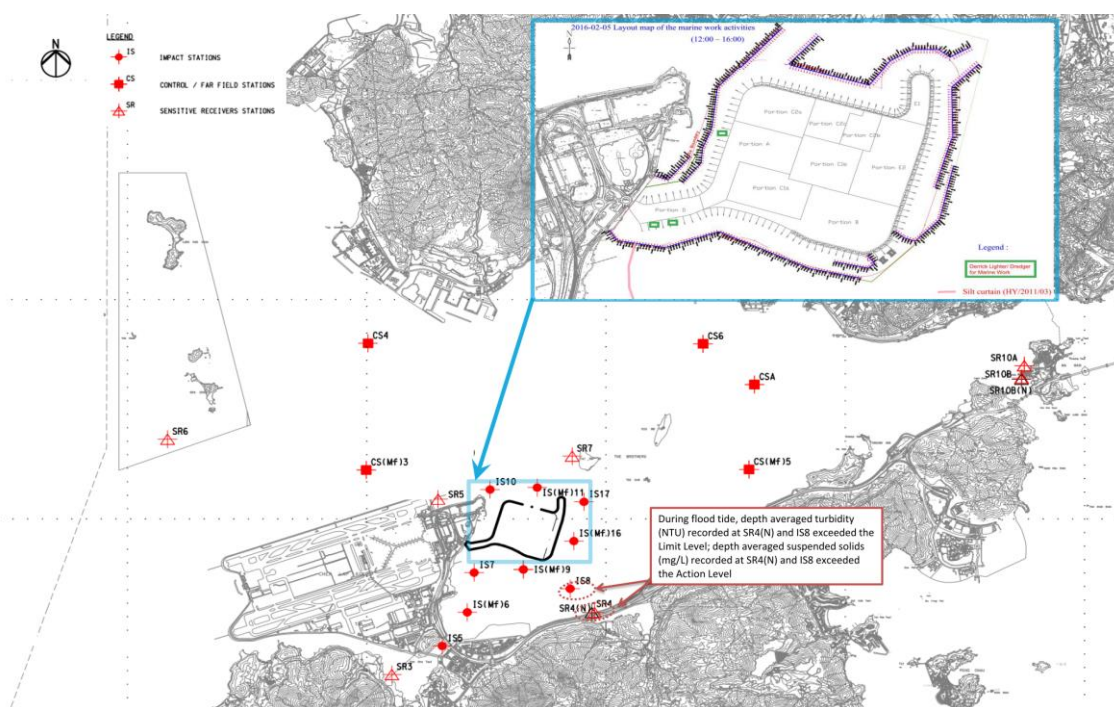
- 3.3.3.3 With referred to the layout map below, marine based construction works such box culverts and seawall construction were conducted at Portion D and Portion A respectively, however no silt plume was observed to flow from the inside of the perimeter silt curtain to the outside of the perimeter silt curtain when monitoring was conducted during flood tide. (Also see below Photo record for sea condition observed on 5 February 2016 during flood tide.)

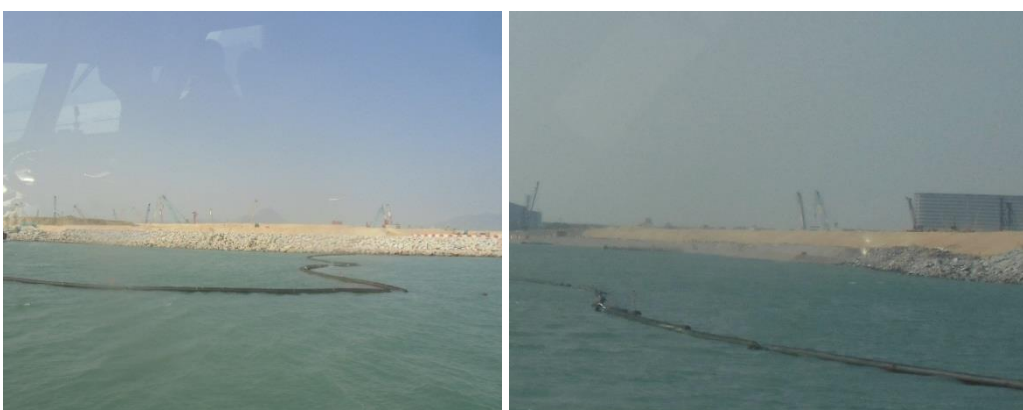
- 3.3.3.4 Photo record below which shows the sea condition at southern and southeastern part of the HKBCF reclamation works during flood tide on 5 February 2016.

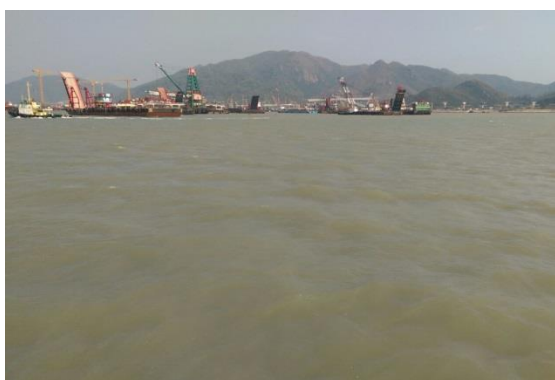
- 3.3.3.6 With referred to the photo record taken at monitoring station IS8 on 5 February 2016 (also see below photo record) turbid water was observed at this area. However, with referred to the below photo record taken at southern and southeastern part of the HKBCF reclamation works during flood tide on 5 February 2016, turbid water was not noted. The photo record below shows that vessel activities was observed when monitoring was conducted at monitoring location IS8, as confirmed with the Contractor of HY/2010/02, this Contract did not have any construction vessels working outside the site boundary of Contract HY/2010/02 on 5 February 2016 (also refer to the below layout map).

- 3.3.3.7 Photo record below shows the sea condition taken on 5 February 2016 at monitoring location IS8 and facing monitoring station SR4(N), turbid water was observed at this area.

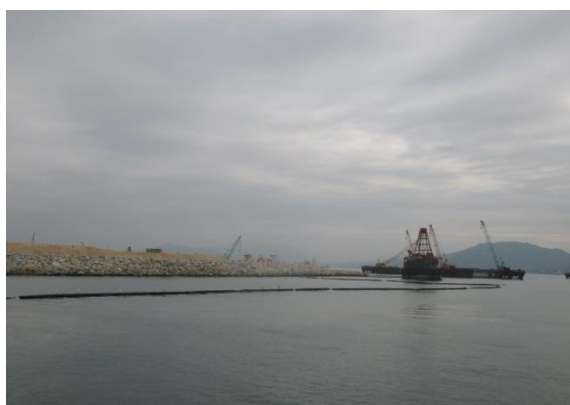
- 3.3.3.8 As shown below by the photo record taken on the 16 February 2016, the latest silt curtain position is within the area of the complete seawall and no more reclamation filling will be conducted by this Contract at the concerned area.

- 3.3.3.12 Nevertheless, the Contractor was reminded to ensure provision of ongoing maintenance to the silt curtains and to carry out maintenance work once defects were found.
 - 3.3.3.13 Maintenance work of the silt curtain was carried out by the Contractor on a daily basis except Sunday and public holiday.
 - 3.3.3.14 The Contractor was reminded to adhere to the environmental permit requirement and undertake the necessary mitigation measures after the realignment of the perimeter silt curtain near southeastern corner of HKBCF Reclamation Works, as necessary.
- 3.3.4 The event action plan is annexed in Appendix K.

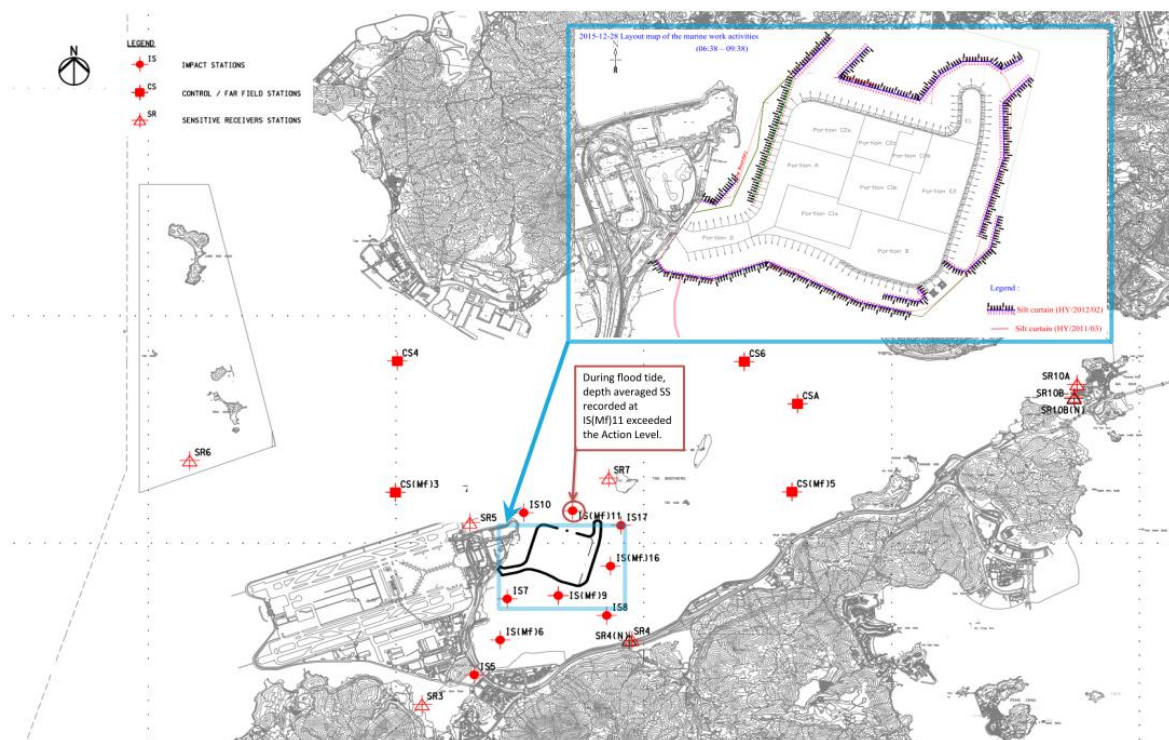
5.1.8 As informed by the Contractor on 23 December 2015, an oil spillage incident was observed near Cell No. 28 on 23 December 2015. For the location of the oil spillage recorded on 23 December 2015, also refer to the map shown below.

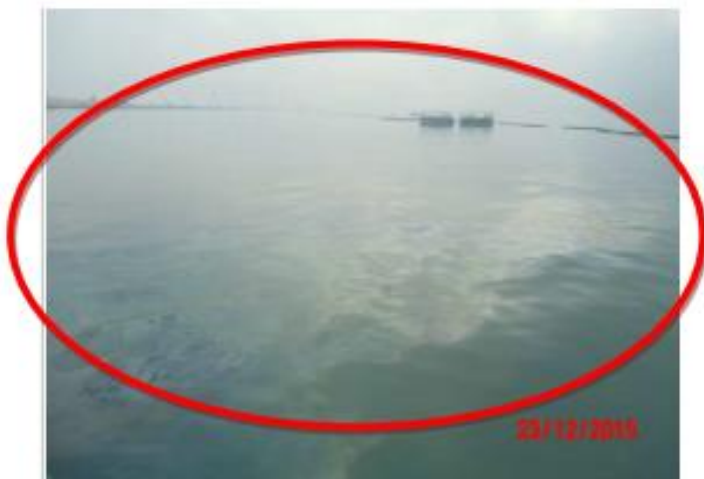
- Oil on sea was observed on sea area near Cell No. 28 within perimeter silt curtain at 09:30 a.m. on 23 December 2015 by the Contractor and RSS (also refer to above layout map).
- The following photo record shows the sea condition when the oil spillage on sea was observed.

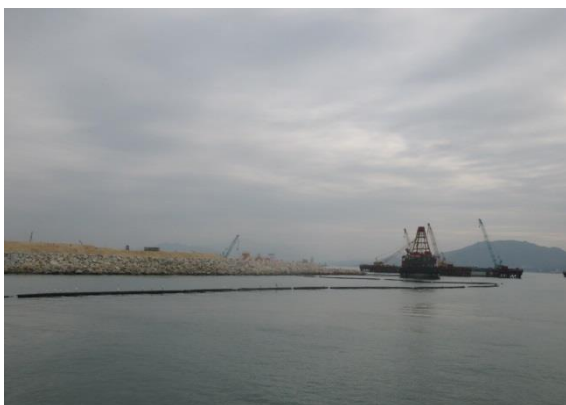
5.1.9.2 As shown below by the photo record taken on the 16 February 2016 and it shows that the latest silt curtain position is within the area of the complete seawall. As informed by the Contractor, no more reclamation filling will be conducted by this Contract at the concerned area.

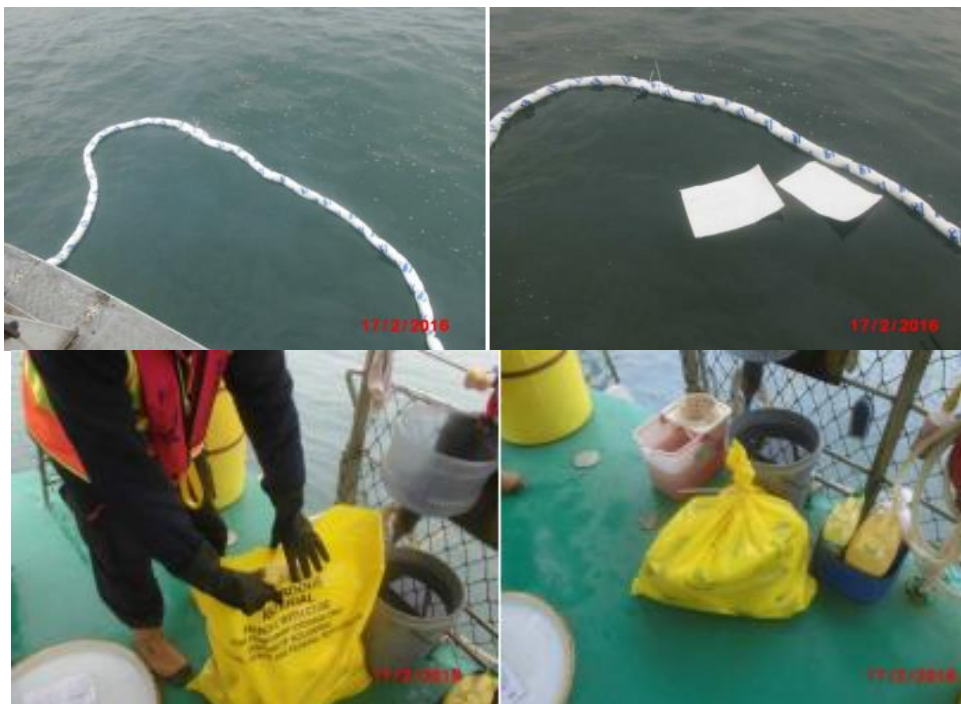
5.1.10.5 The oil spill was identified during join site inspection conducted by the Contractor and RSS on 17 Feb 2016 as discrete, non-continuous source with approximately 20m² spread. Also refer to photo below:

5.1.10.6 The Contractor deployed absorption booms to remove the floating oil from water and the used absorption booms were collected using disposal bags as part of the spill kits item. The used absorption booms were disposed of as chemical waste by the Contractor. (Also refer to photo record below).

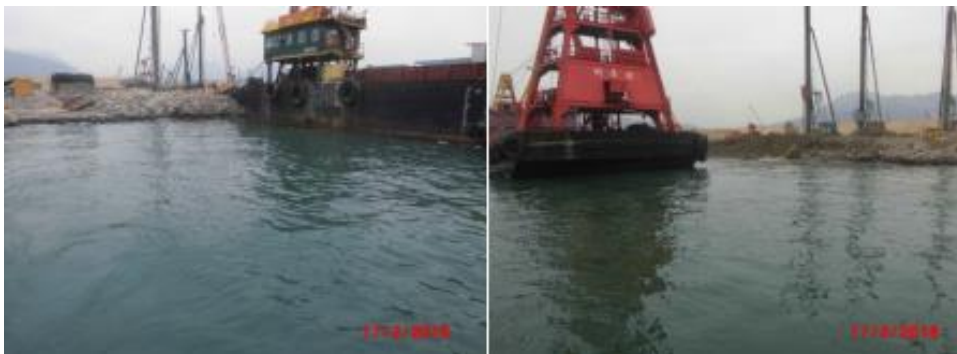
5.1.10.7 Photo record shows that oil on sea was no longer observed at sea area near Cell 109. (Also refer to photo record below)

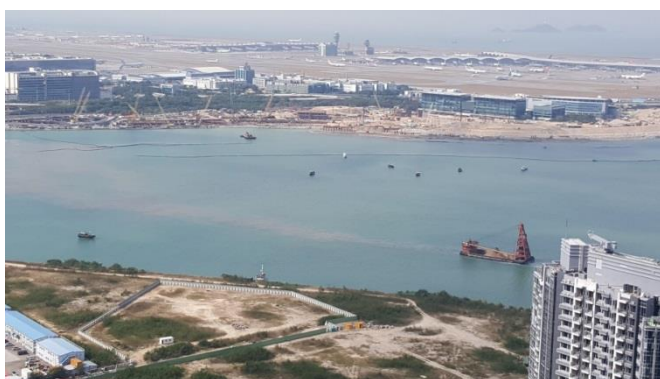
7.1.2 A water quality complaint was referred to the ENPO at 10:22 am on the 4 December 2015 by EPD; ENPO referred this complaint to this Contract on the same day. With referred to the information provided by ENPO, EPD has contacted the complainant, and obtained the additional information from the complainant and it is suspected that the incident happened in the afternoon on 28 November 2015.

7.1.2.1 A video was provided by the complainant, the following photo is captured from the video which shows that turbid water was seen behind a barge, the incident is suspected to be happened in the afternoon on 28 November 2015.
