Contract No. HY/2010/02

## Hong Kong – Zhuhai – Macao Bridge Hong Kong Boundary Crossing Facilities – Reclamation Works

### Quarterly EM&A Summary Report for September 2016 – November 2016

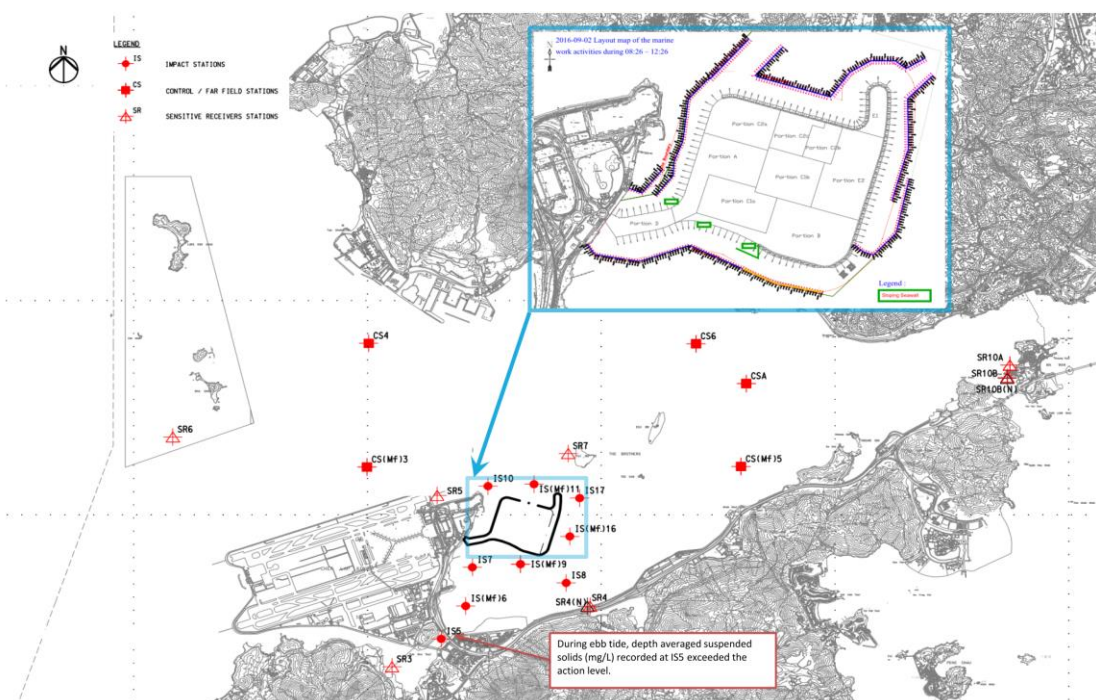
3.3.2.1 Below layout map shows that marine based construction works such as seawall construction was carried out at Portion A and Portion B of HKBCF Reclamation Works:

- 3.3.2.2 Exceedances recorded at IS5 during ebb tide are unlikely due to marine based construction activities of the Contract because:
- 3.3.2.3 With reference to the silt curtain checking record, no defect was observed at southern part of the perimeter silt curtain which is facing IS5.
- 3.3.2.4 With referred to the above layout map, marine based construction work such as seawall construction were conducted at Portion A and Portion B. however no silt plume was observed to flow from the inside of the perimeter silt curtain to the outside of the perimeter silt curtain when monitoring was conducted during ebb tide. (Also see blow Photo record 1 for sea condition observed on 2 September 2016 during ebb tide)

- 3.3.2.5 Also, turbidity and suspended solids levels recorded at IS7, IS(Mf)9 and IS(Mf)6 were below the action and limit level. This indicates that the turbidity and suspended solids levels recorded at monitoring stations closer to the active works, were not adversely affected.

- 3.3.2.6 After investigation, there is no adequate information to conclude the recorded exceedances are related to this Contract.
- 3.3.2.7 Action taken under the action plan:

- 3.3.2.8 Nevertheless, the Contractor was reminded to ensure provision of ongoing maintenance to the silt curtains and to carry out maintenance work once defects were found.

- 3.3.2.9 Maintenance work of the silt curtain was carried out by the Contractor on a daily basis except Sunday and public holiday.

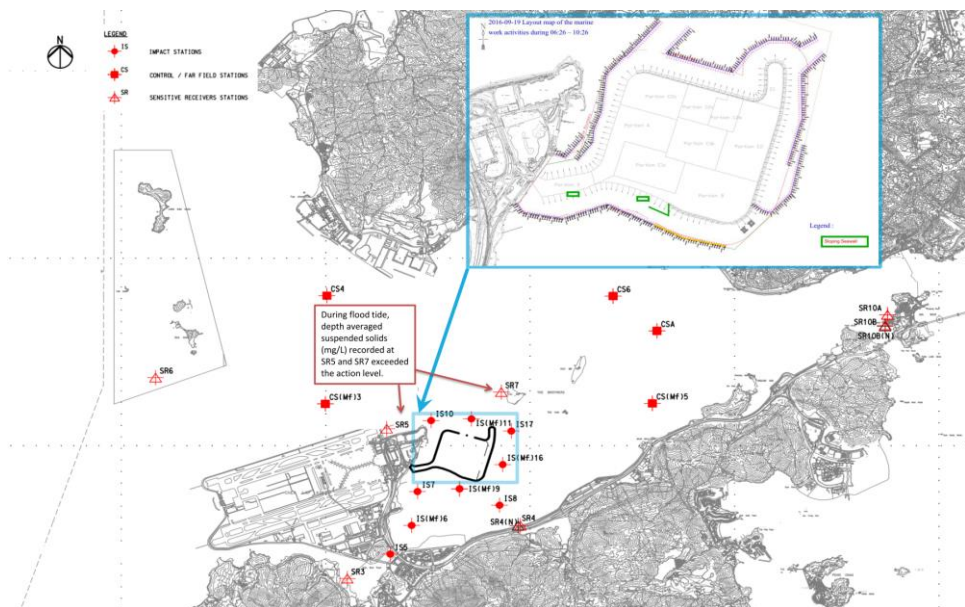
- 3.3.3 2 (Two) action level exceedances of suspended solids were recorded at SR5 and SR7 during flood tide on 19 September 2016.
- 3.3.3.1 Below layout map shows that marine based construction works such as seawall construction was carried out at Portion B and Portion D of HKBCF Reclamation Works:

- 3.3.3.2 Exceedances recorded at SR5 and SR7 during flood tide are unlikely due to marine based construction activities of the Contract because:
- 3.3.3.3 With reference to the silt curtain checking record, no defect was observed at northern part of the perimeter silt curtain which are facing SR5 and SR7
- 3.3.3.4 With referred to the above layout map, no marine based construction work of this Contract was conducted at the north side of HKBCF reclamation work. In addition, no silt plume was observed to flow from the inside of the perimeter silt curtain to the outside of the perimeter silt curtain when monitoring was conducted during flood tide. (Also see below Photo record 1 for sea condition observed on 19 September 2016 during flood tide.)

- 3.3.3.5 Also, turbidity and suspended solids levels recorded at IS10 and IS(Mf)11 were below the action and limit level.
- 3.3.3.6 This indicates that the turbidity and suspended solids levels recorded at monitoring stations closer to the active works, were not adversely affected.

- 3.3.3.7 As such, the exceedances recorded at SR5 and SR7 was unlikely attribute to the active works of this Contract. After investigation, there is no adequate information to conclude the recorded exceedances are related to this Contract.

- 3.3.3.9 Nevertheless, the Contractor was reminded to ensure provision of ongoing maintenance to the silt curtains and to carry out maintenance work once defects were found.

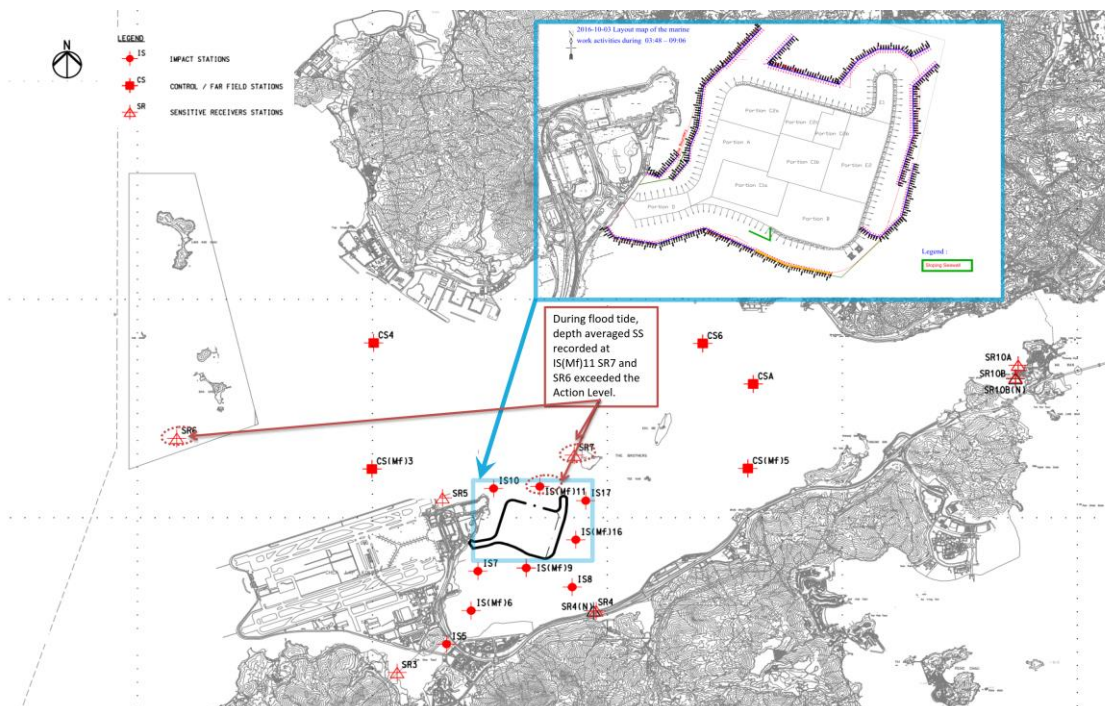
3.3.4.1 Below layout map shows that no marine based construction works were carried out at HKBCF Reclamation Works:

3.3.4.2 Exceedances recorded at IS(Mf)11, SR6 and SR7 during flood tide are unlikely due to marine based construction activities of the Contract because:

3.3.4.3 With refer to the layout map above, no marine based construction works were conducted during flood tide on 3 October 2016, as such, it is unlikely to cause the exceedance of SS at IS(Mf)11, SR6 and SR7.

3.3.4.4 In addition, with referred to silt curtain checking record of 3 October 2016, no defects of the silt curtain was observed.

3.3.4.5 With referred to monitoring record, no sediment plume has been observed to flow from the inside of the perimeter silt curtain to the outside of the perimeter silt curtain during flood tide on 3 October 2016.

5. Since it is considered that the suspended solids exceedance is unlikely to be contract related, as such, actions 5-7 under the EAP are not considered applicable.
- 3.3.4.10 Nevertheless, the Contractor was reminded to ensure provision of ongoing maintenance to the silt curtains and to carry out maintenance work once defects were found.
- 3.3.4.11 Maintenance work of the silt curtain will be provided by the Contractor on a daily basis except Sunday and public holiday, when defects were found.

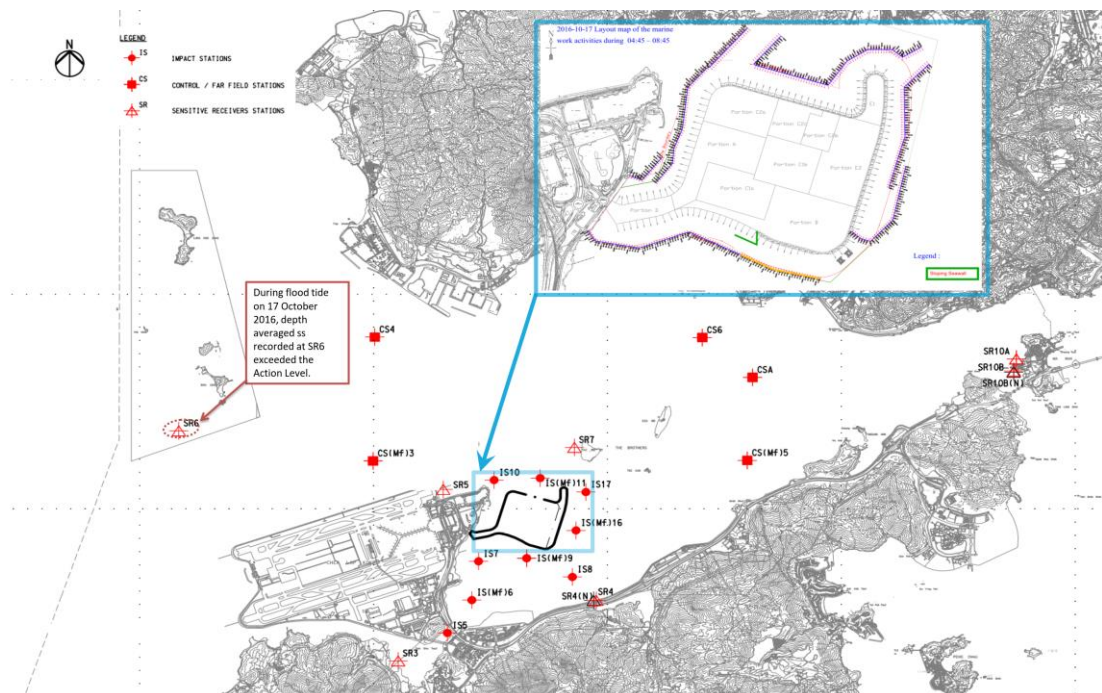
3.3.5.1 With refer to the layout map below, no marine based construction works were conducted during flood tide on 17 October 2016, as such, it is unlikely to cause the exceedance of SS at SR6.

3.3.5.2 Exceedance recorded at SR6 during flood tide is unlikely due to marine based construction activities of the Contract because:

3.3.5.3 With refer to the layout map above, no marine based construction works were conducted during flood tide on 17 October 2016, as such, it is unlikely to cause the exceedance of SS at SR6.

3.3.5.4 In addition, with referred to silt curtain checking record of 17 October 2016, no defects of the silt curtain was observed.

3.3.5.5 With referred to monitoring record, no sediment plume has been observed to flow from the inside of the perimeter silt curtain to the outside of the perimeter silt curtain during flood tide on 17 October 2016.

- 3.3.5.9 Nevertheless, the Contractor was reminded to ensure provision of ongoing maintenance to the silt curtains and to carry out maintenance work once defects were found.
- 3.3.5.10 Maintenance work of the silt curtain will be provided by the Contractor on a daily basis except Sunday and public holiday, when defects were found.

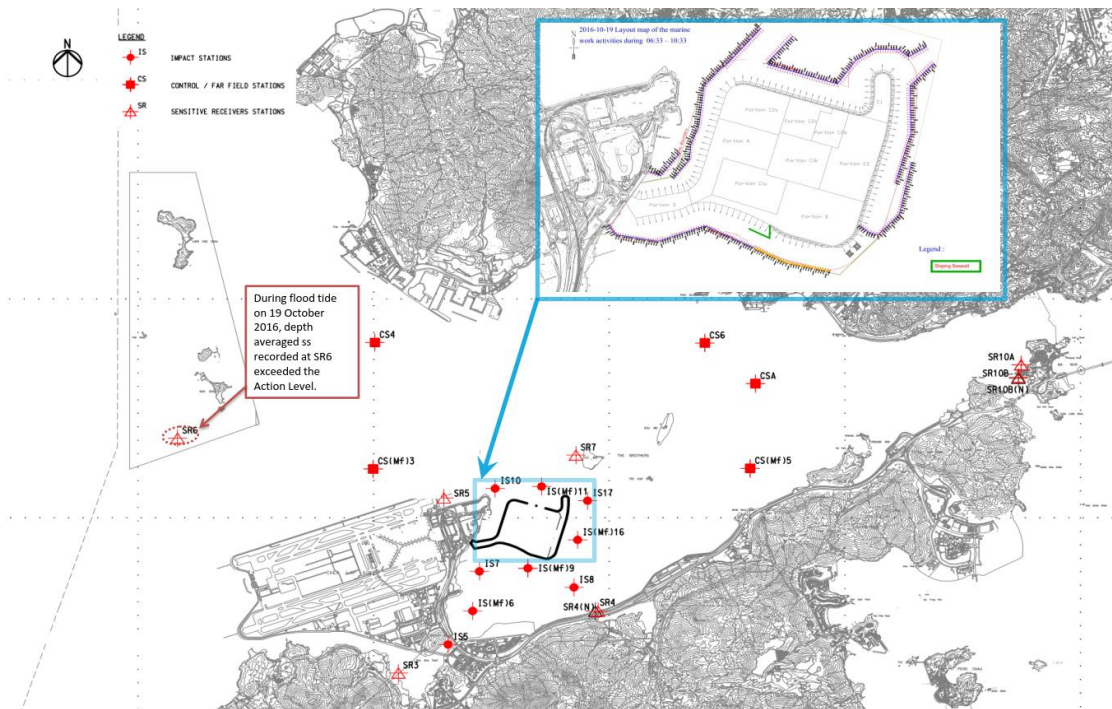
- 3.3.6 1 action level exceedance of suspended solids was recorded at SR6 during flood tide on 19 October 2016.
- 3.3.6.1 With refer to the layout map below, no marine based construction works were conducted during flood tide on 19 October 2016, as such, it is unlikely to cause the exceedance of SS at SR6.

- 3.3.6.2 Exceedance recorded at SR6 during flood tide is unlikely due to marine based construction activities of the Contract because:
- 3.3.6.3 With referred to the layout map attached, no marine based construction works were conducted during flood tide on 19 October 2016, as such, it is unlikely to cause the exceedance of SS at SR6.

- 3.3.6.4 In addition, with referred to silt curtain checking record of 19 October 2016, no defects of the silt curtain was observed.
- 3.3.6.5 With referred to monitoring record, no sediment plume has been observed to flow from the inside of the perimeter silt curtain to the outside of the perimeter silt curtain during flood tide on 19 October 2016.

- 3.3.6.9 Nevertheless, the Contractor was reminded to ensure provision of ongoing maintenance to the silt curtains and to carry out maintenance work once defects were found.
- 3.3.6.10 Maintenance work of the silt curtain will be provided by the Contractor on a daily basis except Sunday and public holiday, when defects were found.

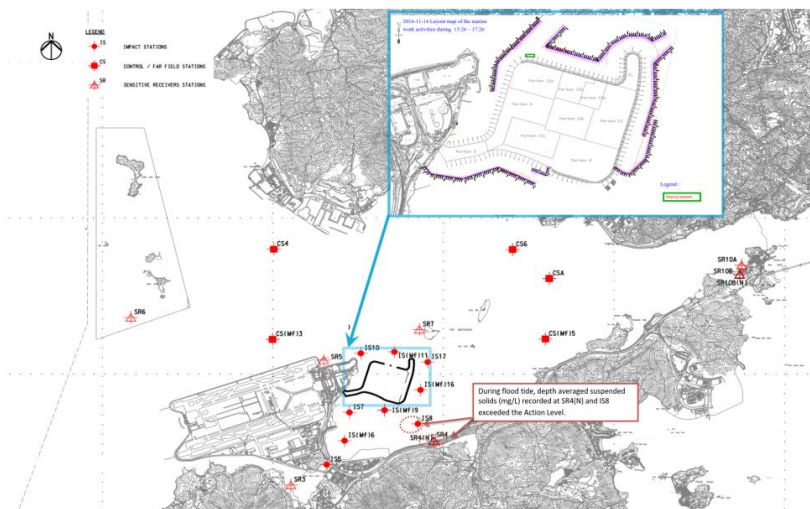
3.3.7.1 Below layout map shows that no marine based construction works were carried out at HKBCF Reclamation Works:

3.3.7.2 Exceedances recorded at SR4(N) and IS8 during mid-flood tide are unlikely due to marine based construction activities of the Contract because:

3.3.7.3 With reference to the silt curtain checking record, no defect was observed at southern and southeastern parts of the perimeter silt curtain which are close to monitoring station SR4(N) and IS8.

3.3.7.5 With referred to monitoring record, no silt plume was observed to flow from the inside of the perimeter silt curtain to the outside of the perimeter silt curtain when monitoring was conducted during flood tide.

- 3.3.7.11 Nevertheless, the Contractor was reminded to ensure provision of ongoing maintenance to the silt curtains and to carry out maintenance work once defects were found.
- 3.3.7.12 The Contractor was reminded that maintenance work of the silt curtain should be carried out on a daily basis except Sunday and public holiday, as necessary.
- 3.3.7.13 The Contractor was reminded to adhere to the environmental permit requirement and undertake the necessary mitigation measures after the realignment of the perimeter silt curtain of HKBCF Reclamation Works, as necessary.

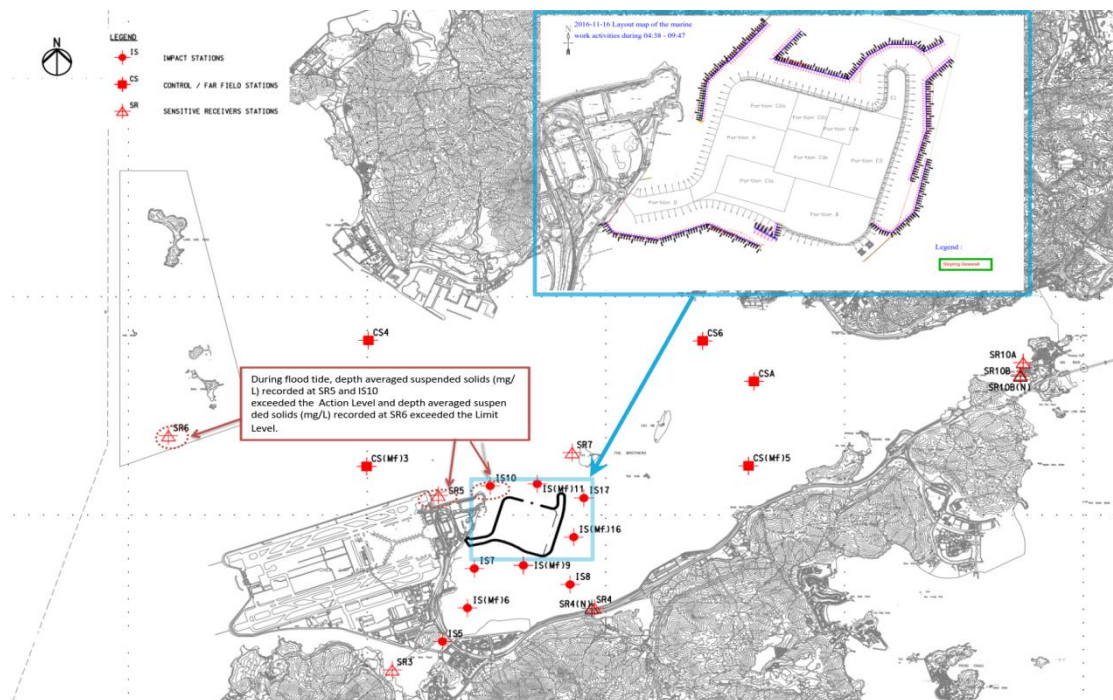
3.3.8.1 Below layout map shows active works conducted on 16 Nov 2016. Construction works such as rock filling was conducted near portion C2a of the HKBCF Reclamation Works on 16 November 2016.

3.3.8.2 Exceedances recorded at IS10, SR5 and SR6 during mid-flood tide are unlikely due to marine based construction activities of the Project because:

3.3.8.3 With reference to the silt curtain checking record, defects were not observed at northwest part of the perimeter silt curtain which are close to the IS10 and SR5.

3.3.8.4 With referred to the layout map attached, no marine construction activities was conducted during flood tide on 16 November 2016. In addition, no silt plume was observed to flow from the inside of the perimeter silt curtain to the outside of the perimeter silt curtain when monitoring was conducted during flood tide.

- 3.3.8.9 Nevertheless, the Contractor was reminded to ensure provision of ongoing maintenance to the silt curtains and to carry out maintenance work once defects were found.
- 3.3.8.10 The Contractor was reminded that maintenance work of the silt curtain should be carried out on a daily basis except Sunday and public holiday, as necessary.
- 3.3.8.11 The Contractor was reminded to adhere to the environmental permit requirement and undertake the necessary mitigation measures after the realignment of the perimeter silt curtain of HKBCF Reclamation Works, as necessary.

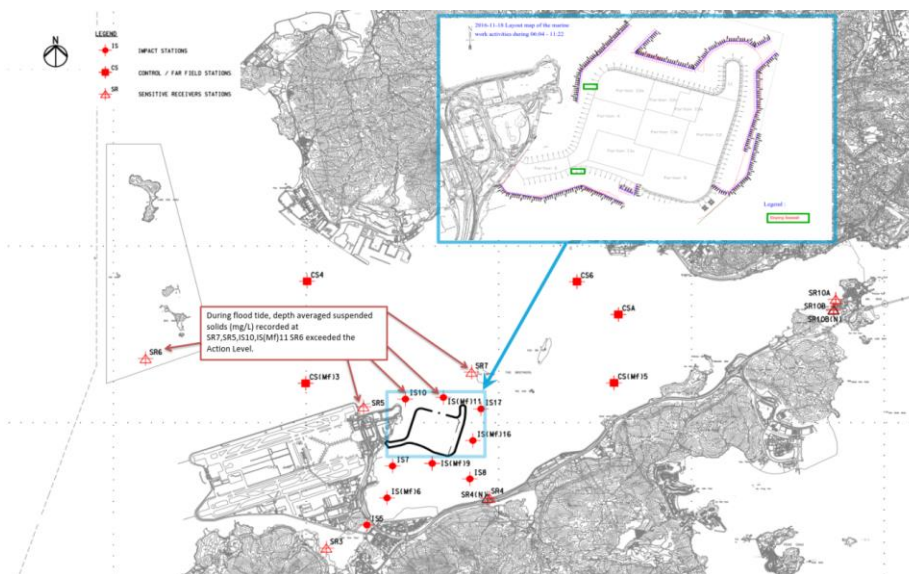
- 3.3.9 Action Level Exceedance of SS at IS(Mf)11, IS10, SR5, SR6 and SR7 were recorded at Mid-Flood tide on 18 November 2016;
- 3.3.9.1 Below layout map shows active works conducted on 18 Nov 2016. Construction of seawall was conducted at Portion C2a and Portion B the HKBCF Reclamation Works.

- 3.3.9.2 Exceedance recorded at IS(Mf)11, IS10, SR5, SR6 and SR7 during mid-flood tide are unlikely due to marine based construction activities of the Project because:

- 3.3.9.3 With reference to the silt curtain checking record, a minor disconnection of floating pipe at northeast corner of the perimeter silt curtain was noted, the location is near the northeast marine access of HKBCF Reclamation Works. However, this was subsequently rectified by the Contractor. Defect was not observed at the rest northern part of the perimeter silt curtain, in particular, no defects was observed at section of perimeter silt curtain close to active works.

- 3.3.9.4 Construction of seawall was conducted at Portion C2a and Portion B the HKBCF Reclamation Works during flood tide on 18 November 2016 but no silt plume was observed to flow from the inside of the perimeter silt curtain to the outside of the perimeter silt curtain when monitoring was conducted at IS(Mf)11, IS10 and SR5; no silt plume was observed when monitoring was conducted at monitoring station SR6 and SR7.

3. IEC, Contractor and ER were informed via email;
  4. Monitoring data, all plant, equipment and Contractor's working methods were checked;
  5. Since it is considered that the suspended solids exceedance is unlikely to be contract related, as such, actions 5-7 under the EAP are not considered applicable.
- 3.3.9.9 Nevertheless, the Contractor was reminded to ensure provision of ongoing maintenance to the silt curtains and to carry out maintenance work once defects were found.
- 3.3.9.10 Maintenance work of the silt curtain was carried out by the Contractor on a daily basis except Sunday and public holiday.
- 3.3.9.11 The Contractor was reminded to adhere to the environmental permit requirement and undertake the necessary mitigation measures after the realignment of the perimeter silt curtain of HKBCF Reclamation Works, as necessary.

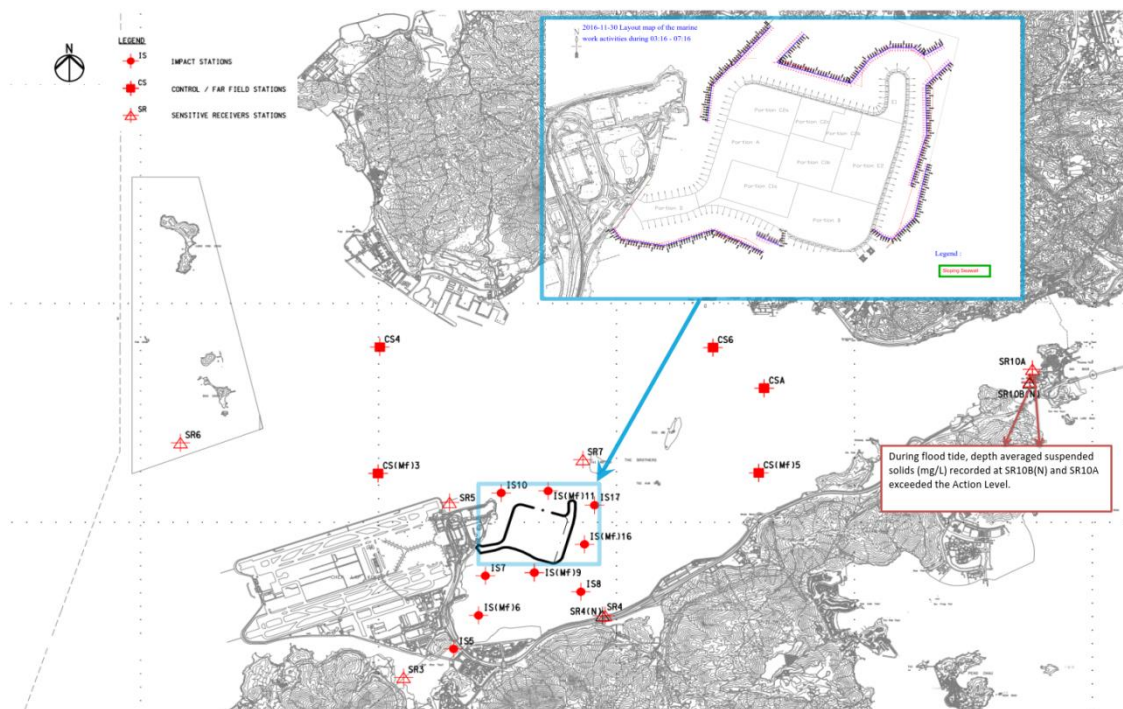
3.3.10.1 Below layout map shows that there had no marine based construction works conducted on 30 Nov 2016 during flood tide.

3.3.10.2 Exceedance was not due to marine based construction works of the Project because:

3.3.10.3 IS(Mf)11, SR5 and IS10 are located downstream and closer to the active works than monitoring station SR10B(N) and SR10A during flood tide. Depth Averaged Suspended Solids (SS) values (in mg/L) recorded during flood tide on the same day at IS(Mf)11, SR5 and IS10 were below the Action and Limit Level which indicates this Contract is unlikely to contribute to the action level exceedance recorded at SR10B(N).

3.3.10.5 With reference to the silt curtain checking record, no defects of the perimeter silt curtain was observed on 30 November 2016.

- 3.3.10.10 Nevertheless, the Contractor was reminded to ensure provision of ongoing maintenance to the silt curtains and to carry out maintenance work once defects were found.
