# China Harbour Engineering Company Limited

Contract No. HY/2010/02

## Hong Kong – Zhuhai – Macao Bridge Hong Kong Boundary Crossing Facilities – Reclamation Works

Annual Review Report for  
March 2014- February 2015

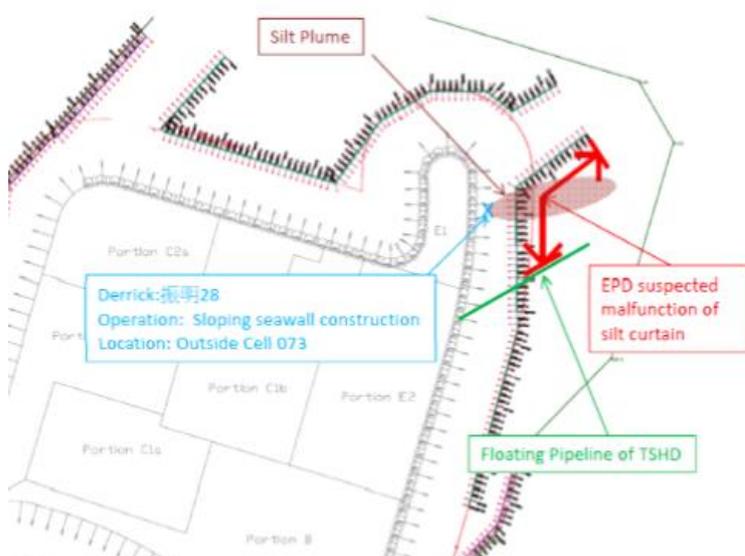
- The Contractor arranged diver to check the integrity of the concerned silt curtain. Minor damaged found on the concerned silt curtain and rectification works had been carried out by the Contractor.

- Diver checking and rectification record for integrity of silt curtain has been checked and it shows that the part of the silt curtain which was suspected to be malfunction (showed by red arrow in the diagram below) has been rectified by the Contractor.

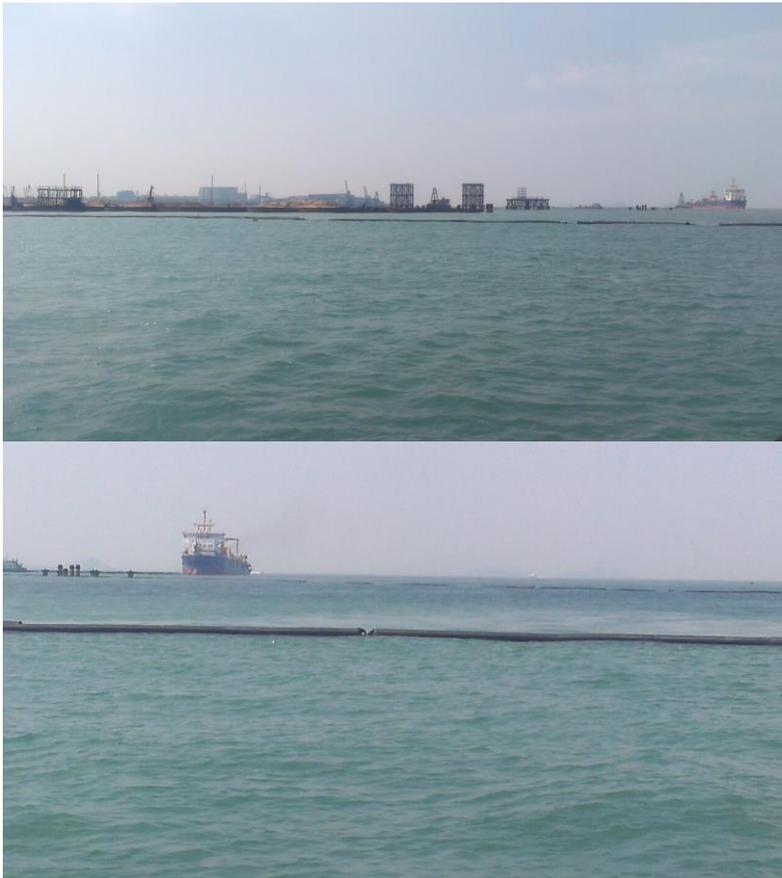
- Subsequently, a rock placement trial was conducted by the Contractor on 28 October 2014. Silt plume was observed during the process but Figure 3.8 of the investigation report shows that spreading to the outside of the silt curtain was prevented by the silt curtain.
- Photo records taken on 31 October 2014 shows the sea condition at sea area near the northeast side of the HKBCF Reclamation Works and no silt plume was observed spreading out from Portion E1 of the construction site through the silt curtain:

- 6.1.8.6 As informed by the Contractor, rockfill materials would be placed more slowly by the derrick as well as the lowest dropping point to minimize the generation of silt plume. Daily site inspection in the area would be conducted so that any damaged parts of silt curtain can be observed and repaired promptly.

- 6.1.8.7 The Contractor was further reminded to ensure swift provision of maintenance to the perimeter silt curtains once defects of the perimeter silt curtain were observed and continue the preventive measures during rock filling and keep the site inspected at least daily to ensure compliance with respect to the recommendations in the EIA Report and EM&A Manual in particular on EIA Ref. Section 9.11.1.1
