Hong Kong- Zhuhai- Macao Bridge Hong Kong Boundary Crossing Facilities (Superstructure and Infrastructure Contracts) Notifications of Environmental Quality Limits Exceedances Notification No.: 20180302SS						
Date of Notification: 8 March 2018				Date of Investigation Report: 9 April 2018		
Works Inspected: Data collected from water sampling works on 2 March 2018 and the results were issued on 7 March 2018						
Monitoring Location: Water Quality Monitoring Station						
Parameter: Dissolved Oxygen (DO) / Suspended Solid (SS)/ Turbidity (TURB)						
Action & Limit Level (AL & LL) / Measured Level:						
PARAM	STATION	DEPTH	AL (mg/L)	LL (mg/L)	MEASURED AT MID-EBB TIDE (mg/L)	MEASURED AT MID-FLOOD TIDE (mg/L)
SS	SR6	Depth Average	23.5 and 120% (i.e. 8.3 for mid-ebb/6.6 for mid-flood) of upstream control station's SS at the same tide of the same day	34.4 and 130% (i.e. 9.0 for mid-ebb/7.1 for mid-flood) of upstream control station's SS at the same tide of the same day and 10mg/L for WSD Seawater intakes	10.4	24.6

Contract No.: HY/2013/01

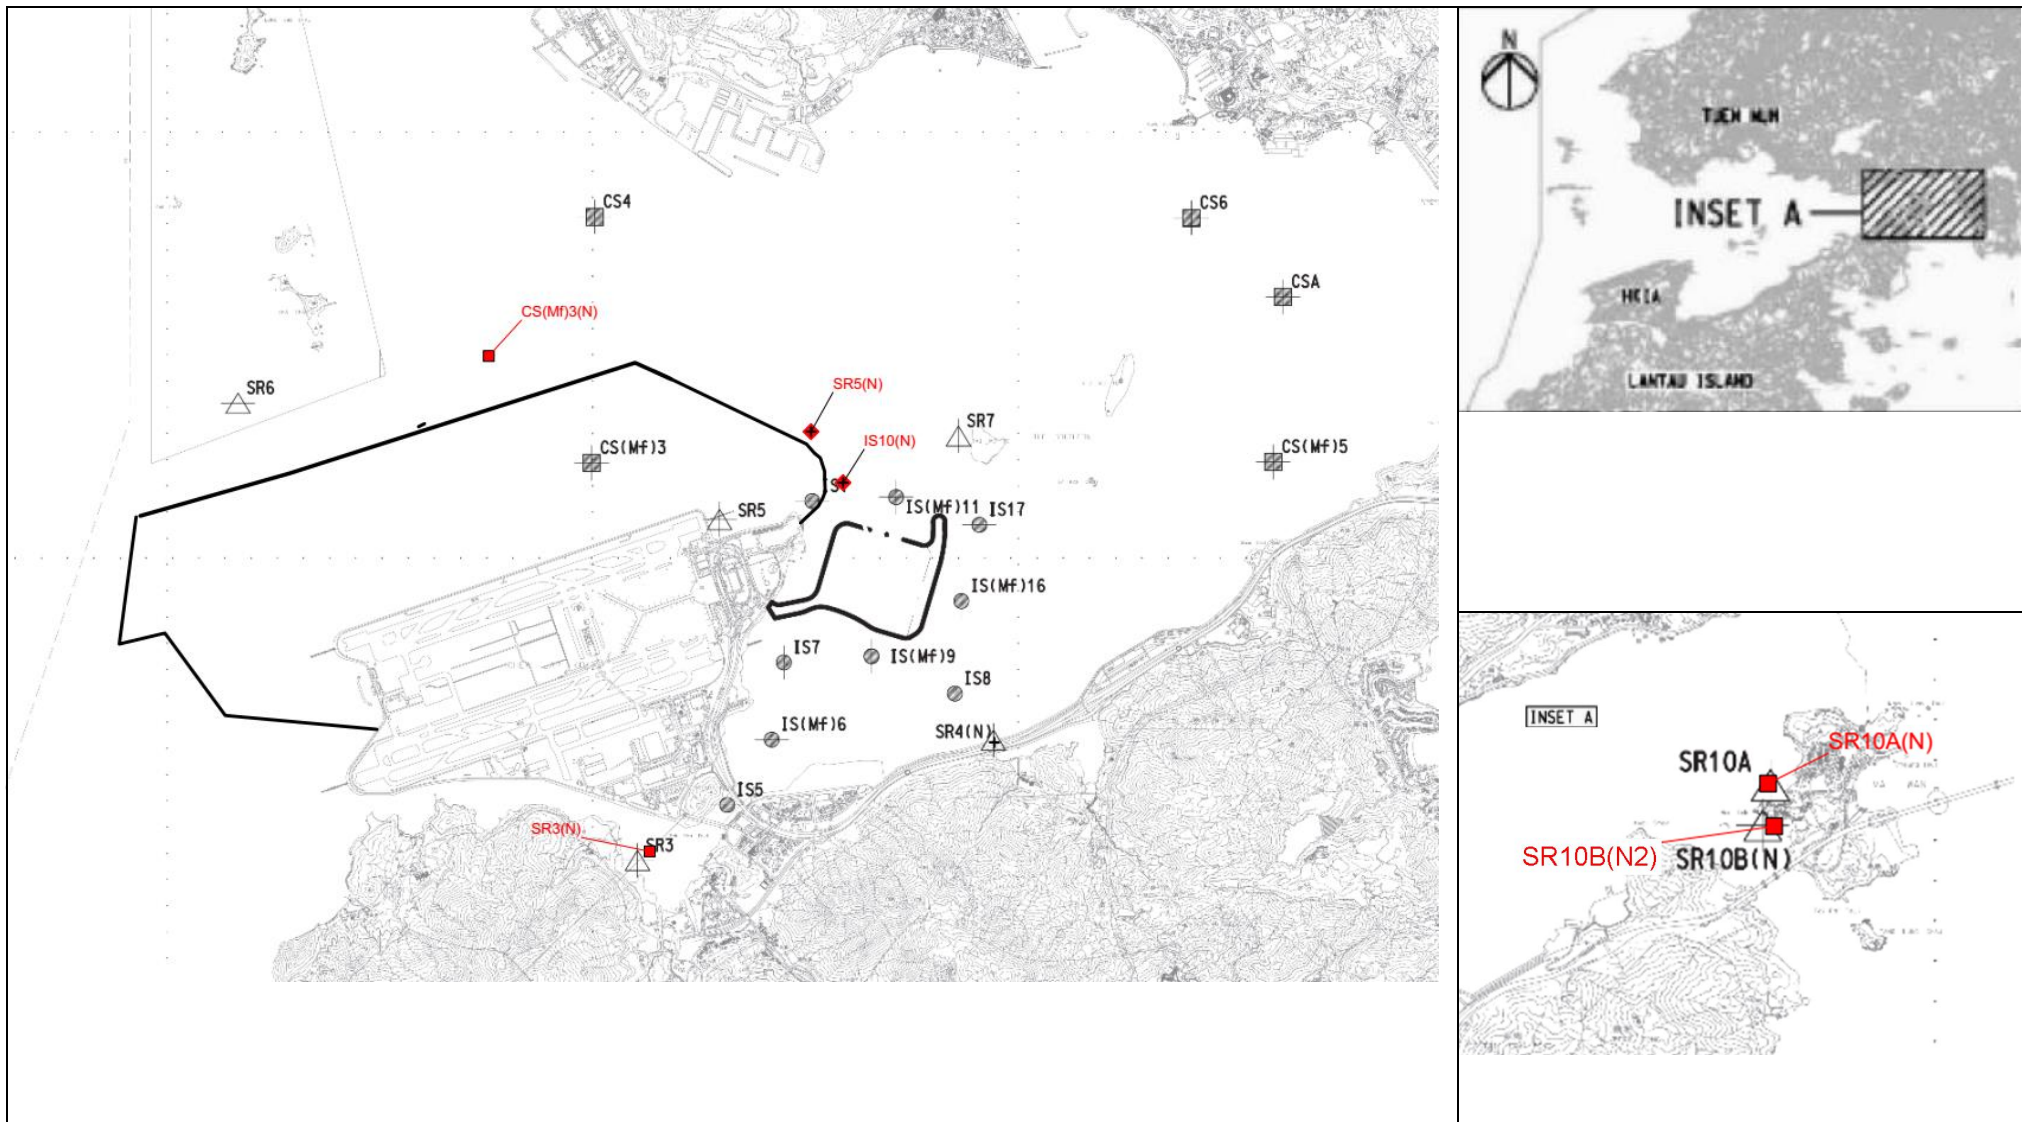
Figure 1: Location Plan

On 2 March 2018, one AL exceedance of SS at SR6 was recorded during mid-flood tide.

The location of the WQM station where exceedances were recorded and all relevant WQM stations are shown in **Figure 1** and the location of marine-based construction works are shown in **Figure 2**.

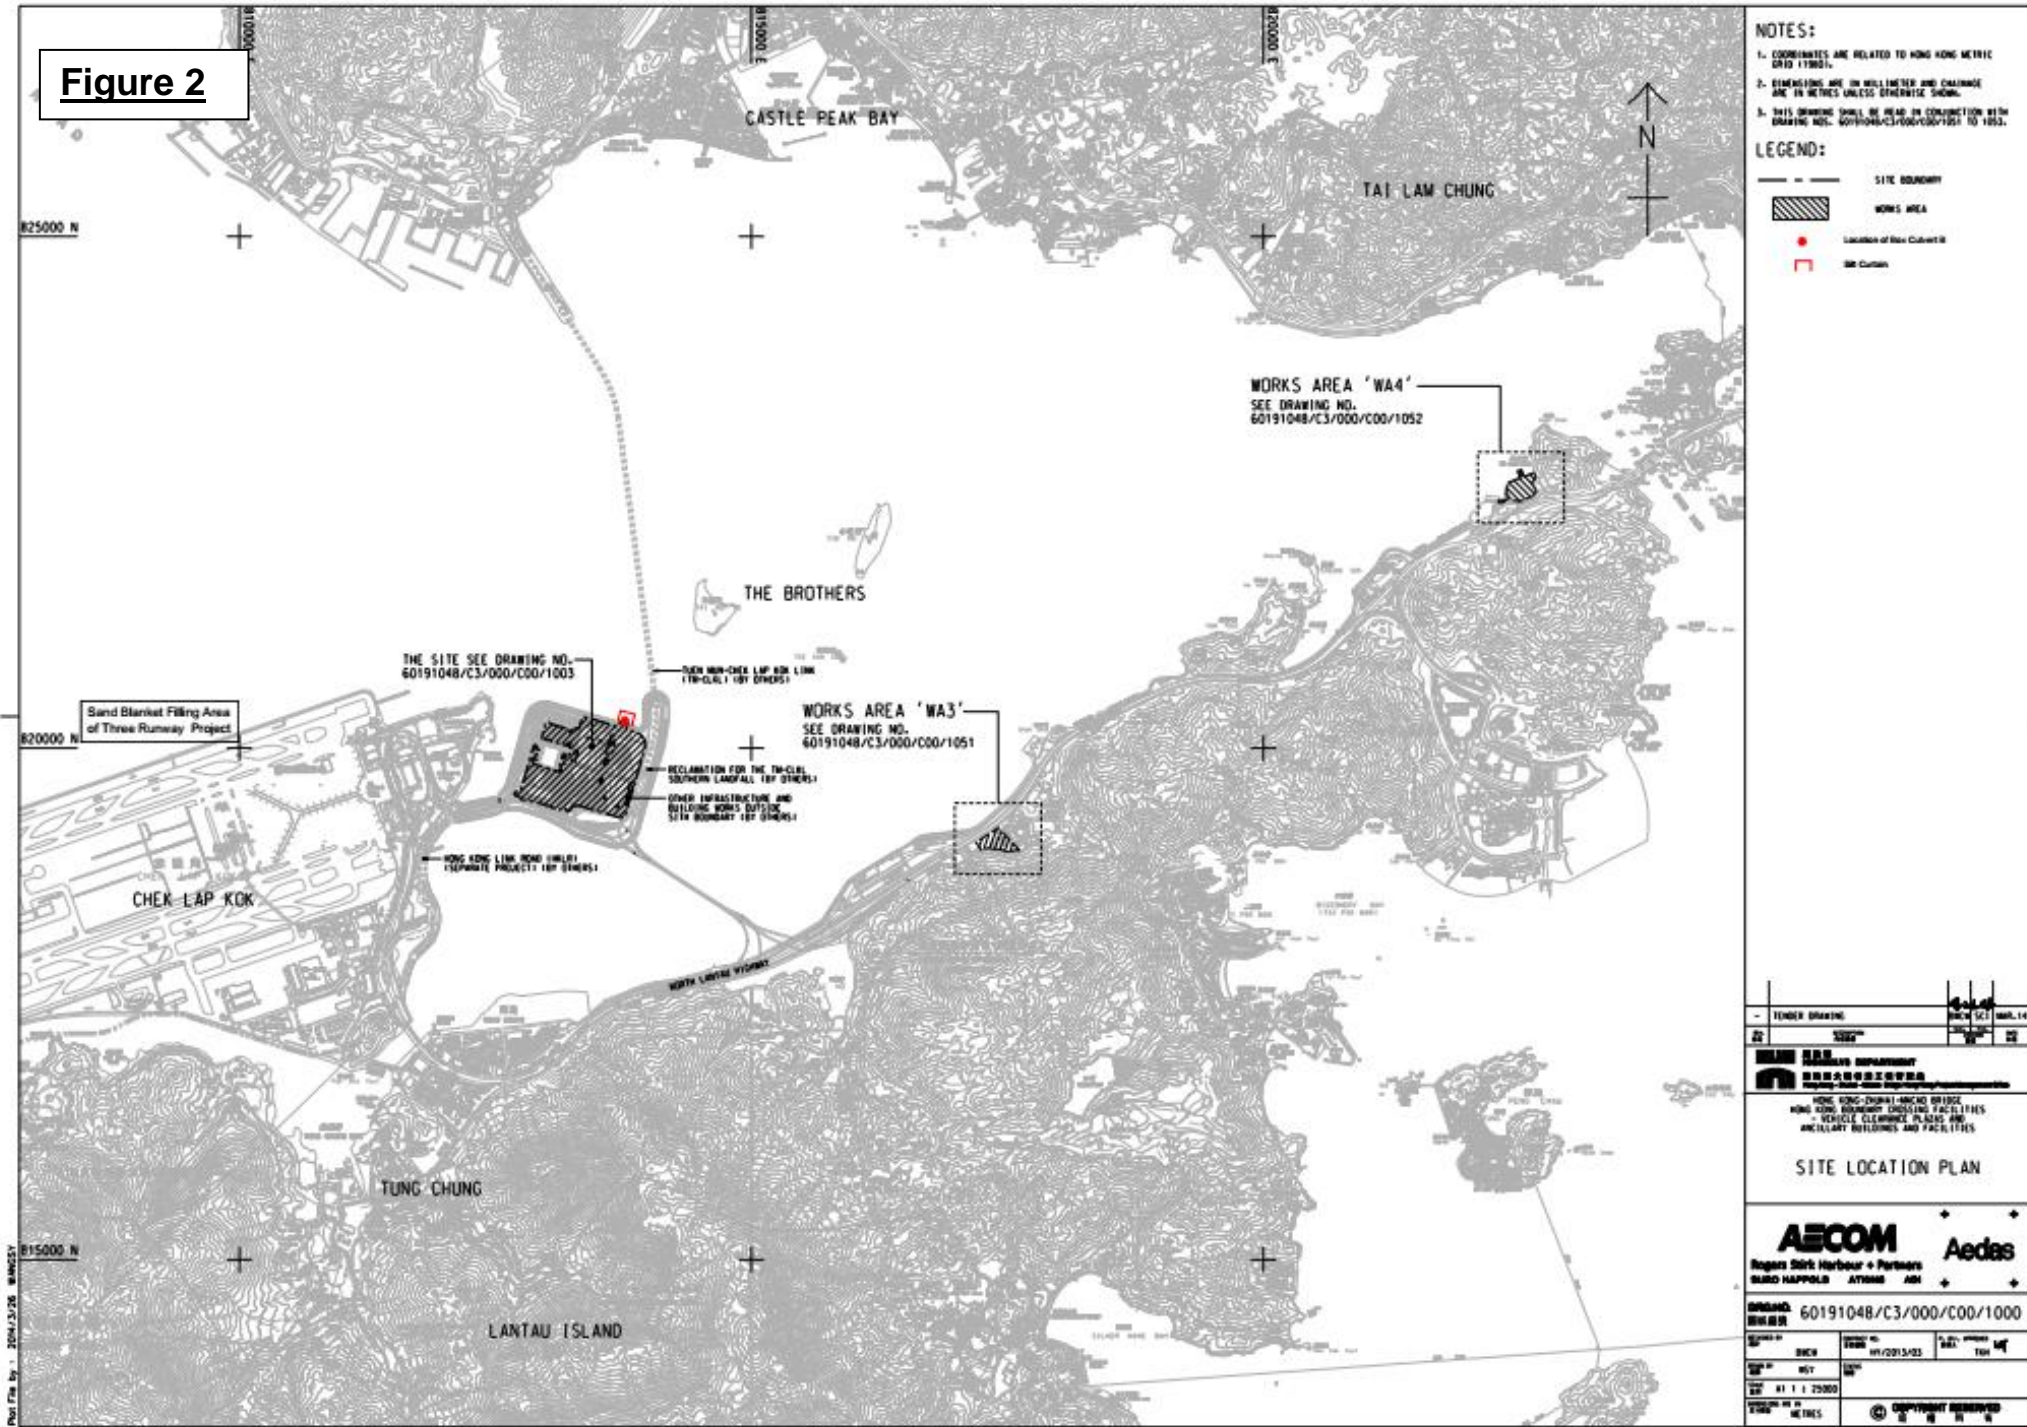
Figure 2

As confirmed with RSS of Contract No. HY/2013/03, there was no marine transportation on the date of exceedance. Regarding marine-based works in Box Culvert B, the work undertaken at the date of exceedance was cat ladder installation inside box culvert which had a cofferdam to separate seawater and works area. Silt curtain was also maintained to enclose the work area of the outlet of the box culvert fully. All sea water flows into the work area of box culvert B will be treated by desilting facilities before discharge in accordance with the discharge license approved by EPD for Contract No. HY/2013/03. For SS exceedance recorded at the WQM station SR6, the concerned WQM stations where the exceedances were recorded were not close to the marine works area of Contract No. HY/2013/03, while there was no notification of exceedance received at the WQM stations closer to the works areas, such as IS(Mf)11. It was unlikely that the works undertaken by Contract No. HY/2013/03 caused SS exceedance recorded at the concerned WQM station during mid-flood tide on 2 March 2018.

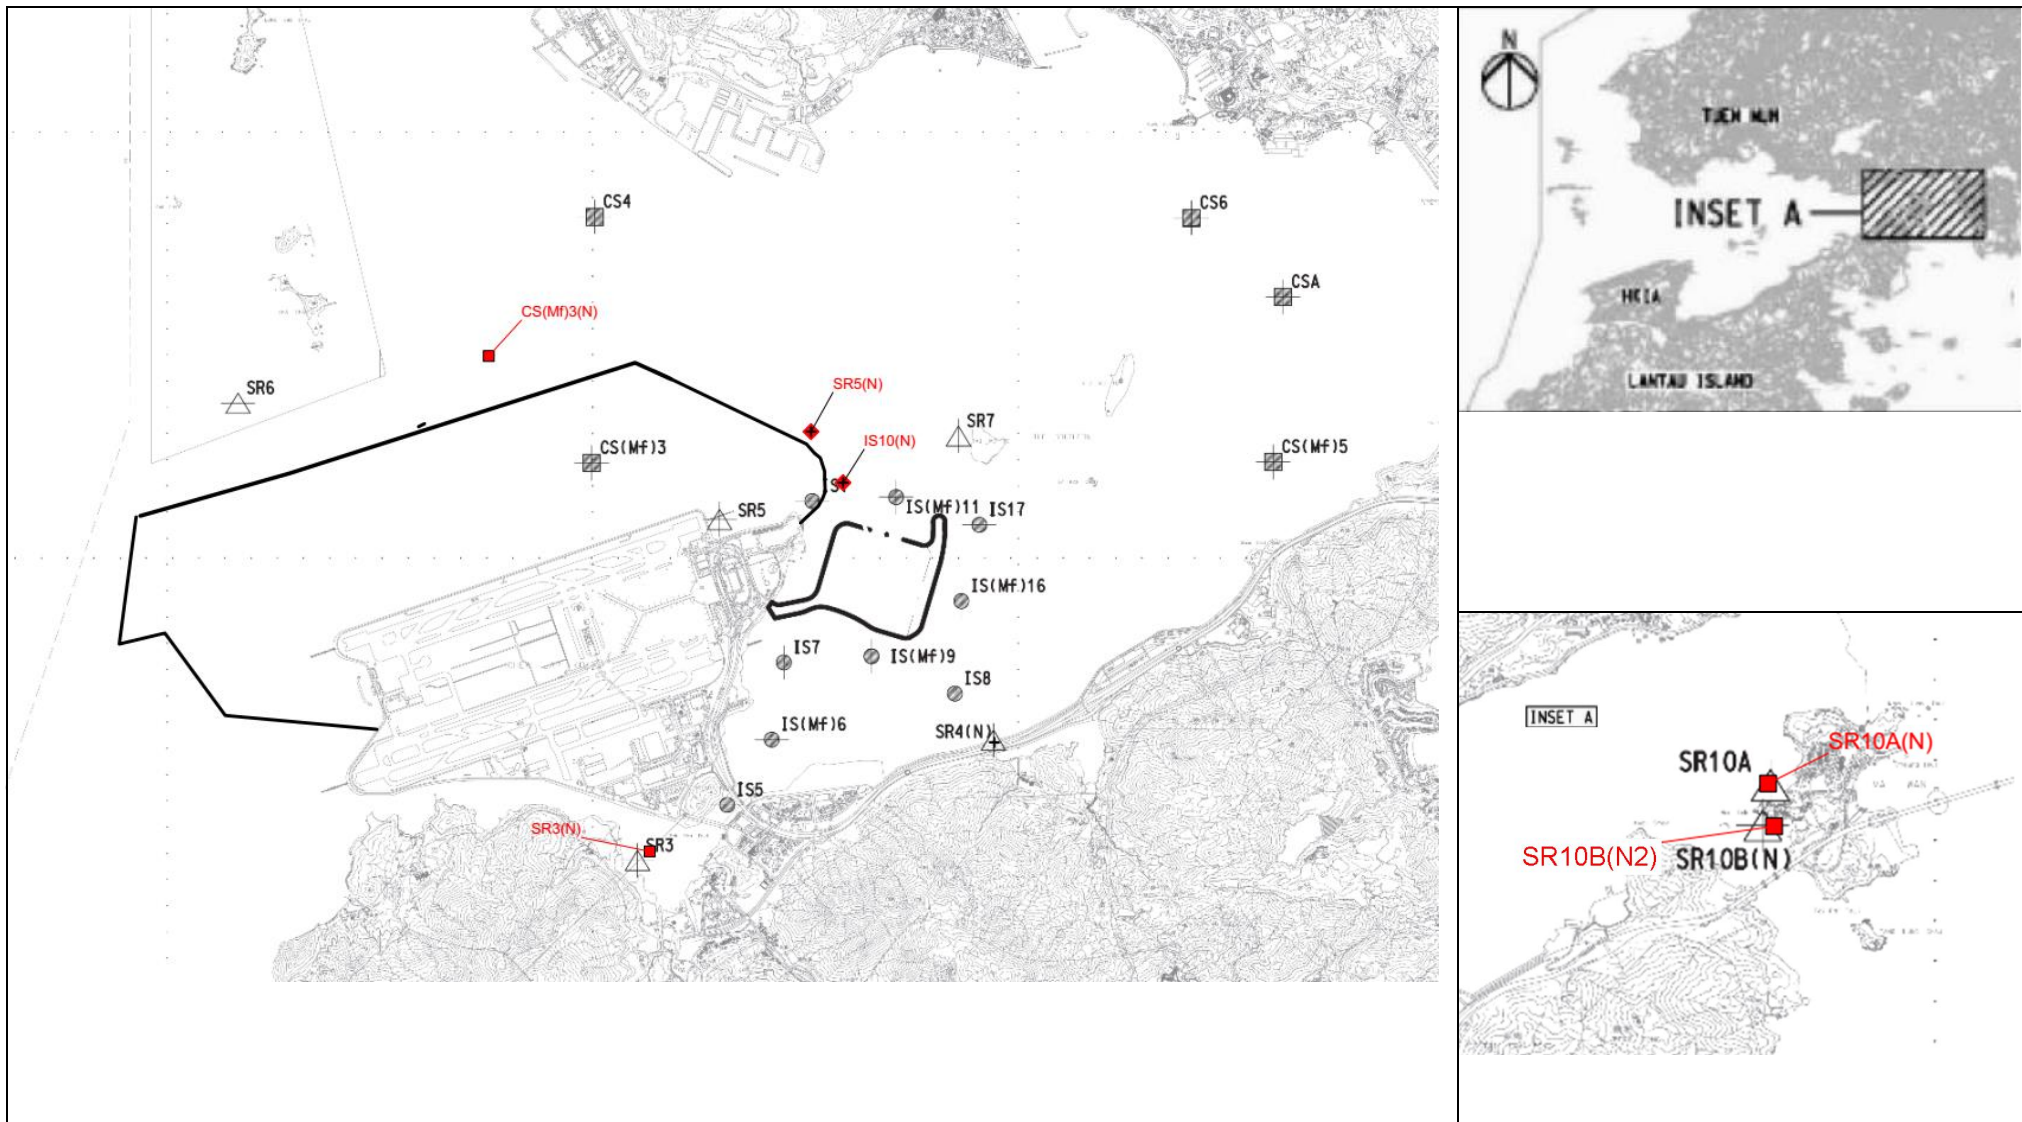
Figure 1: Location Plan

On 16 March 2018, one AL exceedance of SS at SR5(N) was recorded during mid-flood tide.

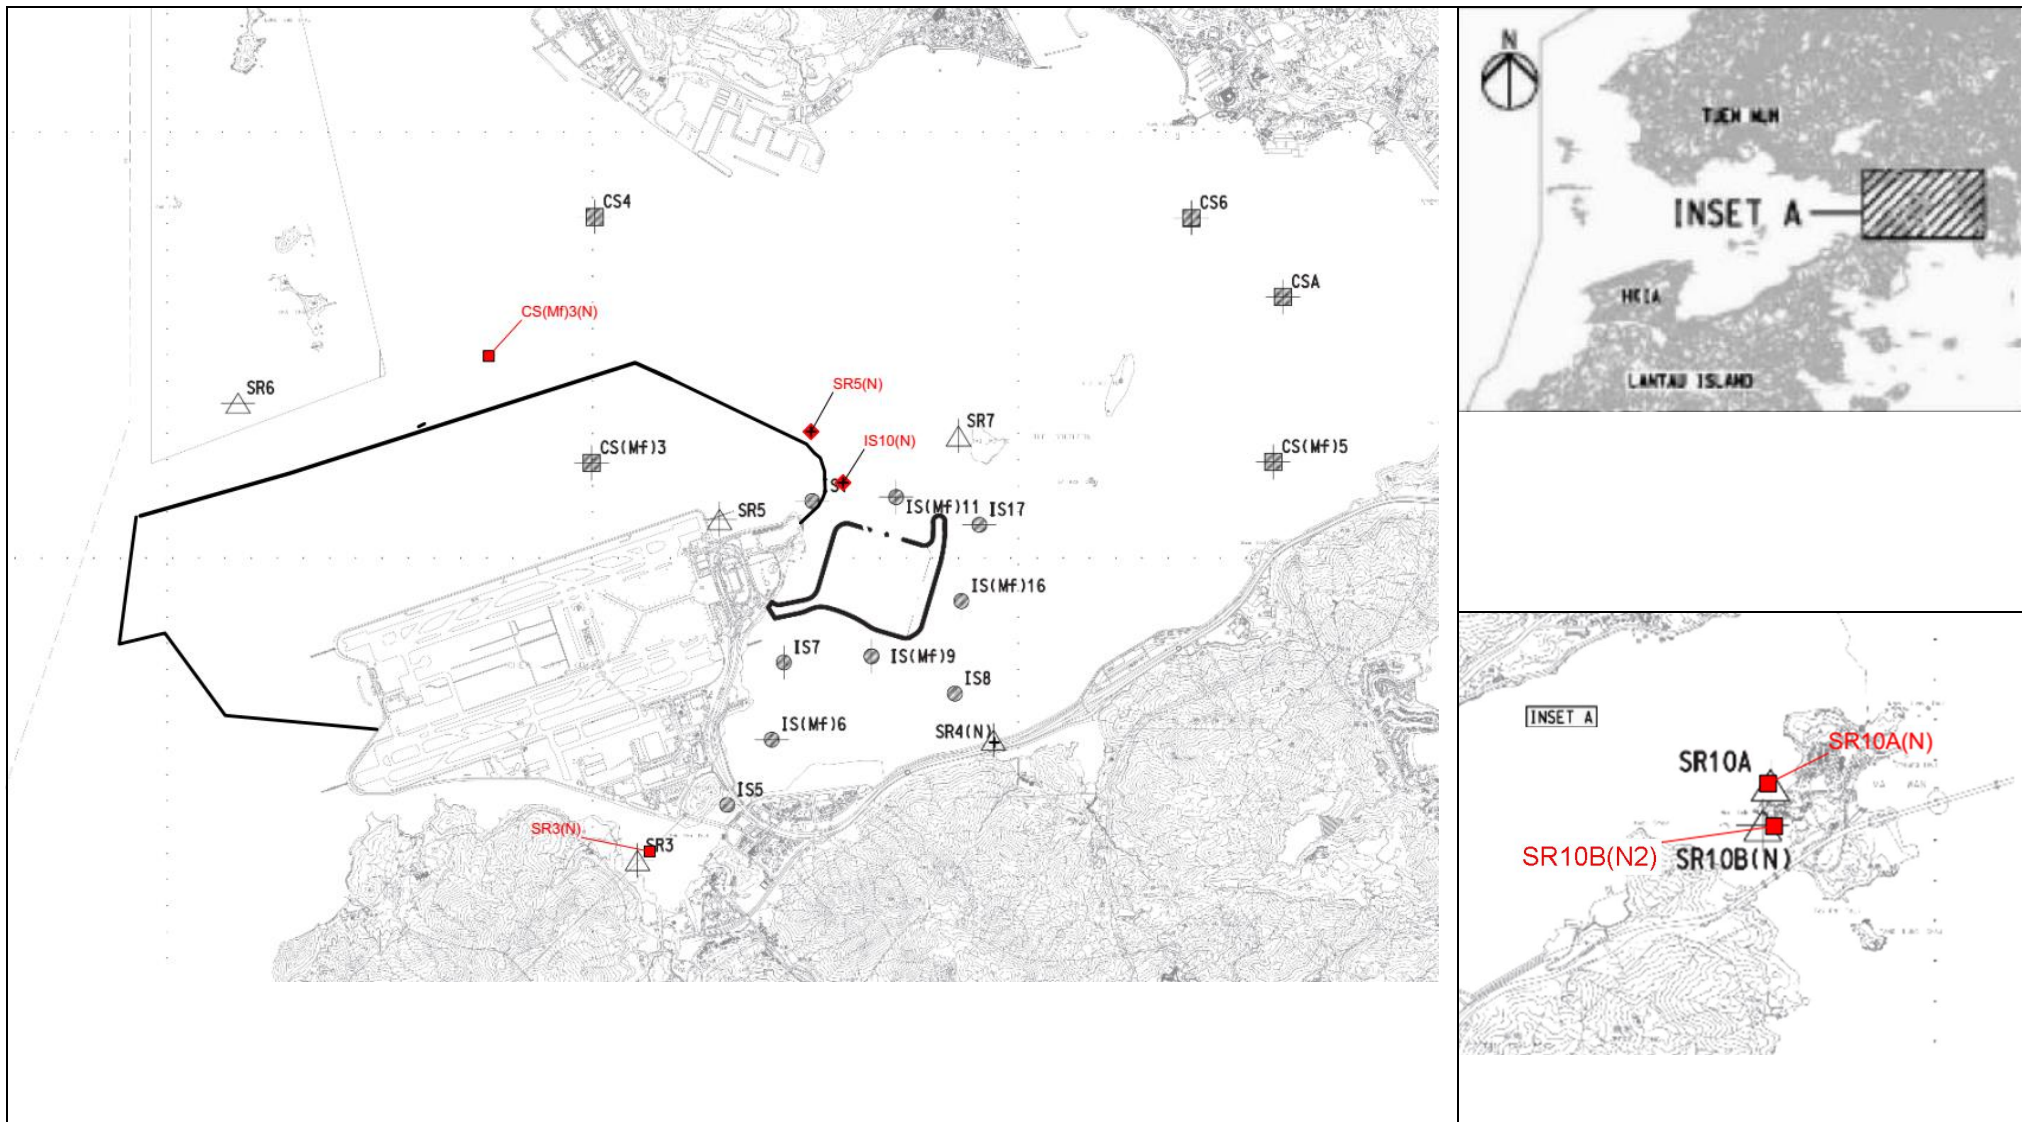
Figure 1: Location Plan

On 21 March 2018, one AL exceedance of SS at IS7 was recorded during mid-flood tide.

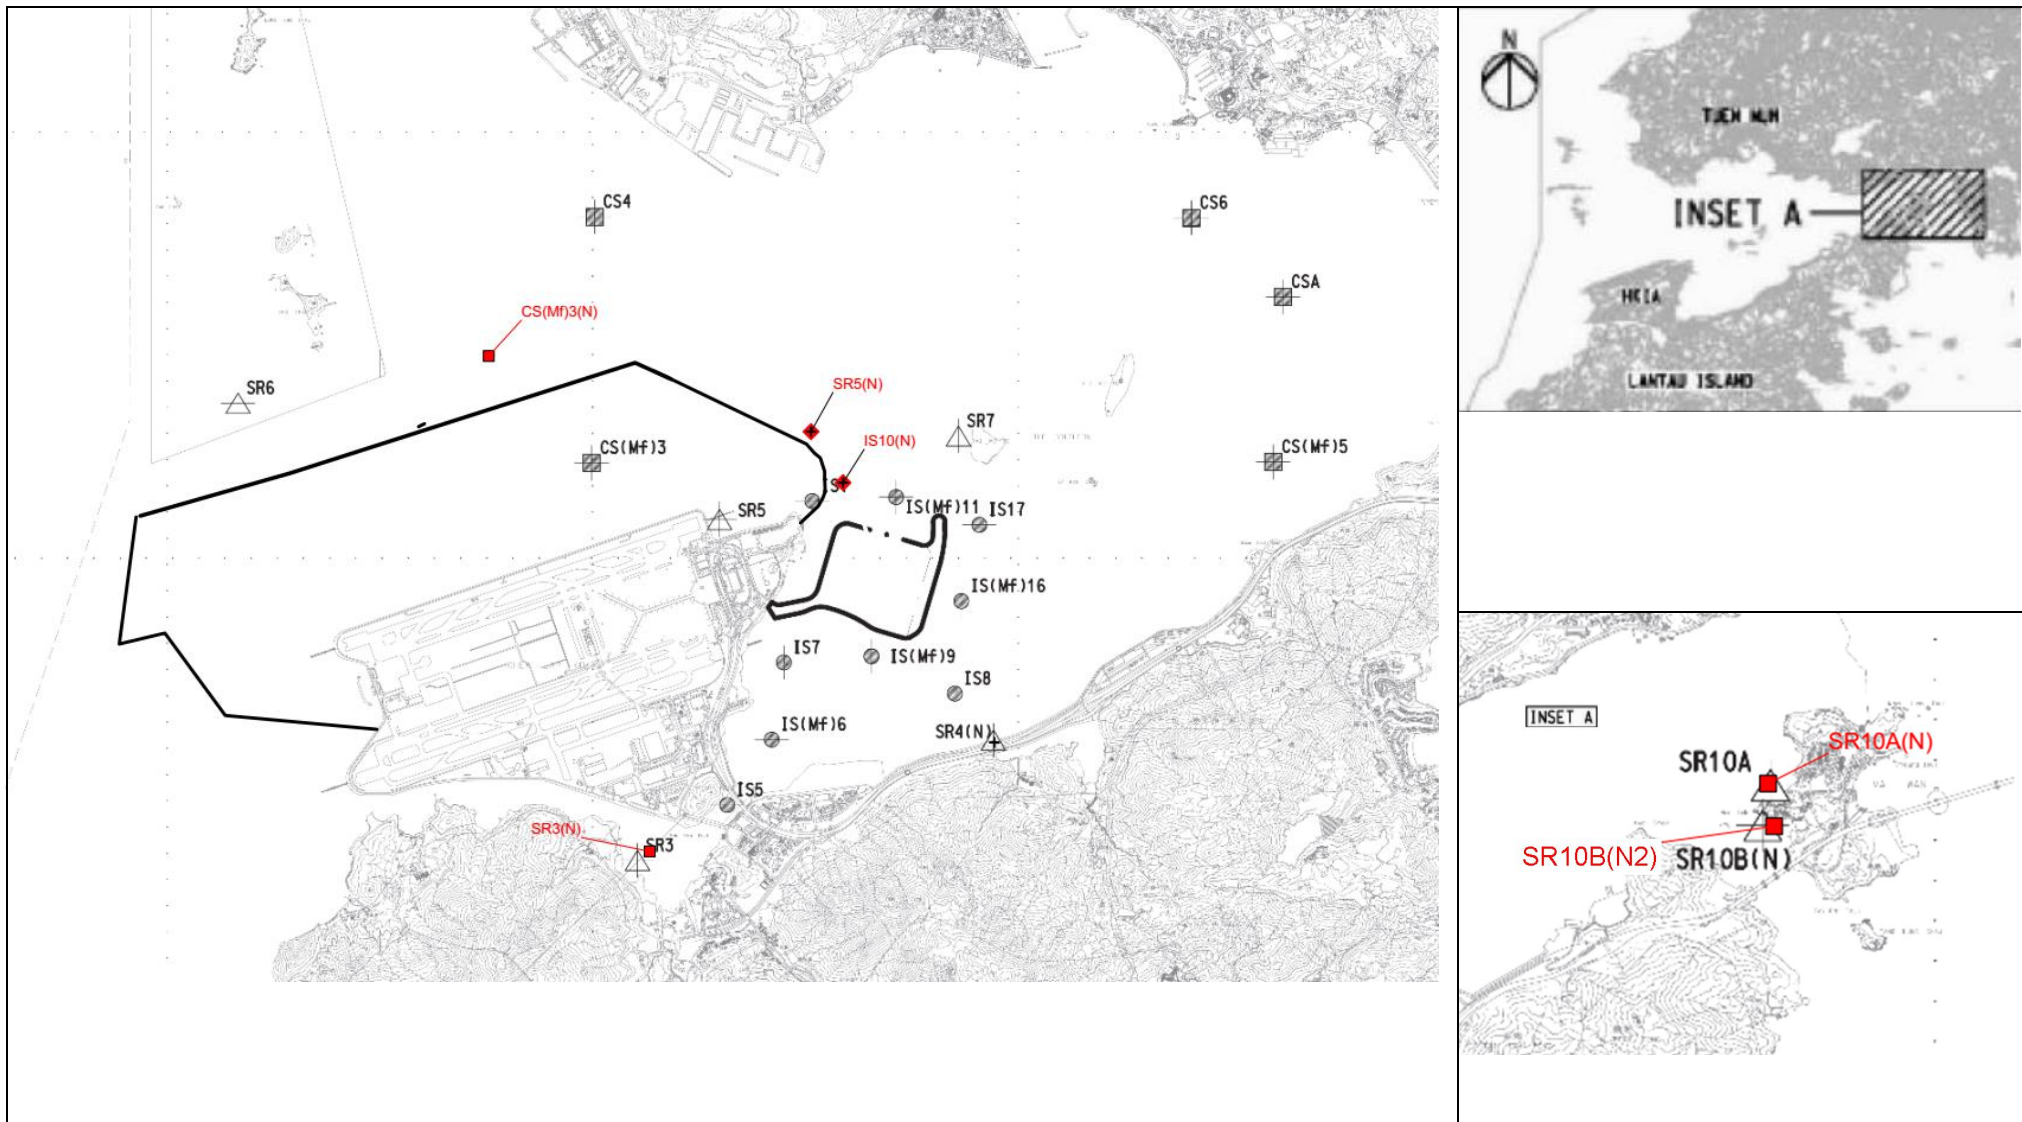
Figure 1: Location Plan

On 30 March 2018, one AL exceedance of SS at SR5(N) was recorded during mid-flood tide.
