Hong Kong- Zhuhai- Macao Bridge Hong Kong Boundary Crossing Facilities (Superstructure and Infrastructure Contracts) Notifications of Environmental Quality Limits Exceedances Notification No.: 20180518TURB_v3						
Date of Notification: 18 May 2018			Date of Investigation Report: 15 June 2018			
Works Inspected: Data collected from water sampling works on 13 May 2018 and the results were issued on 18 May 2018						
Monitoring Location: Water Quality Monitoring Station						
Parameter: Dissolved Oxygen (DO) / Suspended Solid (SS) / Turbidity (TURB)						
Action & Limit Level (AL & LL) / Measured Level:						
PARAM	STATION	DEPTH	AL (NTU)	LL (NTU)	MEASURED AT MID-EBB TIDE (NTU)	MEASURED AT MID-FLOOD TIDE (NTU)
TURB	IS(Mf)11	Depth Average	27.5 and 120% (i.e. 21.7 for mid-ebb/12.3 for mid-flood) of upstream control station's turbidity at the same tide of the same day	47.0 and 130% (i.e. 23.5 for mid-ebb/13.3 for mid-flood) of upstream control station's turbidity at the same tide of the same day	12.1	29.7

Hong Kong- Zhuhai- Macao Bridge Hong Kong Boundary Crossing Facilities (Superstructure and Infrastructure Contracts) Notifications of Environmental Quality Limits Exceedances Notificat

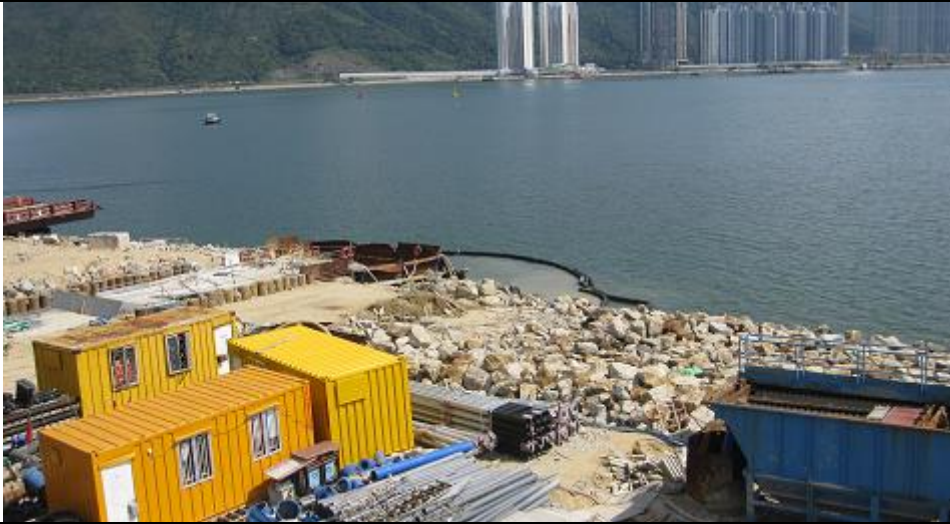
Attachment 1

During ET's (Contract No.: HY/2013/04) subsequent regular weekly site inspection on 14 May 2018, HY/2013/04 site shoreline interfacing with open waters was inspected between 14:20 and 15:20. Regarding water quality mitigation measures associated with that shoreline, it was observed that silty water was observed outside silt curtain at Box Culvert D. The Contractor was reminded to check the integrity of silt curtain. However, the observed silty water was limited to the immediate vicinity of the silt curtain (see photo in Attachment 1). Also, no exceedance was recorded at the monitoring locations closest to the silt curtain at Box Culvert D, namely IS7 and IS(Mf)9, on 13 May 2018. Furthermore, given the large distance between HY/2013/04 site shoreline and the exceedance locations of IS(Mf)11 and SR5(N), it is unlikely that this observation could be related to the subject exceedances. It was concluded that the exceedance was not due to HY/2013/04.

Silty water was observed outside silt curtain at Box Culvert D. The Contractor was reminded to check the integrity of silt curtain.

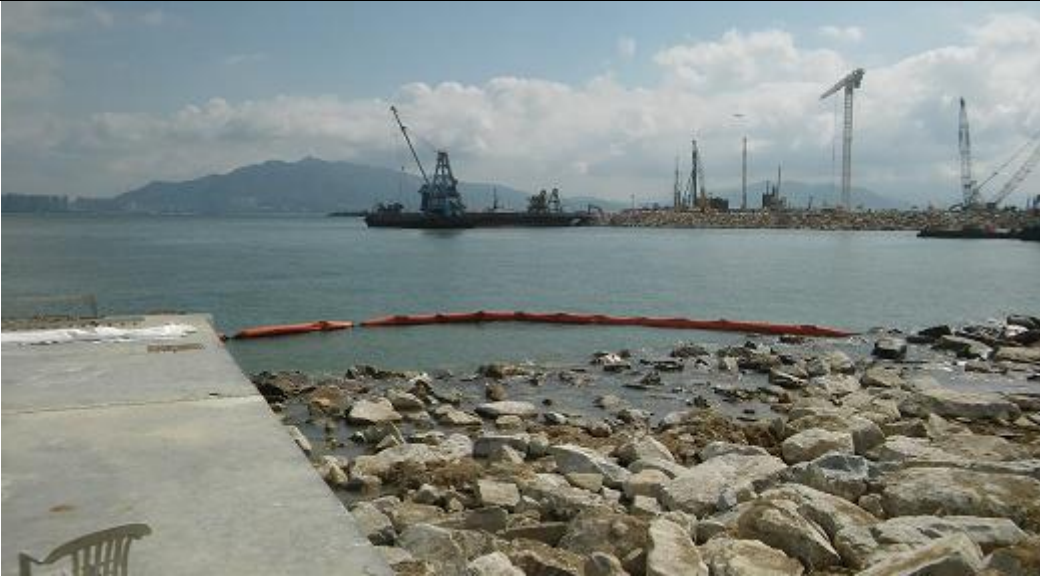
Photo 1

As confirmed with RSS of Contract No. HY/2013/03, there was no marine transportation on the date of exceedance. The marine-based works in Box Culvert B had been completed. Silt curtain was also maintained to enclose the work area of the outlet of the box culvert fully. For turbidity exceedance recorded at the WQM station IS(Mf)11 and SR5(N) closer to the marine delivery route, there was no turbidity exceedance recorded at WQM station IS10(N) which also close to the marine delivery route. It was unlikely that the works undertaken by Contract No. HY/2013/03 caused turbidity exceedance recorded at the concerned WQM station during mid-flood tide on 13 May 2018. The photos of site situation at box culvert are shown in Attachment 2.

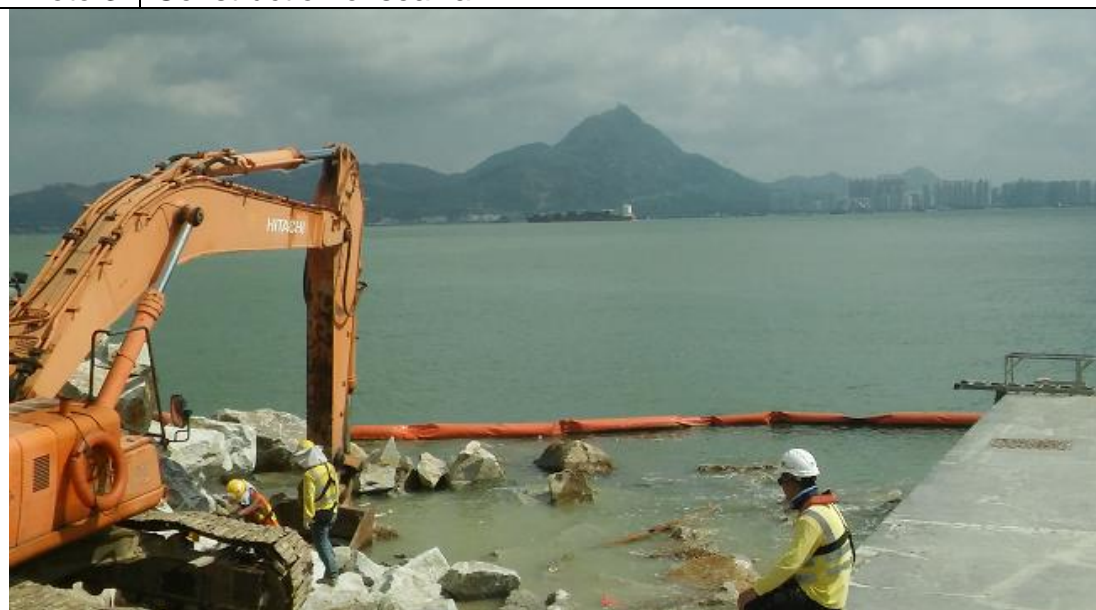
Photo 3 | Construction of seawall
