Hong Kong- Zhuhai- Macao Bridge Hong Kong Boundary Crossing Facilities (Superstructure and Infrastructure Contracts) Notifications of Environmental Quality Limits Exceedances Notification No.: 20180702DO_v1						
Date of Notification: 05 July 2018			Date of Investigation Report: 9 August 2018			
Works Inspected: Data collected from water sampling works on 02 July 2018 and the results were issued on 04 July 2018						
Monitoring Location: Water Quality Monitoring Station						
Parameter: Dissolved Oxygen (DO)/ Suspended Solid (SS) / Turbidity (TURB)						
Action & Limit Level (AL & LL) / Measured Level:						
PARAM	STATION	DEPTH	AL (mg/L)	LL (mg/L)	MEASURED AT MID-EBB TIDE (mg/L)	MEASURED AT MID-FLOOD TIDE (mg/L)
DO	IS10(N)	Bottom	Surface and Middle 5.0 Bottom 4.7	Surface and Middle 4.2 (except 5 mg/L for FCZ) Bottom 3.6	3.6	3.7
DO	IS(Mf)11	Bottom			5.1	3.6
DO	SR5(N)	Bottom			4.0	4.5
DO	SR10A(N)	Bottom			6.0	3.7

Hong Kong- Zhuhai- Macao Bridge
Hong Kong Boundary Crossing Facilities (Superstructure and Infrastructure Contracts)
Notifications of Environmental Quality Limits Exceedances Notification No.: 20180704DO_v2

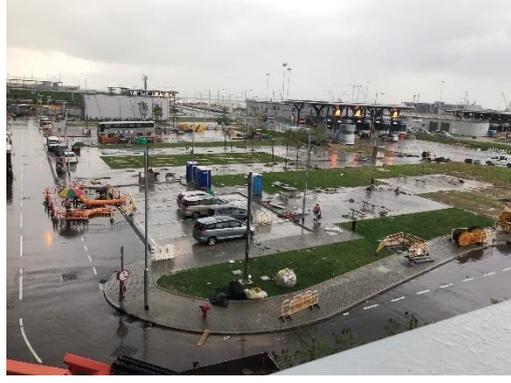
Photo 1 (Photo taken on 13 June 2018)

Date of complaint/ enquiry: 13 June 2018
Time of complaint/ enquiry: Undisclosed
Media: Dust Noise Water Quality Other:
Description: According to ENPO's email to ET, Engineer's Representative and Contractor on 25 June 2018, it was noted that HyD had received a complaint regarding discharge of muddy water from HKBCF on 13 June 2018.

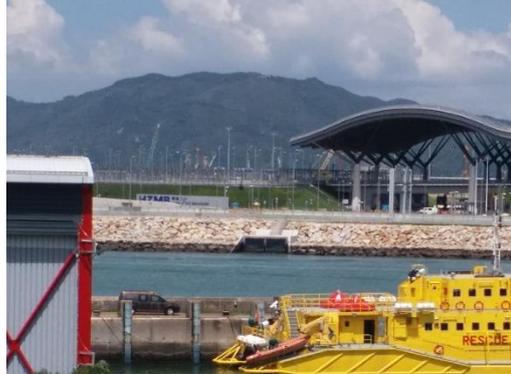
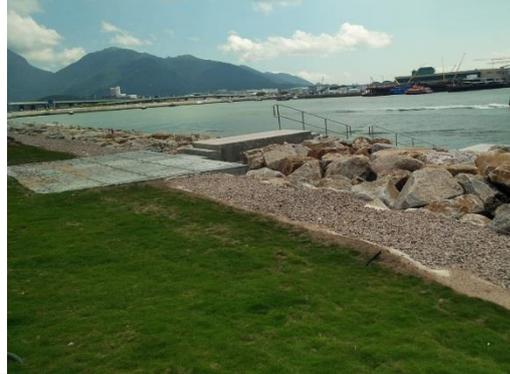
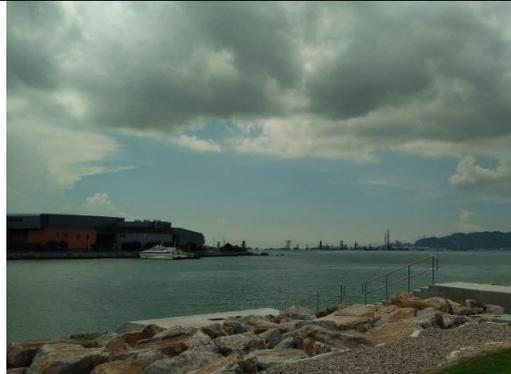
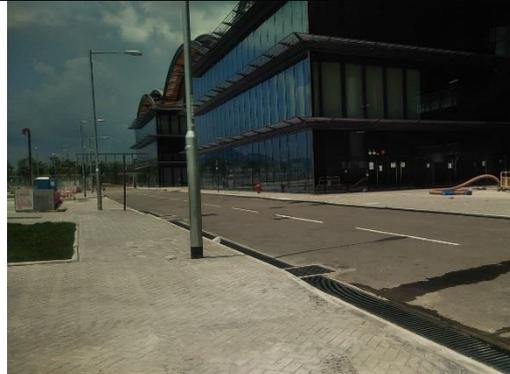
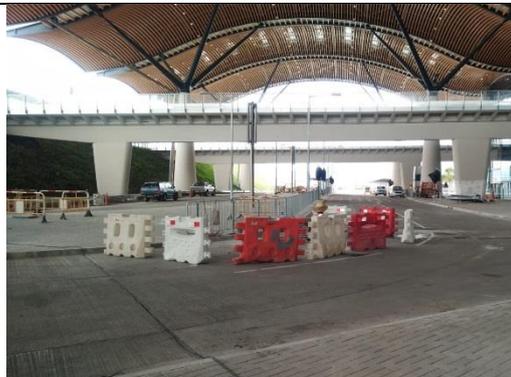
The site investigation was conducted on 26 and 27 June 2018. No muddy water was found near Box Culvert A (Photo 3 to Photo 7). Domestic sewage arising from domestic cleaning was being discharged to domestic sewer which connect to government sewer. The locations where the photos taken are shown in Figure 1.

Based on the investigation results, it is found that the complaint is not related to Contract No. HY/2013/01. No follow up action is required.
