ETS-Testconsult Ltd – Environmental Team (ET)			
Complaint Investigation Report			
Contract No. HY/2013/02 - Hong Kong- Zhuhai- Macao Bridge Hong Kong Boundary Crossing Facilities – Infrastructure Works Stage I (Western Portion)			
Details of the Complaint			Log No. : 013
Date	02 June 2017	Time	---
Location:			
Construction Sites of HKBCF			
Circumstances:			
<p>One complaint was received by Environmental Protection Department on 02 June 2017 from a construction worker and referred to the ENPO. Then the ENPO forwarded the complaint by email to the R.E. (AECOM), the Contractor (China Harbour) and the ET (ETS-Testconsult Ltd.) of Contract No. HY/2013/02 at 13:23 on 06 June 2017. The complaint detail was "地盤工人 X 先生投訴港珠澳大橋人工島出入境旅檢地盤沒有灑水，導致地盤周圍佈滿泥塵，令工人健康受害，要求環保署進行突擊跟進巡查才可發現問題及要求回覆。"</p>			
Follow action(s)			
Follow up by	Environmental Team of Contract No. HY/2013/02	Date	08 June 2017
Details of Follow up action(s)

Contract No. HY/2013/02 – Hong Kong – Zhuhai – Macao Bridge
Hong Kong Boundary Crossing Facilities – Infrastructure Works Stage I (Western Portion) Complaint Investigation Report Log No. 013

Contract No. HY/2013/02 – Hong Kong – Zhuhai – Macao Bridge
Hong Kong Boundary Cros

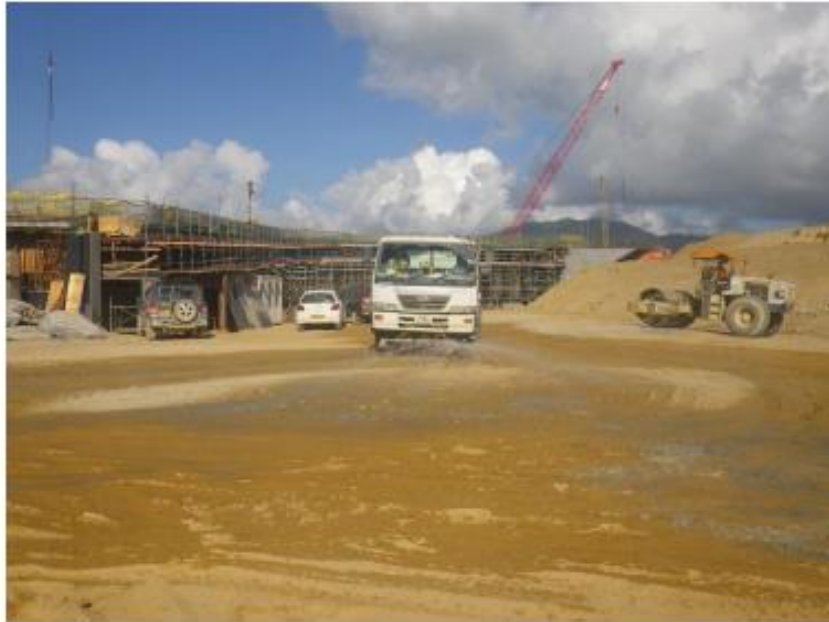
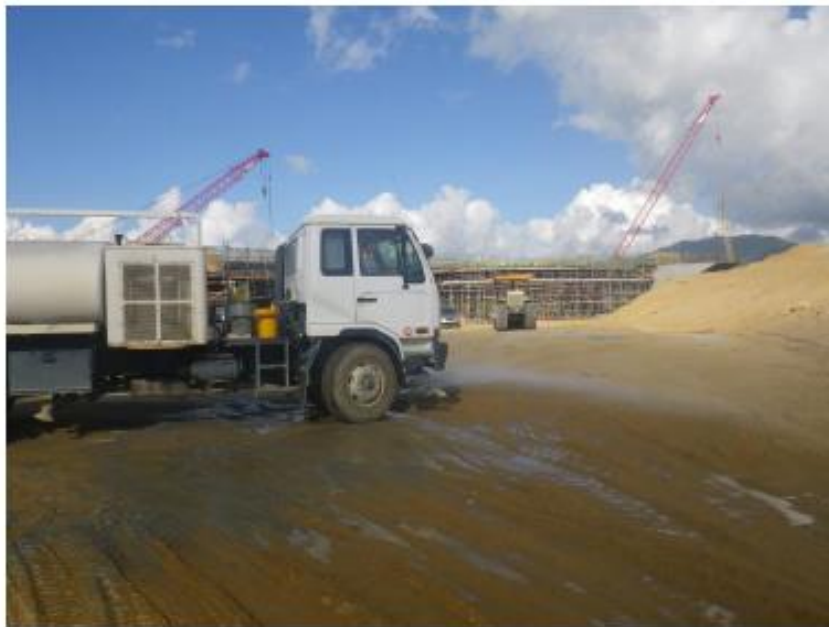
Photo 170608_001 – Regular Watering

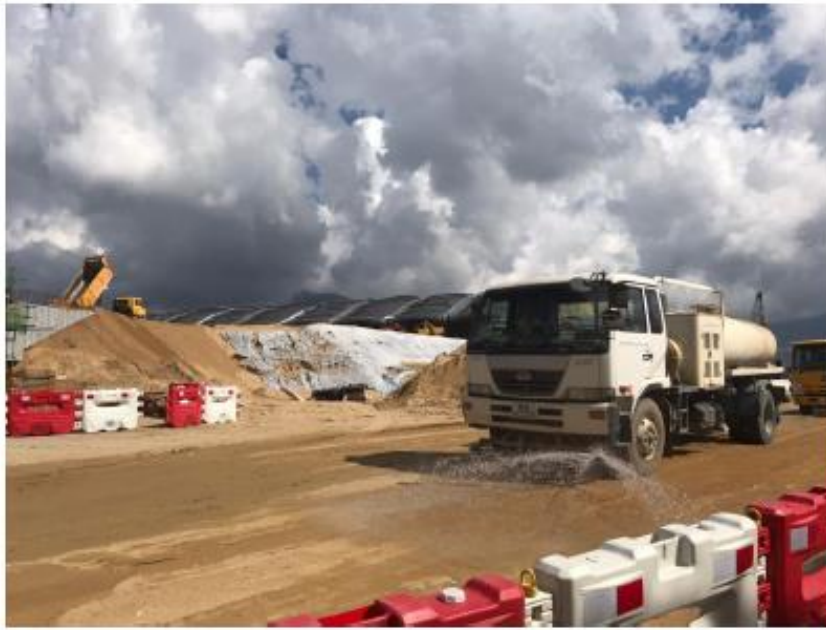
Photo 170608_002 – Watering near 出入境旅檢地盤

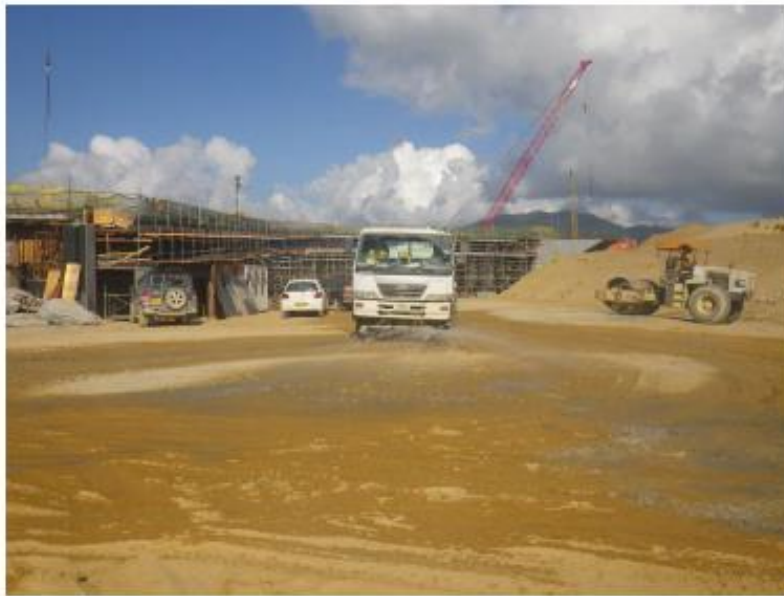
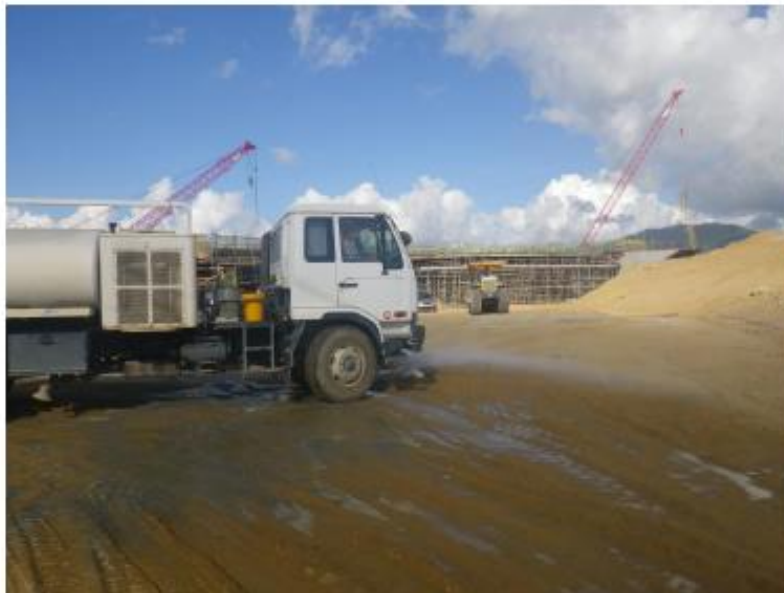
Photo 170608_001 – Regular Watering

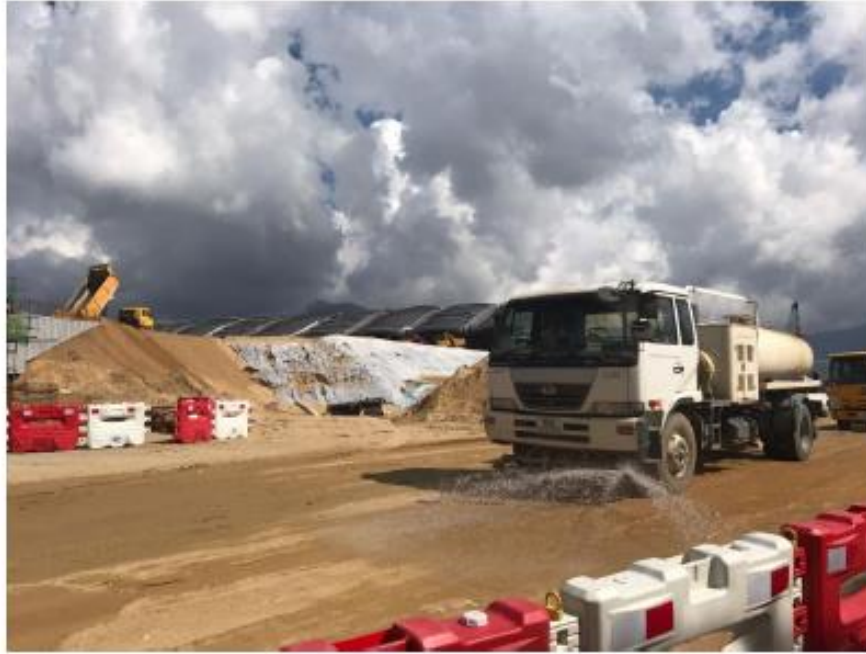
Photo 170608_002 – Watering near 出入境旅檢地盤

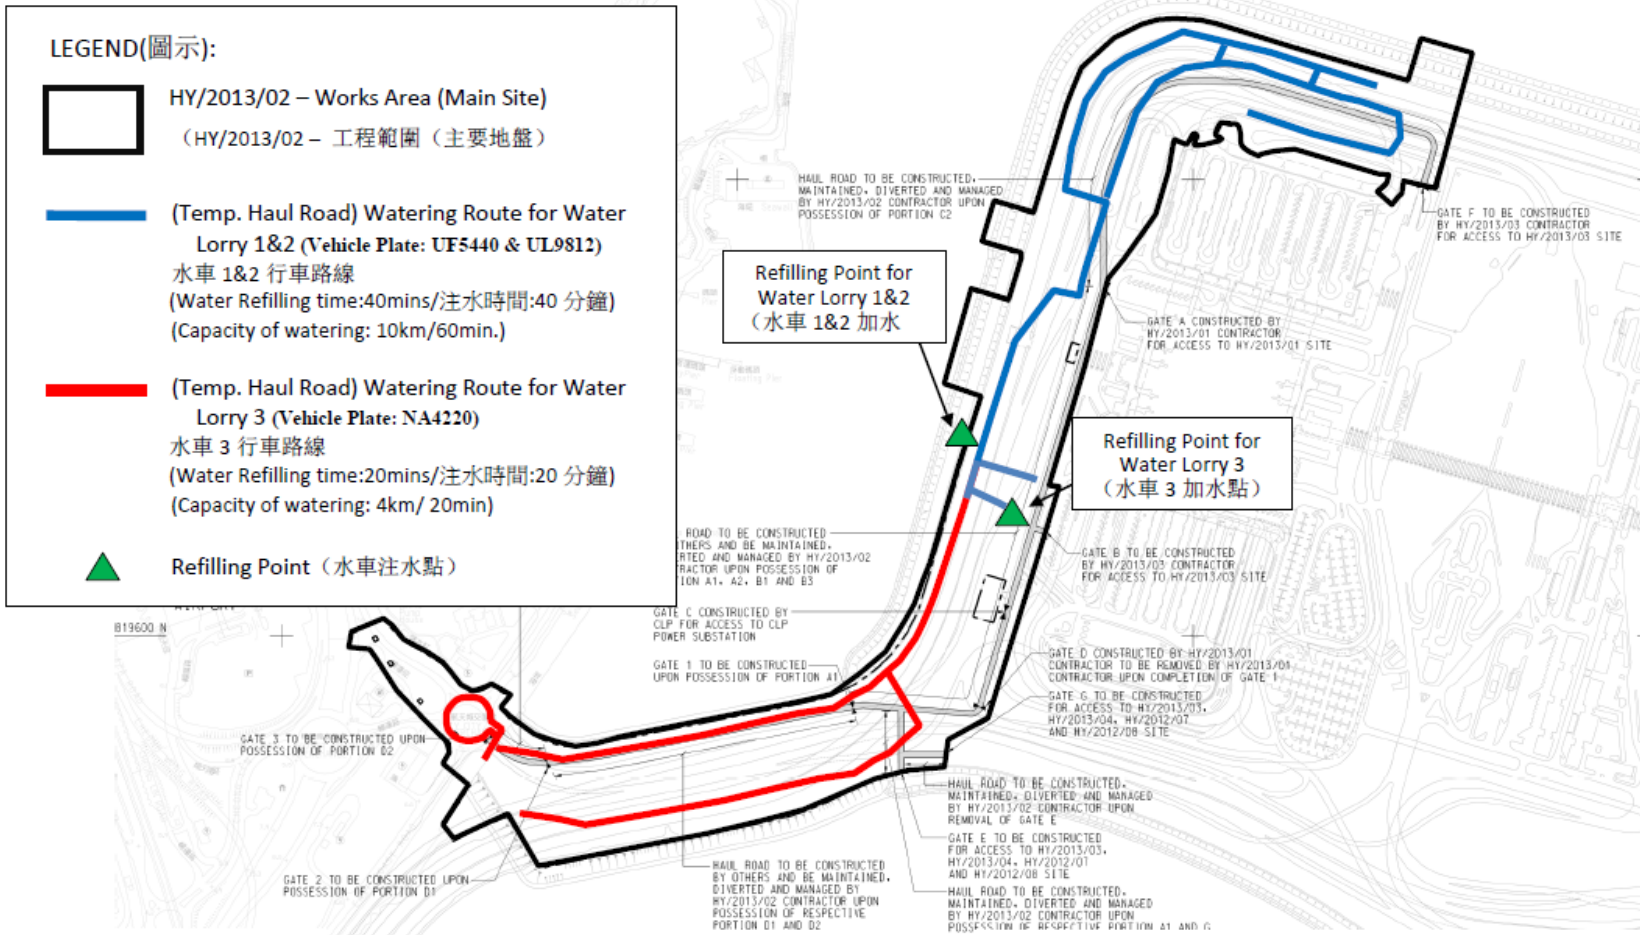
The watering route of main haul road and access

環境許可證(EP-353/2009/K)3.23 條款要求每日至少進行八次灑水
Sub-clause 3.23 of EP-353/2009/K: Watering at least 8 times per day
