Complaint Investigation Report

ETS-Testconsult Ltd – Environmental Team (ET)			
Complaint Investigation Report			
Contract No. HY/2013/02 - Hong Kong- Zhuhai- Macao Bridge Hong Kong Boundary Crossing Facilities – Infrastructure Works Stage I (Western Portion)			
Details of the Complaint			Log No. : 019
Date	13 June 2018	Time	---
Location:			
Construction Sites of HKBCF			
Circumstances:			
One complaint was received by Highways Department on 13 June 2018 and referred to the ENPO on 22 June 2018. Then the ENPO forwarded the complaint by email to the R.E. (AECOM), the Contractor (China Harbour) and the ET (ETS-Testconsult Ltd.) of Contract No. HY/2013/02 at 10:42 on 25 June 2018. The complaint detail was "muddy water discharged via as-constructed box culverts/outfall structures at various parts of seawall on 13 June 2018"			
Follow action(s)			
Follow up by	Environmental Team of Contract No. HY/2013/02	Date	25 June 2018
Details of Follow up action(s)

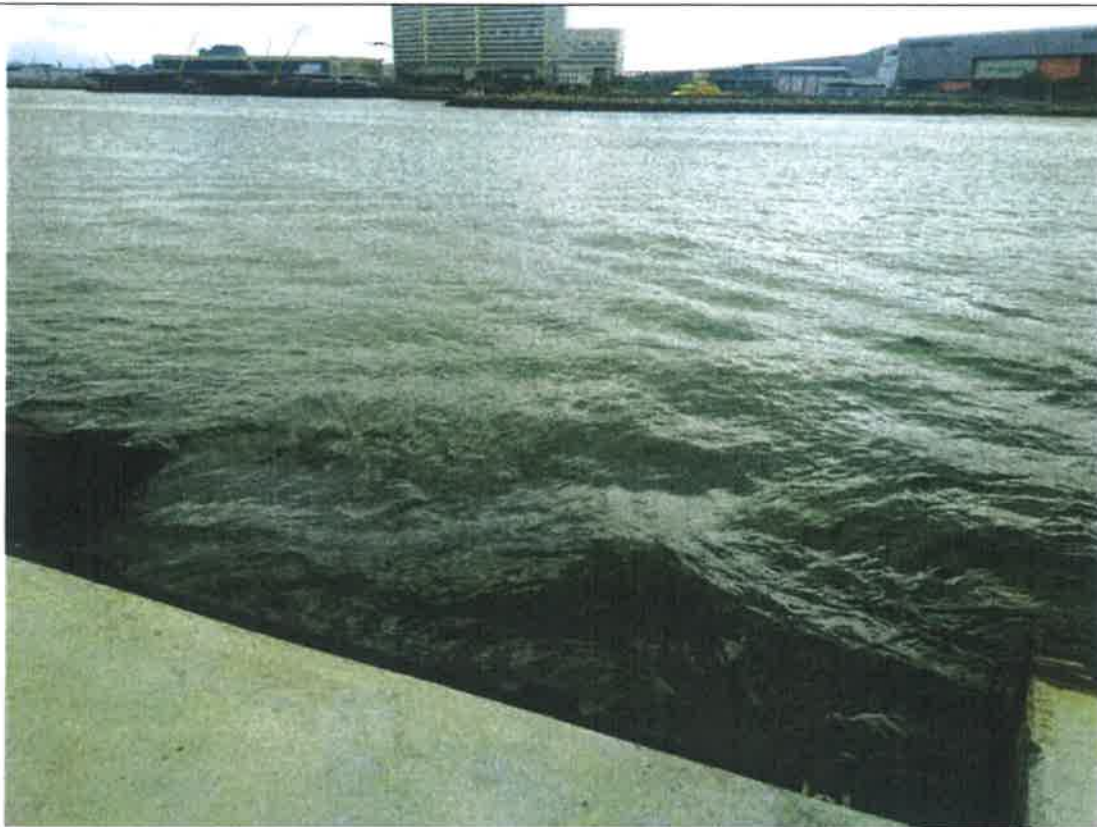
Photo 180625_001 –Box Culvert A on 25 June 2018

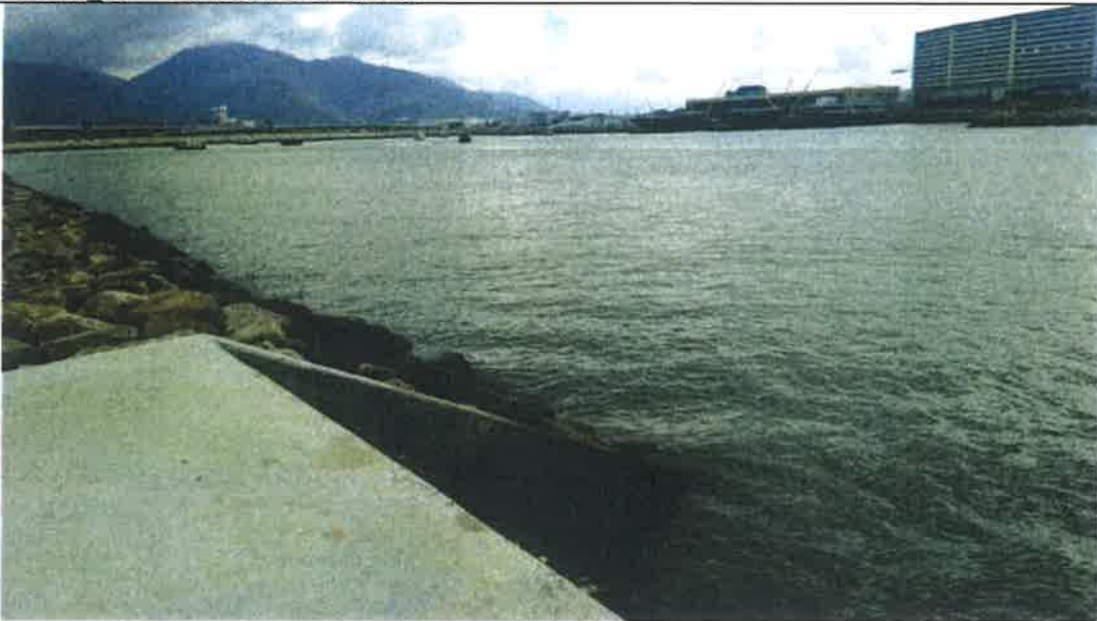
Photo 180625_002 –Box Culvert A on 25 June 2018

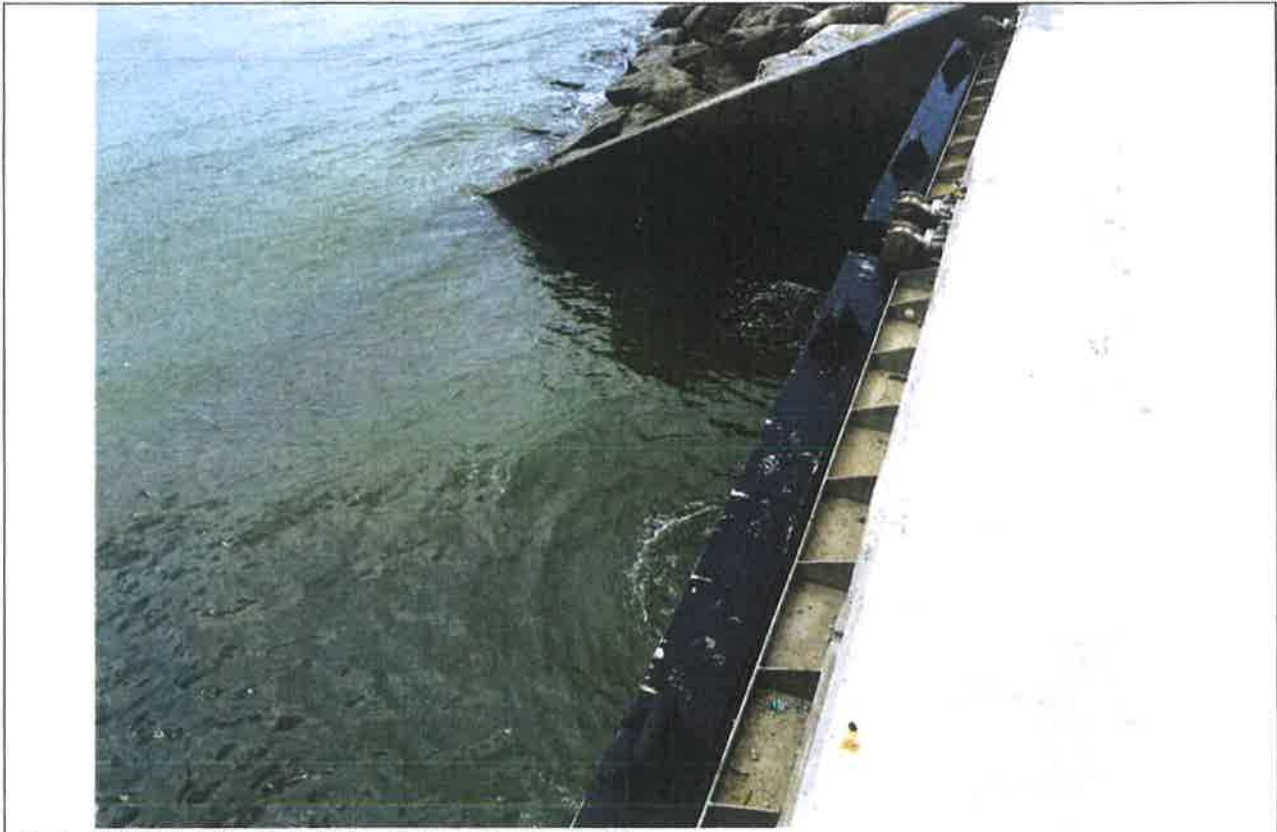
Photo 180627_001 -Box Culvert A on 27 June 2018

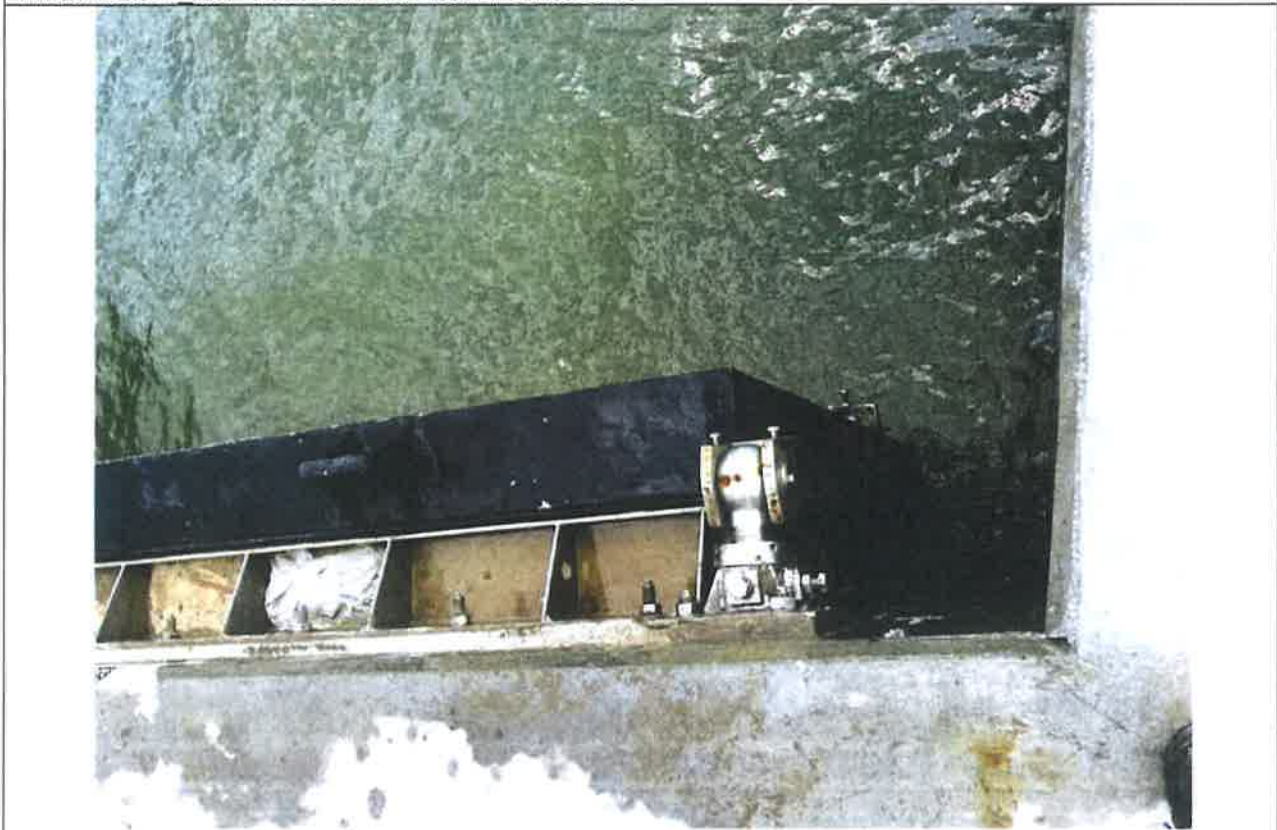
Photo 180627_002 -Box Culvert A on 27 June 2018

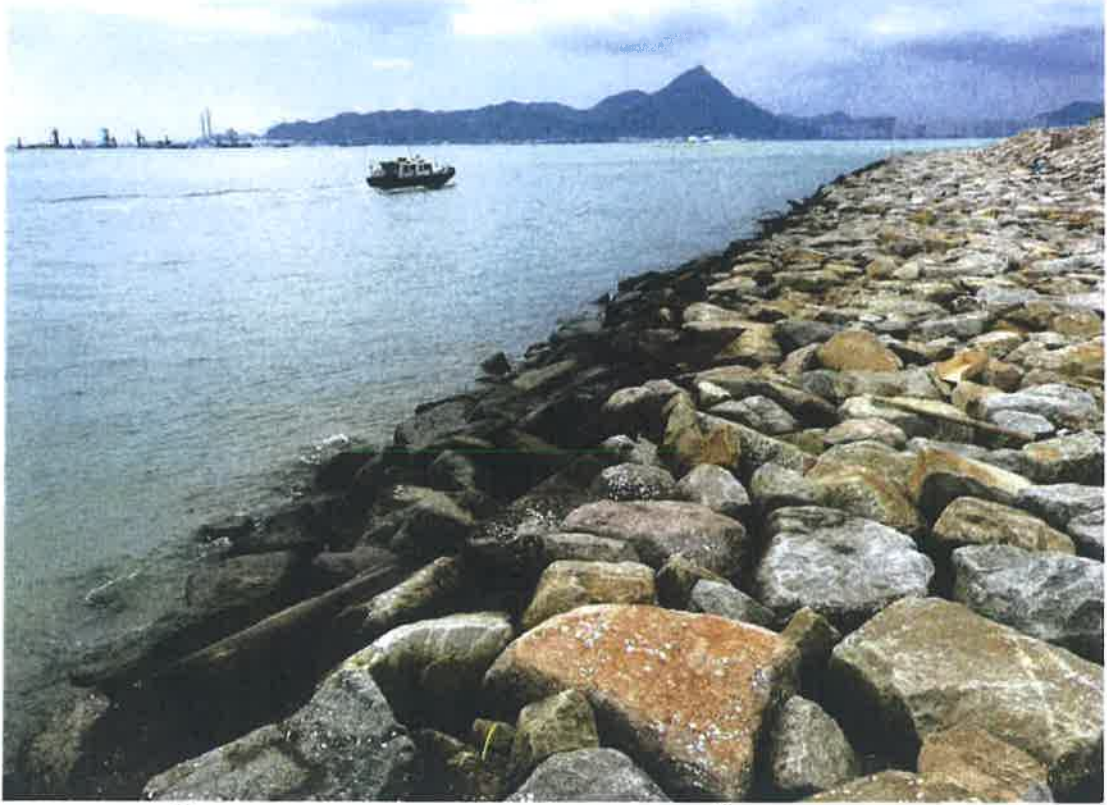
Photo 180627_003 – Open sea near Box Culvert A on 27 June 2018
