INVESTIGATION REPORT ON ACTION AND LIMIT LEVEL NON-COMPLIANCE

CONTRACT NO. HY/2013/03

**Hong Kong Zhuhai Macao Bridge
Hong Kong Boundary Crossing Facilities – Vehicle Clearance Plazas and
Ancillary Buildings and Facilities**

Report No. Ref.: 0165-15-IR002

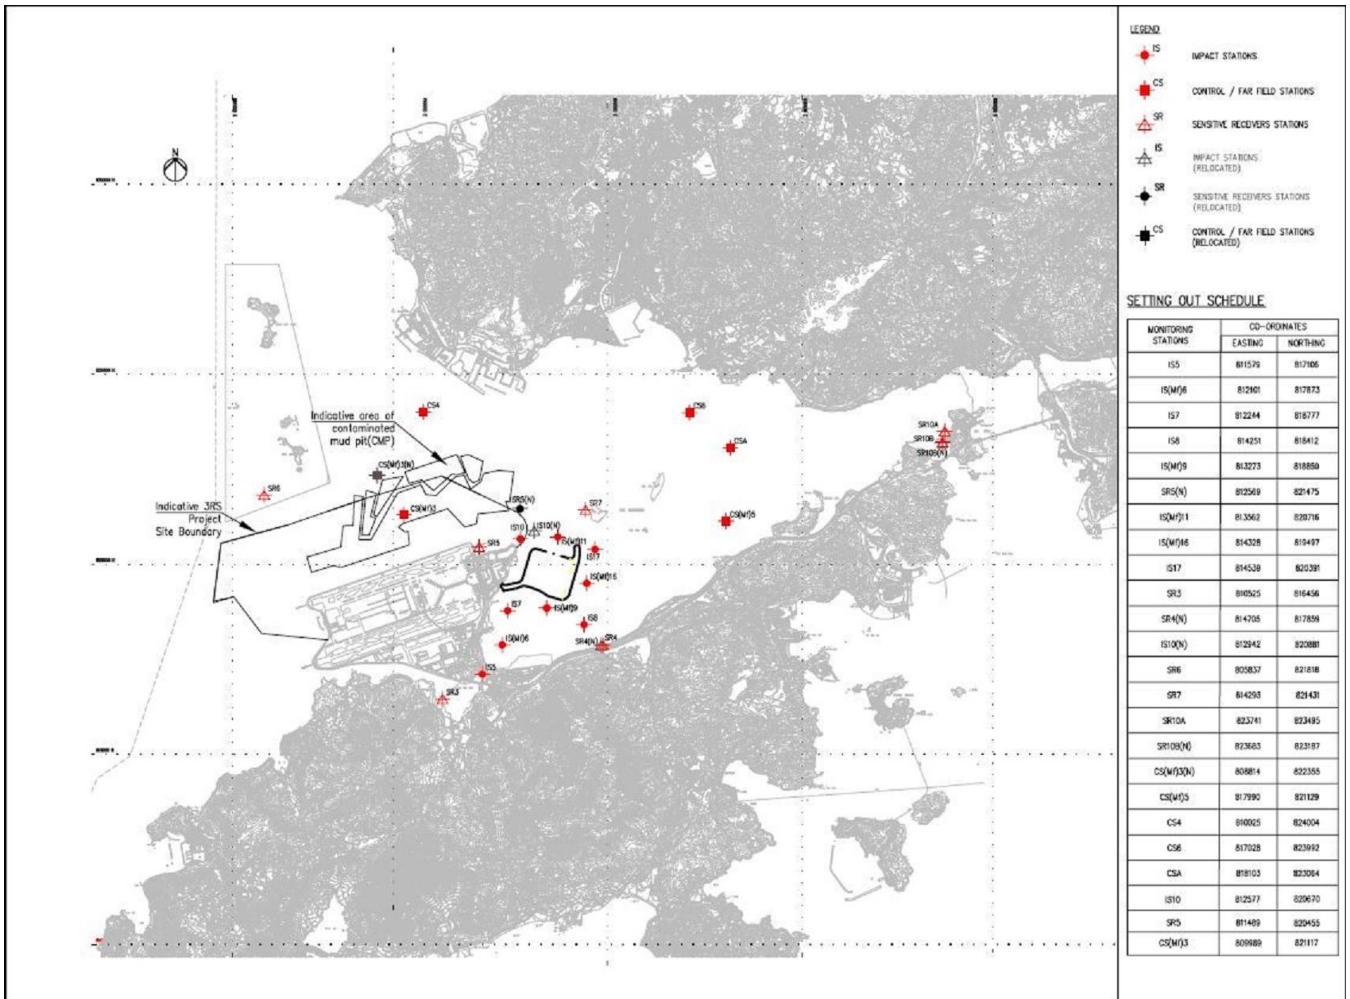
Figure 1

Monitoring Station	Monitoring Time	Measured Depth Averaged	Level Exceeded
SR3	13:49	24.7	Action

The Location of WQM Stations

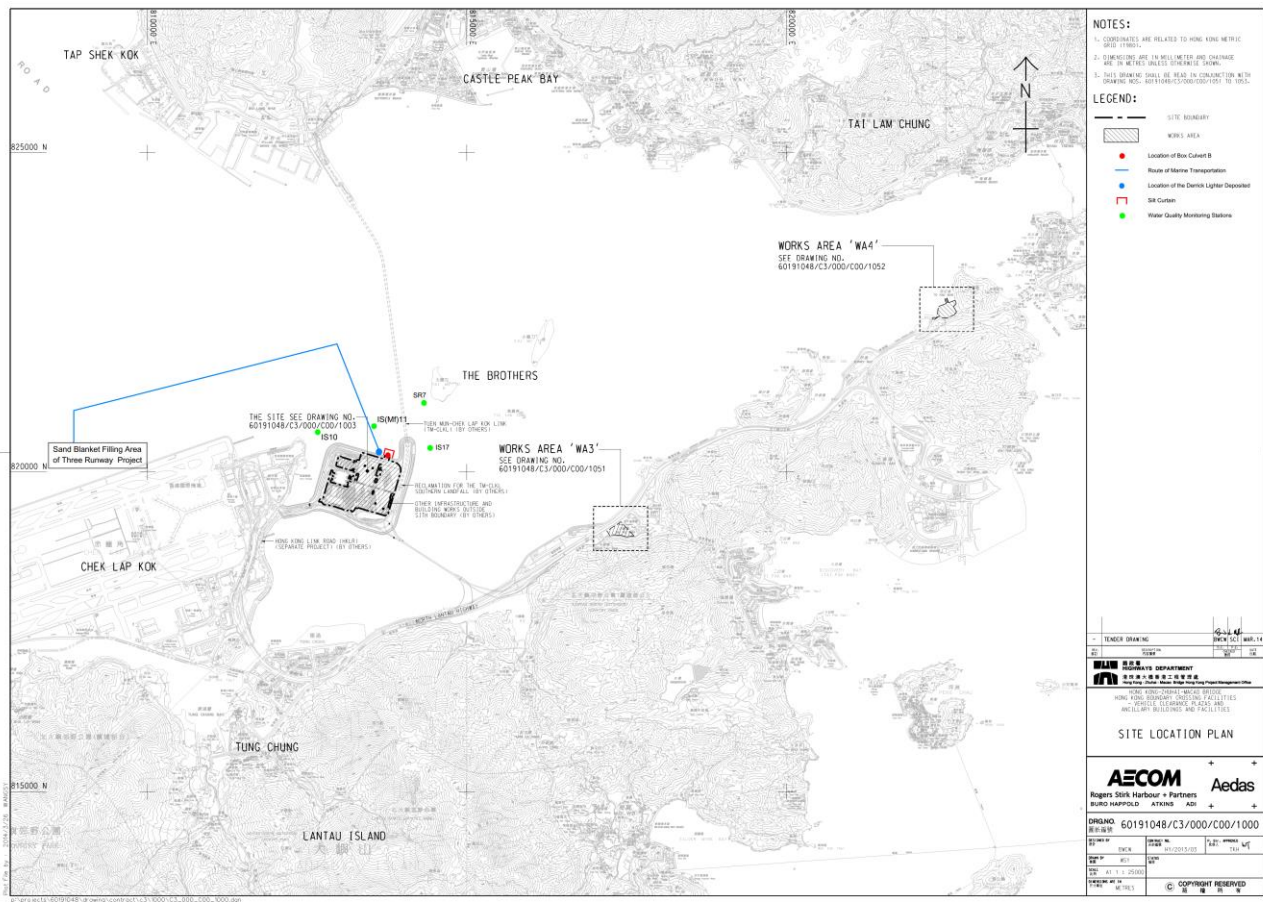
Figure 2

As confirmed with Mr. Marko Chan, Environmental Officer, and operation team of Contract No. HY/2013/03, marine-based construction works were undertaken in Box Culvert B and there was one derrick lighter delivered sand to the work site of Three Runway Project on 12 July 2017 under Contract No. HY/2013/03. Both marine-based construction works and the route of marine transportation were far away from the concerned WQM station SR3. There was no notification of exceedance received at the WQM stations closer to the marine-based construction works areas, such as IS(Mf)11, IS10, IS17 and SR7. Besides, the SS exceedance was recorded at 13:49. The derrick lighter was deposited at HKBCF from morning until 16:00. Therefore, it was unlikely to generate any suspended solids to cause the SS exceedance recorded at the concerned WQM station SR3 during mid-ebb tide on 12 July 2017. The location of the WQM station where exceedance was recorded and all relevant WQM stations are shown in **Figure 1** and the locations of marine transportation and marine-based construction works are shown in **Figure 2**.

The ET of Contract No. HY/2013/03 concluded that the captioned exceedance was not related to the construction site activities of the contract. Nevertheless, the Contractor had been reminded to comply with the requirements stipulated in the Environmental Mitigation Implementation Schedule (EMIS) of the EM&A Manual, in particular:

The Locations of Marine Transportation and Marine-based Construction Works

The Contractor was reminded to continue to fully maintain all water quality mitigation measures.

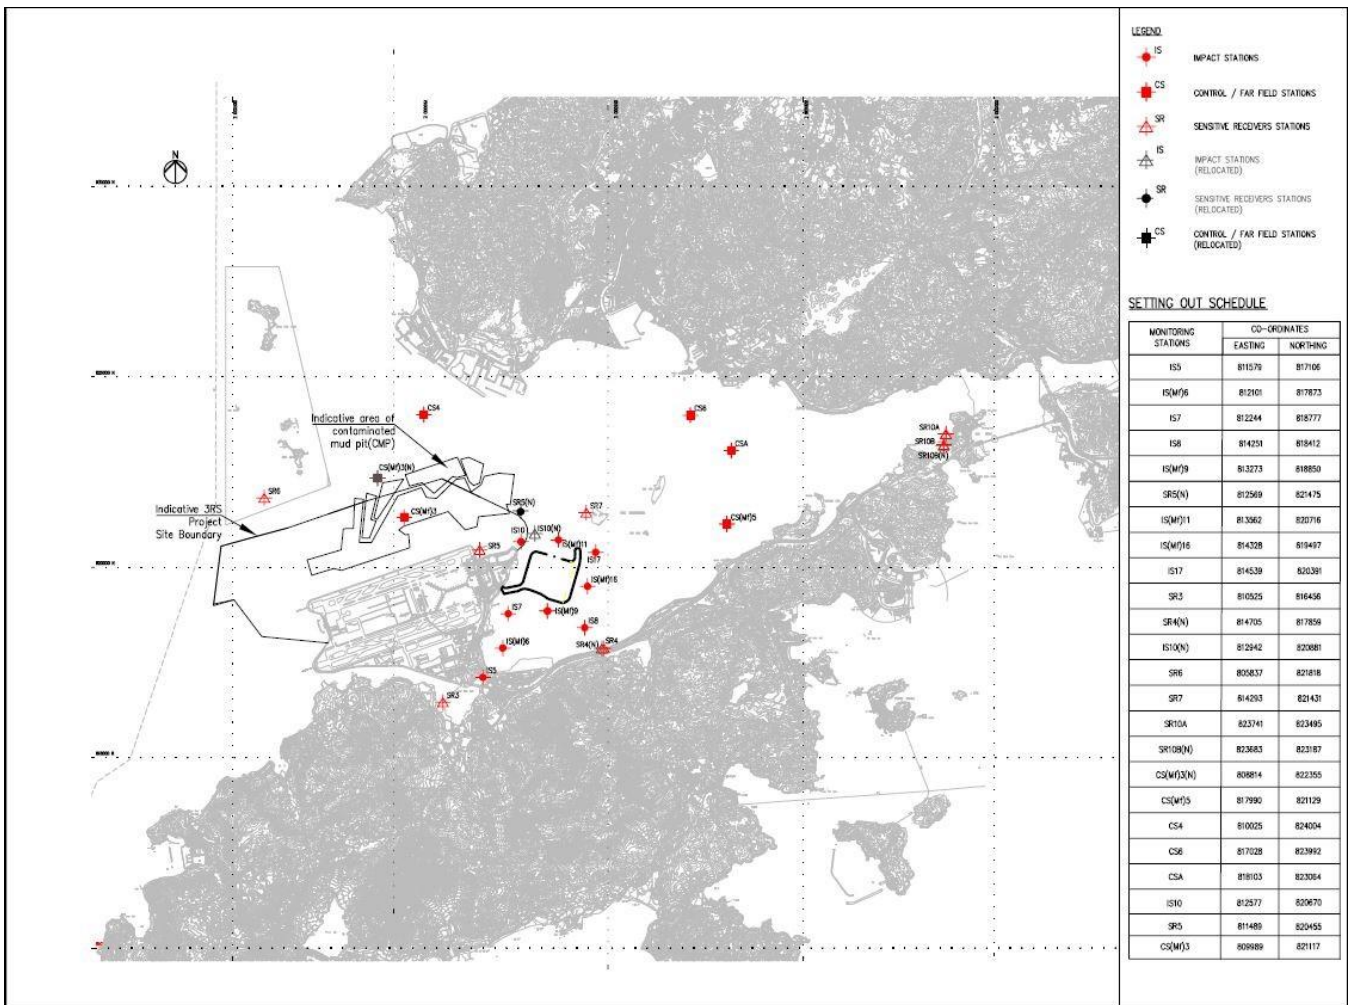
Figure 1

Monitoring Station	Monitoring Time	Measured Depth Averaged	Level Exceeded
IS7	10:17	24.9	Action

The Location of WQM Stations

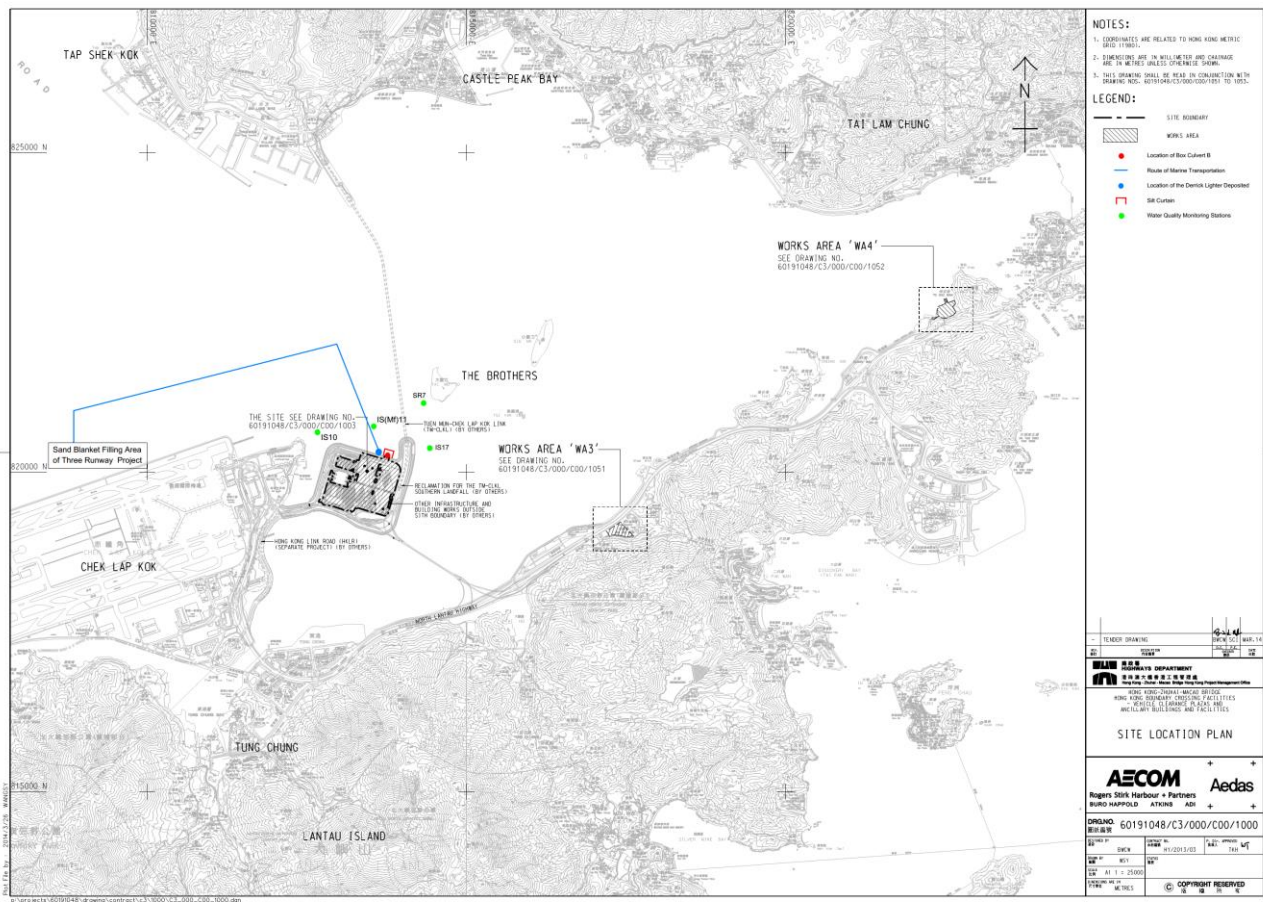
Figure 2

As confirmed with Mr. Marko Chan, Environmental Officer, and operation team of Contract No. HY/2013/03, marine-based construction works were undertaken in Box Culvert B and there were two derrick lighters delivered sand to the work site of Three Runway Project on 14 July 2017 under Contract No. HY/2013/03. Both marine-based construction works and the routes of marine transportation were undertaken in the north side of HKBCF while the concerned WQM station IS7 was in the south-west side. As the concerned monitoring station was far away from both marine-based construction works and the routes of marine transportation and there was no notification of exceedance received at the WQM stations closer to the works areas, such as IS(Mf)11, IS10, SR7 and IS17, it was unlikely to generate any suspended solids to cause the SS exceedance recorded at the concerned WQM station IS7 during mid-flood tide on 14 July 2017. The location of the WQM station where exceedance was recorded and all relevant WQM stations are shown in **Figure 1** and the locations of marine transportation and marine-based construction works are shown in **Figure 2**.

The ET of Contract No. HY/2013/03 concluded that the captioned exceedance was not related to the construction site activities of the contract. Nevertheless, the Contractor had been reminded to comply with the requirements stipulated in the Environmental Mitigation Implementation Schedule (EMIS) of the EM&A Manual, in particular:

The Locations of Marine Transportation and Marine-based Construction Works

The Contractor was reminded to continue to fully maintain all water quality mitigation measures.
