Contract No. HY/2019/01
Hong Kong-Zhuhai-Macao Bridge Hong Kong Boundary Crossing Facilities –
Phase 2 and Other Works
Establishment Inspection Checklist

Date of Site Audit:	2022-04-25	Time of Site Audit:	9:45-11:15
Site Auditor:	Aloysius Wong	Humidity:	87%
Weather Condition:	Fine	Temperature:	24.6°C

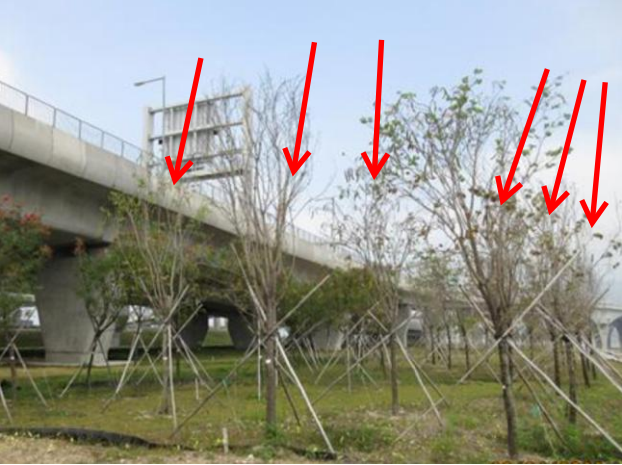
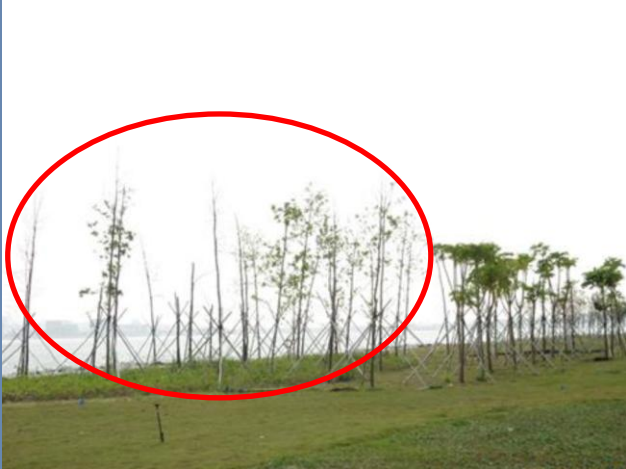
TG46: 2 <i>Grevillea banksii</i> (GB) and 4 <i>Bauhinia variegata</i> (BV) are found dead, replacements are necessary.		TG47: 20 <i>Grevillea robusta</i> (GR) are found dead/poor conditions, replacement is necessary. 1 GR is found missing.

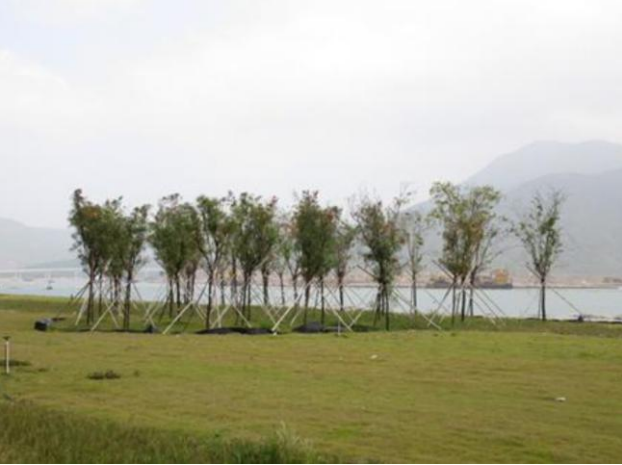
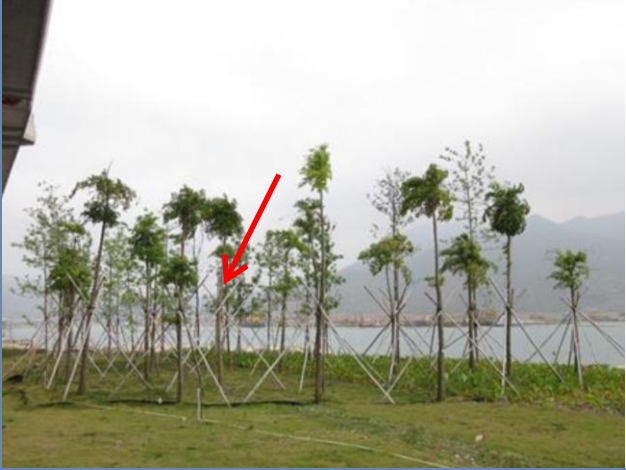
TG48: 18 <i>Grevillea banksii</i> (GB) are found on site. To be replaced by 18 <i>Plumeria rubra</i> (PR).		TG49: 1 <i>Grevillea robusta</i> is found dead, replacement is necessary.

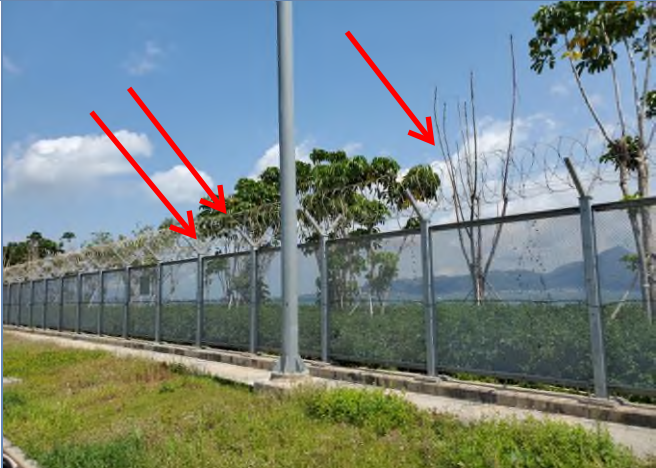
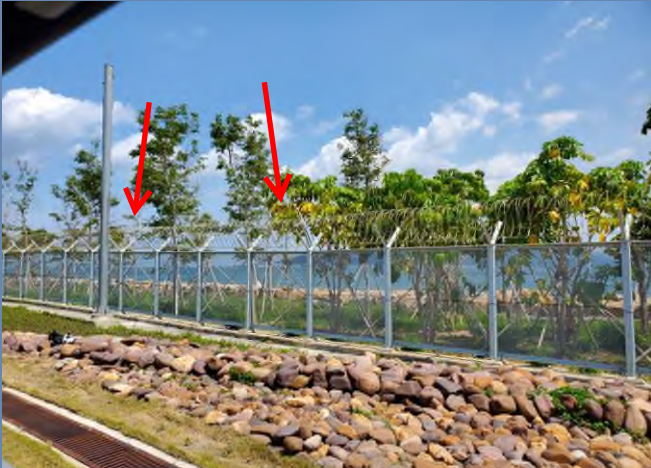
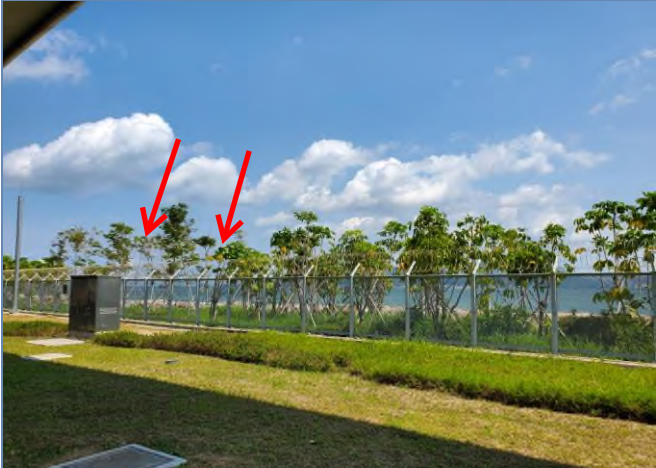
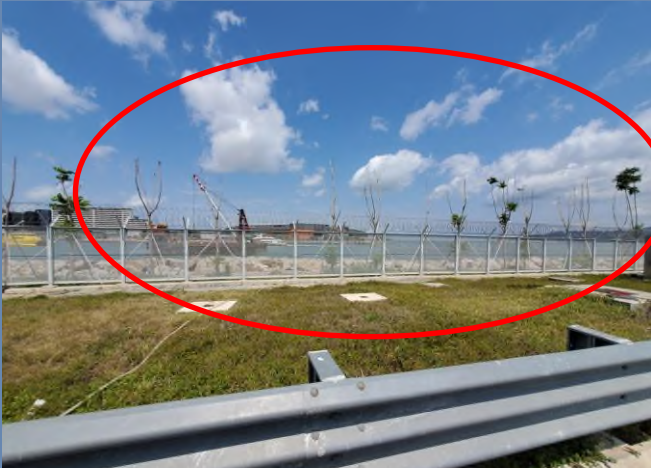
TG05: 3 <i>Bauhinia variegata</i> (BV) are found dead, replacements are necessary.	
TG06: 1 <i>Bauhinia variegata</i> and 1 <i>Cassia siamea</i> (CS) are found dead, replacements are necessary.	
TG07: 2 <i>Cassia siamea</i> (CS) are found dead, replacements are necessary.	
TG12: 14 <i>Heteropanax fragrans</i> (HF) are found dead, replacements are necessary. 1 HF is found missing

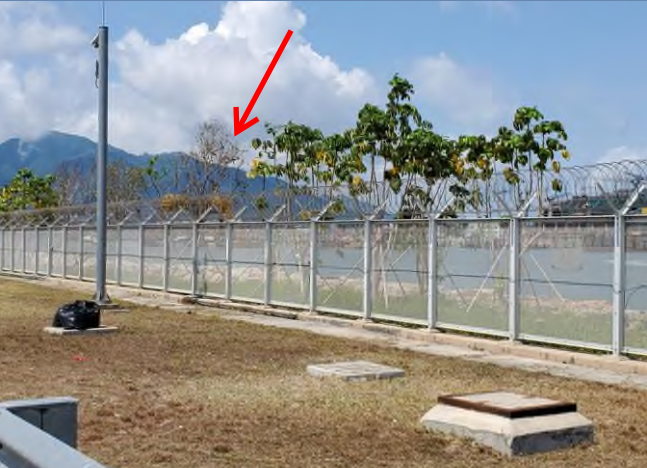
<p>TG13: 1 <i>Bauhinia variegata</i> is found dead, replacement is necessary.</p>

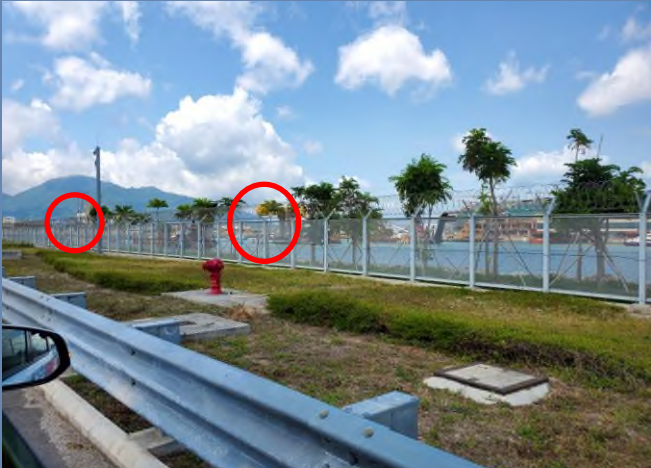
<p>TG15: 10 <i>Heteropanax fragrans</i> are found dead, replacements are necessary.</p>

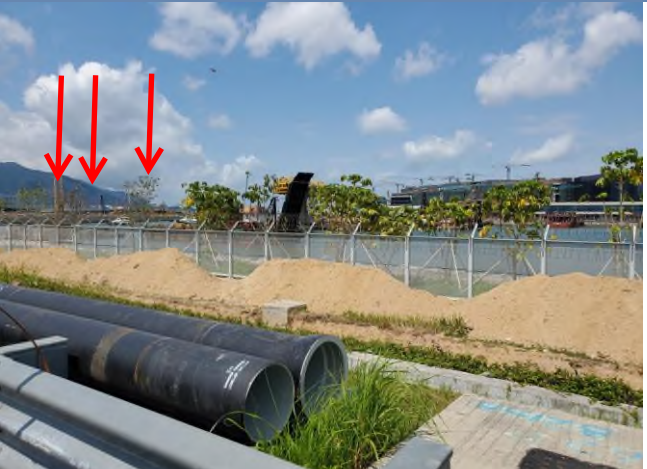
<p>TG16: 3 <i>Bauhinia variegata</i> are found dead, replacements are necessary.</p>

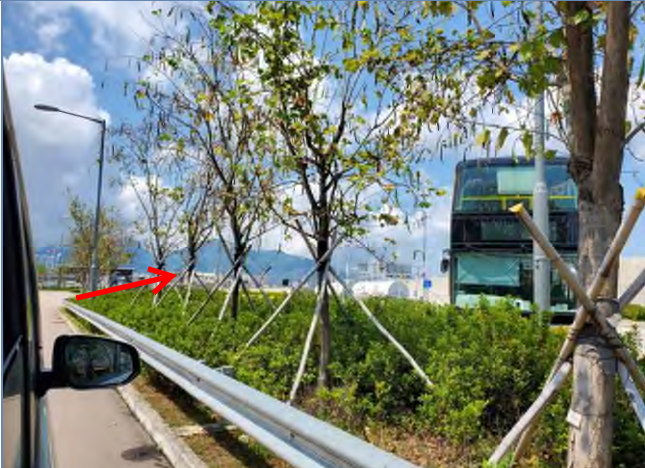
TG42: 1 <i>Bauhinia variegata</i> is found dead, replacement is necessary.
