Contract No. HY/2019/01
Hong Kong-Zhuhai-Macao Bridge Hong Kong Boundary Crossing Facilities –
Phase 2 and Other Works
Establishment Inspection Checklist

Establishment Inspection Checklist

Date of Site Audit:	2022-06-20	Time of Site Audit:	9:45-11:30
Site Auditor:	Aloysius Wong	Humidity:	73%
Weather Condition:	Overcast	Temperature:	30.1°C

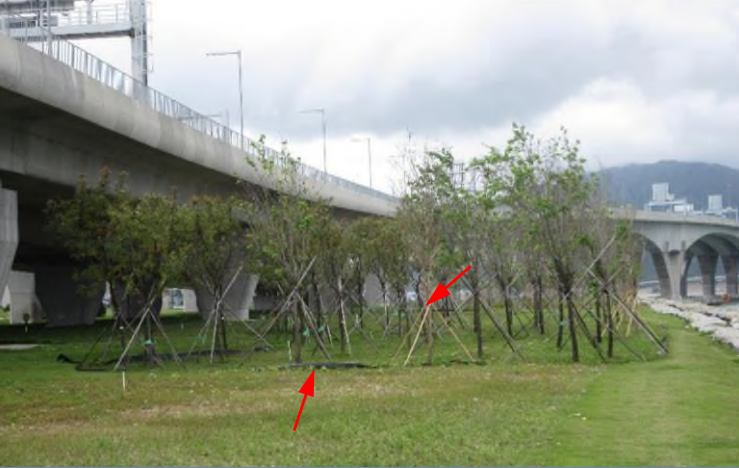
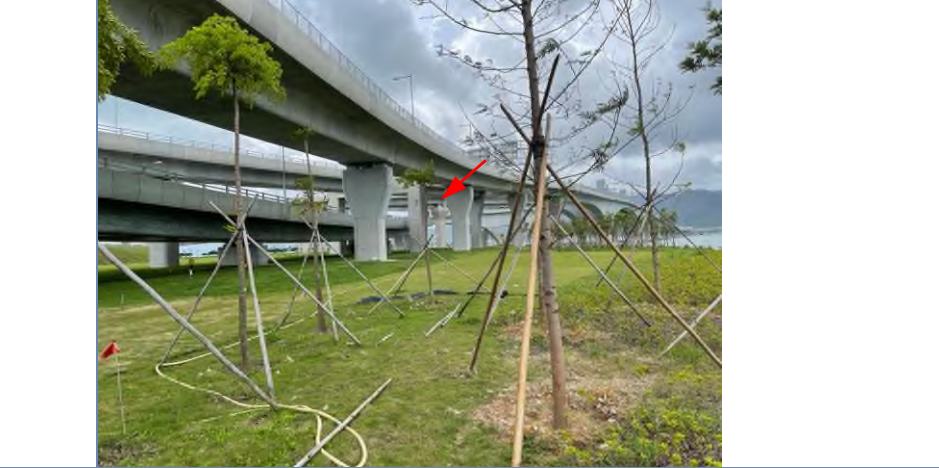
<p>TG46: 2 dead <i>Grevillea banksii</i> (GB) removed, pending replacement.</p>	<p>TG47: 1 previous missing GR replaced with wrong species, further replacement required.</p>

- TG46: 2 dead *Grevillea banksii* (GB) removed, pending replacement; and 4 dead *Bauhinia variegata* (BV) replaced.
- TG47: 20 dead *Grevillea robusta* (GR) replaced; 1 previous missing GR replaced with wrong species, further replacement required.
- TG48: 18 *Grevillea banksii* (GB) are found on site. To be replaced by 18 *Plumeria rubra* (PR).
- TG49: 1 dead *Grevillea robusta* (GR) replaced.

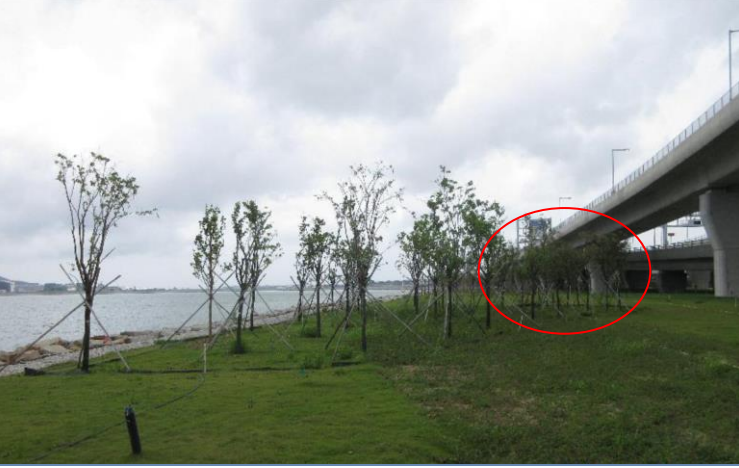
<p>TG48: 18 <i>Grevillea banksii</i> (GB) are found on site. To be replaced by 18 <i>Plumeria rubra</i> (PR).</p>

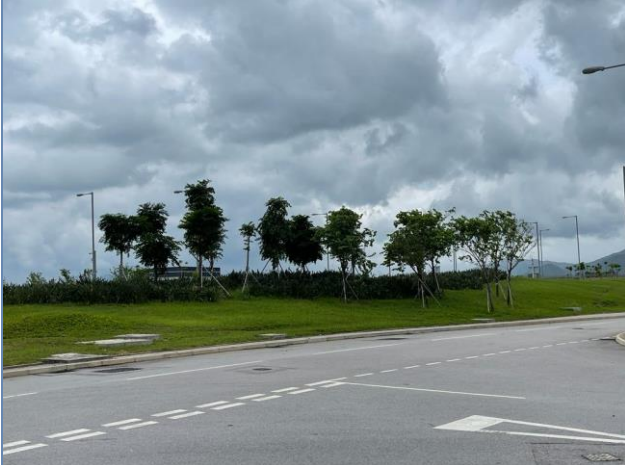
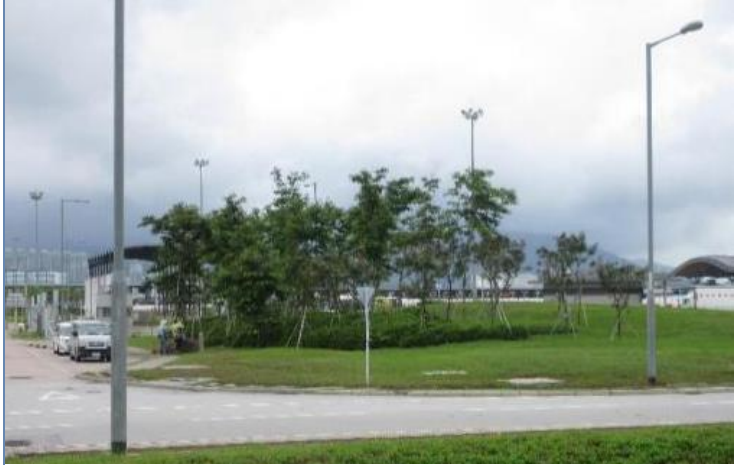
TG20: 2 <i>Heteropanax fragrans</i> (HF) are found missing.		TG22: 2 <i>Grevillea banksia</i> (GB) are found missing.
Portion D

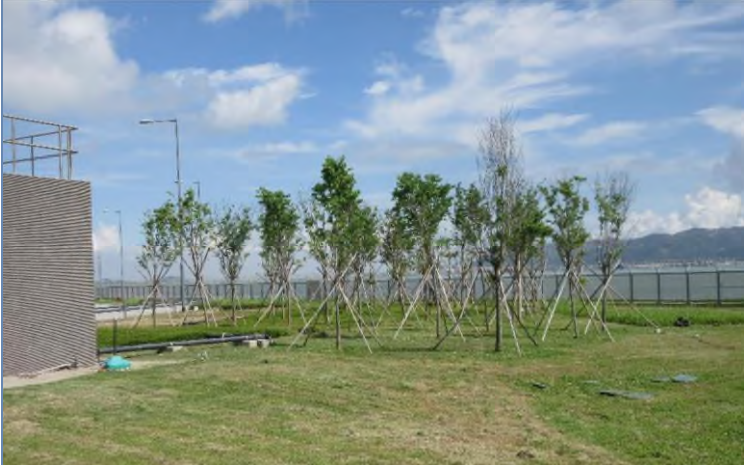
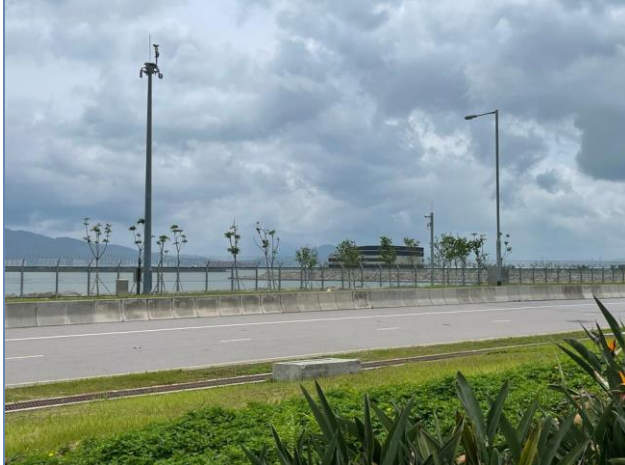
TG02: 1 <i>Heteropanax fragrans</i> (HF) is found missing.		TG03: 3 <i>Bauhinia variegata</i> (BV) and 9 <i>Heteropanax fragrans</i> (HF) are found missing.

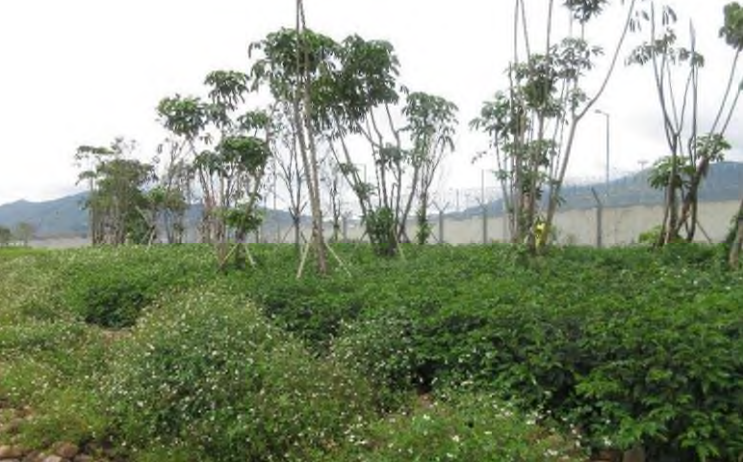
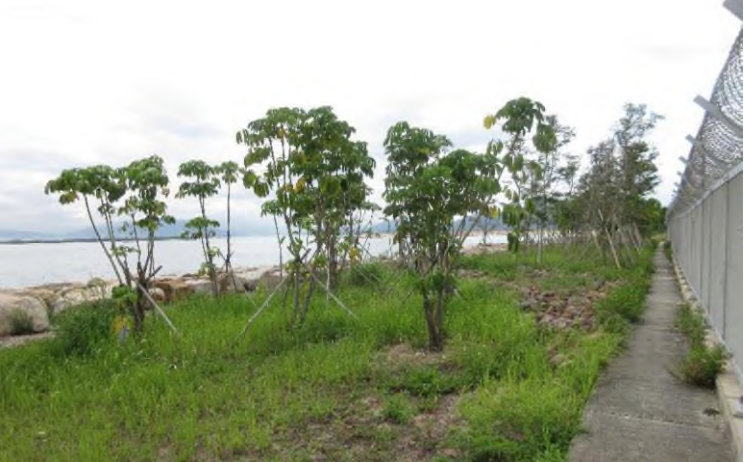
<p>TG05: 3 <i>Brassaia actinophylla</i> (BA) and 4 <i>Bauhinia variegata</i> (BV) are found missing.</p>	<p>TG06: 1 <i>Brassaia actinophylla</i> (BA) and 1 <i>Cassia siamea</i> (CS) are found missing.</p>

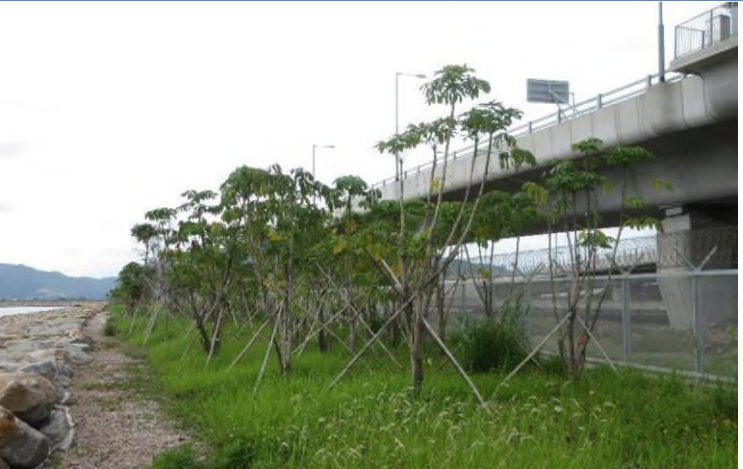
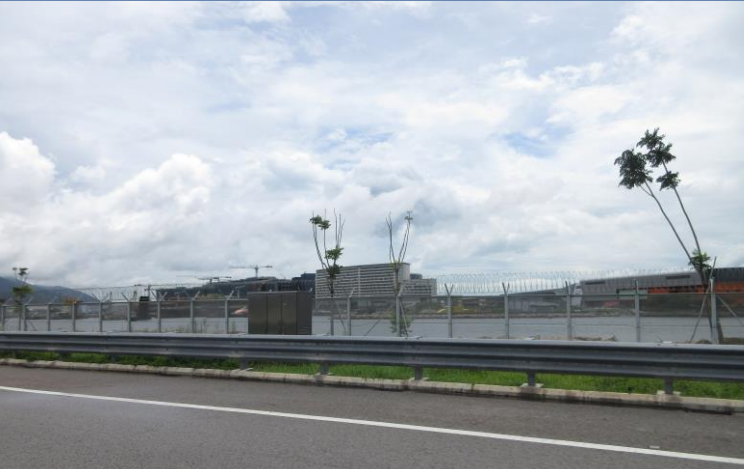
<p>TG07: 1 <i>Brassaia actinophylla</i> (BA) and 2 <i>Cassia siamea</i> (CS) are found missing.</p>	<p>TG12: 16 <i>Heteropanax fragrans</i> (HF) are found missing.</p>

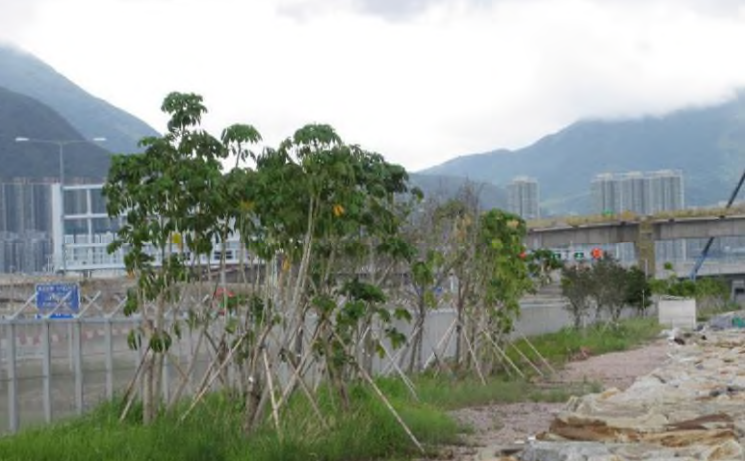
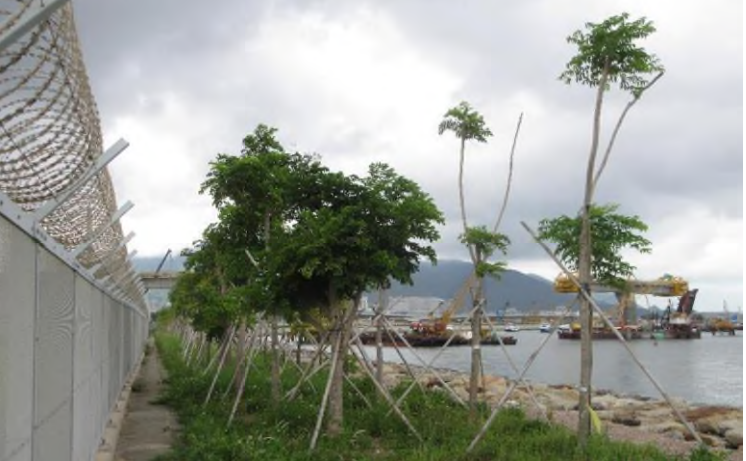
<p>TG13: 1 <i>Bauhinia variegata</i> (BV) is found missing.</p>	<p>TG15: 10 <i>Heteropanax fragrans</i> (HF) are found missing.</p>

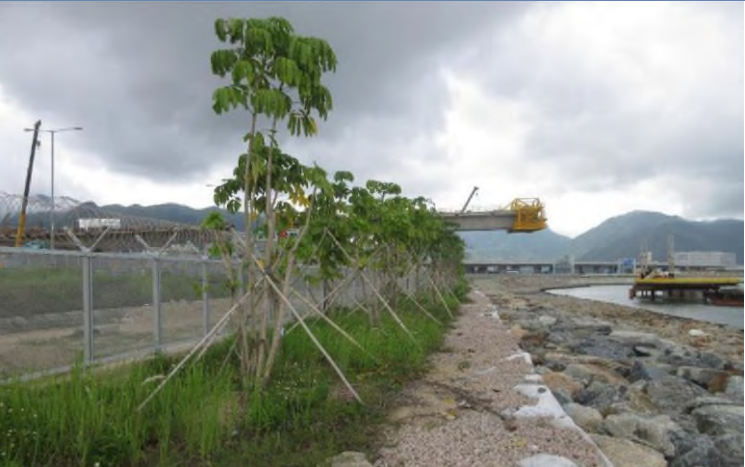
<p>TG16: 4 <i>Bauhinia variegata</i> (BV) are found missing.</p>

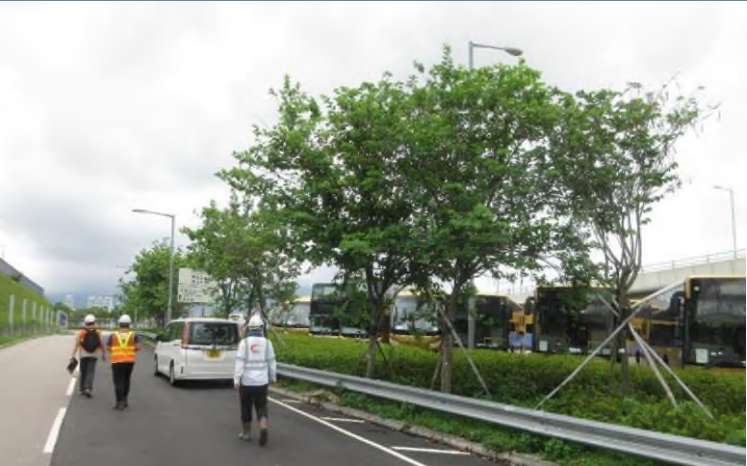
TG42: 4 <i>Bauhinia variegata</i> (BV) are found missing.
