Contract No. HY/2019/01

Hong Kong-Zhuhai-Macao Bridge Hong Kong Boundary Crossing Facilities –

Phase 2 and Other Works

Establishment Inspection Checklist

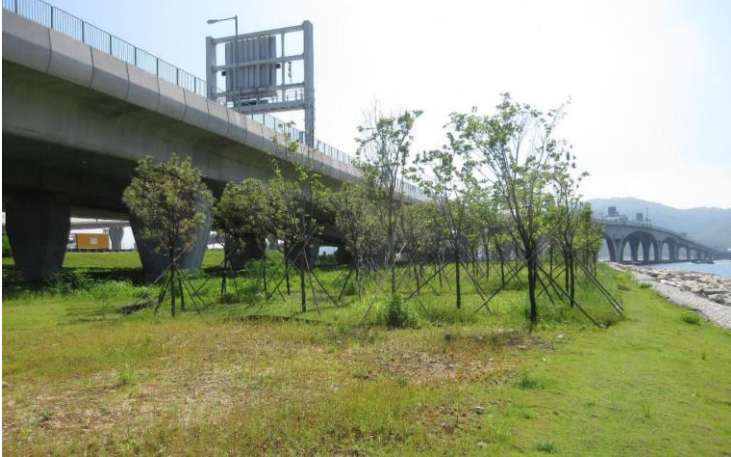
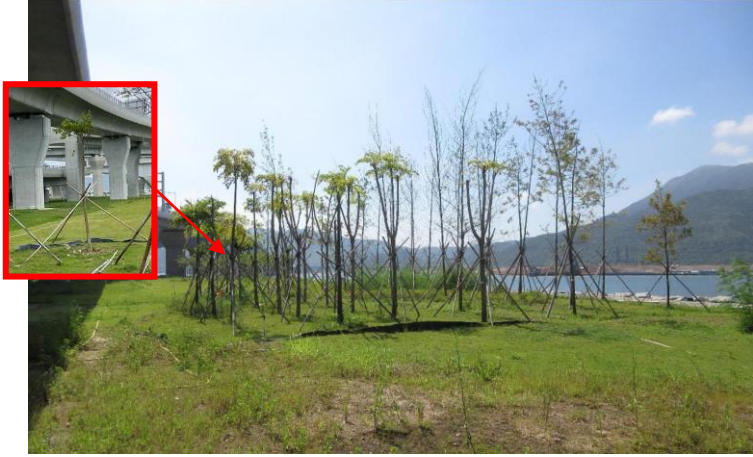
<p>Portion A-1</p>	<p>TG46: 2 <i>Grevillea banksii</i> (GB) are found missing.</p>	<p>TG47: 1 previous missing GR replaced with wrong species, further replacement required.</p>

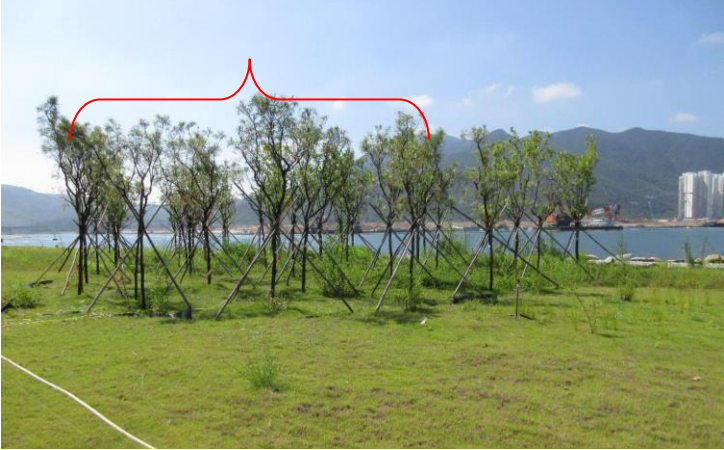
<p>TG48: 18 <i>Grevillea banksii</i> (GB) are found on site. To be replaced by 18 <i>Plumeria rubra</i> (PR).</p>

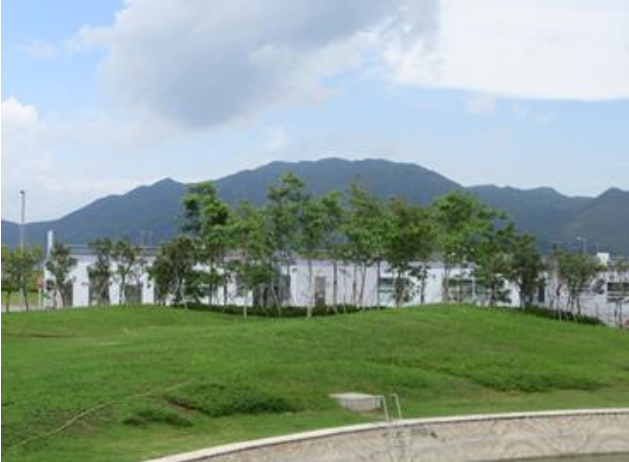
<p>TG22: 3 <i>Grevillea banksii</i> (GB) are found missing.</p>	
<p>Portion D</p>

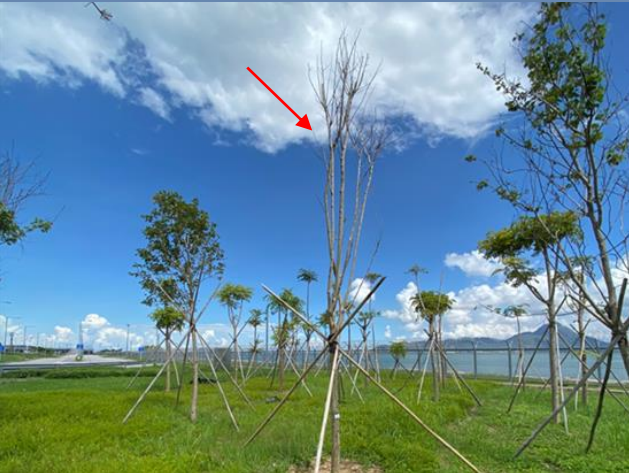
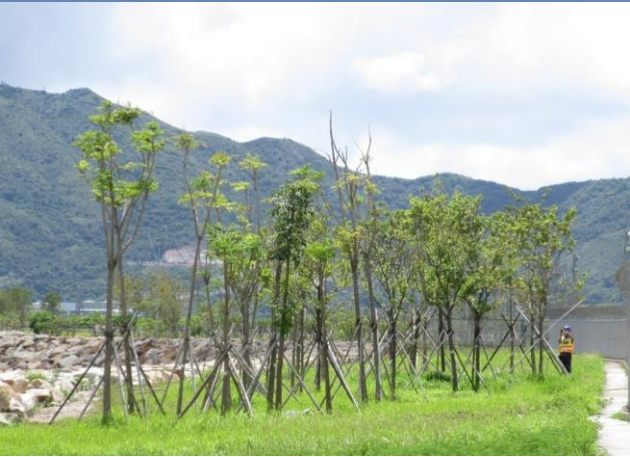
<p>TG02: 1 <i>Bauhinia variegata</i> (BV) is found dead.</p>	
<p>TG03: 3 <i>Bauhinia variegata</i> (BV) are found missing.</p>

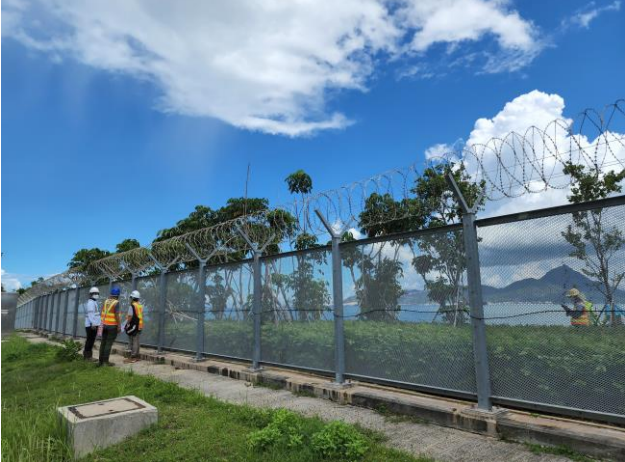
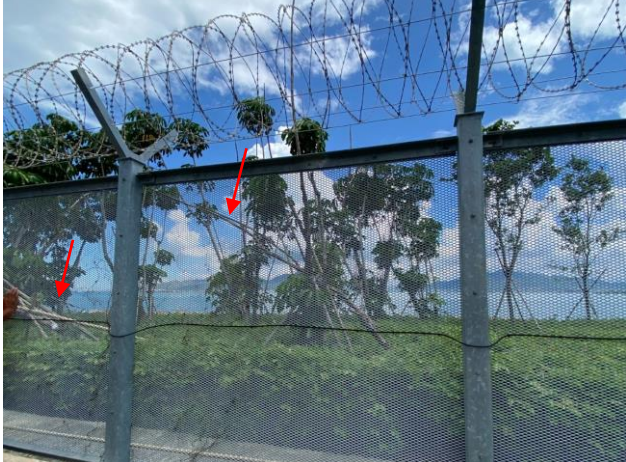
<p>TG05: 4 <i>Bauhinia variegata</i> (BV) are found missing.</p>	<p>(Remarks) TG05: 2 BA are found leaning after Typhoon Mulan approached on 10 Aug 2022.</p>

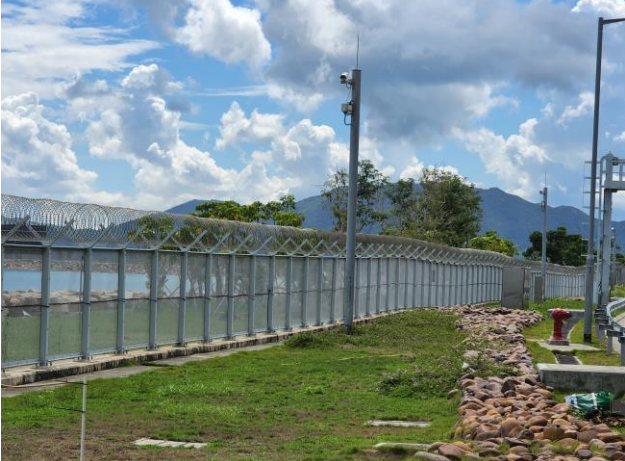
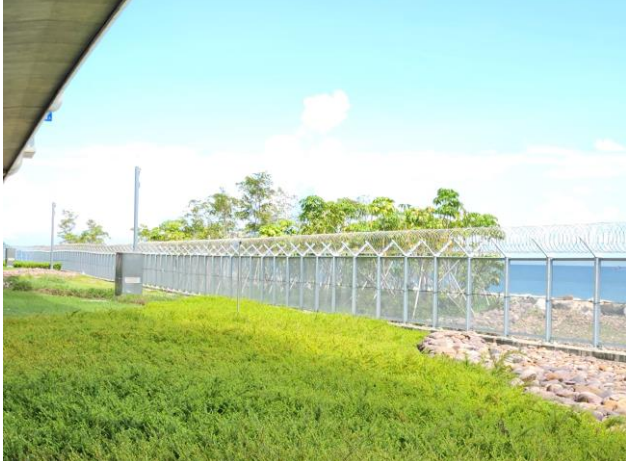
<p>TG06: 1 <i>Cassia siamea</i> (CS) are found missing.</p>	<p>TG07: 2 <i>Cassia siamea</i> (CS) are found missing.</p>
