Bi-Monthly Landscape and Visual Audit Checklist

Contract No. HY/2019/01

Hong Kong-Zhuhai-Macao Bridge Hong Kong Boundary Crossing Facilities –
Phase 2 and Other Works

Establishment Inspection Checklist

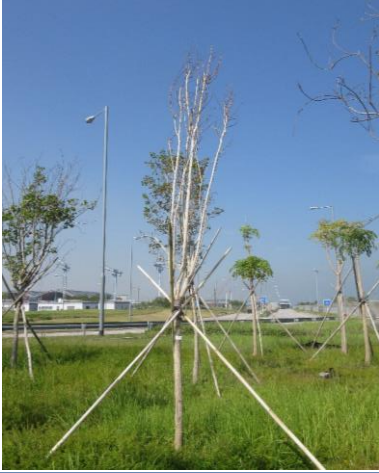
- TG02: 1 *Bauhinia variegata* (BV) is found dead.
- TG03: 3 *Bauhinia variegata* (BV) 1 *Heteropanax fragrans* (HF) previously missing have been replanted.

TG02: 1 <i>Bauhinia variegata</i> (BV) is found dead.		
Portion H

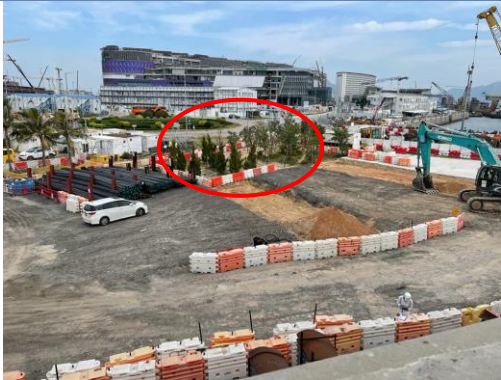
- TG17: 10 *Grevillea banksii* (GB) and 9 *Juniperus chinensis* (JC) are found transplanted by AAHK's contractor without permission from HyD.

TG17: 10 <i>Grevillea banksii</i> (GB) and 9 <i>Juniperus chinensis</i> (JC) are found transplanted by AAHK's contractor without permission from HyD.

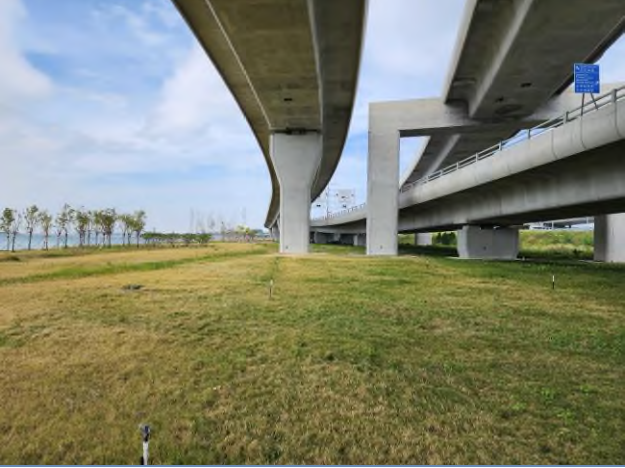
<p>A wide-angle photograph showing a large area of groundcover planting under a concrete bridge structure. The ground is covered with a mix of green and yellowish-brown grasses. In the background, there are concrete bridge pillars and a blue sky with light clouds. A small blue sign is visible on the right side of the bridge structure.</p>
	Groundcover planting in Portion A-1
Portion A-2

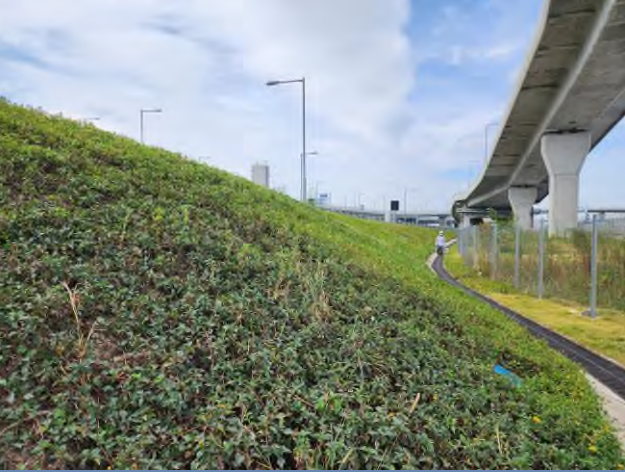
<p>A photograph showing a grassy slope next to a concrete bridge structure. The slope is covered with dense green grass. A paved path runs along the base of the slope. In the background, there are concrete bridge pillars and a blue sky with light clouds.</p>
	Grass Planting in Portion A-2
Portion A-3

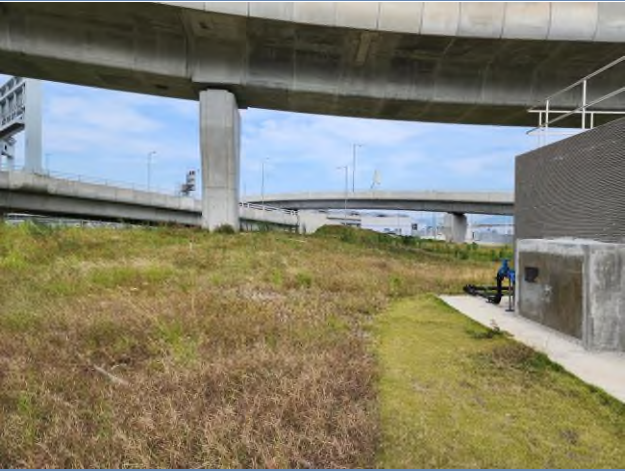
Grass Planting in Portion A-3

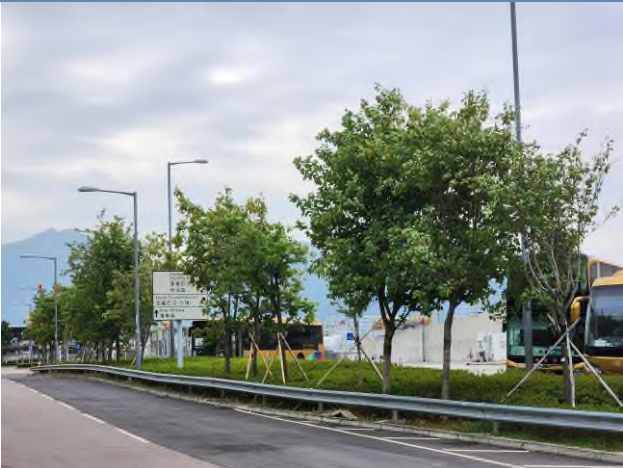
<p data-bbox="804 779 1082 808">Tree planting in Portion E</p>
Portion F

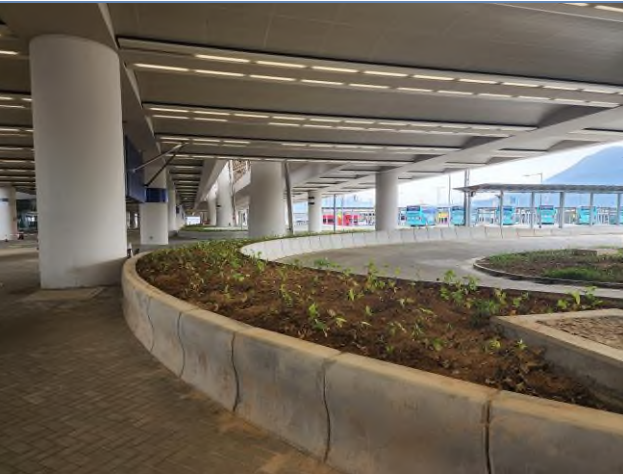
<p data-bbox="804 1301 1082 1330">Shrub planting at Portion F</p>
Portion G

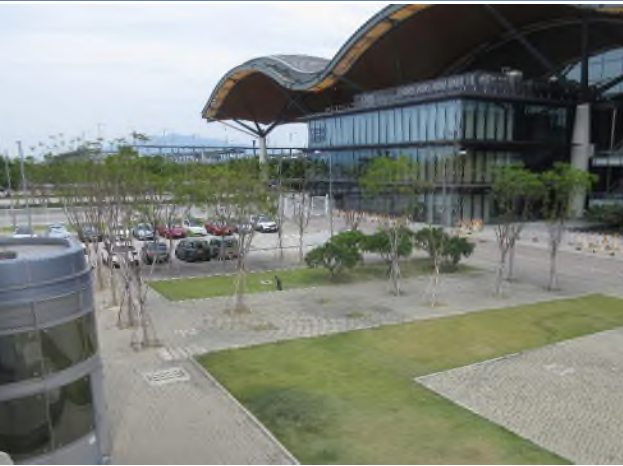
<p data-bbox="804 1818 1082 1848">Tree planting in Portion G</p>

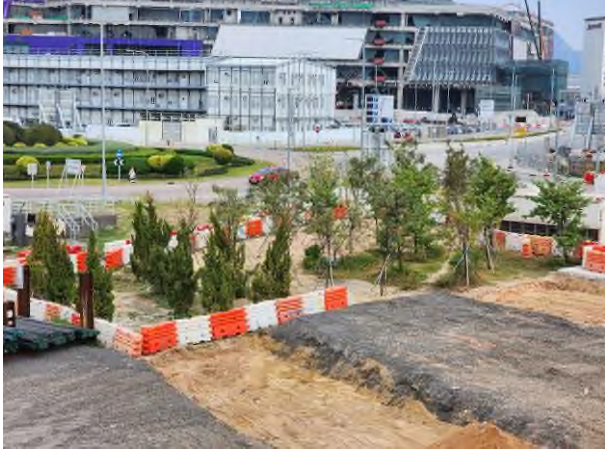
<p data-bbox="799 779 1086 815">Tree planting in Portion H.</p>

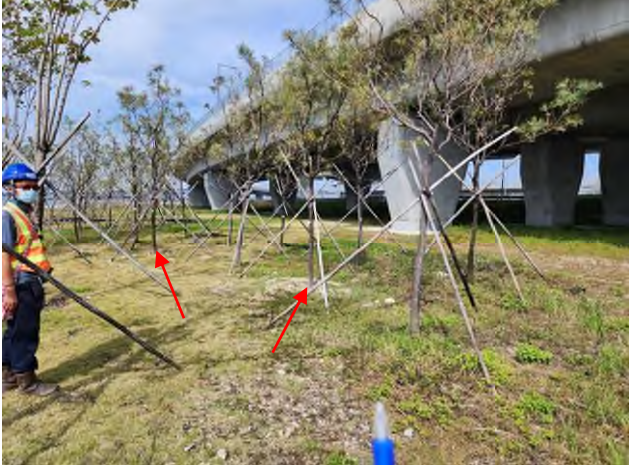
<p>TG46: 2 <i>Grevillea banksii</i> (GB) previously missing have been replanted.</p>
<p>Portion A-1</p>

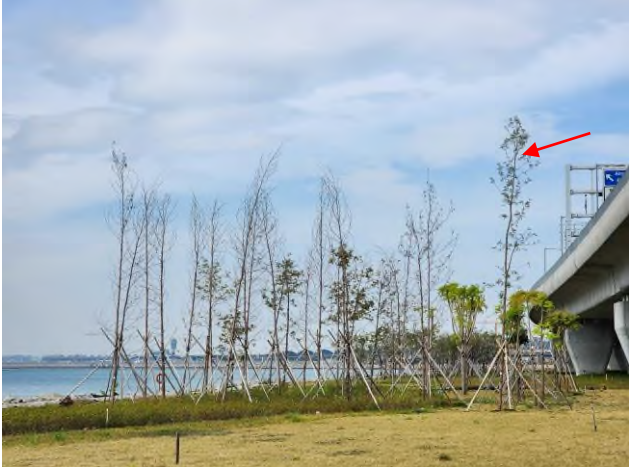
<p>G47: 1 <i>Grevillea robusta</i> (GR) previous planted with wrong species has been rectified.</p>

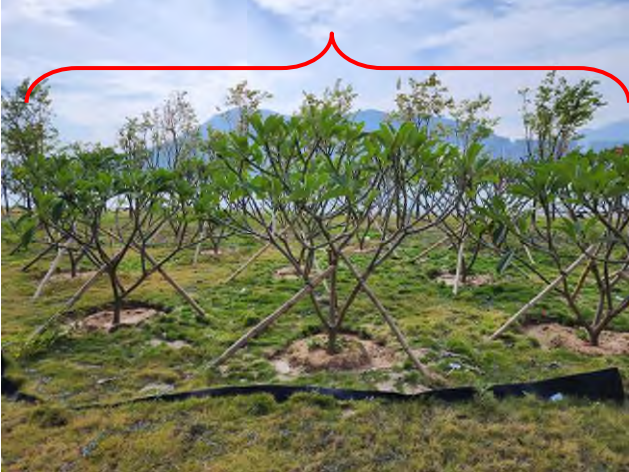
<p>TG48: 18 <i>Plumeria rubra</i> (PR) previous planted with 18 <i>Grevillea banksii</i> (GB) has been rectified.</p>

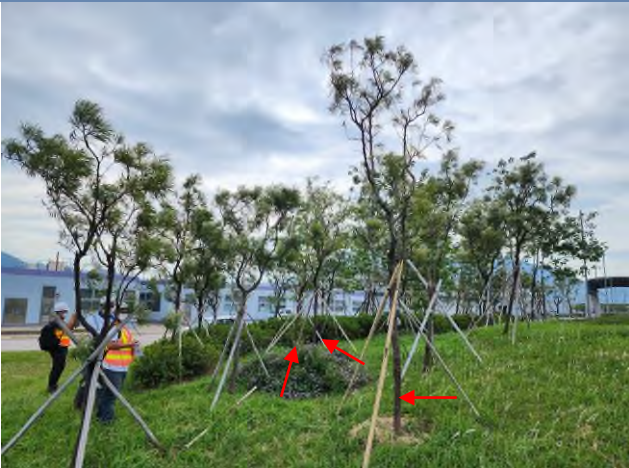
Portion C	TG22: 3 <i>Grevillea banksii</i> (GB) previously missing have been replanted.

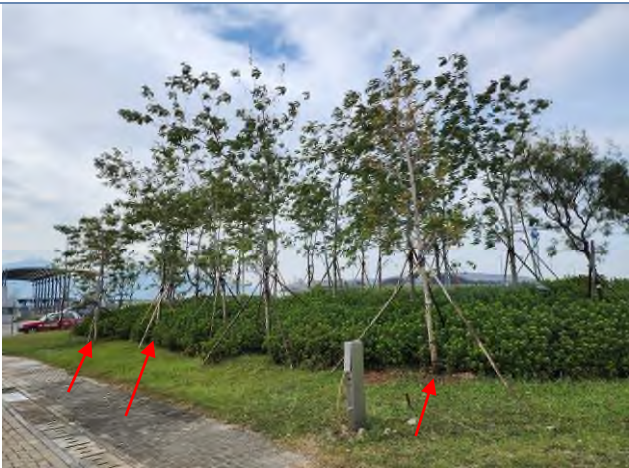
Portion C	TG22: 3 <i>Grevillea banksii</i> (GB) in poor condition have been replaced.
Portion D

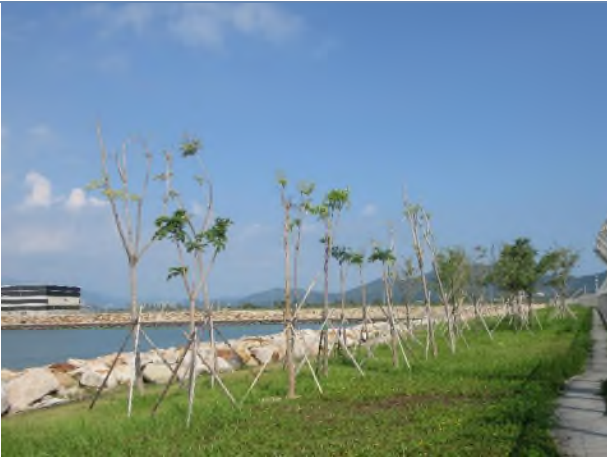
TG03: 3 <i>Bauhinia variegata</i> (BV) 1 <i>Heteropanax fragrans</i> (HF) previously missing have been replanted.

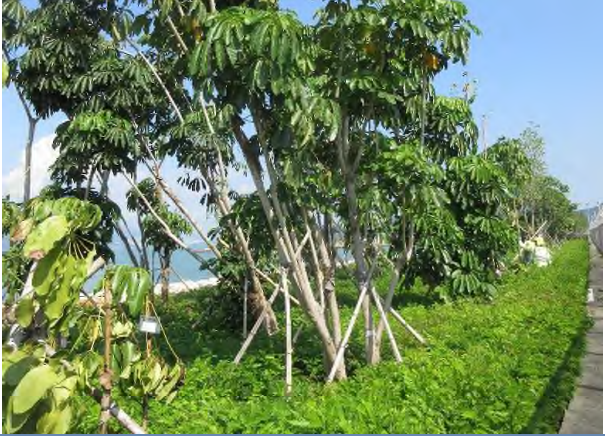
<p>TG05: 4 <i>Bauhinia variegata</i> (BV) and 3 <i>Brassaia actinophylla</i> (BA) previously missing have been replanted.</p>
<p>Portion D</p>

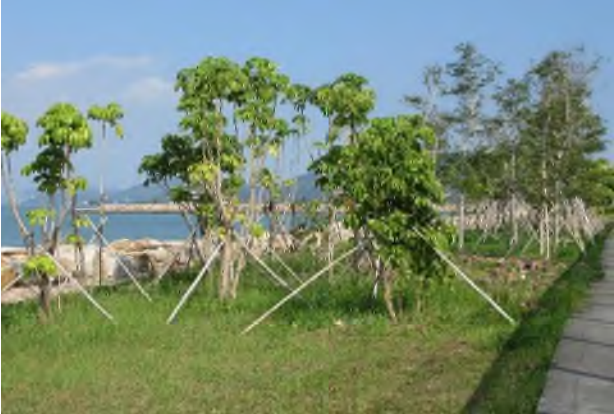
<p>TG06: 2 <i>Cassia siamea</i> (CS) previously missing have been replanted.</p>
<p>Portion D</p>

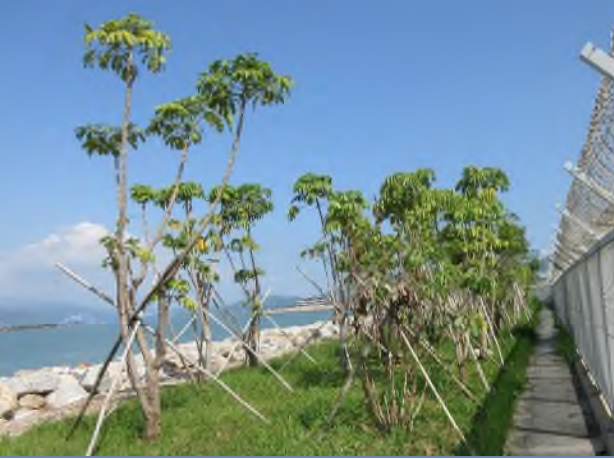
<p>TG07: 3 <i>Cassia siamea</i> (CS) and 2 <i>Brassaia actinophylla</i> (BA) previously missing have been replanted.</p>

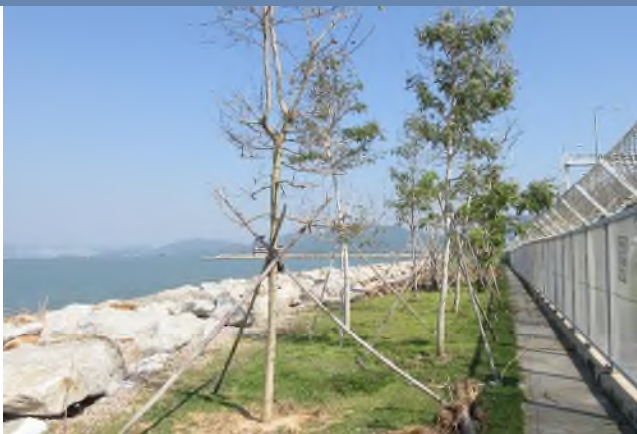
<p>TG08: 1 <i>Cassia siamea</i> (CS) in poor condition have been replaced.</p>	
<p>Portion D</p>

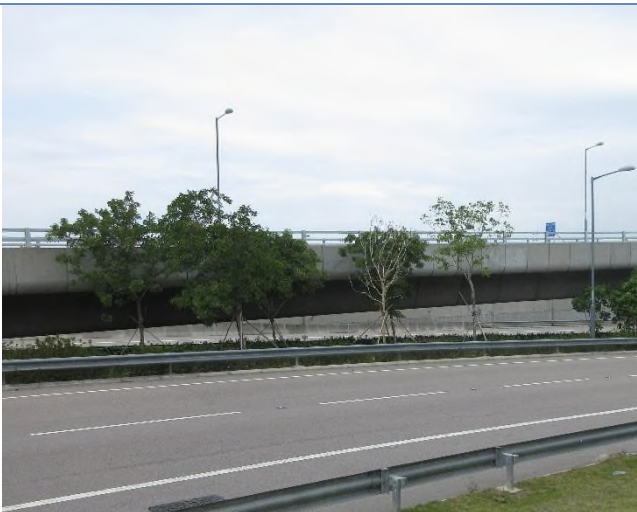
<p>TG10: 1 <i>Albizia lebbbeck</i> (AL) in poor condition have been replaced.</p>	
<p>Portion D</p>

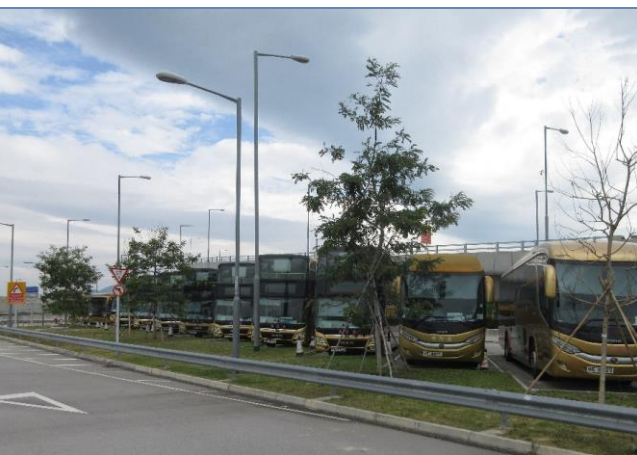
<p>TG11: 2 <i>Cassia siamea</i> (CS) in poor condition have been replaced.</p>

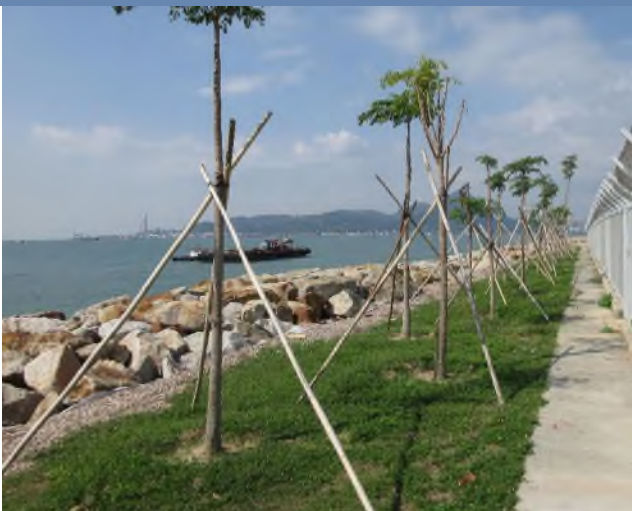
TG12: 16 <i>Heteropanax fragrans</i> (HF) previously found missing have been replanted. 2 <i>Heteropanax fragrans</i> (HF) in poor condition have been replaced.
Portion D

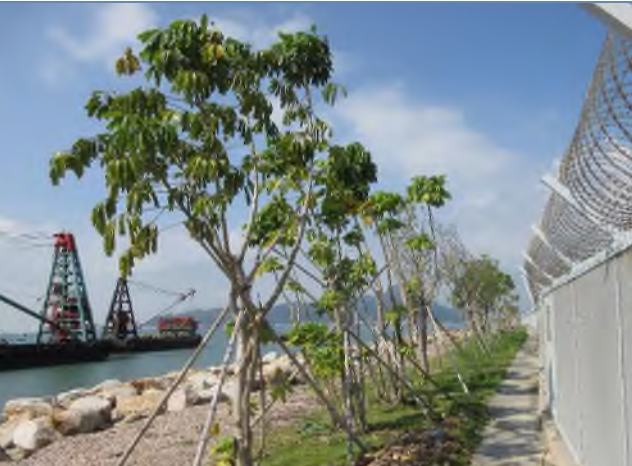
TG13: 1 <i>Bauhinia variegata</i> (BV) previously found missing has been replanted.
Portion D

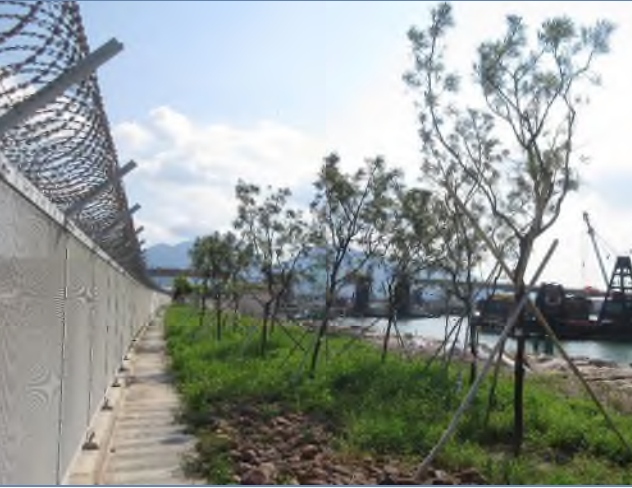
TG14: 2 <i>Grevillea banksii</i> (GB) in poor condition have been replaced.

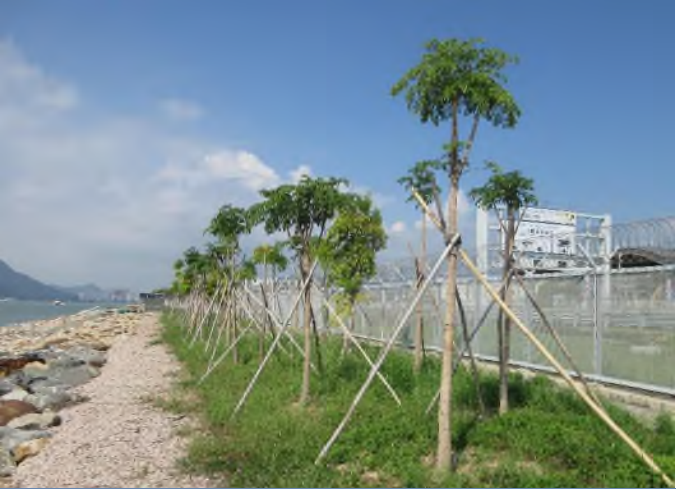
<p>TG15: 10 <i>Heteropanax fragrans</i> (HF) previously found missing have been replanted. 7 <i>Heteropanax fragrans</i> (HF) in poor condition have been replaced.</p>	
<p>Portion D</p>

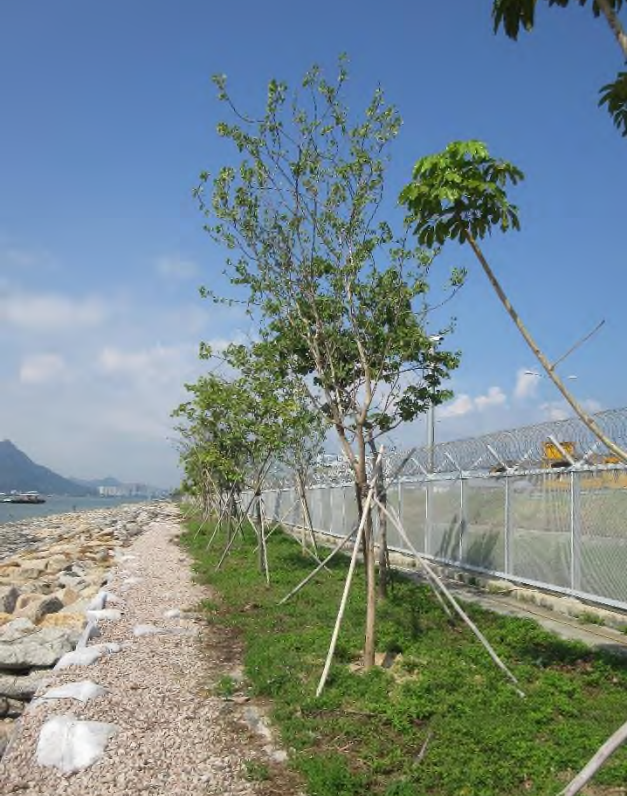
<p>TG16: 4 <i>Bauhinia variegata</i> (BV) previously found missing have been replanted.</p>
