Bi-Monthly Landscape and Visual Audit Checklist

Contract No. HY/2019/01

Hong Kong-Zhuhai-Macao Bridge Hong Kong Boundary Crossing Facilities –  
Phase 2 and Other Works

Establishment Inspection Checklist

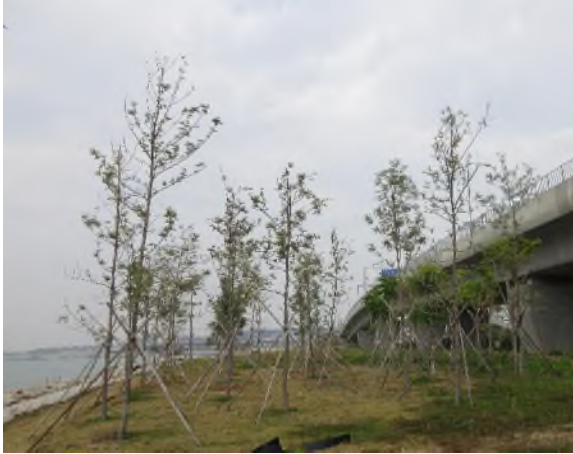
- TG45: 5 *Grevillea banksii* (GB) are proposed to be replaced due to poor conditions.
- TG47: 22 *Grevillea robusta* (GR) are proposed to be replaced due to poor conditions.
- TG49: 1 *Grevillea banksii* (GB) is proposed to be replaced due to poor conditions.

<p>TG45: 5 <i>Grevillea banksii</i> (GB) are replaced.</p>

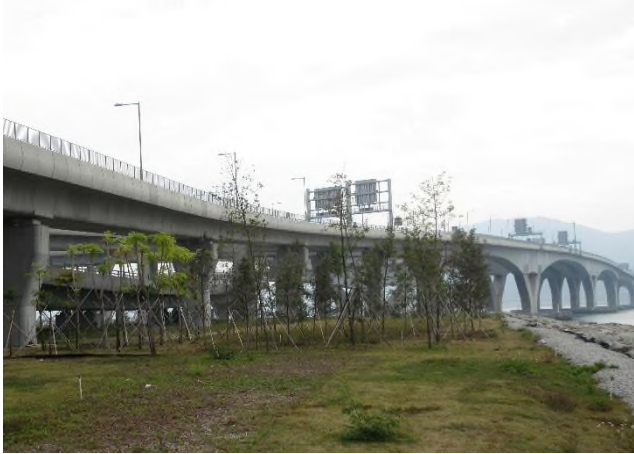
<p>TG47: 22 <i>Grevillea robusta</i> (GR) are replaced.</p>

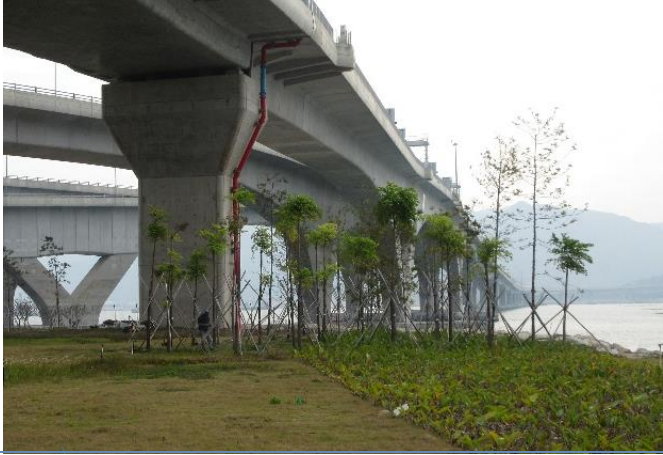
<p>TG49: 1 <i>Grevillea banksii</i> (GB) are replaced.</p>

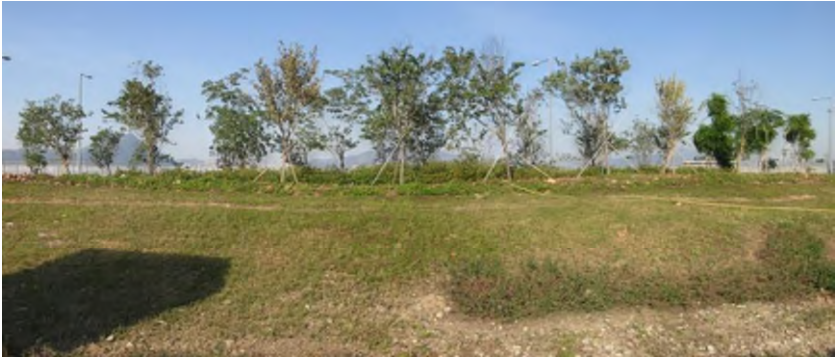
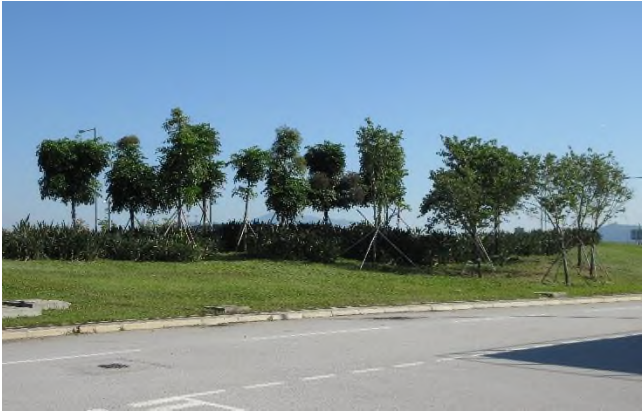
- TG19: 2 *Bauhinia variegata* (BV) are proposed to be replaced due to poor conditions.
- TG20: 1 *Heteropanax fragrans* (HF) is proposed to be replaced due to poor conditions.
- TG21: 1 *Bauhinia variegata* (BV), 6 *Heteropanax fragrans* (HF) are proposed to be replaced due to poor conditions.

TG19: 2 <i>Bauhinia variegata</i> (BV) are replaced.	TG20: 1 <i>Heteropanax fragrans</i> (HF) is replaced.

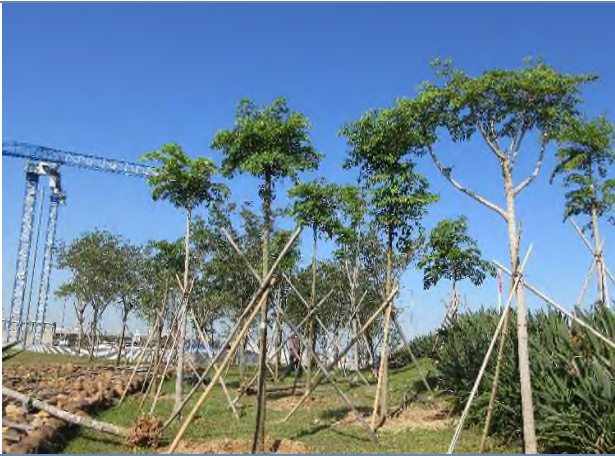
TG21: 1 <i>Bauhinia variegata</i> (BV), 6 <i>Heteropanax fragrans</i> (HF) are replaced.

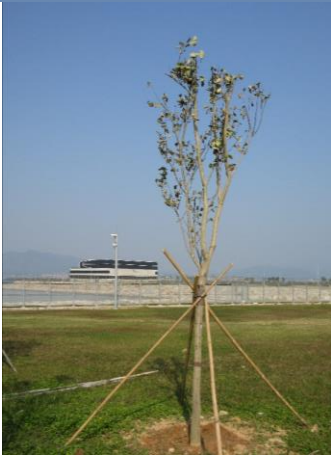
- TG02: 1 *Bauhinia variegata* (BV) is found dead.

TG02: 1 <i>Bauhinia variegata</i> (BV) is replaced.		
Portion G

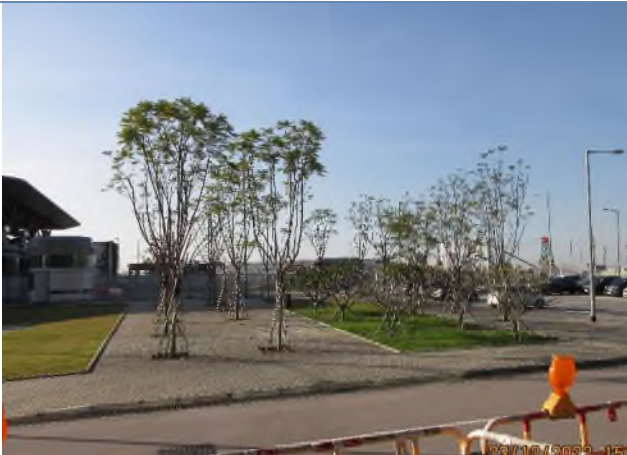
- TG38: 2 *Jacaranda acutifolia* (JA) are proposed to be replaced due to poor conditions.

TG38: 2 <i>Jacaranda acutifolia</i> (JA) are replaced.
