**Contract No. HY/2011/03 -  
Hong Kong- Zhuhai- Macao Bridge  
Hong Kong Link Road Section between Scenic Hill and Hong Kong Boundary Crossing Facilities  
Notifications of Environmental Quality Limits Exceedances**

Notification No.: 258s ver 1

**Date of Notification:** 8 December 2017

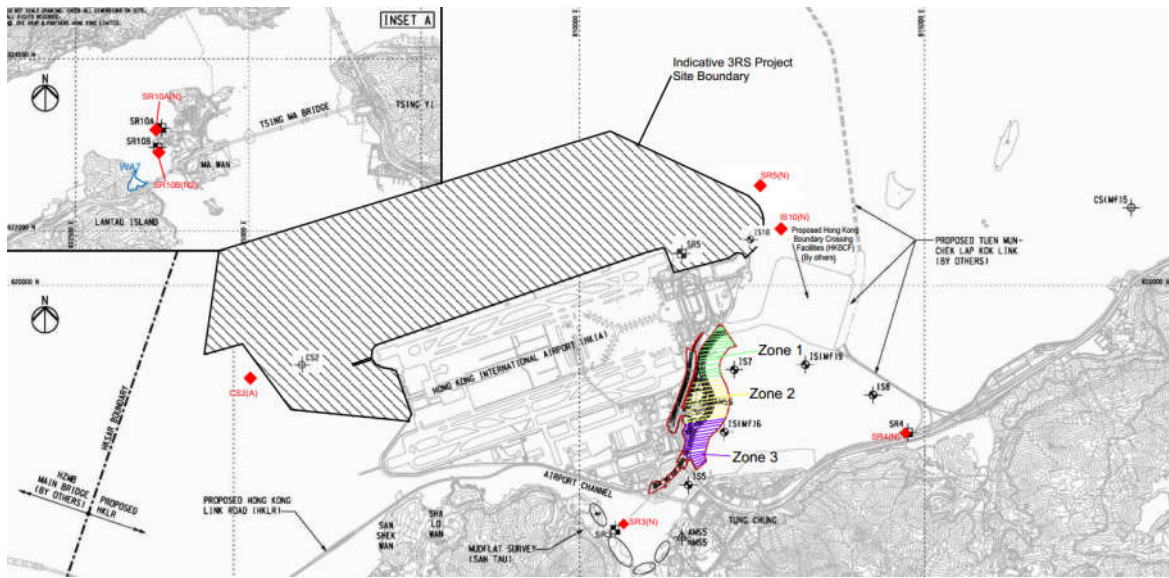
**Location Plan:**

On 4 December 2017, a Limit Level exceedance of suspended solid was recorded at station SR5(N) during mid-flood tide, and an Action Level exceedance of suspended solid was recorded at station IS10(N) during mid-flood tide. The exceedances have been investigated and are considered unlikely to be related to the contract works due to the following reasons:

The measured value for mid-flood tide at stations SR5(N) and IS10(N) was above the range of suspended solid for mid-flood tide during baseline monitoring.

3. During sampling exercise, water was observed moderate at station SR5(N) and turbid at station IS10(N). There was no marine transportation near stations SR5(N) and IS10(N) during sampling period and no marine works were conducted near monitoring stations SR5(N) and IS10(N) which are located outside the site boundary of HKLR03 Contract. No abnormality or malpractice for the contract works was observed during the sampling exercise.
4. There were no specific activities recorded during the monitoring period that would cause any significant impacts on the monitoring results. As such, the exceedances of suspended solid level are considered to be attributed to other external factors such as sea condition, rather than the contract works.

As the suspended solid level recorded beyond the water quality criteria were not related to the contract works, no immediate actions are considered necessary. However, the Contractor is reminded to ensure that the silt curtain is fully maintained throughout the construction works and construction works are carried out under stringent supervision to prevent any water quality impacts to the seawater.

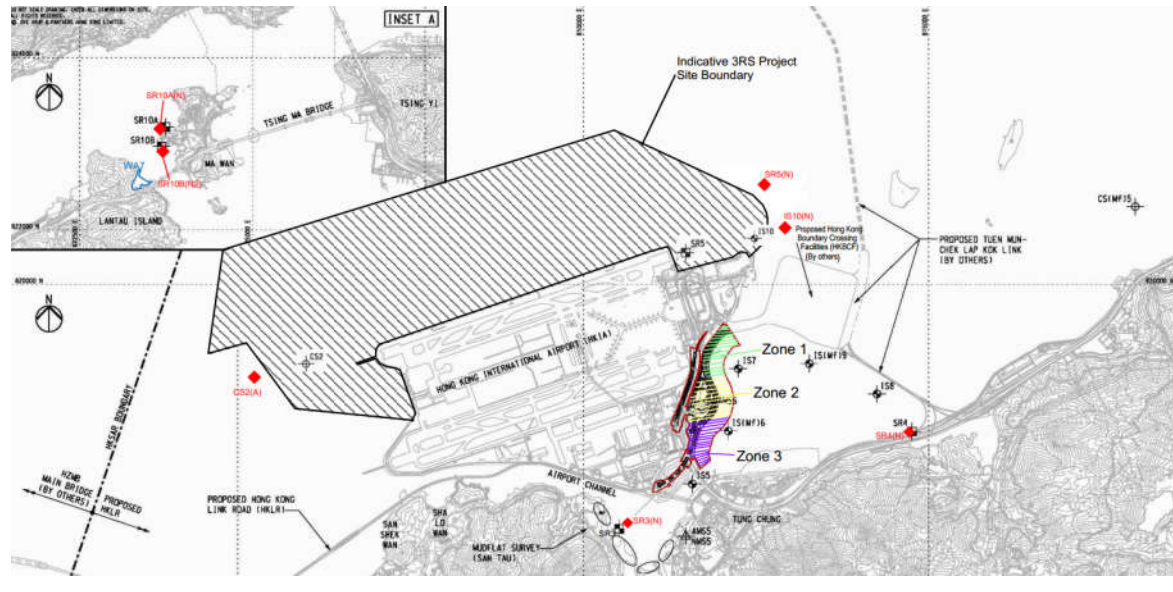
**Location Plan:**

On 8 December 2017, an Action Level exceedance of suspended solid was recorded at station IS8 during mid-flood tide. The exceedance has been investigated and is considered unlikely to be related to the contract works due to the following reasons:

The measured value for mid-flood tide at station IS8 was within the range of suspended solid for mid-flood tide during baseline monitoring.

3. During sampling exercise, water was observed moderate at station IS8. There was no marine transportation near station IS8 during sampling period and no marine works were conducted near station IS8 which is located outside the site boundary of HKLR03 Contract. No abnormality or malpractice for the contract works was observed during the sampling exercise.
4. There were no specific activities recorded during the monitoring period that would cause any significant impacts on the monitoring results. As such, the exceedance of suspended solid level is considered to be attributed to other external factors such as sea condition, rather than the contract works.

As the suspended solid level recorded beyond the water quality criteria was not related to the contract works, no immediate actions are considered necessary. However, the Contractor is reminded to ensure that the silt curtain is fully maintained throughout the construction works and construction works are carried out under stringent supervision to prevent any water quality impacts to the seawater.

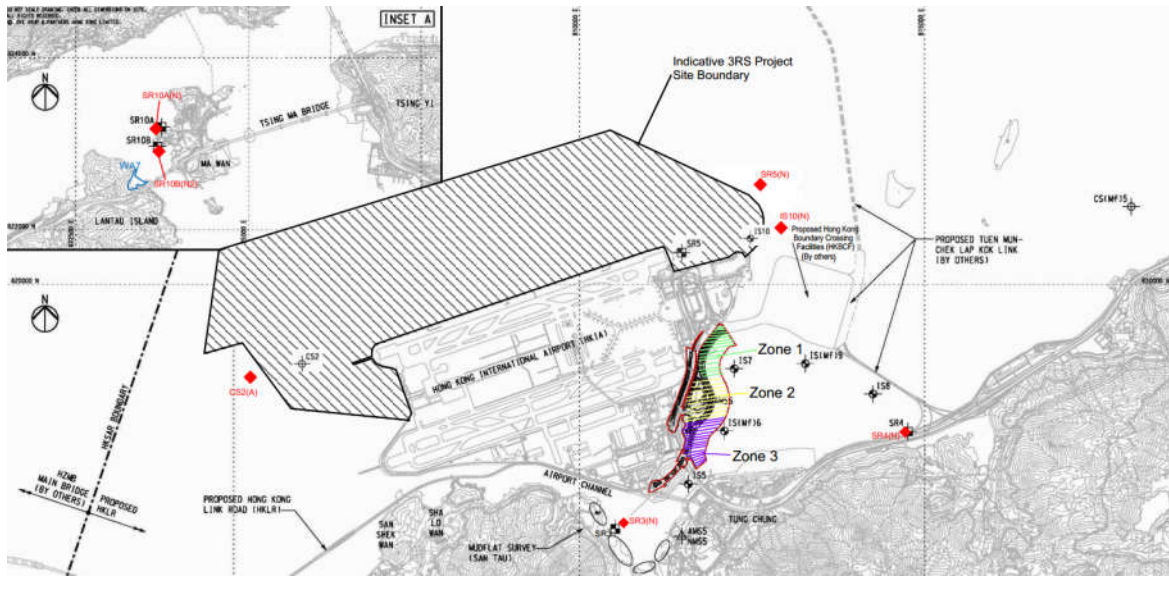
**Location Plan:**

On 13 December 2017, an Action Level exceedance of suspended solid was recorded at station IS(Mf)9 during mid-flood tide. The exceedance has been investigated and is considered unlikely to be related to the contract works due to the following reasons:

The measured value for mid-flood tide at station IS(Mf)9 was slightly above the range of suspended solid for mid-flood tide during baseline monitoring.

3. During sampling exercise, water was observed moderate at station IS(Mf)9. There was no marine transportation near station IS(Mf)9 and no marine works were conducted near monitoring station IS8 which is located outside the site boundary of HKLR03 Contract. No abnormality or malpractice for the contract works was observed during the sampling exercise.
4. There were no specific activities recorded during the monitoring period that would cause any significant impacts on the monitoring results. As such, the exceedance of suspended solid level is considered to be attributed to other external factors such as sea condition, rather than the contract works.

As the suspended solid level recorded beyond the water quality criteria was not related to the contract works, no immediate actions are considered necessary. However, the Contractor is reminded to ensure that the silt curtain is fully maintained throughout the construction works and construction works are carried out under stringent supervision to prevent any water quality impacts to the seawater.

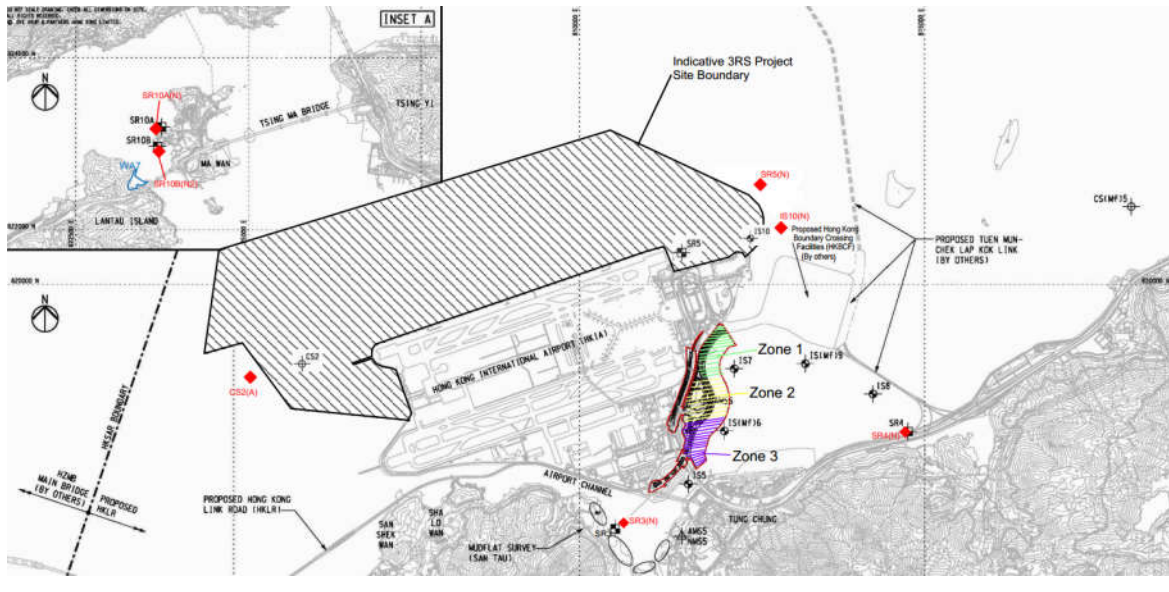
**Location Plan:**

On 18 December 2017, an Action Level exceedance of suspended solid was recorded at station IS8 during mid-flood tide. The exceedance has been investigated and is considered unlikely to be related to the contract works due to the following reasons:

The measured value for mid-flood tide at station IS8 was within the range of suspended solid for mid-flood tide during baseline monitoring.

3. During sampling exercise, water was observed clear at station IS8. There was no marine transportation near station IS8 during sampling period and no marine works were conducted near monitoring station IS8 which is located outside the site boundary of HKLR03 Contract. No abnormality or malpractice for the contract works was observed during the sampling exercise.
4. There were no specific activities recorded during the monitoring period that would cause any significant impacts on the monitoring results. As such, the exceedance of suspended solid level is considered to be attributed to other external factors such as sea condition, rather than the contract works.

As the suspended solid level recorded beyond the water quality criteria was not related to the contract works, no immediate actions are considered necessary. However, the Contractor is reminded to ensure that the silt curtain is fully maintained throughout the construction works and construction works are carried out under stringent supervision to prevent any water quality impacts to the seawater.

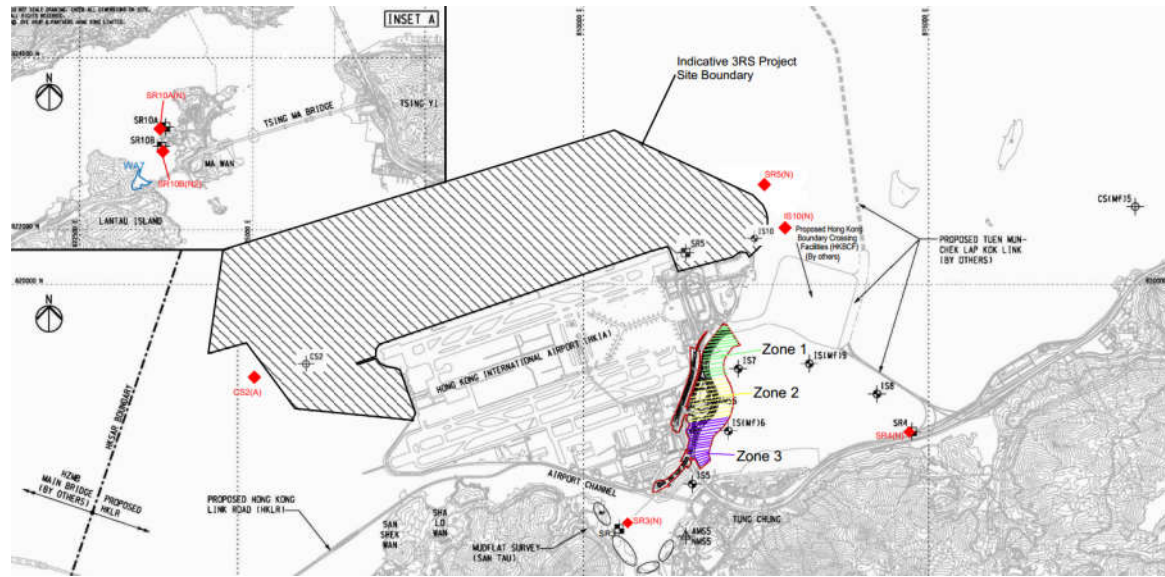
**Location Plan:**

On 20 December 2017, an Action Level exceedance of suspended solid was recorded at station IS(Mf)9 during mid-flood tide. The exceedance has been investigated and is considered unlikely to be related to the contract works due to the following reasons:

The measured value for mid-flood tide at station IS(Mf)9 was slightly above the range of suspended solid for mid-flood tide during baseline monitoring.

3. During sampling exercise, water was observed clear at station IS(Mf)9. There was no marine transportation near station IS(Mf)9 during sampling period and no marine works were conducted near monitoring station IS(Mf)9 which is located outside the site boundary of HKLR03 Contract. No abnormality or malpractice for the contract works was observed during the sampling exercise.
4. There were no specific activities recorded during the monitoring period that would cause any significant impacts on the monitoring results. As such, the exceedance of suspended solid level is considered to be attributed to other external factors such as sea condition, rather than the contract works.

As the suspended solid level recorded beyond the water quality criteria was not related to the contract works, no immediate actions are considered necessary. However, the Contractor is reminded to ensure that the silt curtain is fully maintained throughout the construction works and construction works are carried out under stringent supervision to prevent any water quality impacts to the seawater.
