**Contract No. HY/2011/03 -
Hong Kong- Zhuhai- Macao Bridge
Hong Kong Link Road Section between Scenic Hill and Hong Kong Boundary Crossing Facilities
Notifications of Environmental Quality Limits Exceedances**

Notification No.: 270s ver 0

Date of Notification: 13 February 2018

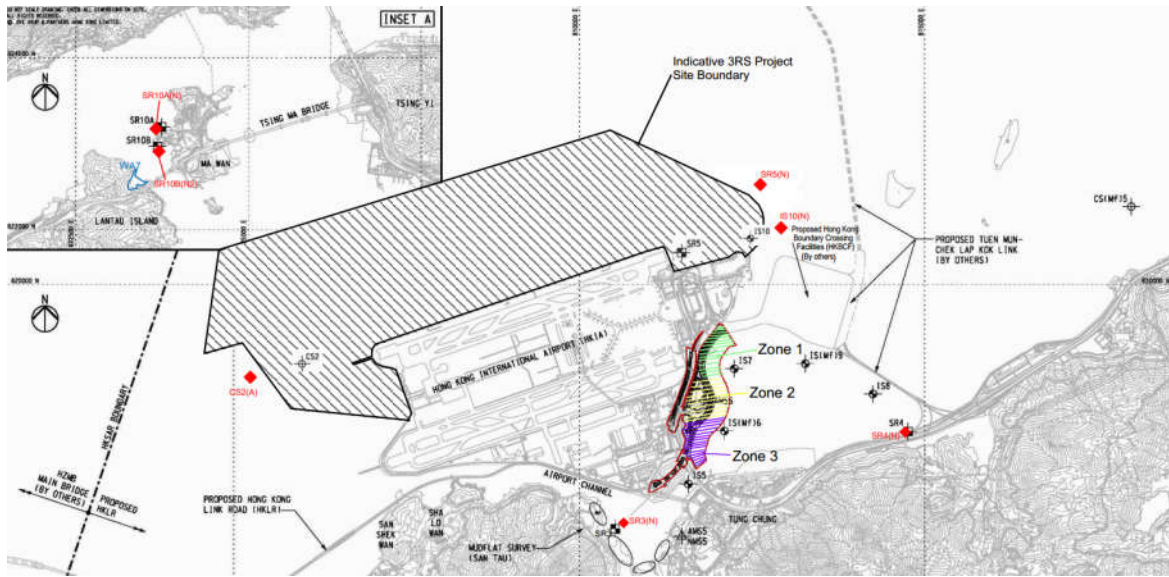
Location Plan:

On 5 February 2018, an Action Level exceedance of suspended solid was recorded at station IS8 during mid-flood tide. The exceedance has been investigated and is considered unlikely to be related to the contract works due to the following reasons:

3. During sampling exercise, water appearance was observed moderate at station IS8. There was no marine transportation near station IS8 during sampling period and no marine works were conducted near station IS8 which is located outside the site boundary of HKLR03 Contract. No abnormality or malpractice for the contract works was observed during the sampling exercise.
4. There were no specific activities recorded during the monitoring period that would cause any significant impacts on the monitoring results. As such, the exceedance of suspended solid level is considered to be attributed to other external factors such as sea condition, rather than the contract works.

As the suspended solid level recorded beyond the water quality criteria was not related to the contract works, no immediate actions are considered necessary. However, the Contractor is reminded to ensure that the silt curtain is fully maintained throughout the construction works and construction works are carried out under stringent supervision to prevent any water quality impacts to the seawater.

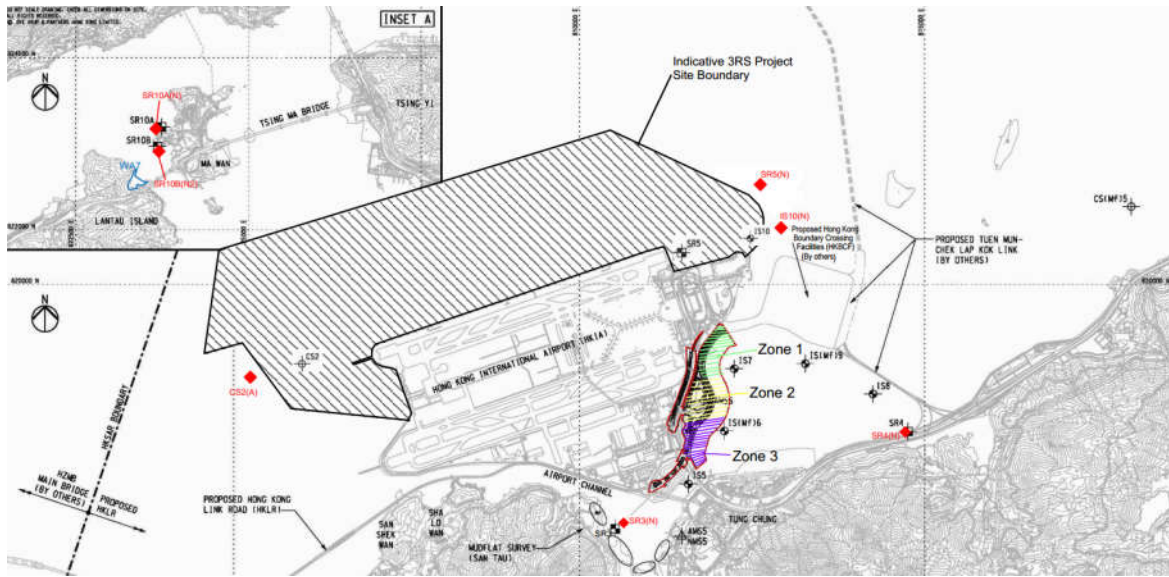
Location Plan:

On 7 February 2018, an Action Level exceedance of suspended solid was recorded at station IS(Mf)9 during mid-flood tide. The exceedance has been investigated and is considered unlikely to be related to the contract works due to the following reasons:

3. During sampling exercise, water appearance was observed moderate at station IS(Mf)9. There was no marine transportation near station IS(Mf)9 during sampling period and no marine works were conducted near station IS(Mf)9 which is located outside the site boundary of HKLR03 Contract. No abnormality or malpractice for the contract works was observed during the sampling exercise.
4. There were no specific activities recorded during the monitoring period that would cause any significant impacts on the monitoring results. As such, the exceedance of suspended solid level is considered to be attributed to other external factors such as sea condition, rather than the contract works.

As the suspended solid level recorded beyond the water quality criteria was not related to the contract works, no immediate actions are considered necessary. However, the Contractor is reminded to ensure that the silt curtain is fully maintained throughout the construction works and construction works are carried out under stringent supervision to prevent any water quality impacts to the seawater.
