**Contract No. HY/2011/03 -
 Hong Kong- Zhuhai- Macao Bridge
 Hong Kong Link Road Section between Scenic Hill and Hong Kong Boundary Crossing Facilities
 Notifications of Environmental Quality Limits Exceedances** Notification No.: 278a ver 1

Date of Notification: 13 June 2018

**Contract No. HY/2011/03 -
 Hong Kong- Zhuhai- Macao Bridge
 Hong Kong Link Road Section between Scenic Hill and Hong Kong Boundary Crossing Facilities**
Notifications of Environmental Quality Limits Exceedances Notification No.: 279 ver0

Date of Notification: 6 July 2018

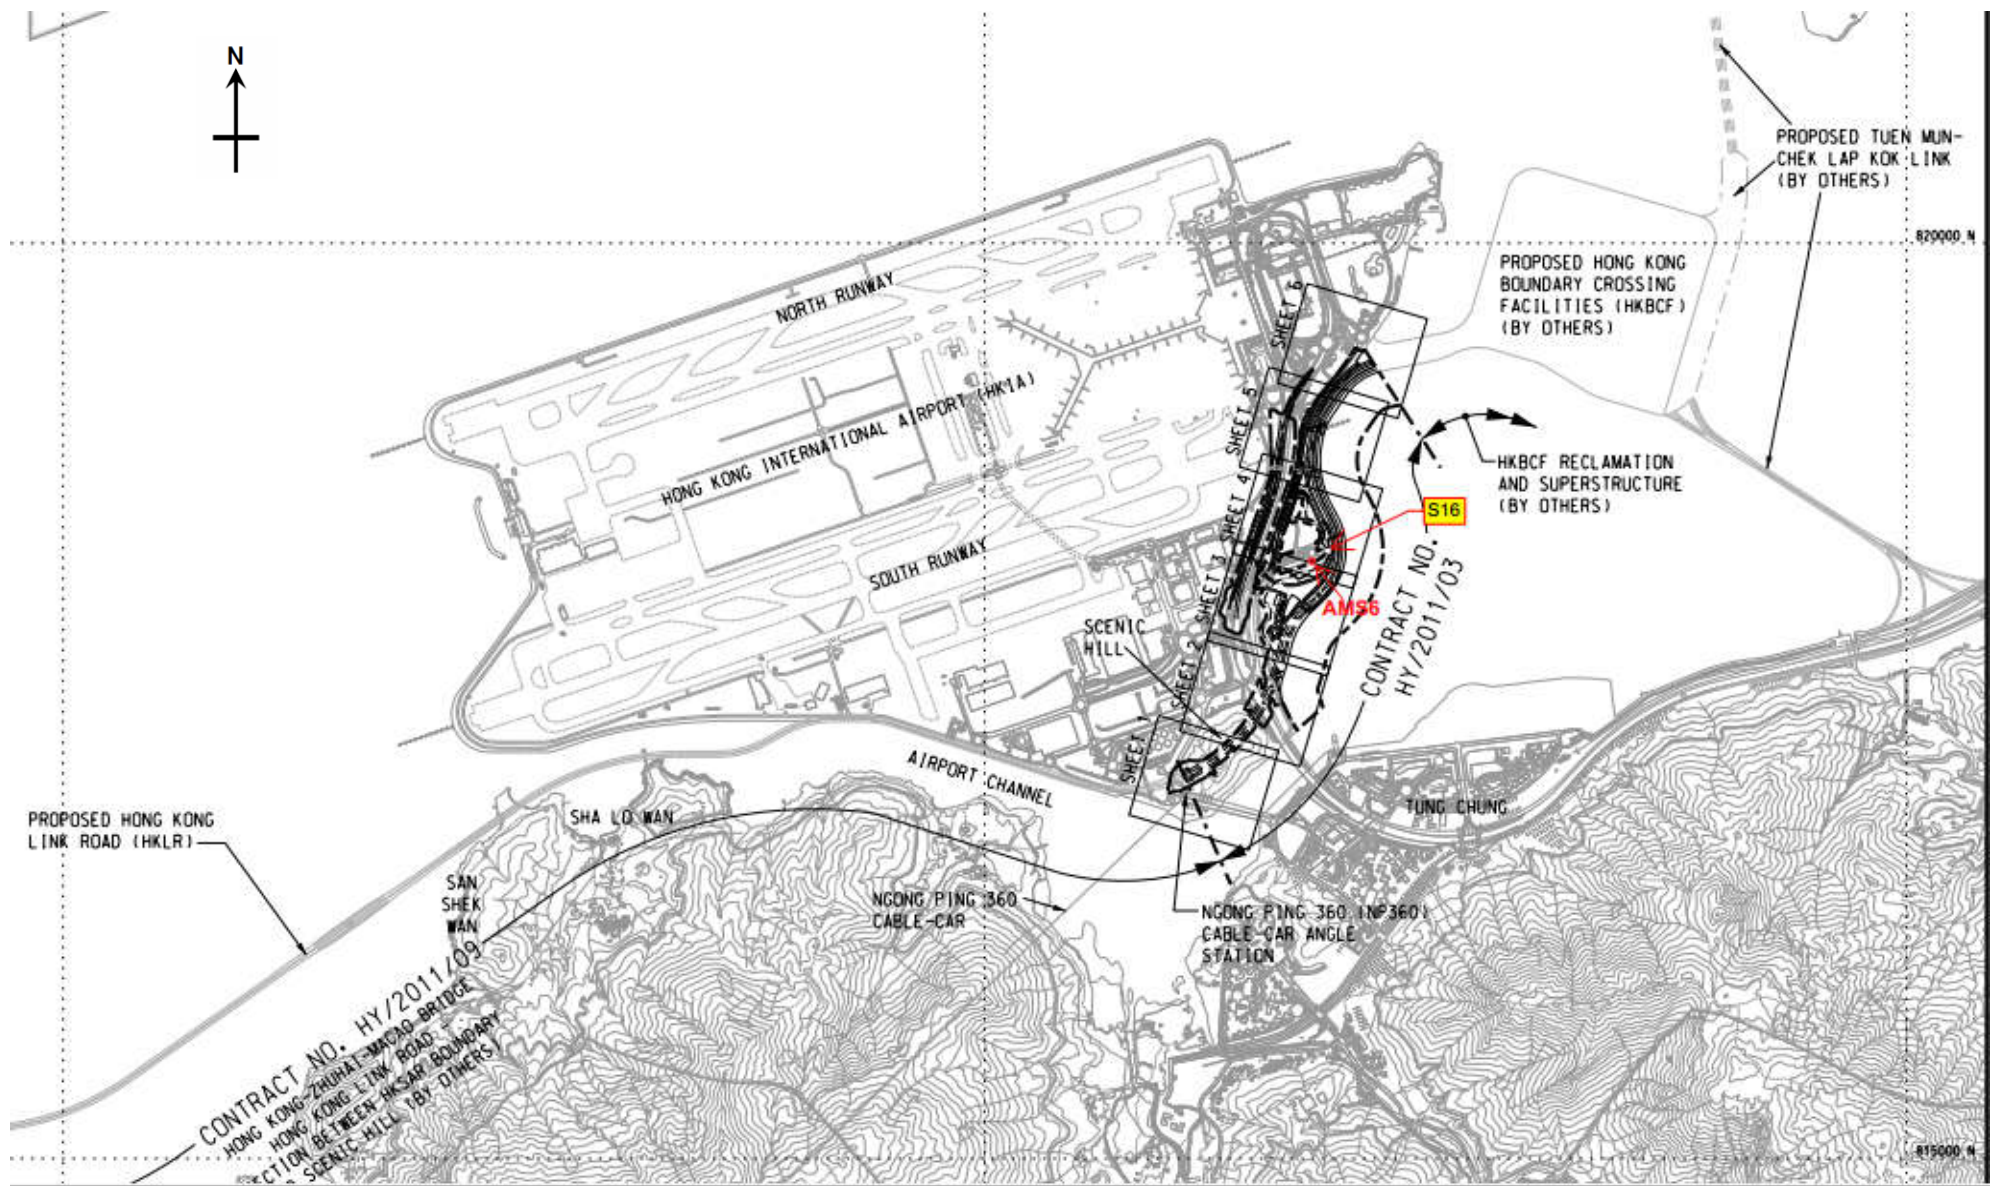
Figure 1 - Location of Construction Site S16 and Air Monitoring Station AMS6

A Limit Level exceedance of 24-hr TSP level was recorded at AMS6 - Dragonair Building on 1 June 2018.

According to the information provided by the Contractor, landscaping works were conducted at construction site S16 which is located near AMS6 during the sampling period on 1 June 2018. Figure 1 shows the location of construction site S16 and air monitoring station AMS6. According to information provided by the Contractor, water spraying was provided for dusty materials to maintain the entire surface in a damp condition and haul roads were sprayed with water by water trucks regularly.

During collection of filter paper at AMS6 on 4 June 2018, weed was observed on the filter paper which was used for monitoring on 1 June 2018. Also, the weed in the vicinity of station AMS6 was found to be cleared by other parties. It is noted that the weed removal work in the vicinity of station AMS6 was not carried out under the Contract No. HY/2011/03. The weed clearing activities in the vicinity of AMS6 may be one of dust sources to cause the 24-hr TSP LL exceedance on 1 June 2018. An additional monitoring was carried out on 6 June 2018 and a routine monitoring was carried out on 7 June 2018. The 24-hr TSP result on 6 and 7 June 2018 were $32 \mu\text{g}/\text{m}^3$ which were below Action and Limit Level. It was also noted that no Action and Limit Level exceedances of 1-hr TSP were recorded at air monitoring station AMS6 - Dragonair Building during the period from 1 June 2018 to 20 June 2018.

It was noted that the Contractor has implemented dust control measure throughout the construction phase. There is no direct evidence that the exceedance is related to the Contract. No immediate actions are considered necessary. However, the Contractor is reminded to continuously implement the dust mitigation measures as specified in Environmental Mitigation Implementation Schedule (EMIS), Environmental Management Plan, Method Statements, General and Particular Specifications of this Contract throughout the construction phase.

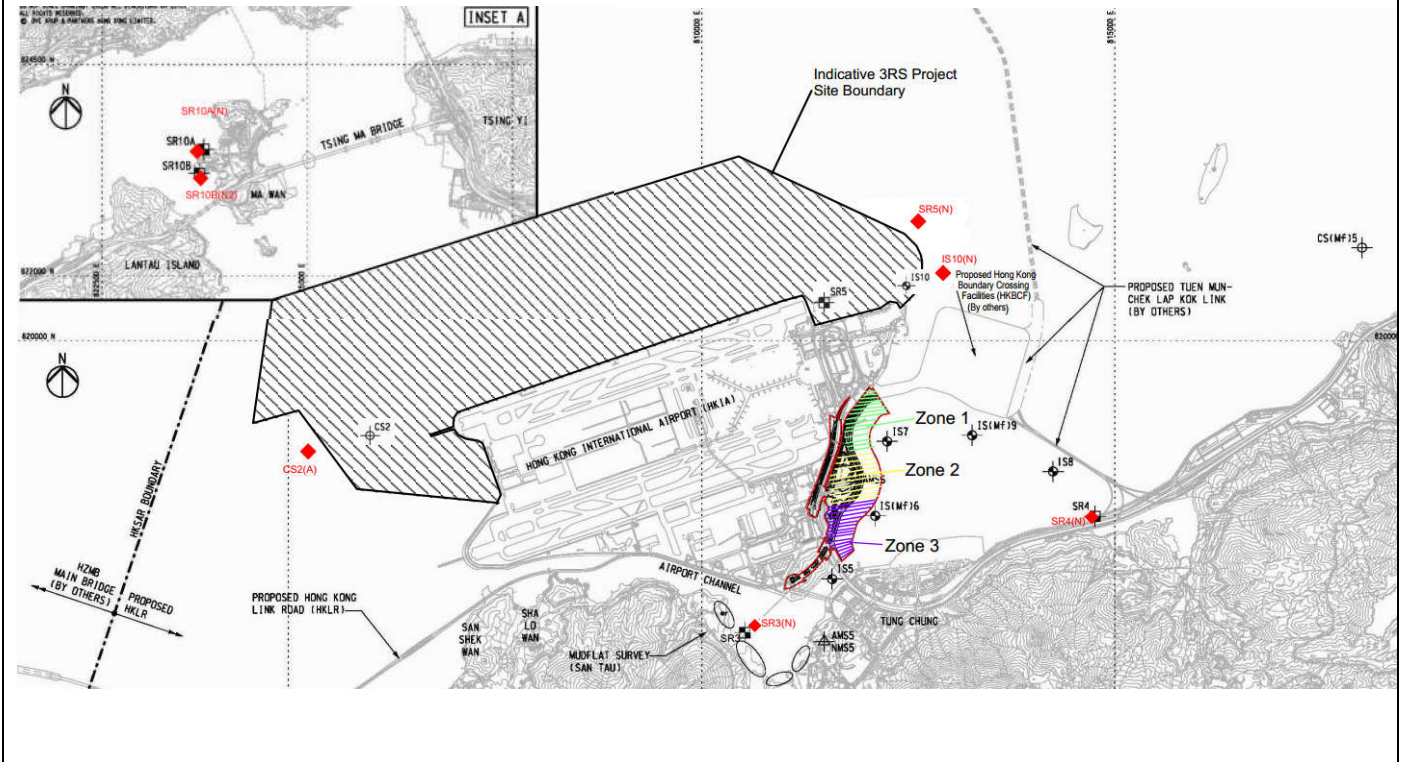
Location Plan:

On 29 June 2018, an Action Level exceedance of dissolved oxygen was recorded at station IS5 during the mid-ebb tide. The exceedance has been investigated and is considered unlikely to be related to contract works due to the following reasons:

1. According to Contractor's information, there was no marine transportation near station IS5 during sampling period and no marine works were conducted near station IS5 which is located outside the site boundary of HKLR03 Contract. No abnormality or malpractice for the contract works was observed during the sampling exercise.
2. The range of dissolved oxygen for bottom level at station IS5 during the baseline monitoring is shown as below:

On 29 June 2018, the measured value of dissolved oxygen for bottom level at station IS5 during the mid-ebb tide was within the range of the baseline monitoring.

3. There were no specific activities recorded during the monitoring period that would cause any significant impact on the monitoring results. As such, the exceedance in DO level is considered to be attributed to other external factors rather than the contract works.

As the DO level recorded beyond the water quality criteria was not related to contract works, no immediate actions are considered necessary. However, the Contractor is reminded to ensure the silt curtain is fully maintained throughout the construction works and construction works are under stringer supervision to prevent any water quality impacts to the seawater.
