Hong Kong- Zhuhai- Macao Bridge

Hong Kong Link Road Section between Scenic Hill and Hong Kong Boundary Crossing Facilities

Notifications of Environmental Quality Limits Exceedances Notification No.: 286a ver0

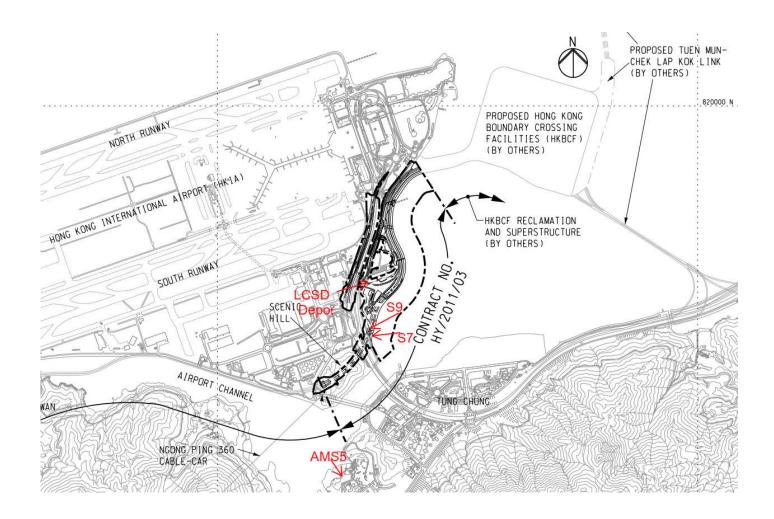
Figure 1 - Location of Construction Site at LCSD Depot, S7 and S9 and Air Monitoring Station AMS5

Three Action Level exceedances of 1-hr TSP level were recorded for monitoring period from 14:47 – 17:47 hours at AMS5 – Ma Wan Chung Village, on 16 October 2018.

According to the information provided by the Contractor, the following construction activities were undertaken at LCSD Depot, S7 and S9 which are located near AMS5 during the sampling period on 16 October 2018:

- Construction of LCSD Depot
- Reinstatement works of Kwo Lo Wan Road near S7
- Landscaping work at S9

Figure 1 shows the location of construction sites and air monitoring station AMS5. During the site visit undertaken on 16 October 2018, no fugitive dust emission was observed by ET at the construction sites near AMS5. According to information provided by the Contractor, water spraying was provided for dusty materials to maintain the entire surface in a damp condition and haul roads were sprayed with water by water trucks regularly.

The Air Quality Health Index (AQHI) recorded by EPD at the Tung Chung station ranged from 2 (low) to 5 (moderate) during the sampling period on 16 October 2018. The general weather condition during the monitoring period was hazy with low visibility. The hazy weather could cause higher readings of the portable dust meter. It is considered that the exceedances are not related to the construction activities of the Contract and may be caused by the weather condition.

The Contractor has properly implemented dust control measures efficiently throughout the construction phase. Also, no fugitive dust emission was observed by ET on 16 October 2018 at construction sites near monitoring station AMS5. As such the exceedances recorded at monitoring station AMS5 are unlikely to be related to the Contract. In this case, no immediate actions are required. However, the Contractor is reminded to continuously implement the dust mitigation measures as specified in Environmental Mitigation Implementation Schedule (EMIS), Environmental Management Plan, Method Statements, General and Particular Specifications of this Contract throughout the construction phase.
