Appendix N

Cumulative Statistics on
Exceedances, Complaints,
Notifications of Summons
and Successful Prosecutions

ENVIRONMENTAL COMPLAINT/ ENQUIRY FORM

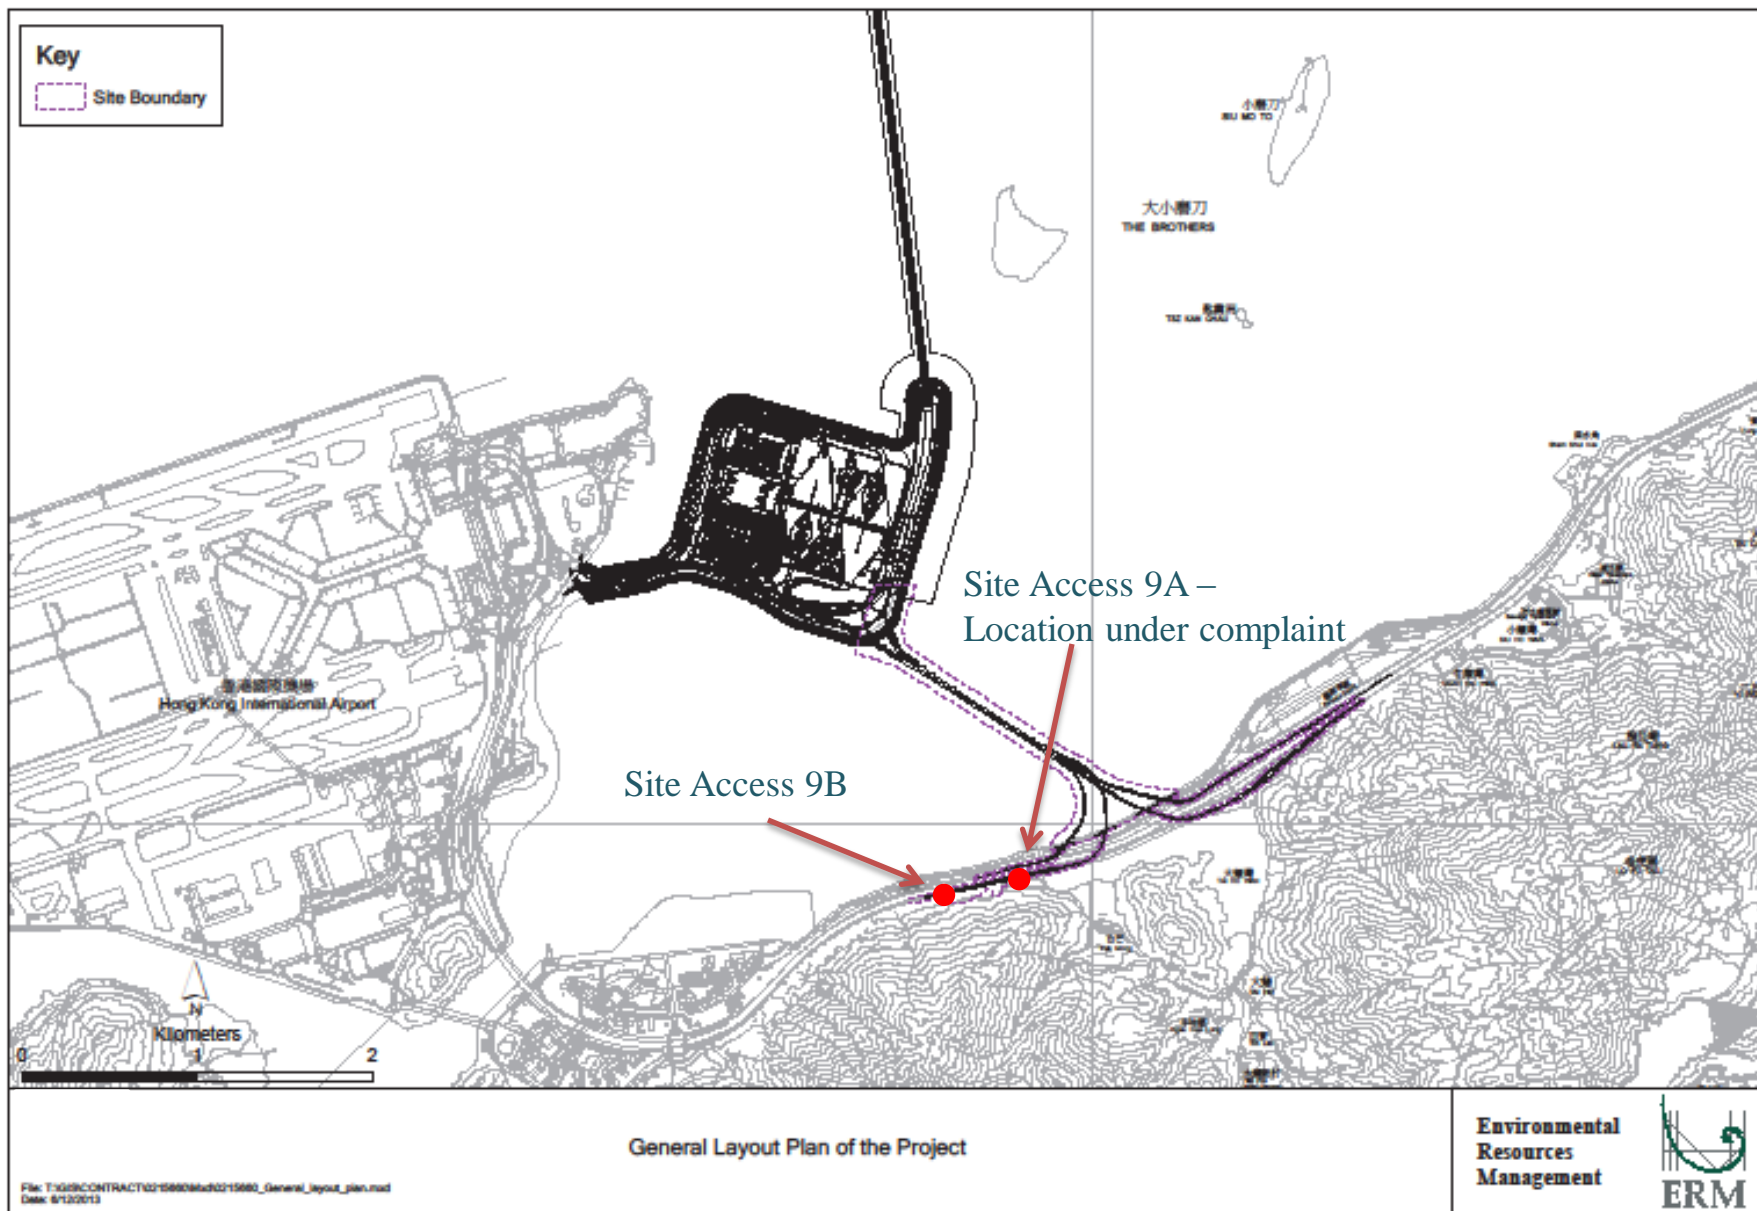
Figure 1.2

An initial investigation was conducted on 25 June by ET with EPD, Contractor and SOR. Based on the weather information from the Hong Kong Observatory (HKO), heavy rain was recorded on 23 June 2014 (*Figure 1.1*). Rain water was found accumulating in the Site Access 9A (*Figure 1.2*) which was probably related to the heavy rain. Besides direct rainfall, the construction site was next to a slope which was partly unpaved. Soil was suspected to be flushed from the slope. However, there was no evidence that the accumulated muddy water was being discharged from the site.

- Muddy water that was accumulated at the Site Access 9A due to the heavy rainfall was removed off-site by licensed suction tanker.
- Water sample from the treatment plant was taken for suspended solid analysis to ensure the effluent quality was in compliance with the discharge licence conditions.
- The slope next to the storm drains had been hydro-seeded which aimed at stabilizing the soil on the slope.

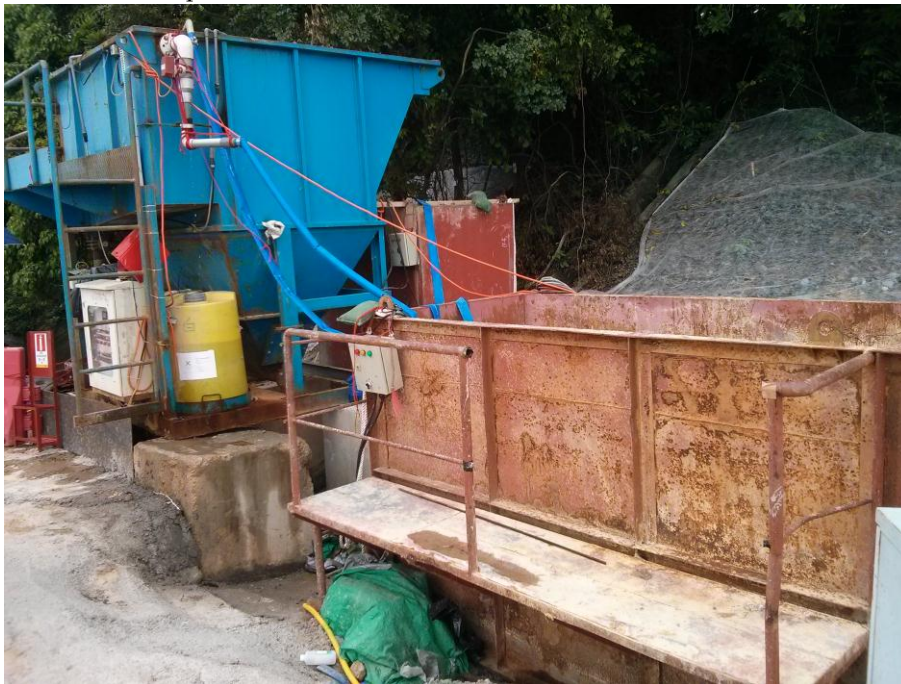
Figure 1.3 Measures undertaken by the Contractor to deal with the accumulation of muddy water before receiving the complaint (Photos taken on 25 June 2014)

Water treatment plant

- A set of waste water treatment plant was being established. Any runoff in the Site Access 9A was pumped to the temporary sedimentation tank.
- Unpaved area and exposed slope had been covered by tarpaulin sheet to prevent direct flushing by rainfall.
- Clearing of mud and soil residue had been performed constantly on site.

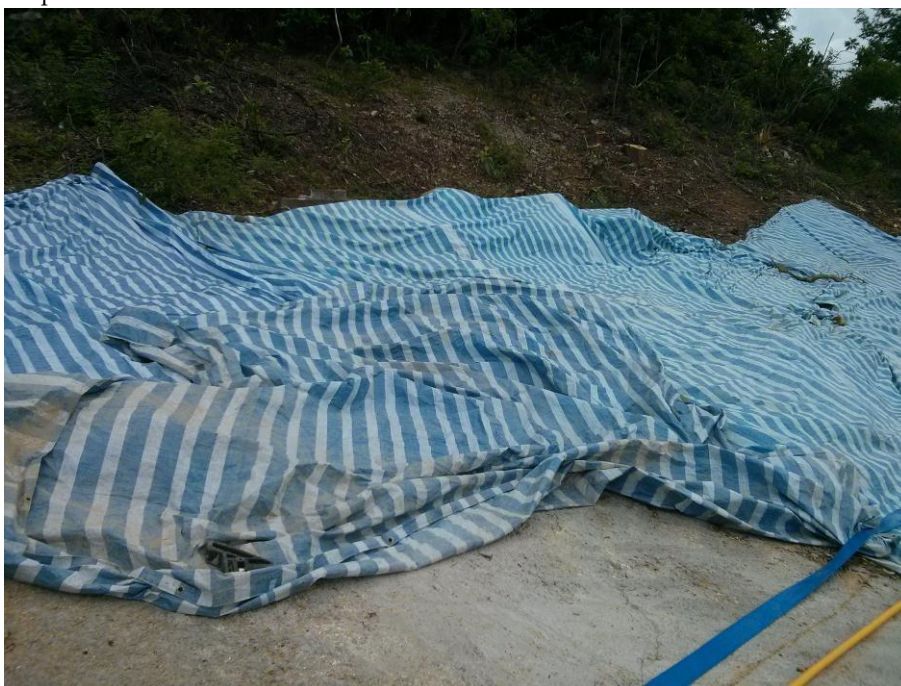
Tarpaulin sheet cover

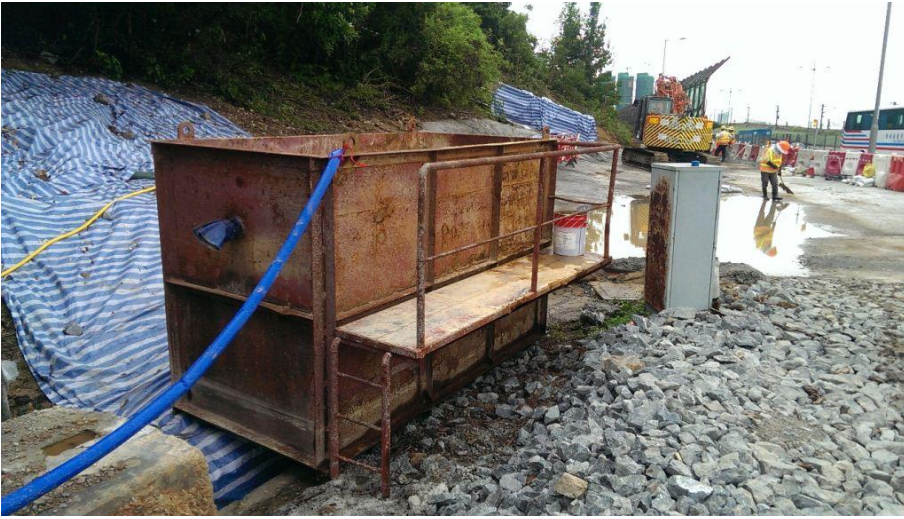
General mud and soil removal

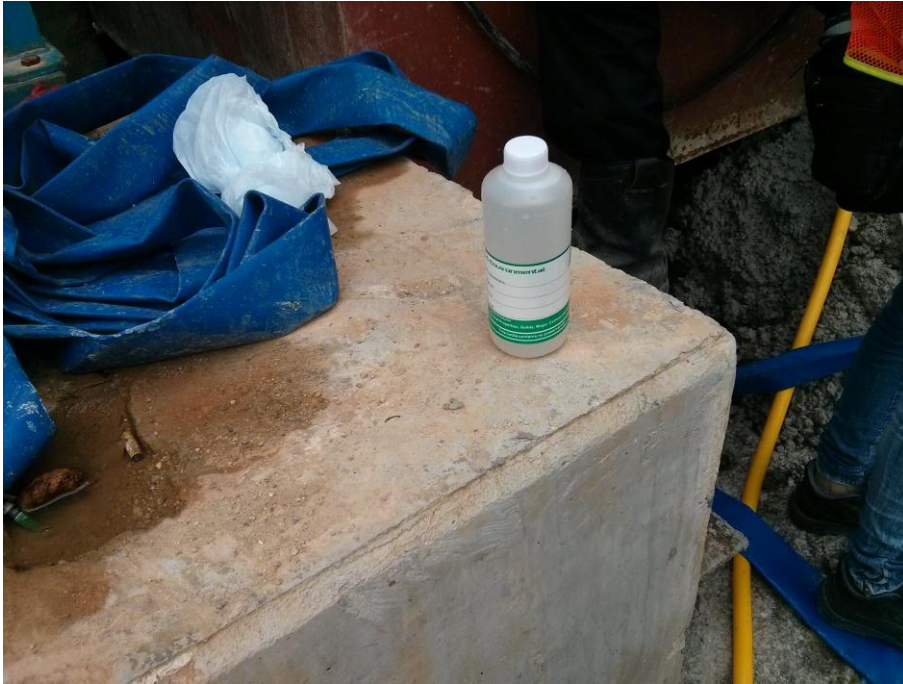
Figure 1.4 Follow-up actions undertaken by the Contractor after receiving the complaint (Photos taken on 26 June 2014)

Water sample for Suspended Solid analysis

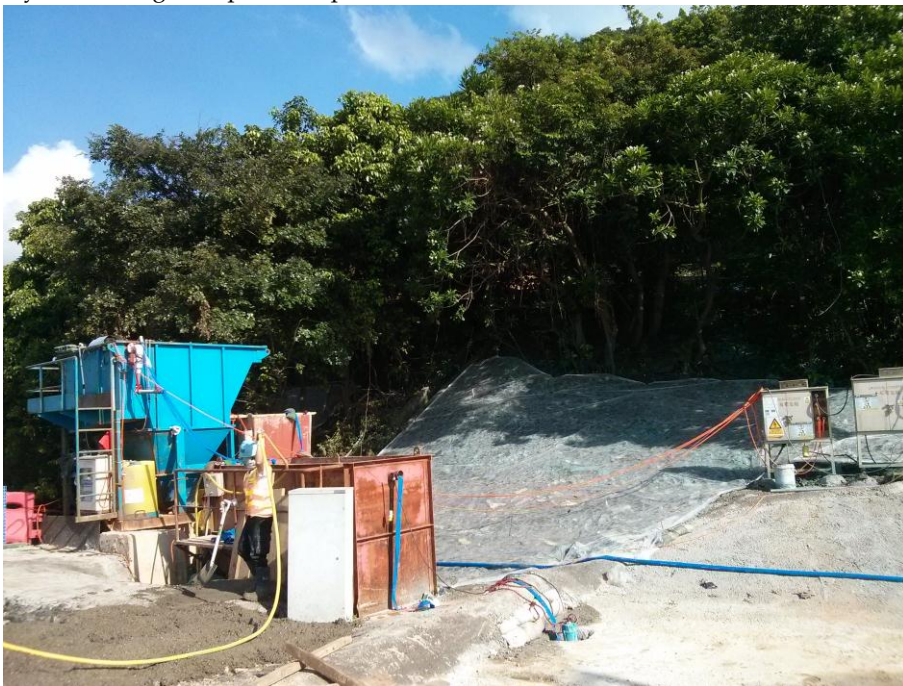
Hydro-seeding at unpaved slope

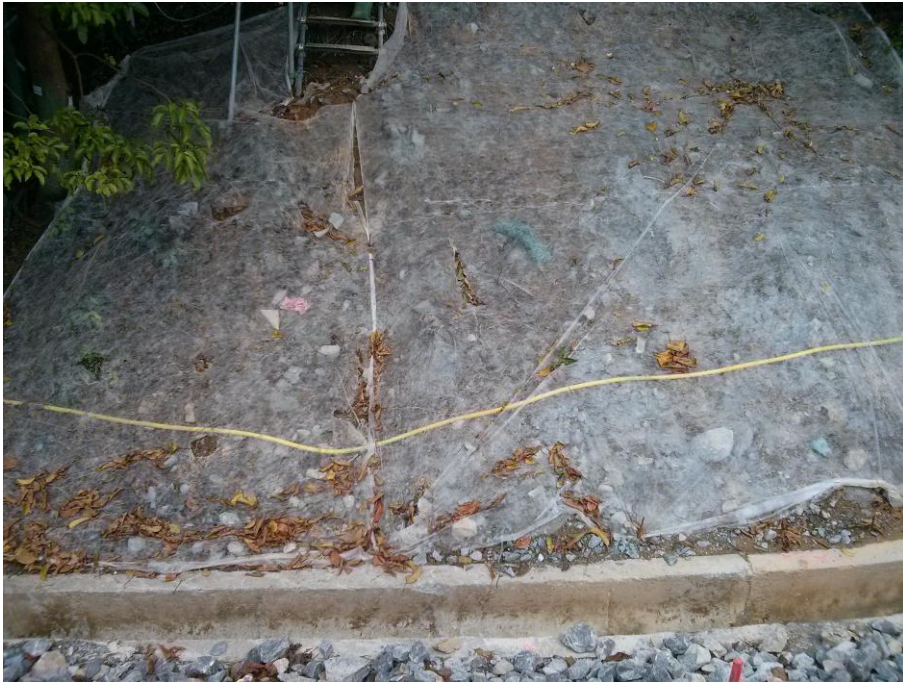
Hydro-seeding at unpaved slope nearby drainage

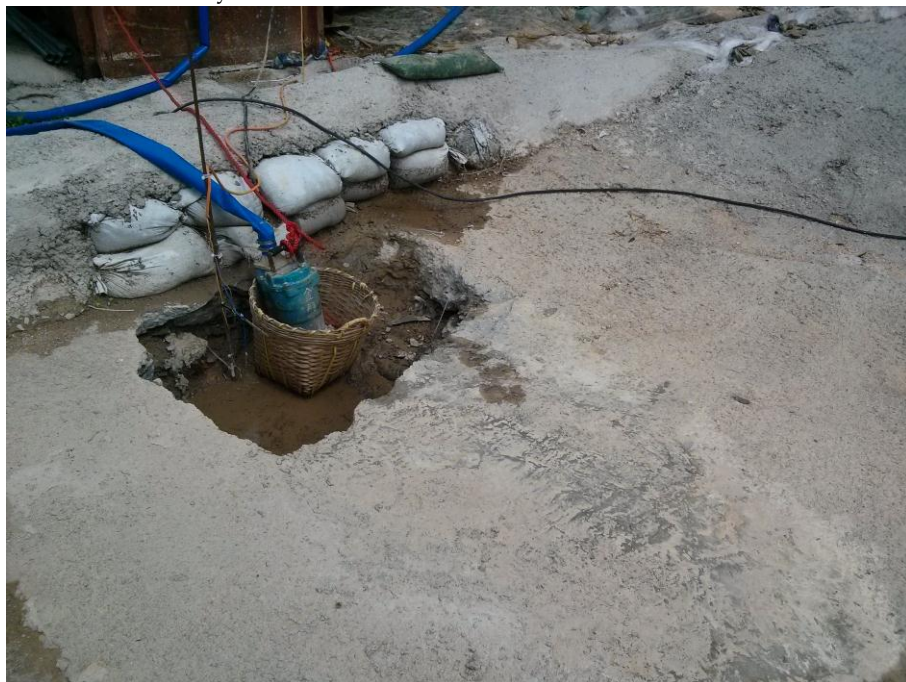
- No accumulation or illegal discharge of muddy water was observed after heavy rainfall.
- Muddy water from rainfall was collected into the sedimentation tank for water treatment.
- The water treatment plant was considered able to handle muddy water generated from heavy rainfall. It will be deployed until the end of rainy season or longer if necessary.

Figures 1.6 Follow-up investigation (Photos taken on 10 July 2014)

Collection of muddy water

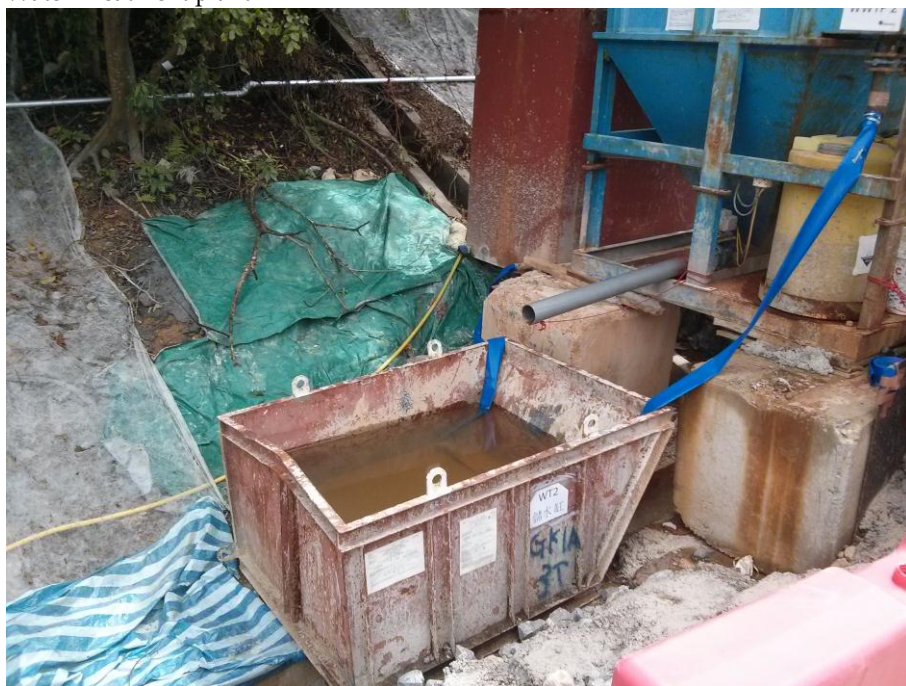
Water Treatment plant

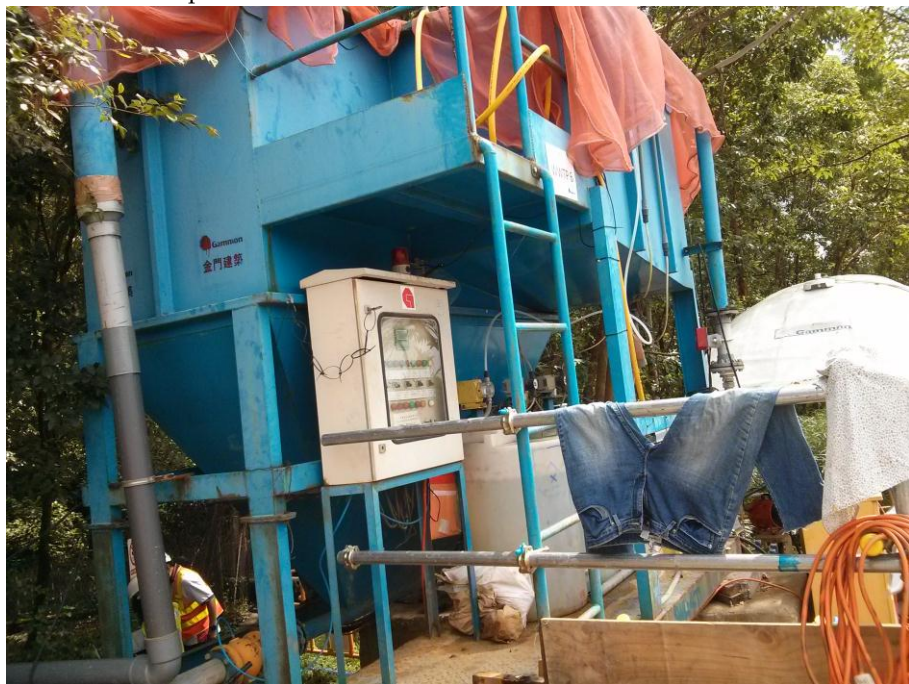
Site Access 9B (adjacent to the same slope at) was also visited. A set of water treatment plant was established to avoid muddy water generated by rainfall (Figure 1.7). Lack of precaution measures was not identified at Site Access 9B.

Figure 1.7 Inspections at Site Access 9B (Photo taken on 10 July 2014)

Water treatment plant
