ENVIRONMENTAL COMPLAINT/ ENQUIRY FORM

Description: A notification of complaint from EPD was received on 18 June 2015 regarding dust emission from dump trucks (Plate number: SE 577, NM 577 and NH 327) working for construction site of Tuen Mun-Chek Lap Kok Link-Southern Connection Viaduct Section (the Project). The complainant suspected that the dust suppression measures on site were insufficient.

Investigation Report & Response

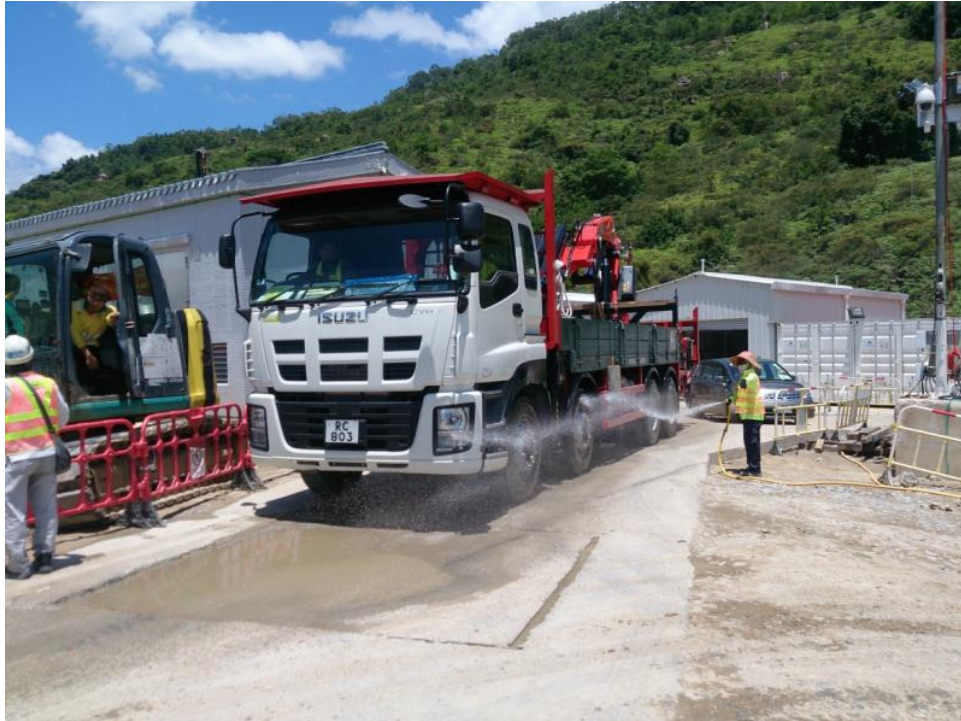
Truck wheel washing at Area 1 (without loading)

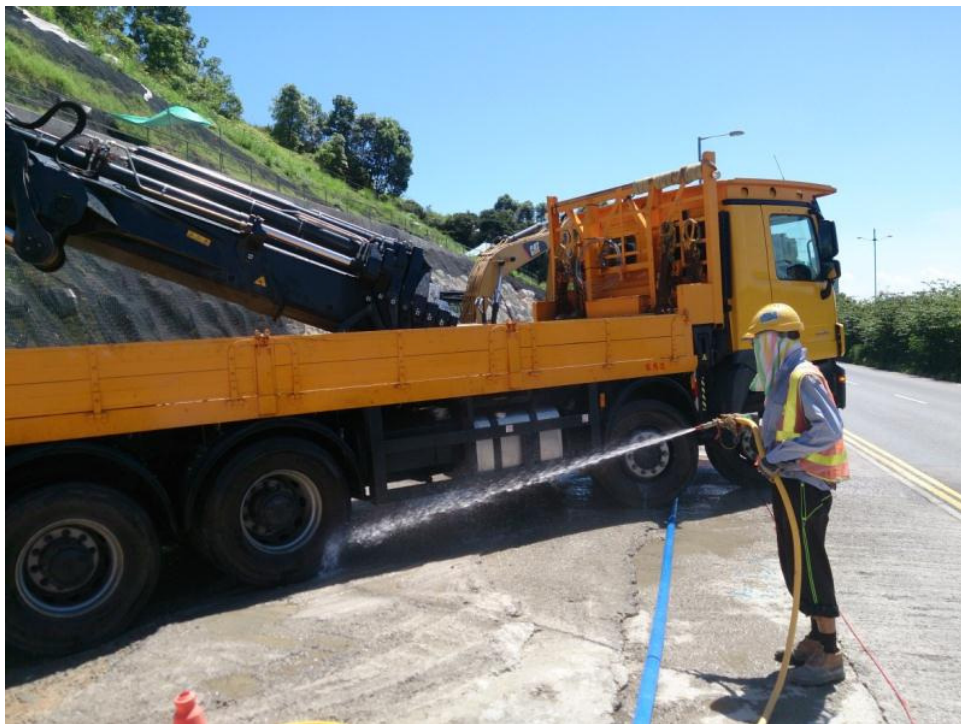
Truck wheel washing at Site Access 9B (without loading)

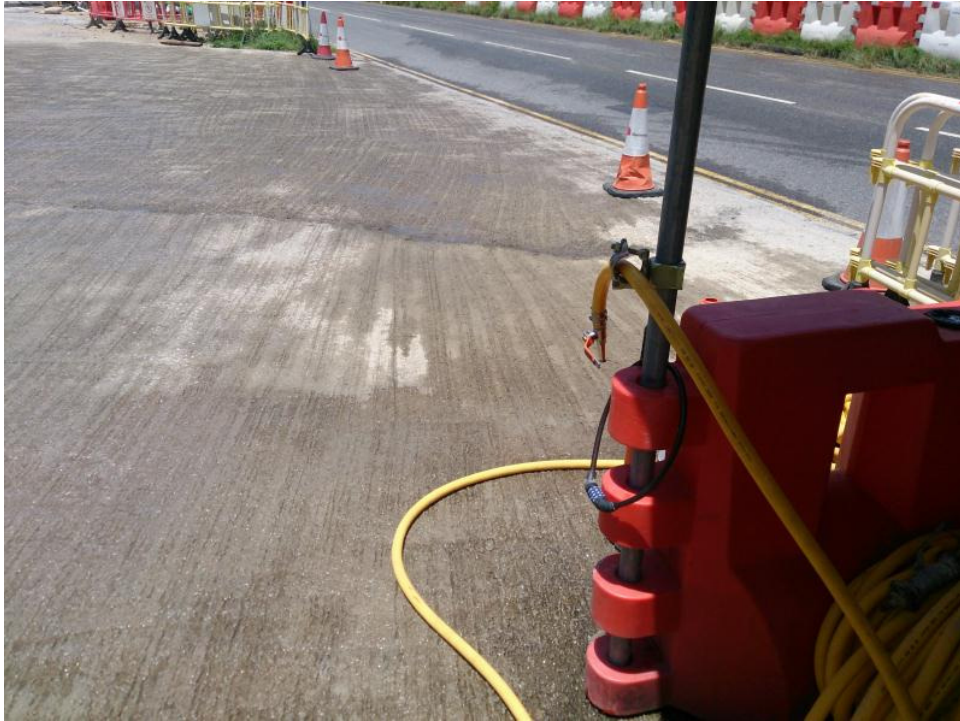
Wheel washing facility at Site Access 4A

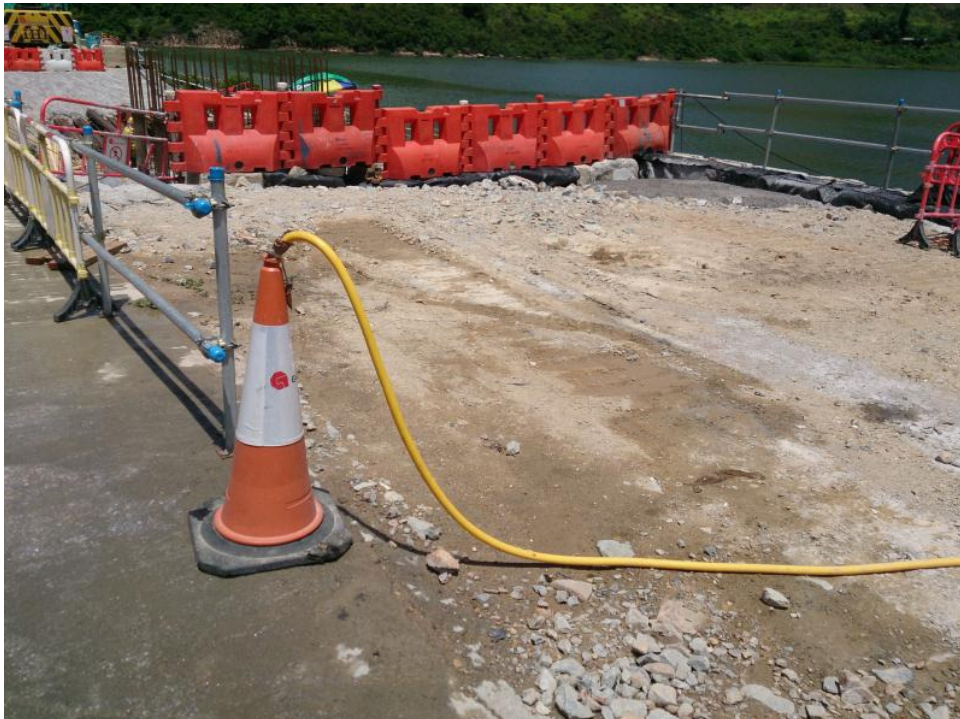
Wheel washing facility at Site Access 3B

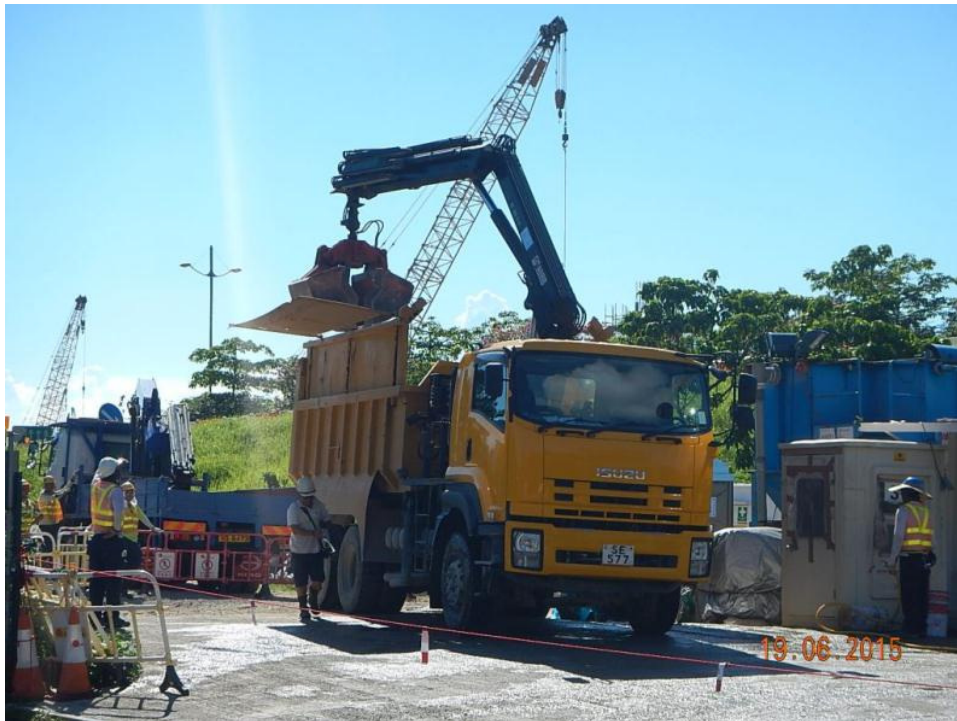
During the inspection on 19 June 2015, 2 of the trucks under complaint (car plate number: SE 577 and NH 327) were inspected. EPD had no adverse comment on NH 327. However, the sideboards of SE 577 were found higher than normal and the skip was found not fully covered by the mechanical cover. The truck driver was then advised by EPD representative that the cover was considered unable to mitigate dust emission effectively. Onsite discussion was conducted among EPD, SOR, Contractor and the truck driver. The truck driver took immediate action to lower the sideboards and to ensure the skip of dump truck was fully covered. Photos of the trucks under complaint are provided by Contractor and shown in *Annex B*.

Sideboards of truck (SE 577) were too high and loaded material was not fully covered (Photo taken on 19 Jun 2015)

1. Dust emission material should not be loaded to a level higher than side or tail boards and should be fully covered by tarpaulin sheet;
2. The tarpaulin sheet should be properly secured and shall extend at least 300mm over the edges of the side and tail boards;
3. The Contractor and the assigned traffic controllers should ensure the truck drivers of this Project using the mechanical cover properly, and all dusty materials should be fully covered;
4. The Contractor and the assigned traffic controllers should also ensure wheel washing is applied to all trucks at every entrance of Project area and the trucks are not overloading; and,
5. Toolbox talk trainings should be provided to truck drivers and traffic controllers, in which the truck drivers should be reminded to avoid sideboards or tailboards higher than normal to prevent dust emission.

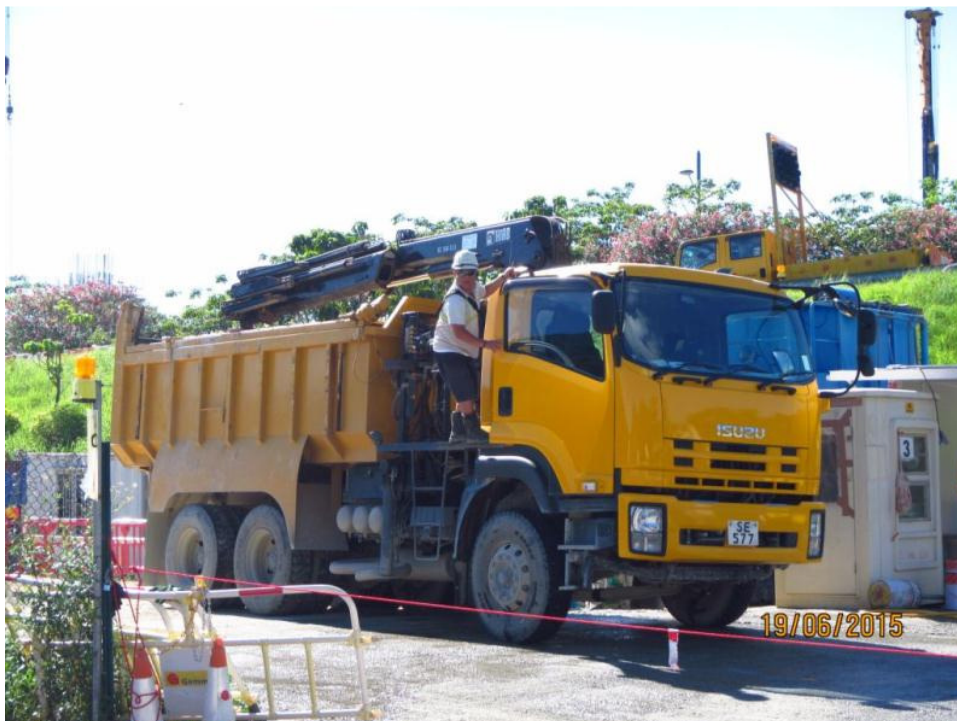
Sideboards of truck (SE 577) were lower and mechanical cover can properly cover the dusty material (Photo taken on 19 Jun 2015)

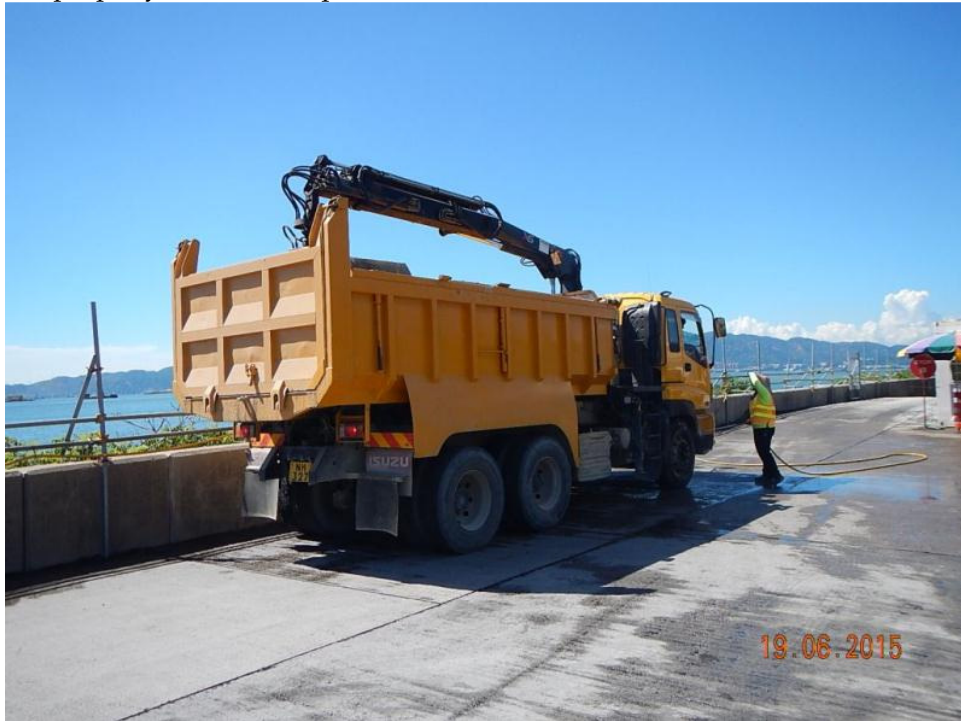
Truck under complaint (NH 327) was wheel washed and its mechanical cover can properly cover the skip (Photo taken on 19 June 2015)

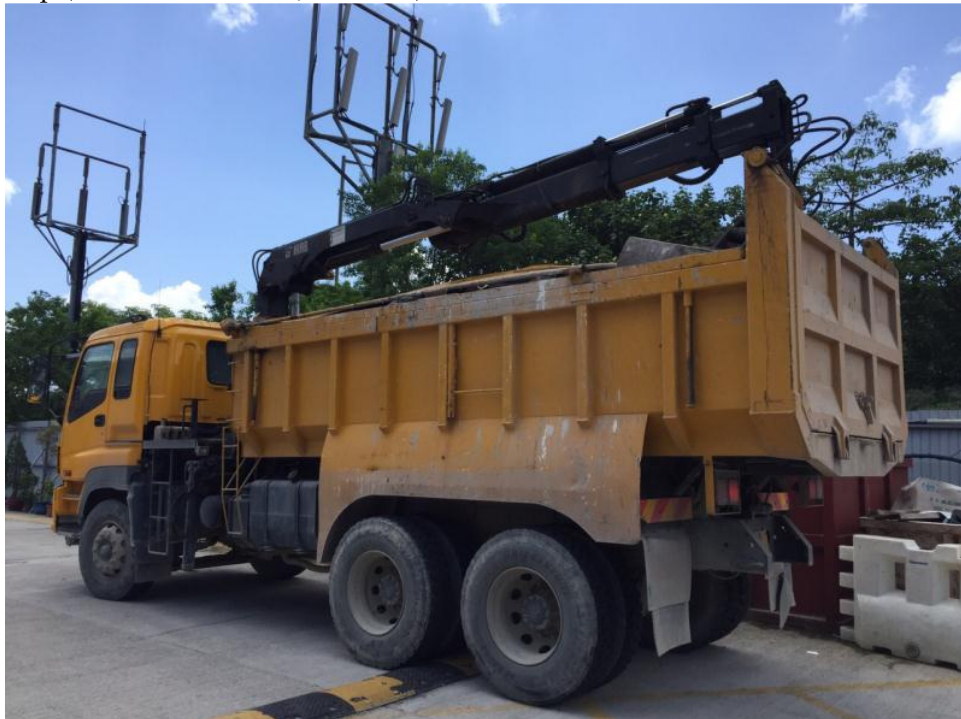
Mechanical cover of truck under complaint (NM 577) can properly cover the skip (Photo taken on 26 June 2015)
