ENVIRONMENTAL COMPLAINT/ ENQUIRY FORM

Description: A complaint was received by EPD on 31 May 2017 regarding construction dust nuisance nearby vehicle access road of 044 and 045 buildings of Hong Kong Boundary Crossing Facilities (HKBCF) of Hong Kong–Zhuhai–Macau Bridge (HZMB) Projects (See *Figure 1*). The Contractor was notified by EPD regarding the complaint on 2 June 2017. The Environmental Team (ET) received the complaint notification from the Independent Environmental Checker (IEC) on 6 June 2017.

Photos of site inspection at
Southern Landfall on 7 June
2017

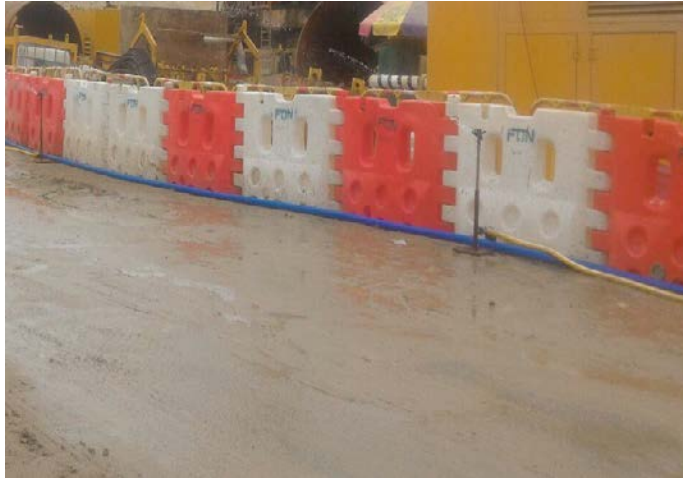
Site inspection at the concerned area was carried out on 7 June 2017. During the site inspection, frequent vehicle movement on an unpaved haul road near 044 and 045 buildings and a nearby stockpile of excavated soil were observed. Based on the observation, it is believed that the major sources of dust nuisance were generated from vehicle movements on unpaved roads and windblown dust of stockpiled material. Water sprinkling systems were installed along the unpaved haul road and on the soil stockpile as an enhanced measure by the Contractor on 4 June 2017 for dust suppression (see *Figure 2*). The water sprinkling systems were subsequently checked during the site inspection on 7 June 2017. Regular watering was observed maintained at the concerned area nearby 044 and 045 buildings of HKBCF (see *Annex A*).

Photo 1 - Water sprinklers installed along the access road near 044 and 045 buildings

1. Watering of the construction sites for 8 times per day shall be maintained in all areas throughout the construction period. Increase in watering frequency should be considered if necessary.
2. All stockpiles of aggregate should be covered and water applied especially in dry condition.

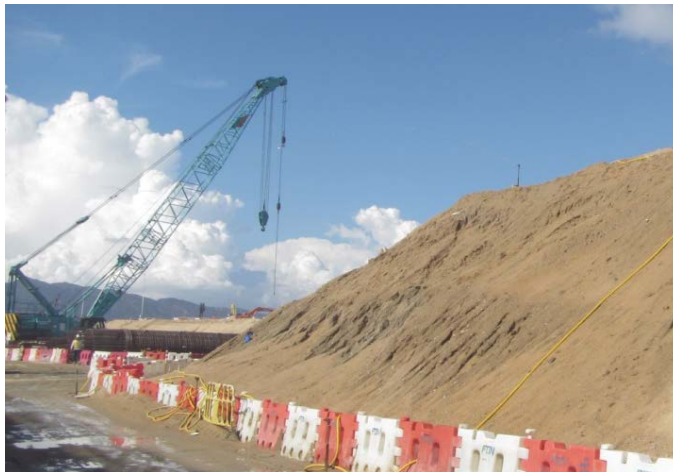
Photo 2 - Water sprinklers installed on the soil stockpile for dust suppression

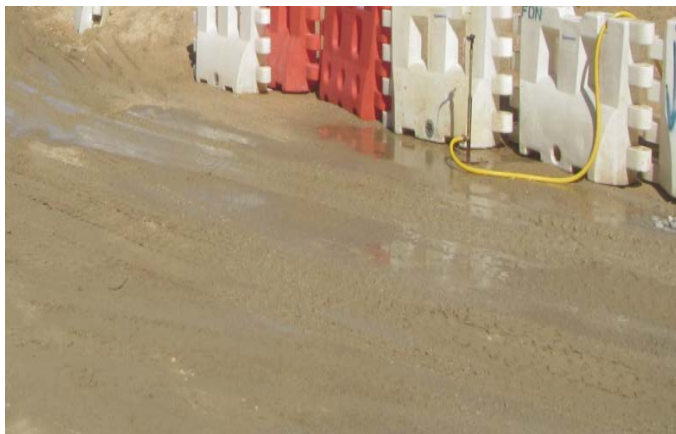
Photo 3 - Moist road surface was observed at the concerned area
