**Ref/Project number** Contract No. HY/2012/07  
Tuen Mun – Chek Lap Kok Link – Southern  
Connection Viaduct Section

**Subject** Notification of Exceedance for Marine Water  
Quality Impact Monitoring

TUEN MUN – CHEK LAP KOK LINK –  
SOUTHERN CONNECTION VIADUCT SECTION

Marine Water Quality Impact Monitoring

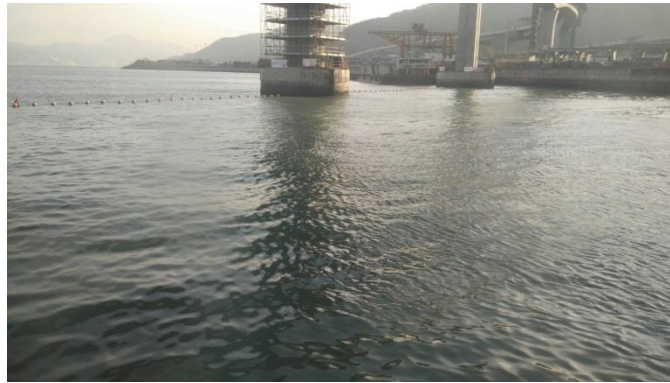
Photo 1 - Mid-Flood at SR4a on 3 January 2018

Works Undertaken (at the time of monitoring event)	<p>No major marine works was undertaken under this Contract on 3 January 2018.</p>	
Possible Reason for Action or Limit Level Exceedance(s)	<p>The exceedances of depth-averaged SS are unlikely to be due to the Project, in view of the following:</p> <ul style="list-style-type: none"> <li>• No marine works was undertaken under this Contract on 3 January 2018.</li> <li>• Apart from SR4a, depth-averaged SS levels at all other sensitive receiver stations and impact stations were in compliance with the Action and Limit Levels during both mid-flood and mid-ebb tides on the same day.</li> <li>• Depth-averaged Turbidity levels and average DO levels at all stations were in compliance with the Action and Limit Levels during both mid-ebb and mid-flood tides on the same day.</li> <li>• According to ET's site inspection on 3 January 2018, no particular finding was observed at SR4a (see <i>site photo record</i>).</li> </ul>

Actions Taken/ To Be Taken	<p>No immediate action is considered necessary. The ET will monitor for future trends in exceedances.</p>	
Remarks	<p>The monitoring results on 3 January 2018 and locations of water quality monitoring stations are attached. Site photo record on 3 January 2018 is attached.</p>

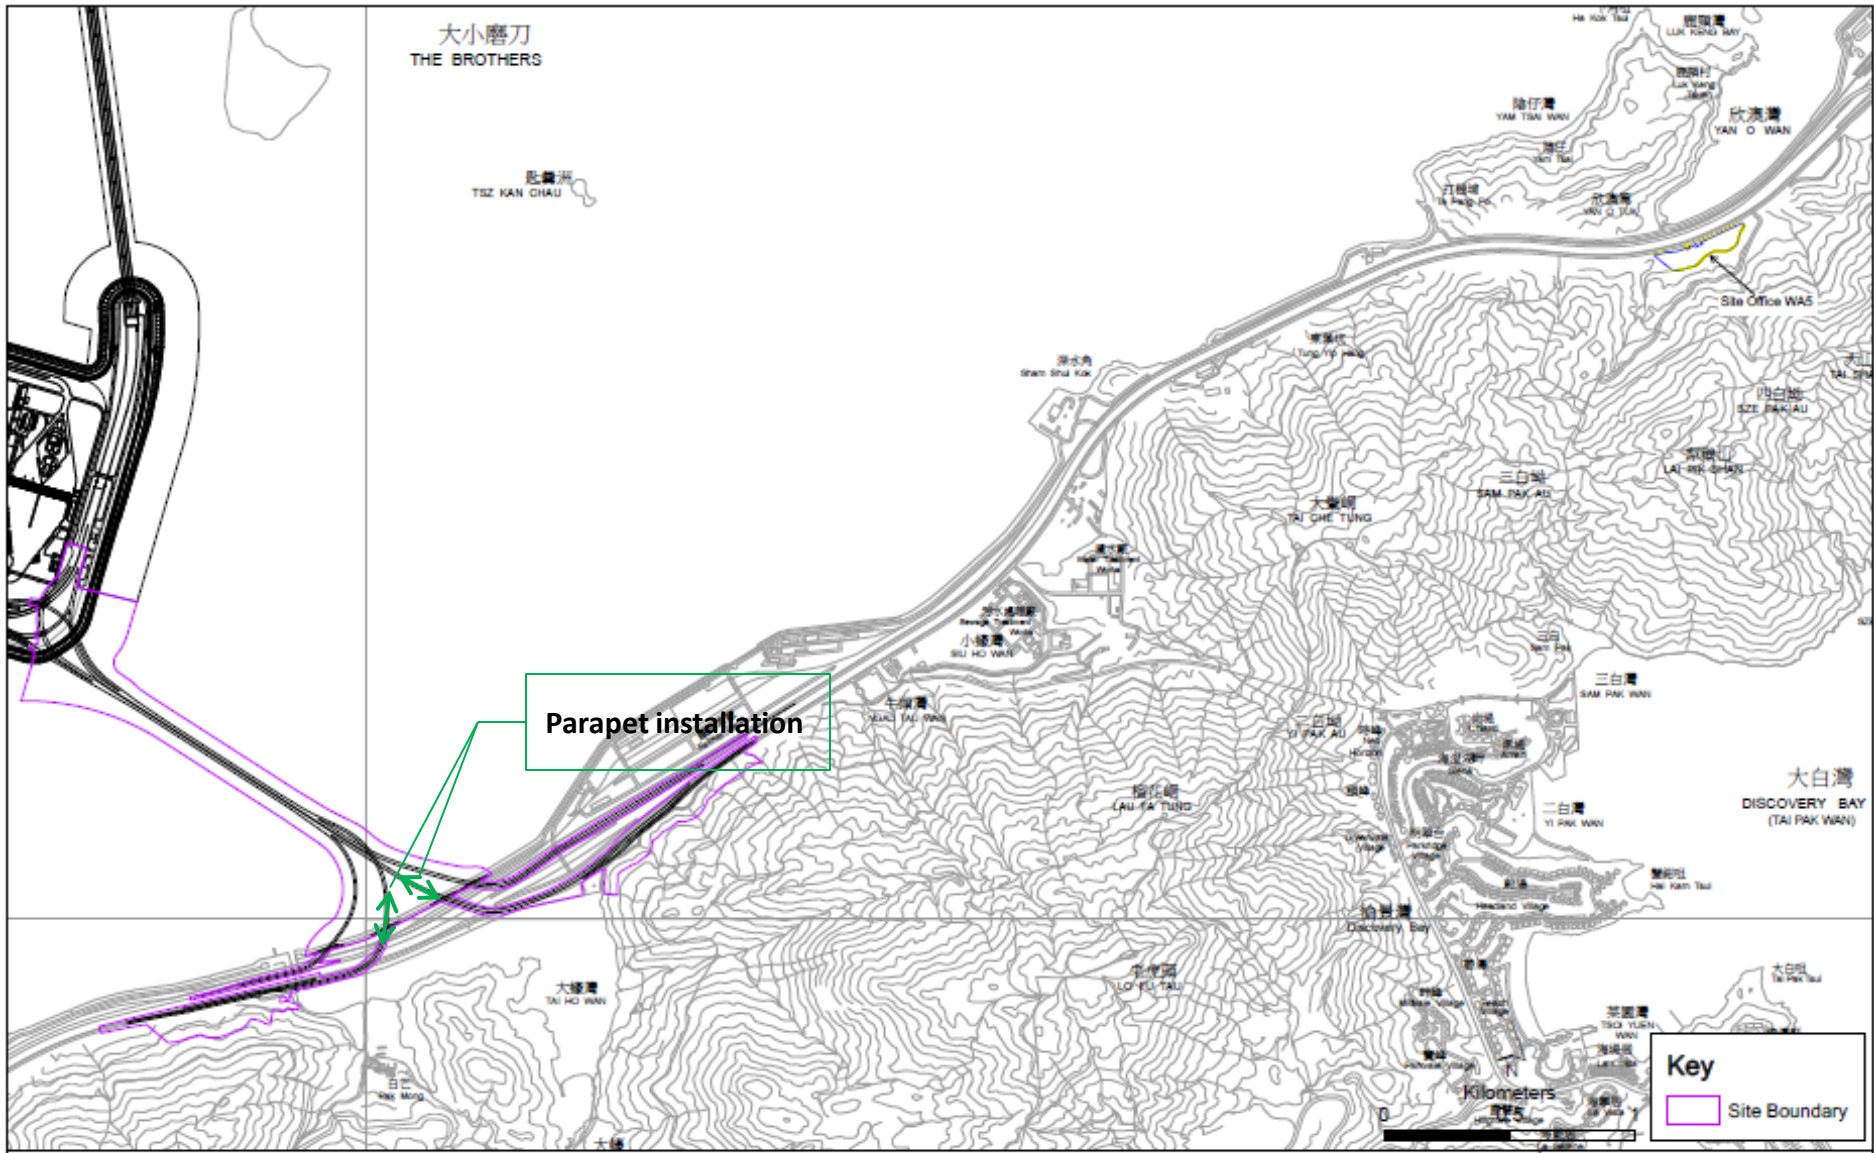
Figure 1

Work records of the concerned period were reviewed upon receiving the complaint. Based on the work records provided by the Contractor, works nearby Tai Ho Wan during the previous week of the complaint log date was mainly parapet installation at Viaduct B (Pier B6-B8) and Viaduct C (Pier C4-C6) (Figure 1). No record of falling objects from height was reported during the concerned period.

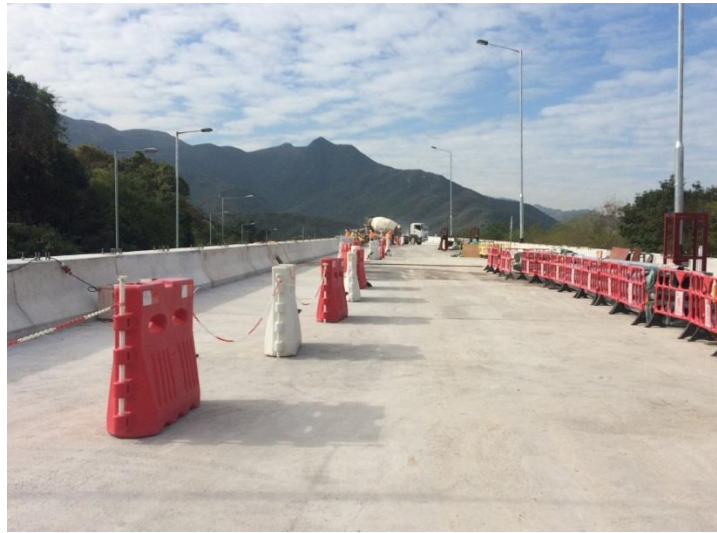
Photo 1 - Adequate housekeeping was maintained at site  
(10 January 2018)

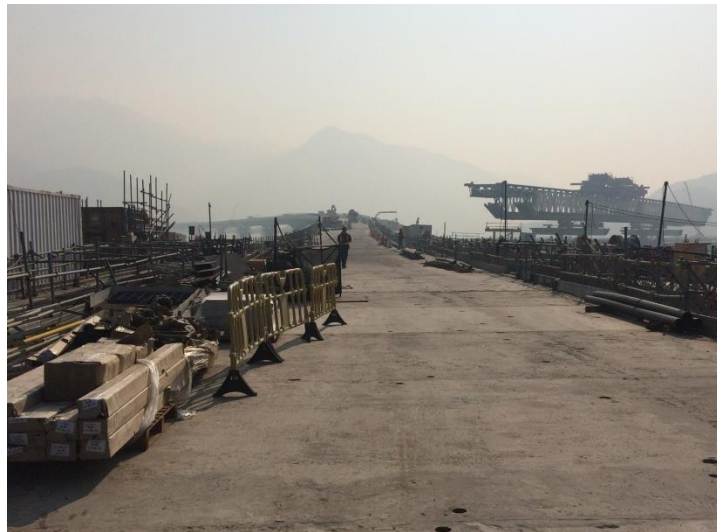
Photo 2 - Construction materials were stored at the designated areas  
(17 January 2018)

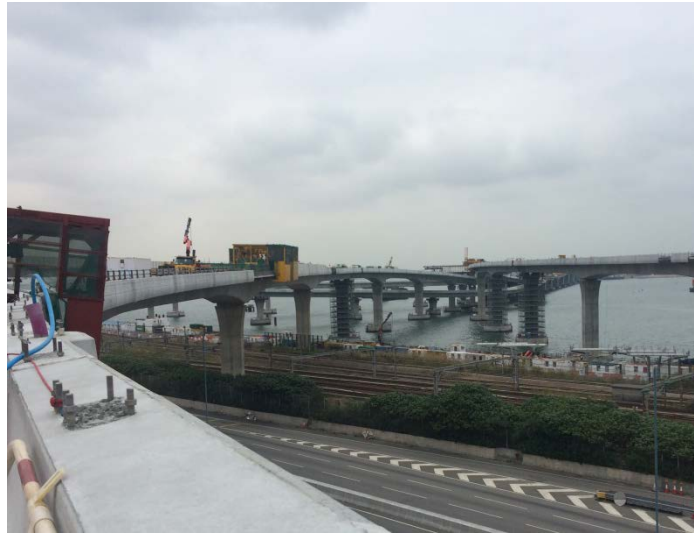
A joint site inspection amongst ENPO, Supervising Officer's Representative (SOR) and ET was held on 29 January 2018. During the joint site inspection, it was observed that majority of the parapets were completely installed as safety barrier at the edge of viaducts. For small gaps and openings, 200mm high toe-board and erected guard-rails (450-600mm for mid rail and 900-1150mm for top rail) were installed to prevent falling objects (Annex B).

Photo 1 - Parapet installation at Viaduct B and C

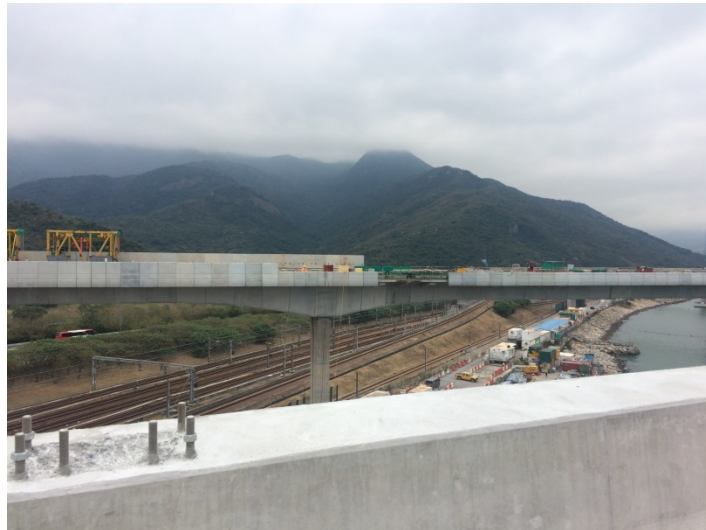
Photo 2 - Land portion of Viaduct B (near Tai Ho Wan)

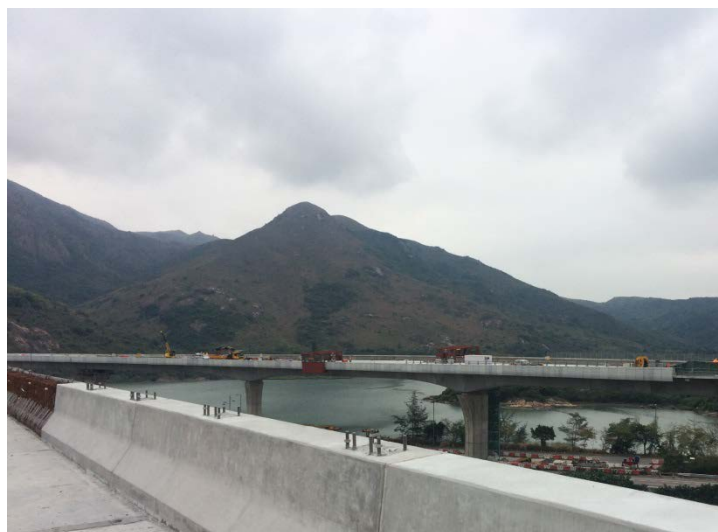
Photo 3 - Land portion of Viaduct C (near Tai Ho Wan)

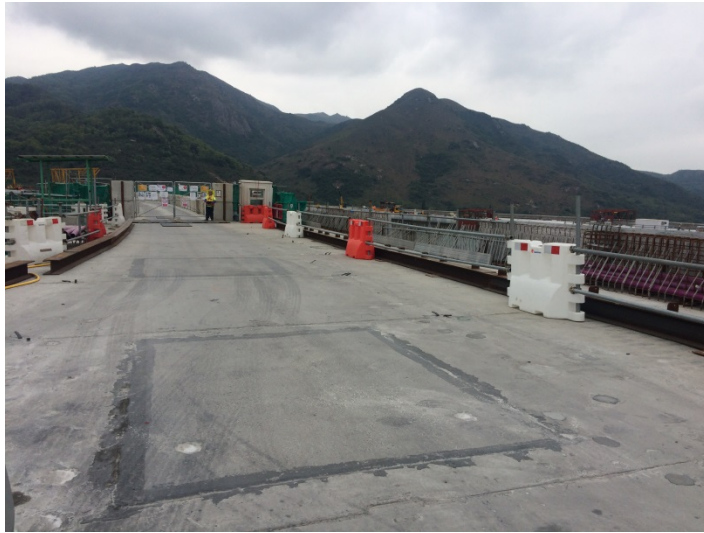
Photo 4 - High toe-board and erected guard-rails were installed between gaps

The Contractor has been reminded to maintain waste management practices and increase training frequency for the workers. In addition, the Contractor has been reminded to review the safety measures in all construction areas under this Contract to prevent falling objects from height. Moreover, the Contractor has been reminded to implement relevant environmental protection measures specified in the Environmental Permits and EM&A Manual of the Tuen Mun-Chek Lap Kok Link Project to mitigate the impacts on dolphins.

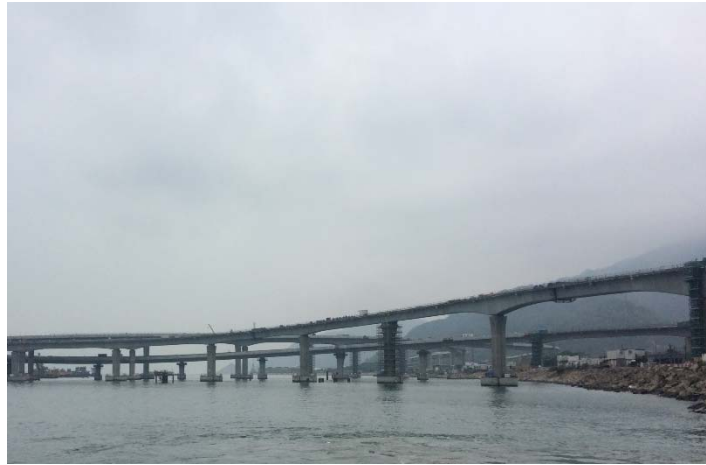
A joint investigation was conducted on 30 January 2018 by ET, EPD, the Contractor, and SOR. Construction works and corresponding safety measures at the Project areas nearby Tai Ho Wan were inspected. On-site implementation of DEZ was reviewed. No falling objects from elevated structures/sighting of dolphins were observed during the joint investigation (Annex C).

Photo 1 - Overview of the Project area (near Tai Ho Wan)

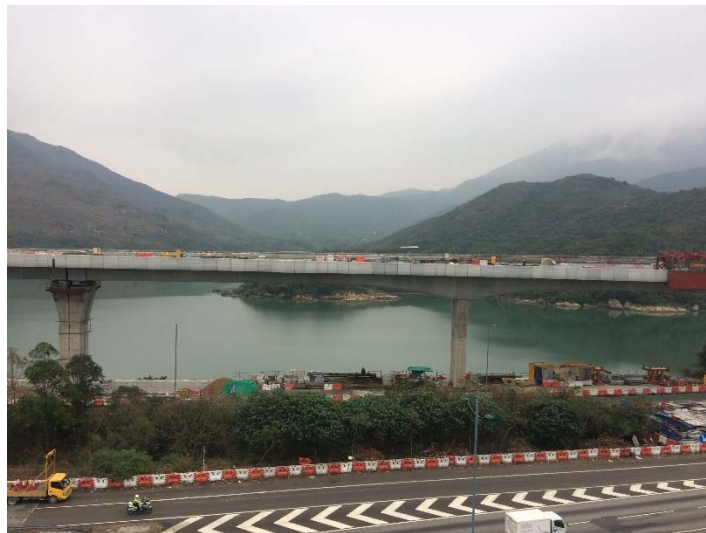
Photo 2 - Land portion of Viaduct D (near Tai Ho Wan)
