ENVIRONMENTAL COMPLAINT/ ENQUIRY INVESTIGATION REPORT

Our Reference: 0212330_25April2014_CompLog_01

Annex A Photo Records taken during Environmental Site Inspection

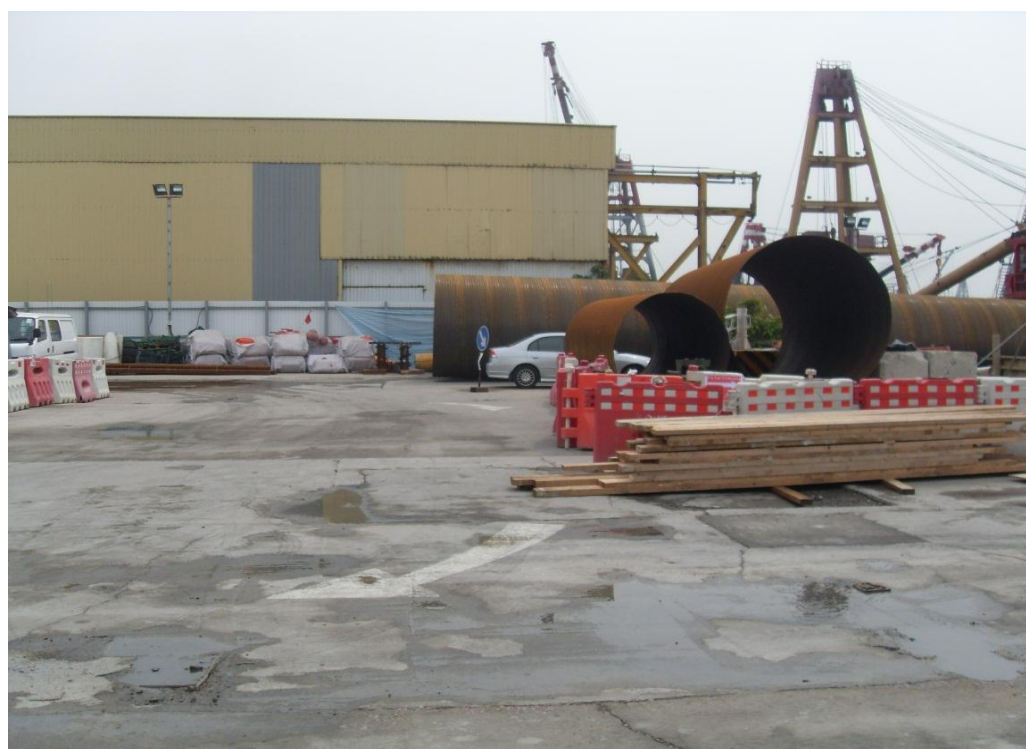
The ground was observed wet during site inspection. Water spraying was applied regularly in the construction site - Portion N6.
