Contract No. HY/2012/08 Tuen Mun - Chek Lap Kok Link -Northern Connection Sub-sea Tunnel Section

ENVIRONMENTAL COMPLAINT/ENQUIRY INVESTIGATION REPORT

Our Reference: 0212330_Complaint LOG_20170117_11

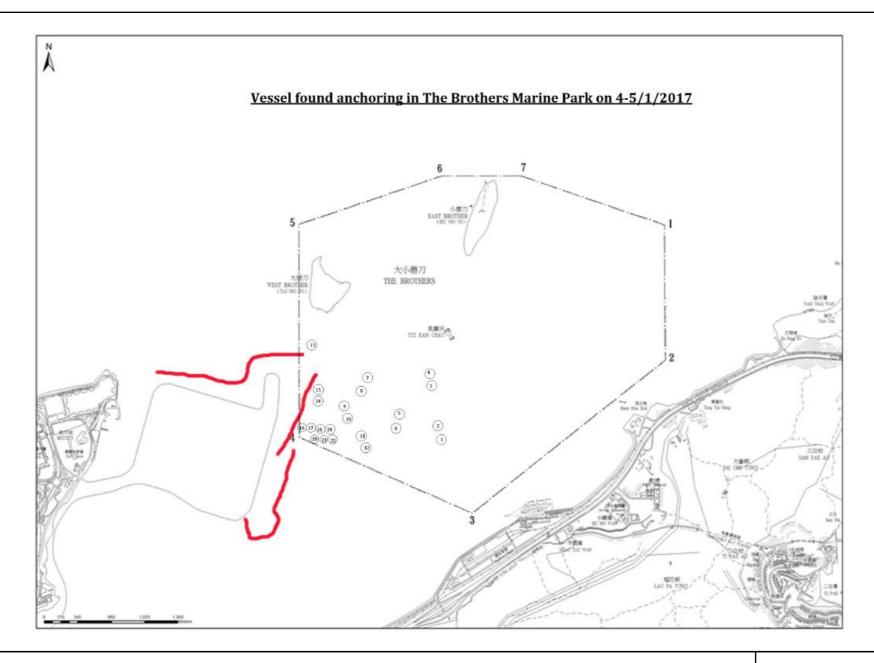
On 13 January 2017, AFCD was informed by project team of BCF that the Northeaster section of HKBCF perimeter silt curtain was found within the BMP while construction vessels were anchored within the BMP during the inspection on 4 and 5 January 2017(see *Figure 1*). The Contractor, the Environmental Team (ET) and SOR received the enquiry from IEC on 17 January 2017.

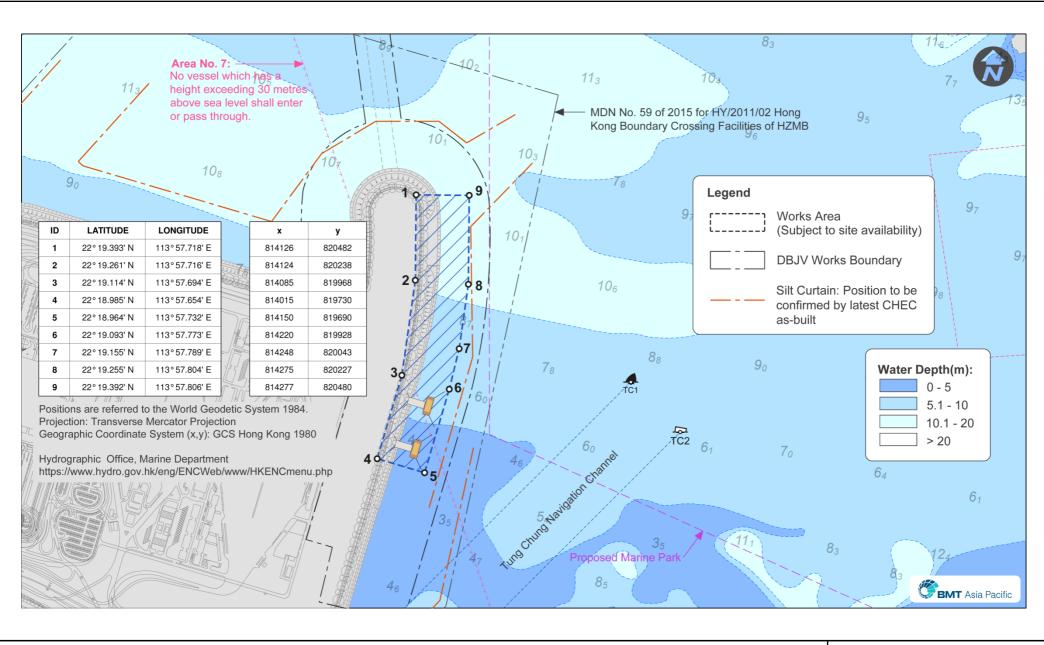
Figure 2 Location Map of site area

According to the vessel operation record provided by the Contractor, there were no DBJV construction vessels operating within the BMP during the above period. None of the construction vessels in the list provided by AFCD were employed under this Contract. According to the construction programme, major marine works in this month were mainly dredging and construction of vertical seawall at Portion N-A. All Contract-related construction vessels were found working inside the project site boundary. Location map of site area and travel route of marine vessels and barges are provided (see *Figure 2 and Figure 3*).
