CONTRACT NO. HY/2012/08
 TUEN MUN – CHEK LAP KOK LINK –
 NORTHERN CONNECTION SUB-SEA TUNNEL SECTION

Air Quality Impact Monitoring
 Notification of Exceedance

Log No.	0212330_3February2018_1hrTSP_Station ASR1 0212330_3February2018_1hrTSP_Station ASR5 [Total No. of Exceedances = 2]	
Date	3 February 2018 (Measured) 13 February 2018 (Laboratory results received by ERM)	
Monitoring Station	ASR1, ASR5, ASR6, ASR10 and AQMS1	
Parameter(s) with Exceedance(s)	1-hr TSP	
Action Levels	24-hr TSP ($\mu\text{g}/\text{m}^3$)	ASR1 = 213 ASR5 = 238 AQMS1 = 213 ASR6 = 238 ASR10 = 214
	1-hr TSP ($\mu\text{g}/\text{m}^3$)	ASR1 = 331 ASR5 = 340 AQMS1 = 335 ASR6 = 338 ASR10 = 337
Limit Levels	1-hr TSP ($\mu\text{g}/\text{m}^3$)	500
	24-hr TSP ($\mu\text{g}/\text{m}^3$)	260
Measured Levels	Action Level Exceedance for 1-hr TSP is observed at ASR1 (392 $\mu\text{g}/\text{m}^3$) during 0900 – 1000 hrs. Action Level Exceedance for 1-hr TSP is observed at ASR5 (455 $\mu\text{g}/\text{m}^3$) during 0849 – 0949 hrs.	
Works Undertaken (at the time of monitoring event)	On 3 February 2018, box culvert extension was carried out at Works Area Portion N-A and Construction of Ventilation Building at Portion N-C.

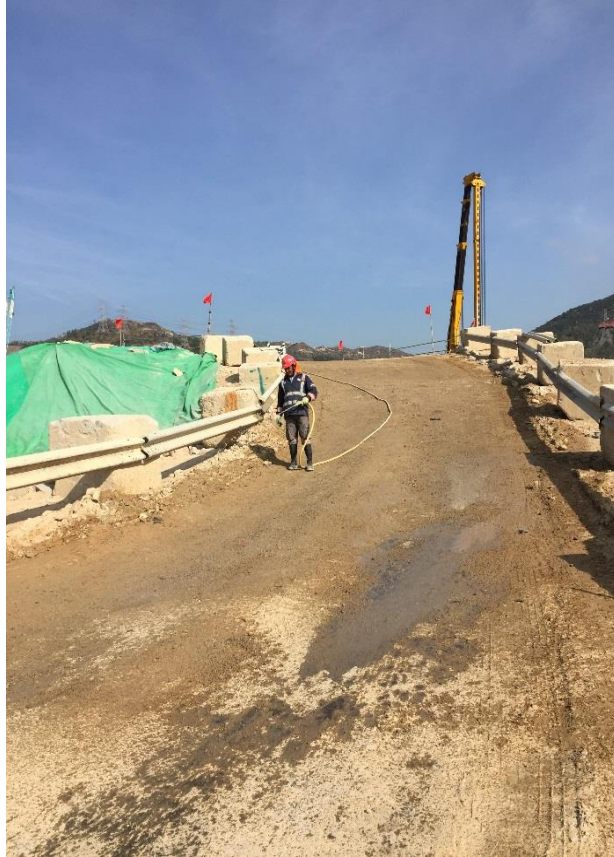
Water spraying was applied frequently on site.
(Works Area Portion N-A)

Actions Taken/ To Be Taken	<p>Follow up site inspection was carried out on 14 February 2018. Box culvert extension was carried out at Works Area Portion N-A and Construction of Ventilation Building was carried out at Portion N-C. Exposed soil at Portion N-A was covered by tarpaulin sheets and water spraying was also applied to prevent dust. Photo record is provided in Annex A. Photos taken during AQM were also provided. No significant dust impact was observed at ASR1 and ASR5. Dust suppression measures were properly implemented during the site inspections. Based on the above, no additional action is required.</p> <p>The Contractor has been reminded to implement the required mitigation measures as per the EP, approved EIA and Updated EM&A Manual including watering to maintain all exposed road surfaces and dust sources wet, use of sprinklers for water spraying, covering the materials having the potential to create dust by clean tarpaulin, use of water truck and watering on all exposed soil within the Project site) throughout the construction period. The Contractor was also reminded to ensure all dust mitigating measures are provided at Portion N-A and Portion N-C, where the construction works are carried out.</p>

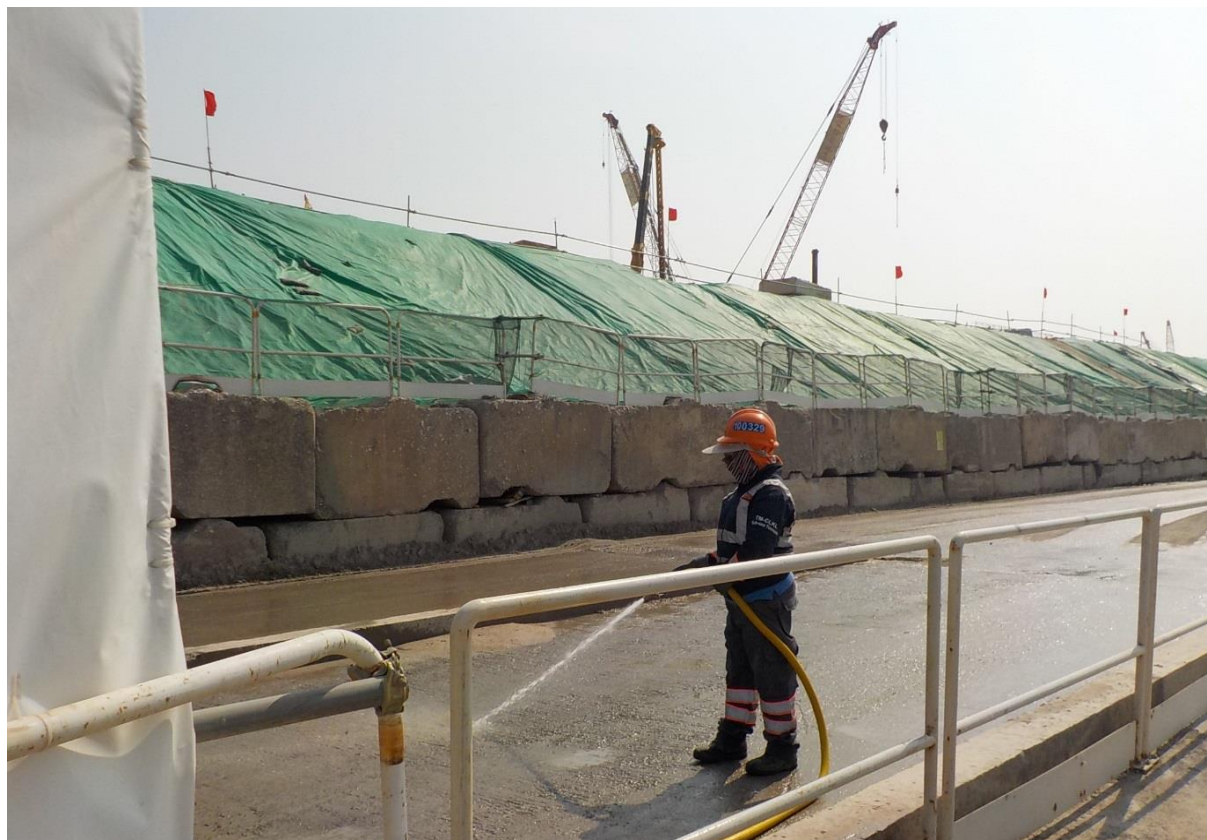
Exposed soil at Portion N-A was covered by tarpaulin sheets. (Works Area Portion N-A)

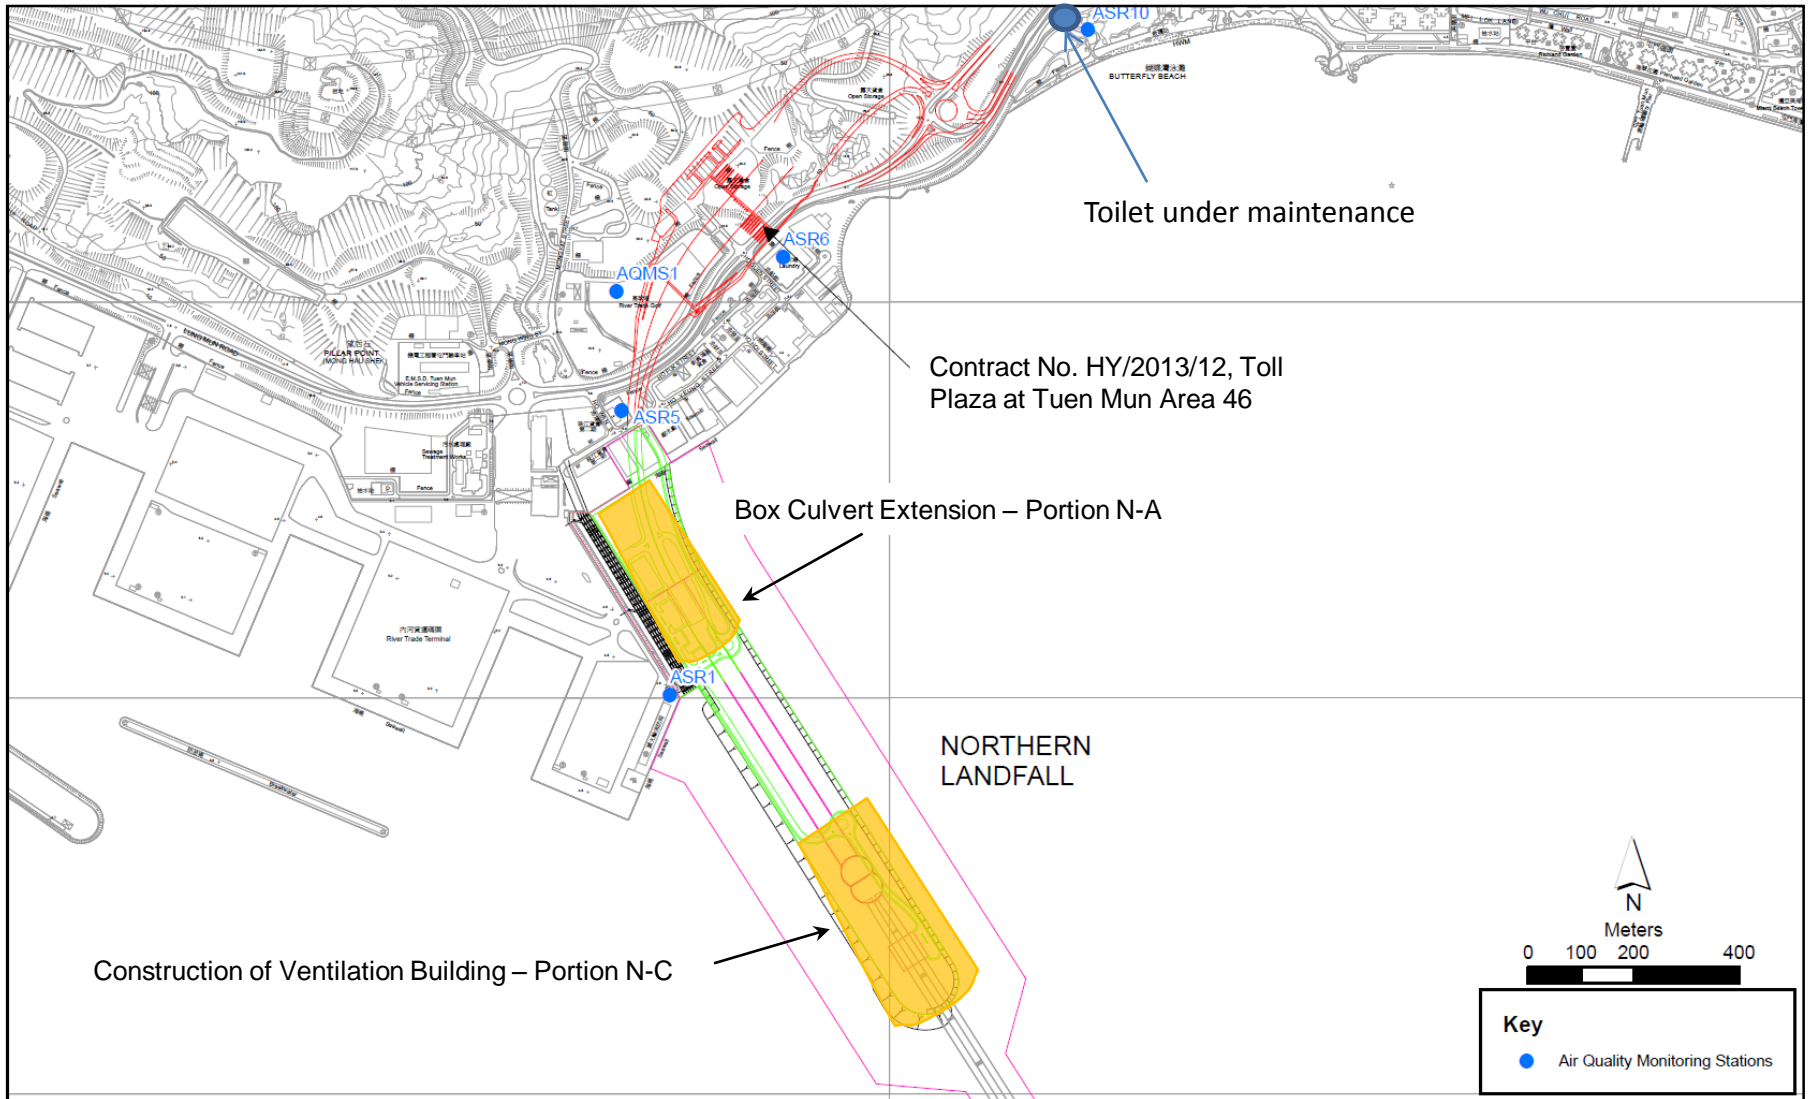
Figure 1

Indicative Construction Works Area on 3 February 2018
