Subject Notification of Exceedance for Air Quality
Impact Monitoring

CONTRACT NO. HY/2012/08
 TUEN MUN – CHEK LAP KOK LINK –
 NORTHERN CONNECTION SUB-SEA TUNNEL SECTION

Air Quality Impact Monitoring
 Notification of Exceedance

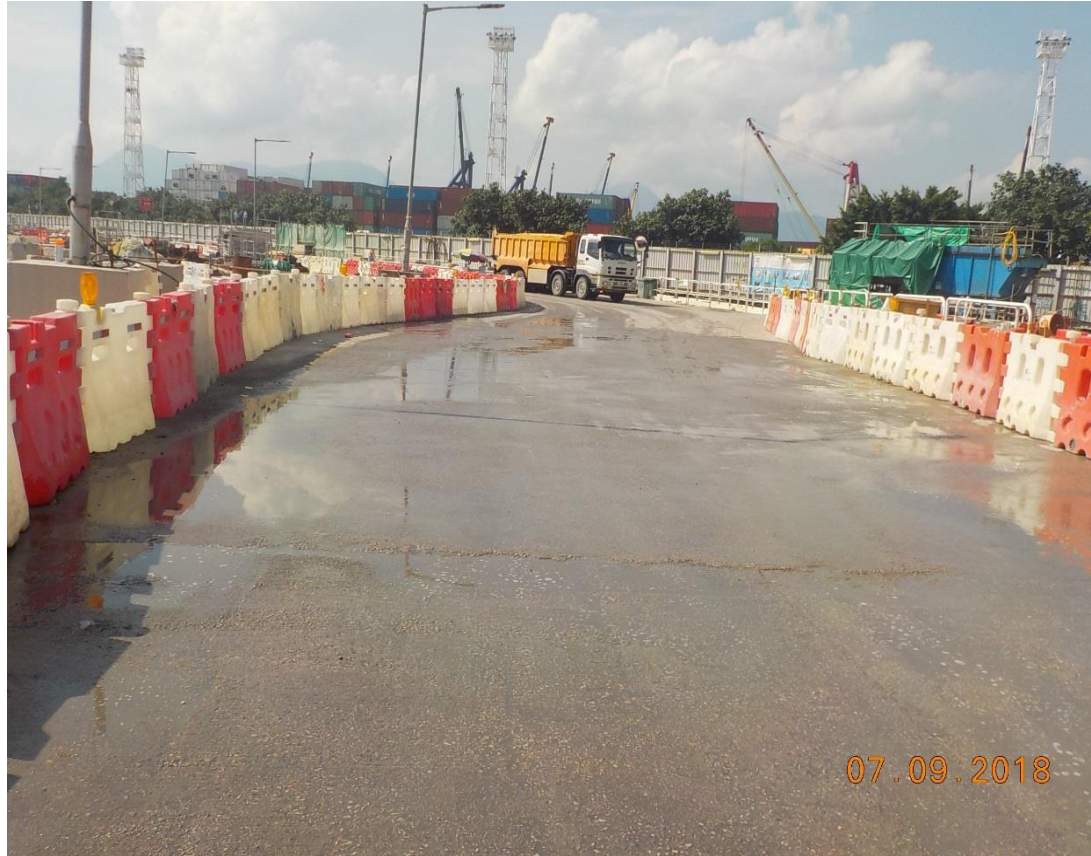
Water spraying was applied frequently on site. (Works Area Portion N-A)

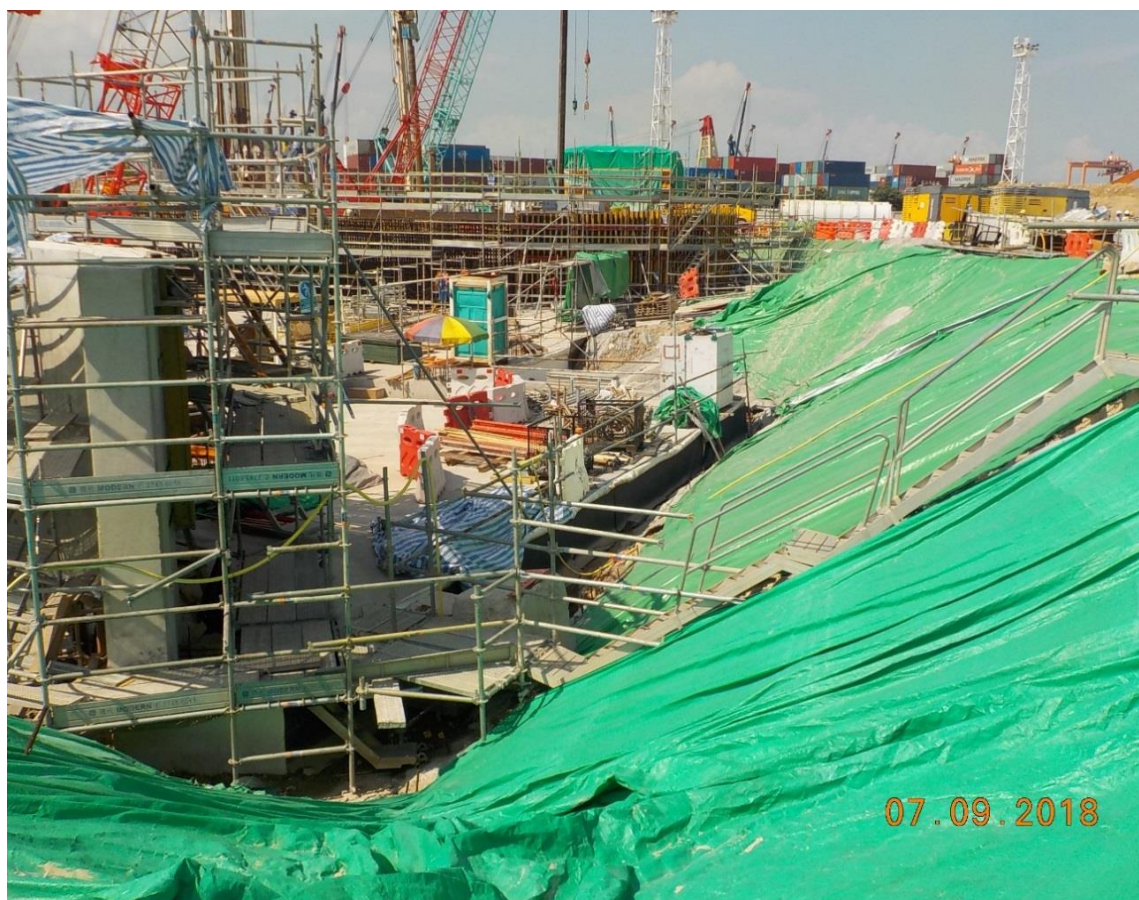
Exposed soil at Portion N-A was covered by tarpaulin sheets. (Works Area Portion N-A)

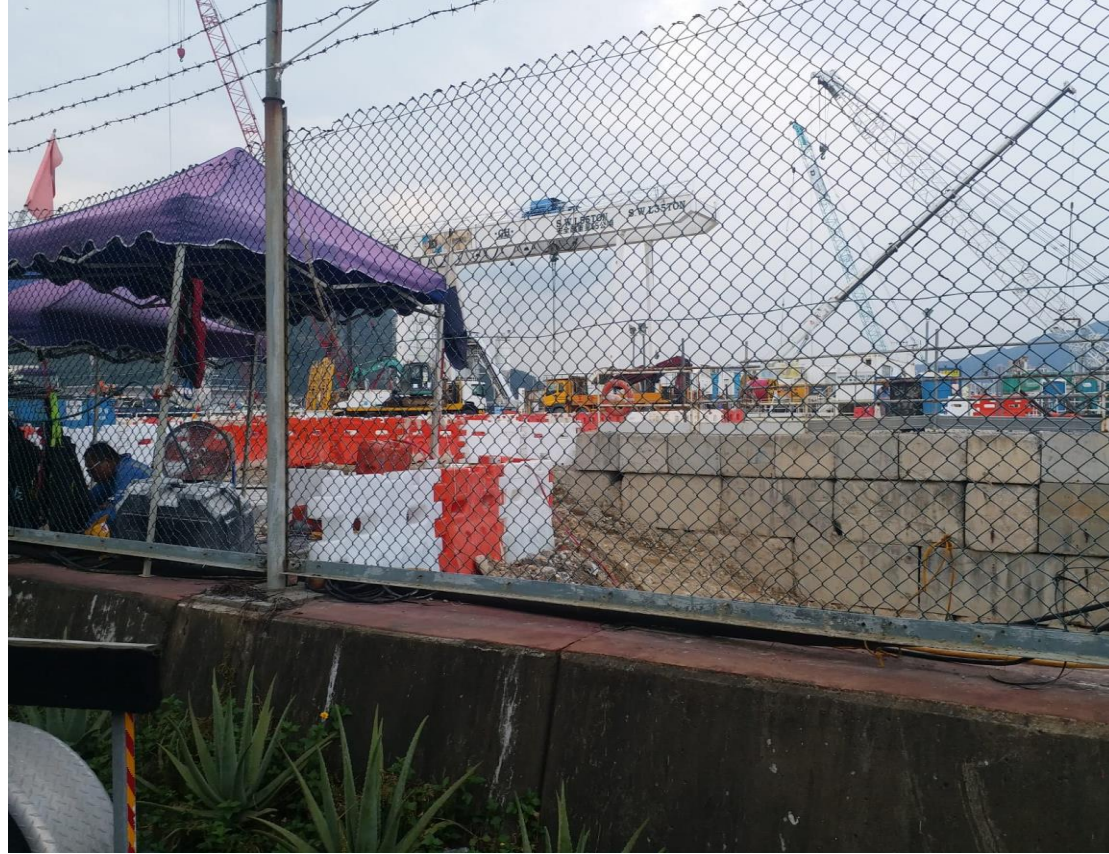
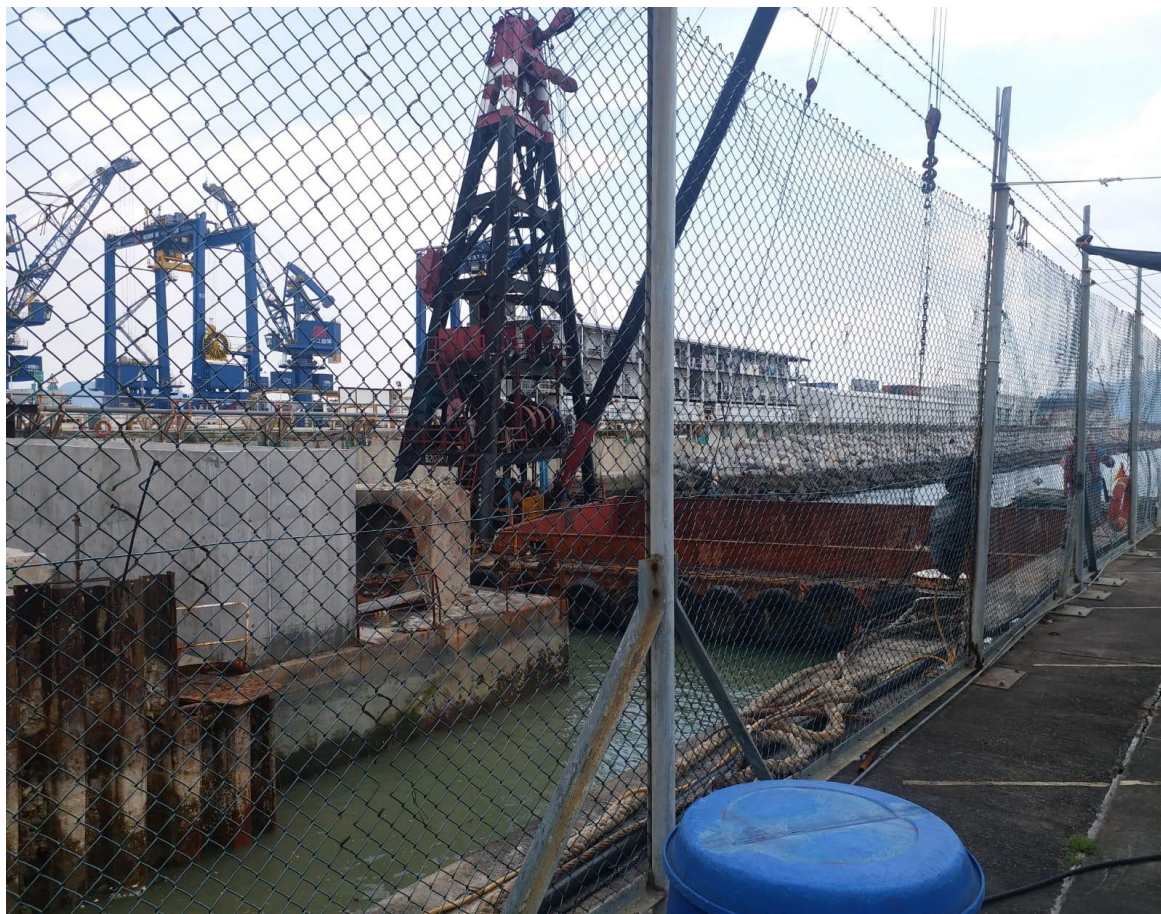
ASR1

Actions Taken/ To Be Taken	<p>According to the construction information provided by the Contractor, no ground construction works were carried out on 7 September 2018. Water spraying was applied to prevent dust. Photos taken during AQM were provided in Annex A. No significant dust impact was observed at ASR1. Follow-up site inspection was carried out on 21 September 2018. Dust suppression measures were properly implemented during the site inspections. Photos are provided in Annex A. Based on the above, no additional action is required.</p> <p>The Contractor has been reminded to implement the required mitigation measures as per the EP, approved EIA and Updated EM&A Manual including watering to maintain all exposed road surfaces and dust sources wet, use of sprinklers for water spraying, covering the materials having the potential to create dust by clean tarpaulin, use of water truck and watering on all exposed soil within the Project site) throughout the construction period. The Contractor was also reminded to ensure all dust mitigation measures are provided at Portion N-A and Portion N-C, where the construction works are carried out.</p>

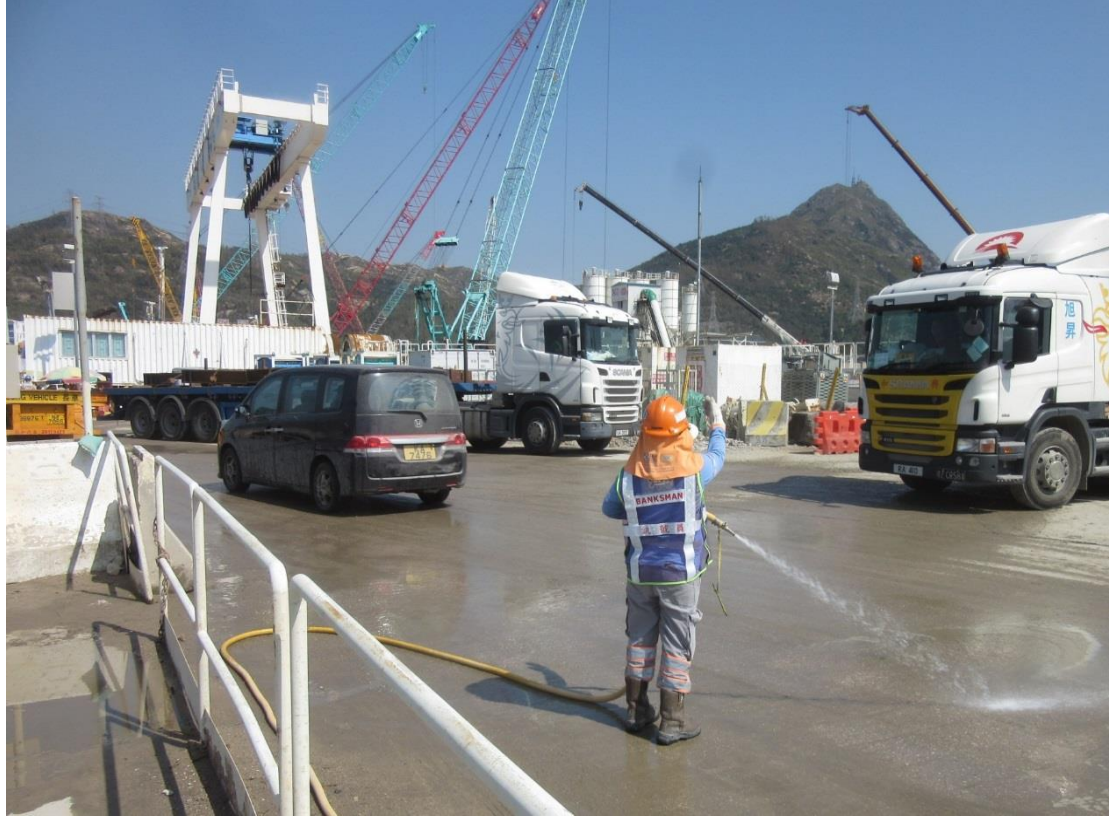
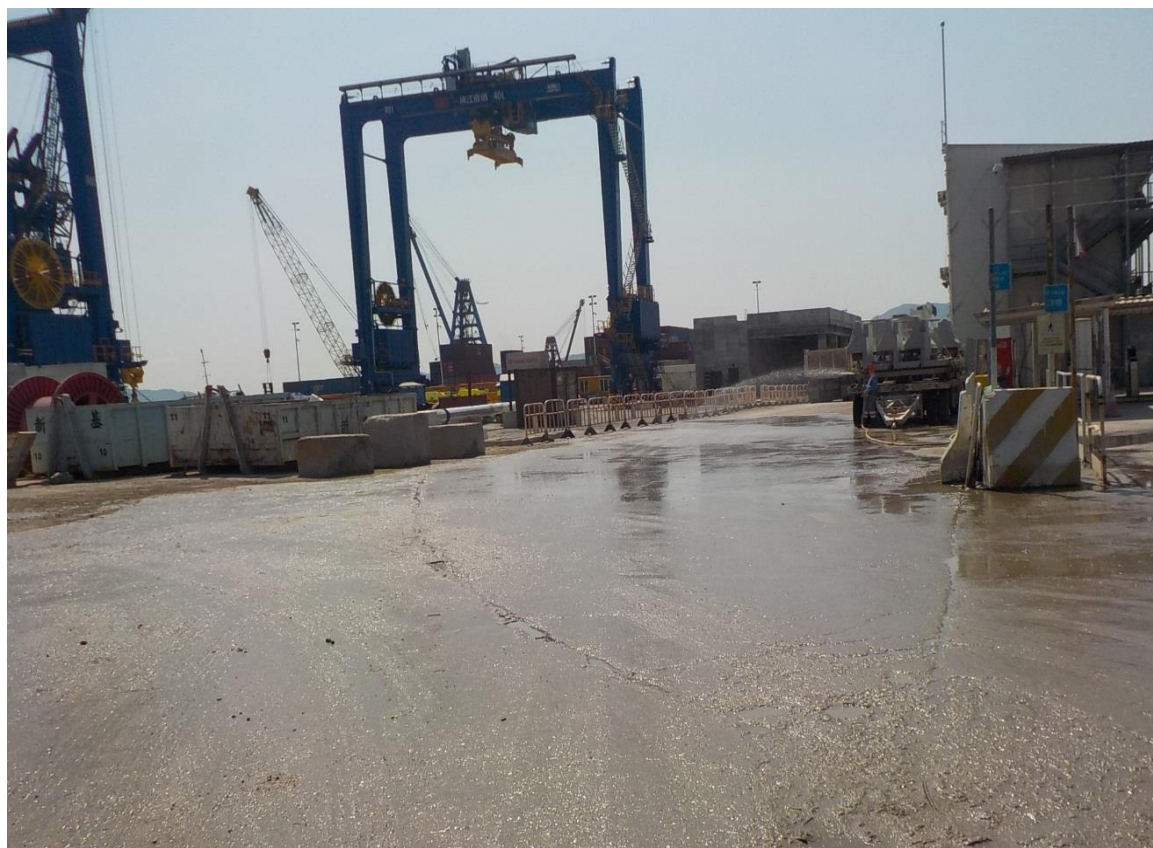
Water spraying are applied frequently.

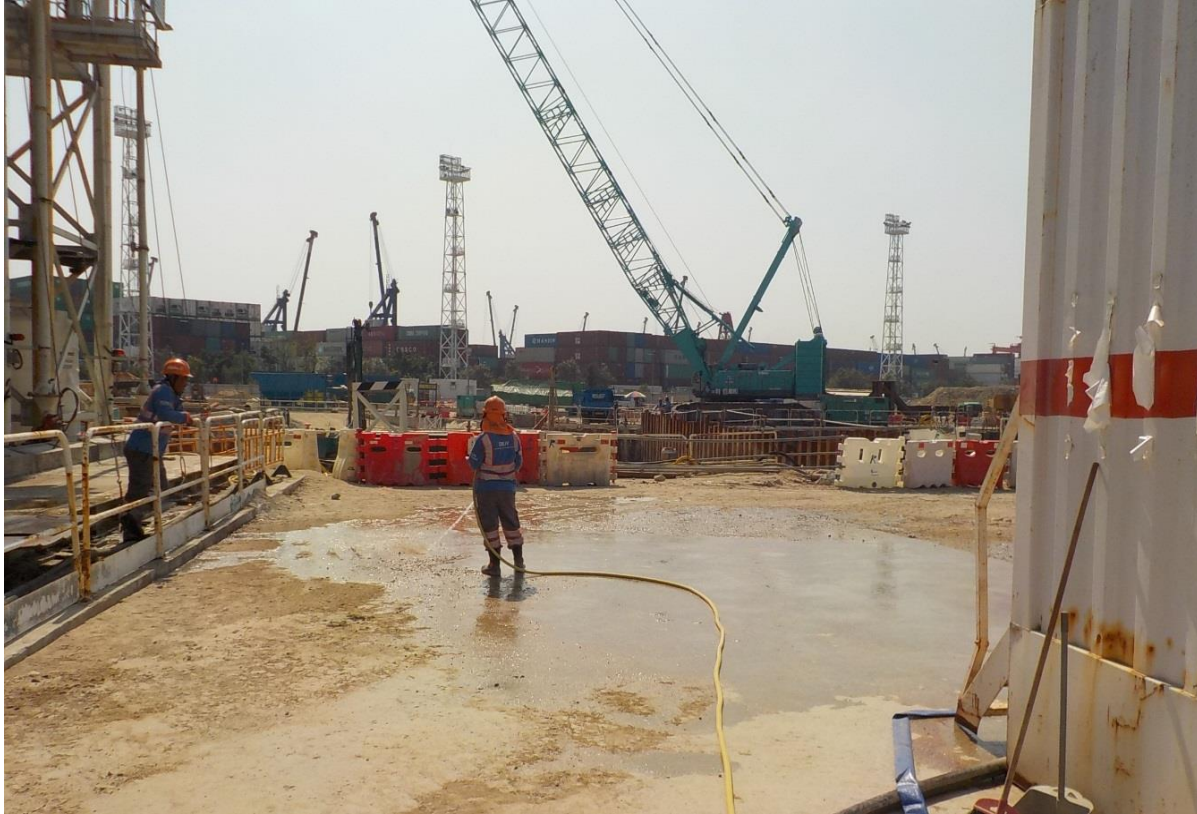
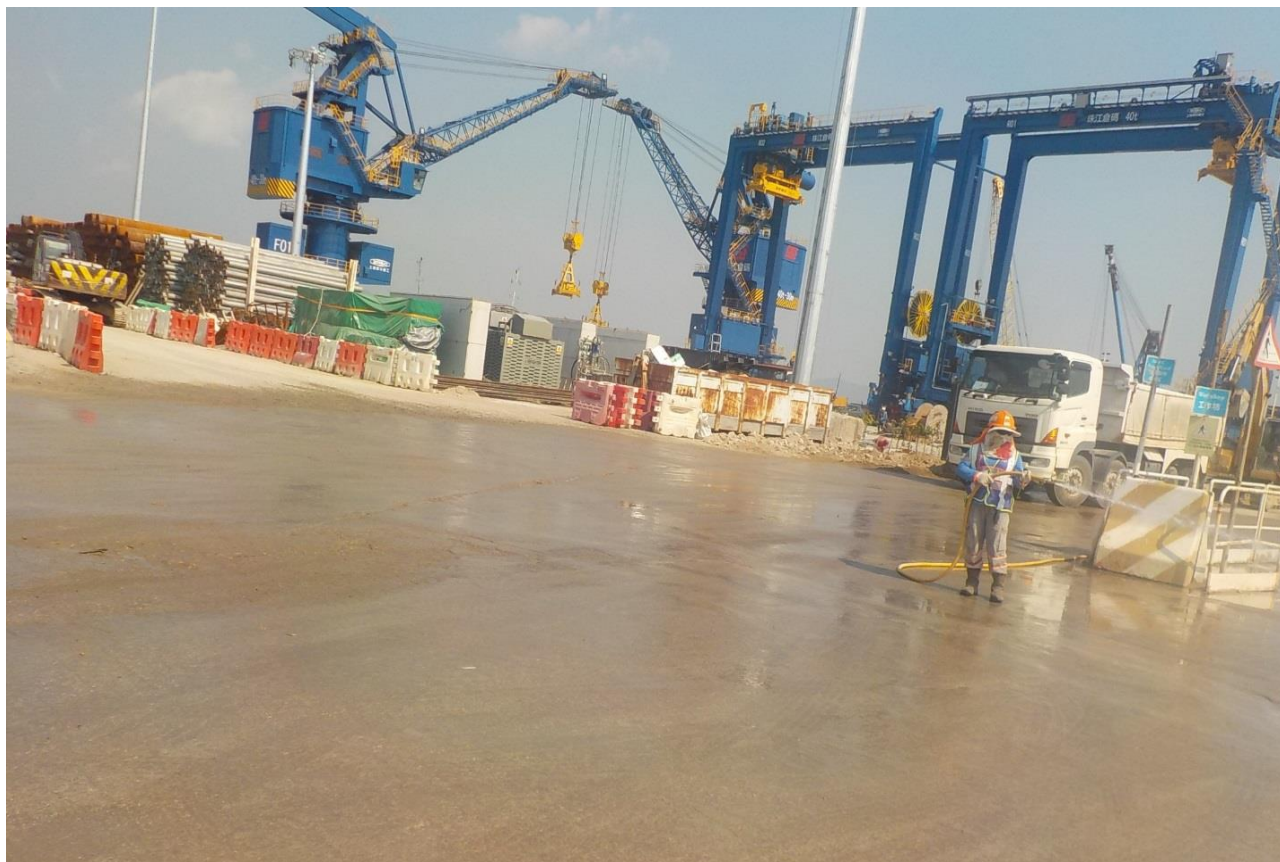
Water spraying was applied frequently on site. (Works Area Portion N-A)

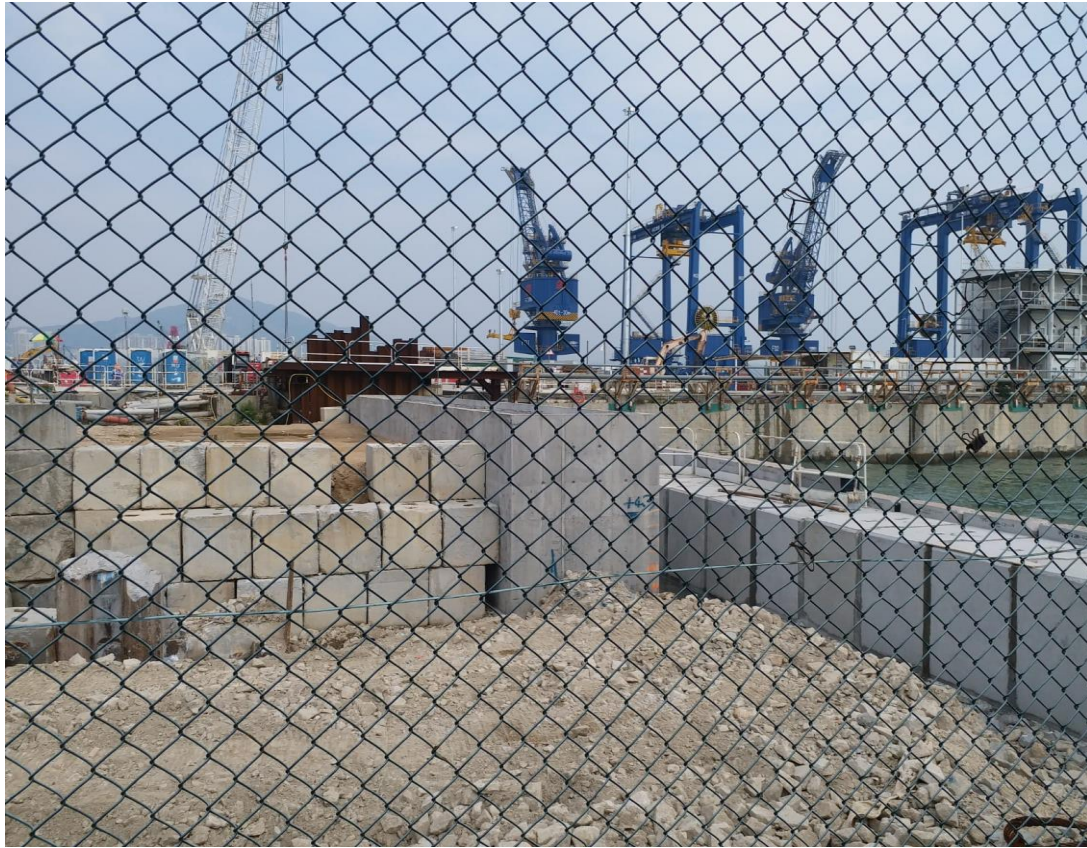
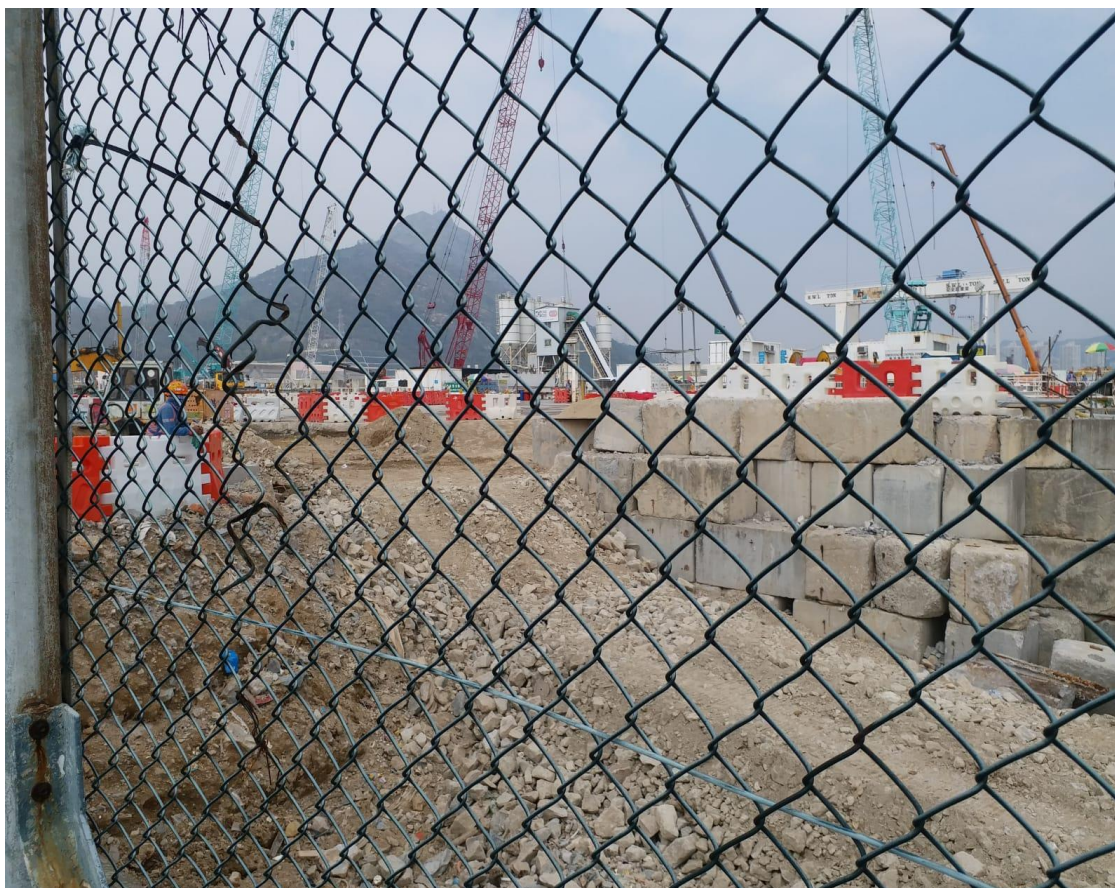
Actions Taken/ To Be Taken	<p>According to the construction information provided by the Contractor, no ground construction works were carried out on 28 September 2018. Water spraying was applied to prevent dust. Photos taken during AQM were provided in Annex A. No significant dust impact was observed at ASR1. Site inspection was carried out on 10 October 2018 and ASR1 was also inspected. Dust suppression measures were properly implemented during the site inspections and no significant dust impact was observed at ASR1. Photos are provided in Annex A. Based on the above, no additional action is required.</p> <p>The Contractor has been reminded to implement the required mitigation measures as per the EP, approved EIA and Updated EM&A Manual including watering to maintain all exposed road surfaces and dust sources wet, use of sprinklers for water spraying, covering the materials having the potential to create dust by clean tarpaulin, use of water truck and watering on all exposed soil within the Project site) throughout the construction period.</p>

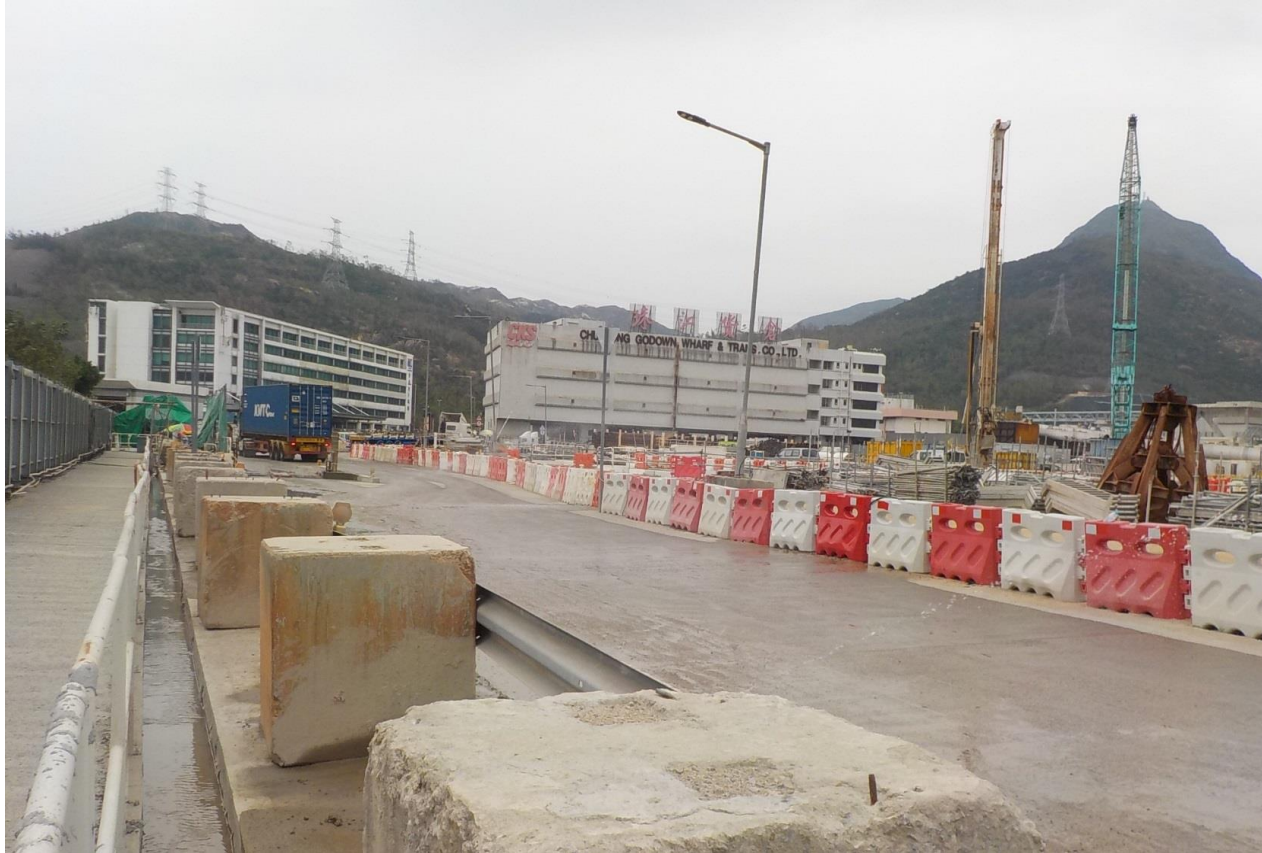
Water spraying was applied frequently on site. (Works Area Portion N-A)

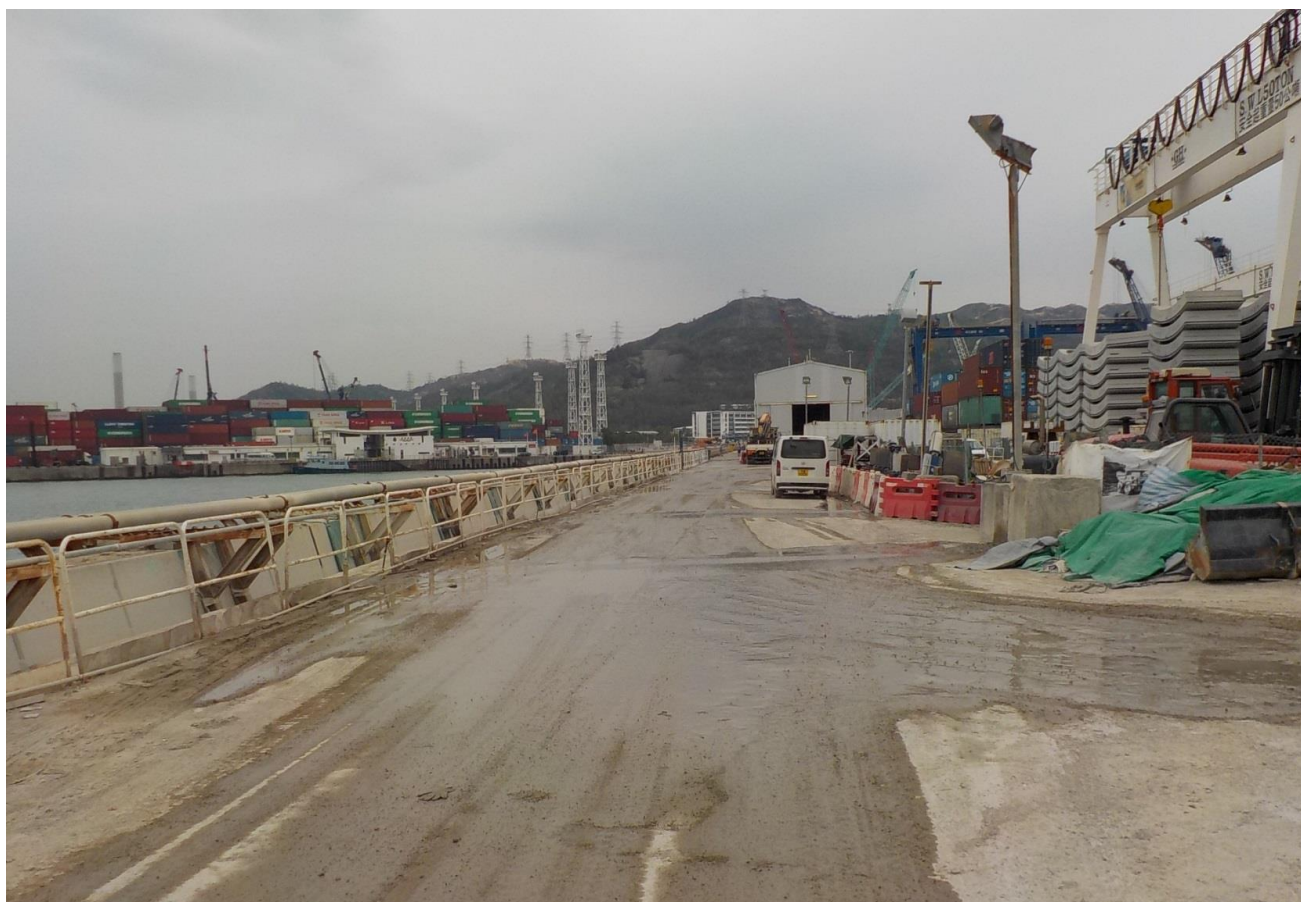
Water spraying was applied frequently on site. (Works Area Portion N-B)
