Appendix K

Ref/Project number Contract No. HY/2012/08 Tuen Mun–Chek Lap
Kok Link–Northern Connection Sub-sea Tunnel
Section

Subject Notification of Exceedance for Air Quality
Impact Monitoring

Air Quality Impact Monitoring
 Notification of Exceedance

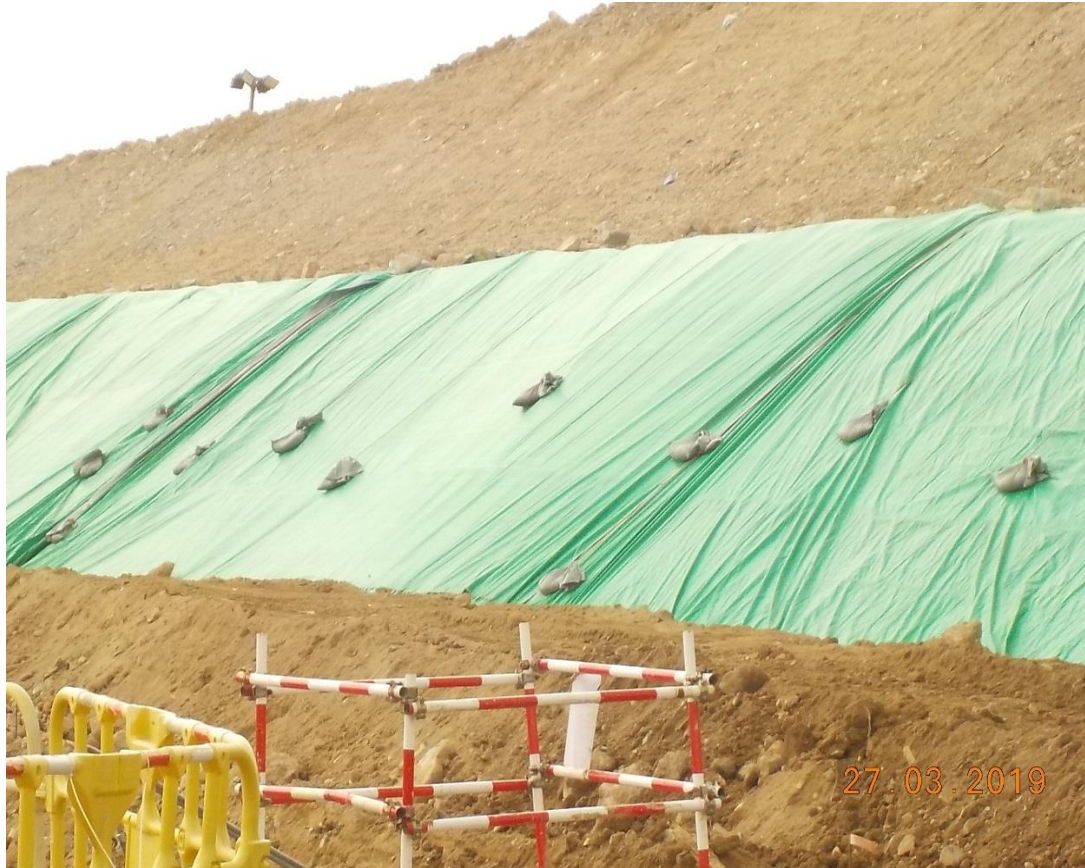
Exposed soil was covered by tarpaulin sheet to prevent dust. (Works Area Portion N-C)

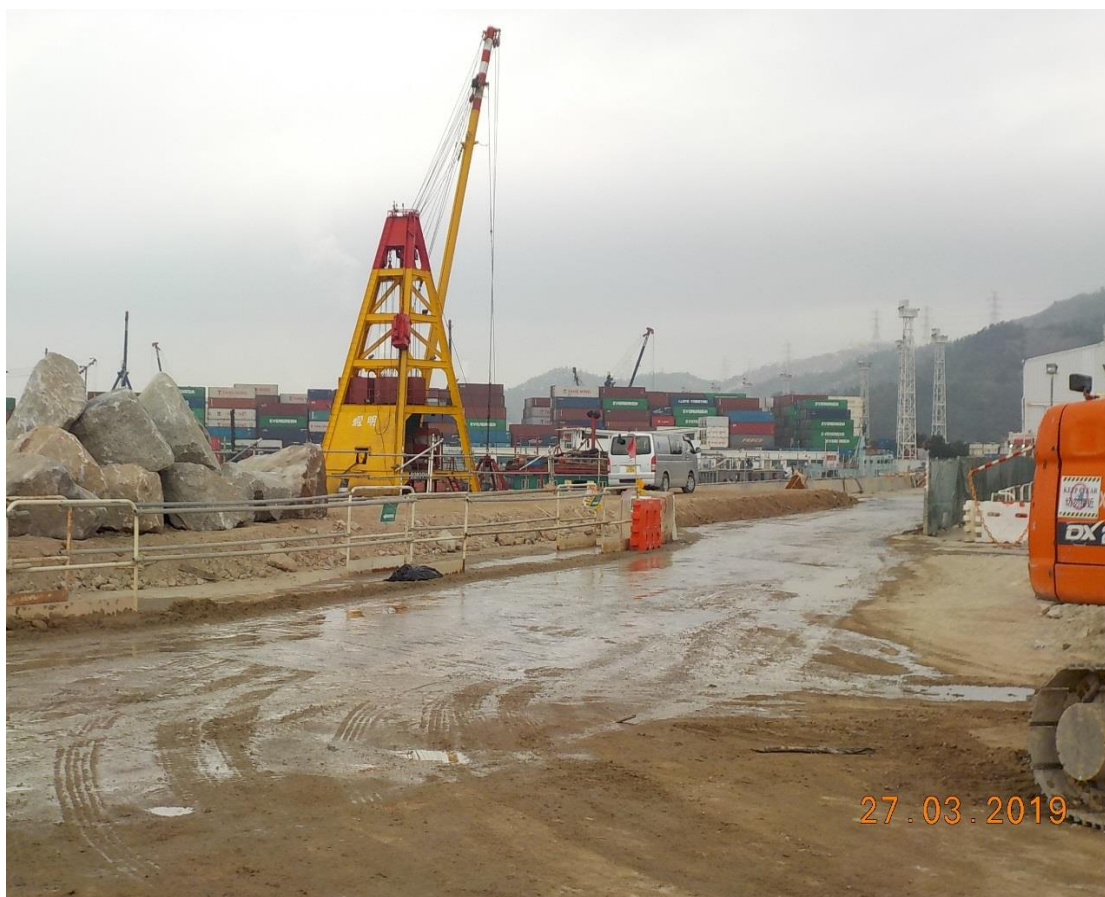
Water spraying was applied at the main haul road to prevent dust. (Works Area Portion N-A)

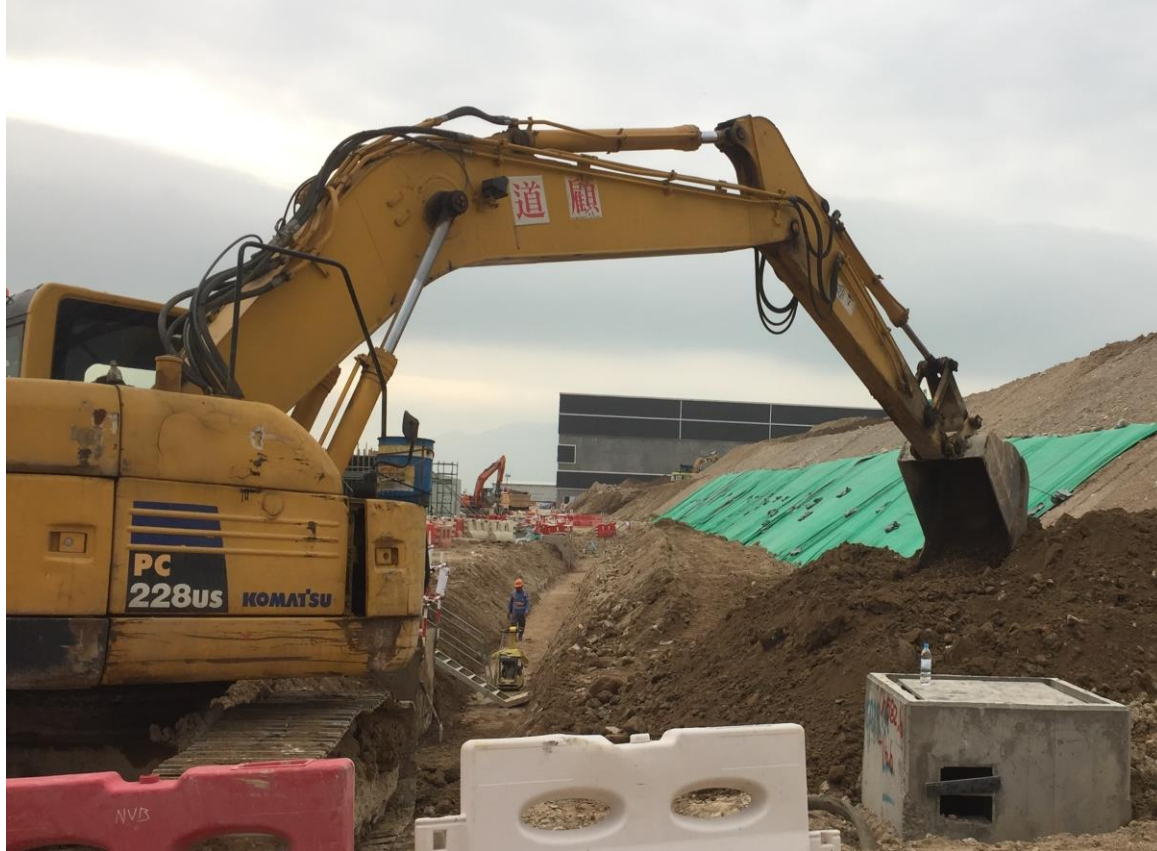
Exposed soil was covered by tarpaulin sheet to prevent dust. (Works Area Portion N-C)

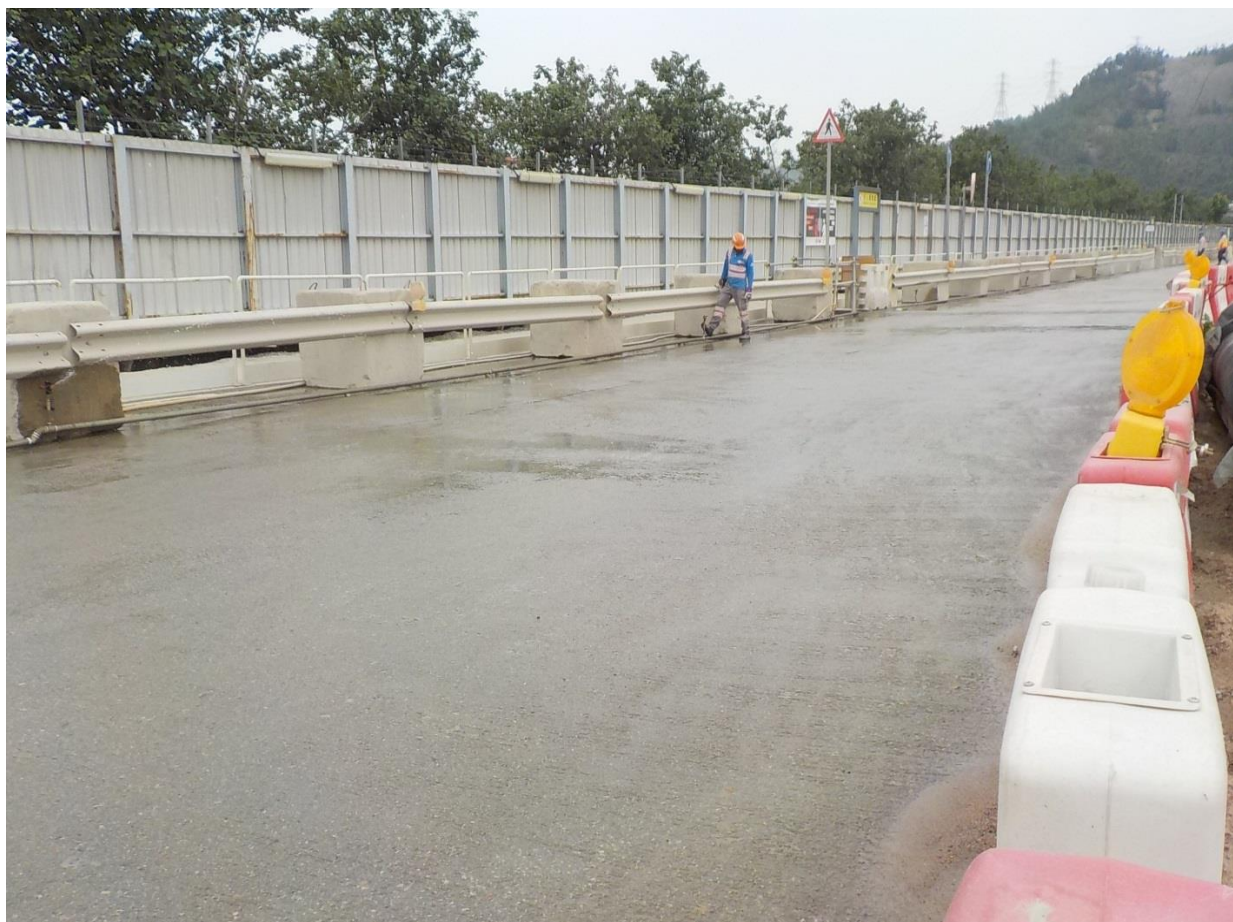
Water spraying was applied at the main haul road to prevent dust. (Works Area Portion N-A)
