Contract No. HY/2012/08 Tuen Mun-Chek Lap

Subject Notification of Exceedance for Air Quality

# CONTRACT NO. HY/2012/08 TUEN MUN - CHEK LAP KOK LINK NORTHERN CONNECTION SUB-SEA TUNNEL SECTION

## Air Quality Impact Monitoring Notification of Exceedance

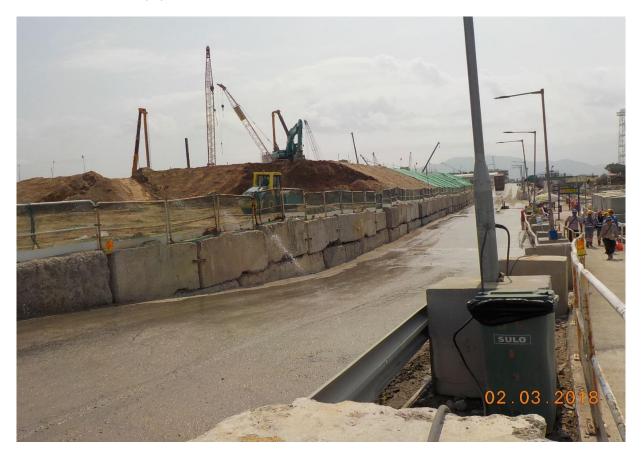
Water spraying was applied frequently on site. (Works Area Portion N-A)

As occasional exceedances were observed at ASR1, the Contractor has been reminded to enhance their dust mitigation measures at the works area, especially Portion N-A, which is closest to ASR1. Water spraying should be applied more frequently to prevent dust. The Contractor should also ensure that the exposed soil at Portion N-A was covered by tarpaulin sheets.

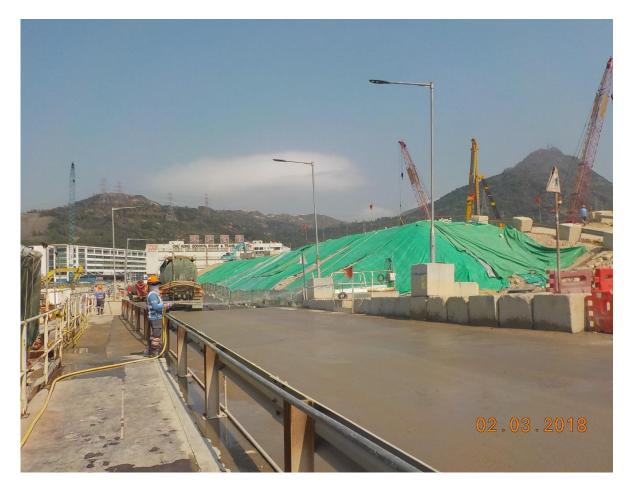
Exposed soil at Portion N-A was covered by tarpaulin sheets. (Works Area Portion N-A)

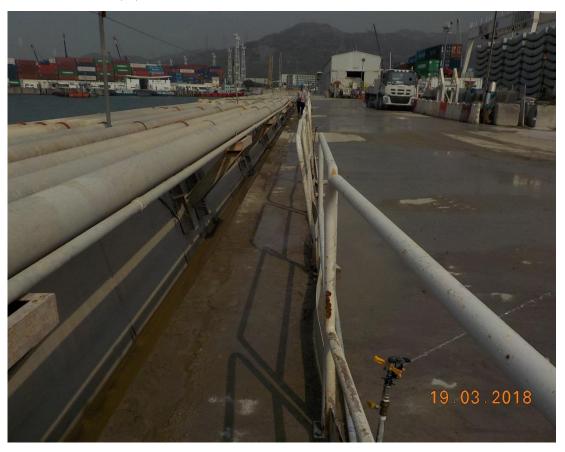
Water spraying was applied frequently on site. (Works Area Portion N-C)

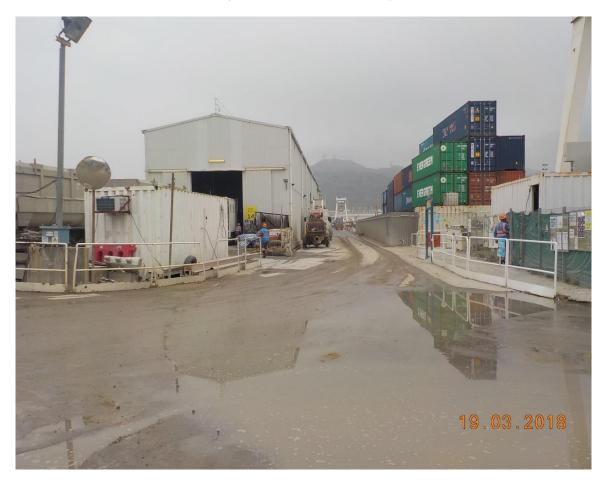
Water spraying was applied frequently on site. (Works Area Portion N-B)

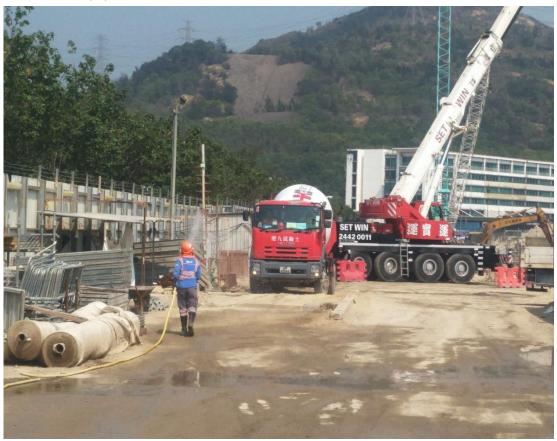
Water spraying was applied frequently on site. (Works Area Portion N-A)

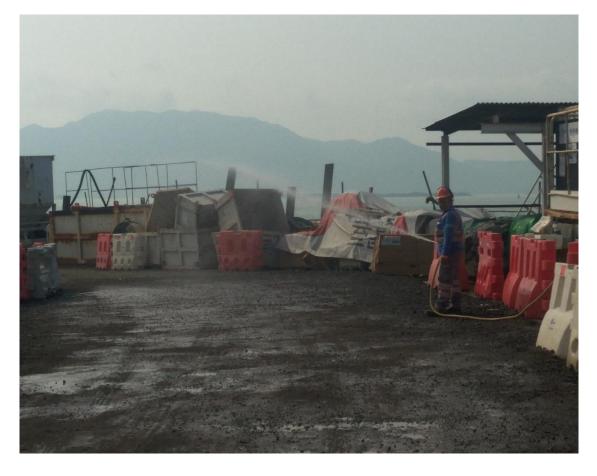
Water spraying was applied frequently on site. (Works Area Portion N-C)

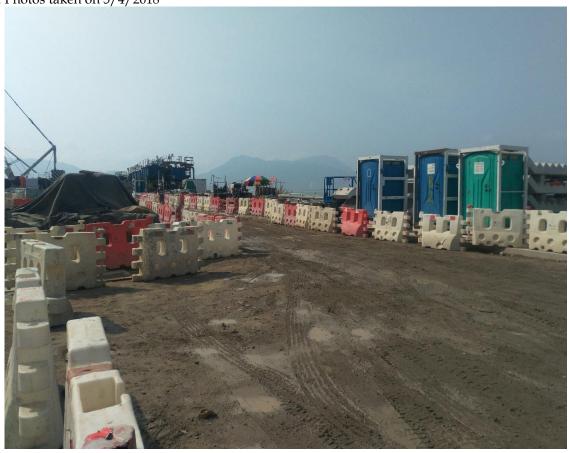
Water spraying was applied frequently on site. (Works Area Portion N-C)

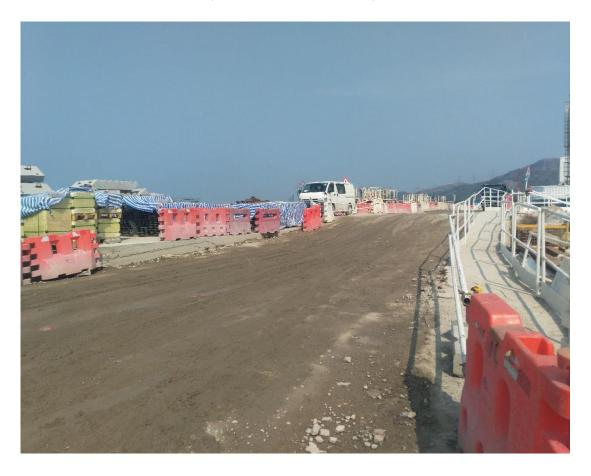
Water spraying was applied frequently on site. (Works Area Portion N-C)

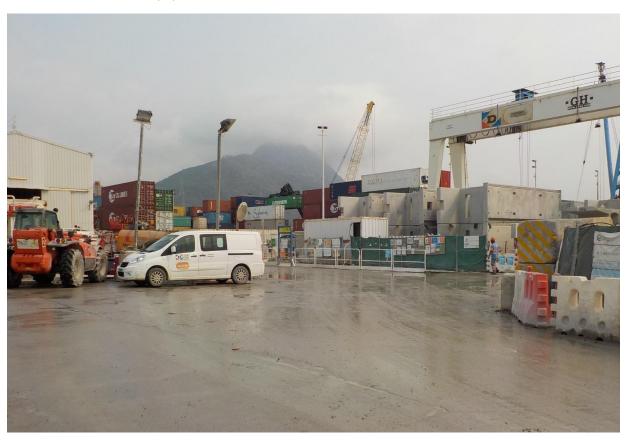
Water spraying was applied frequently on site. (Works Area Portion N-B)

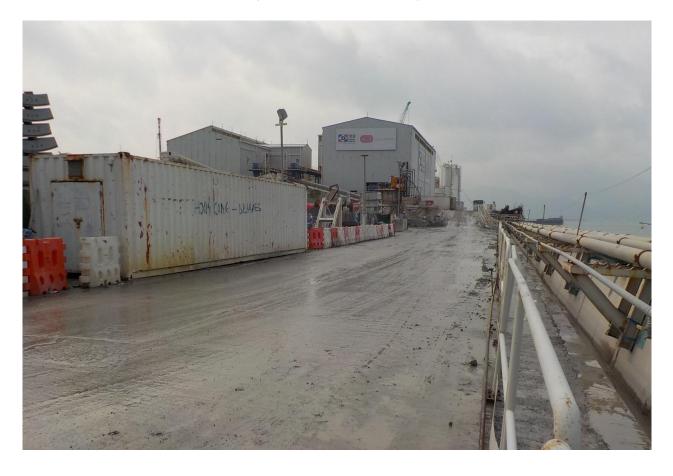
Water spraying was applied frequently on site. (Works Area Portion N-C)

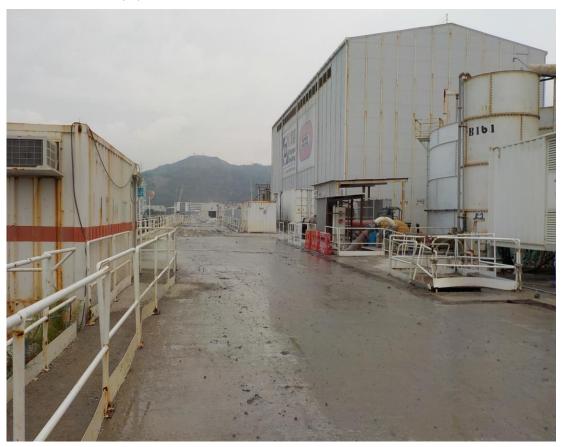
Water spraying was applied frequently on site. (Works Area Portion N-A)

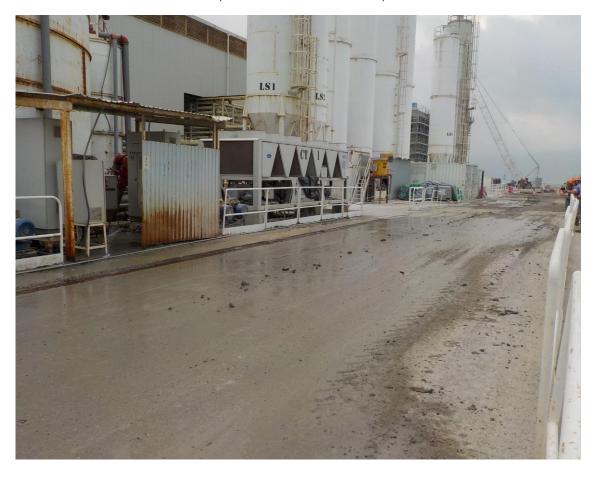
Water spraying was applied frequently on site. (Works Area Portion N-C)
