Appendix E – Approval Letter of Tree Removal Application and Tree Schedule

Contract No. HY/2013/02
Hong Kong-Zhuhai-Macau Bridge (HZMB)
Hong Kong Boundary Crossing Facilities (HKBCF) –
Infrastructure Works Stage I (Western Portion)
Tree Removal Application

Tree Schedule

TREE ASSESSMENT SCHEDULE

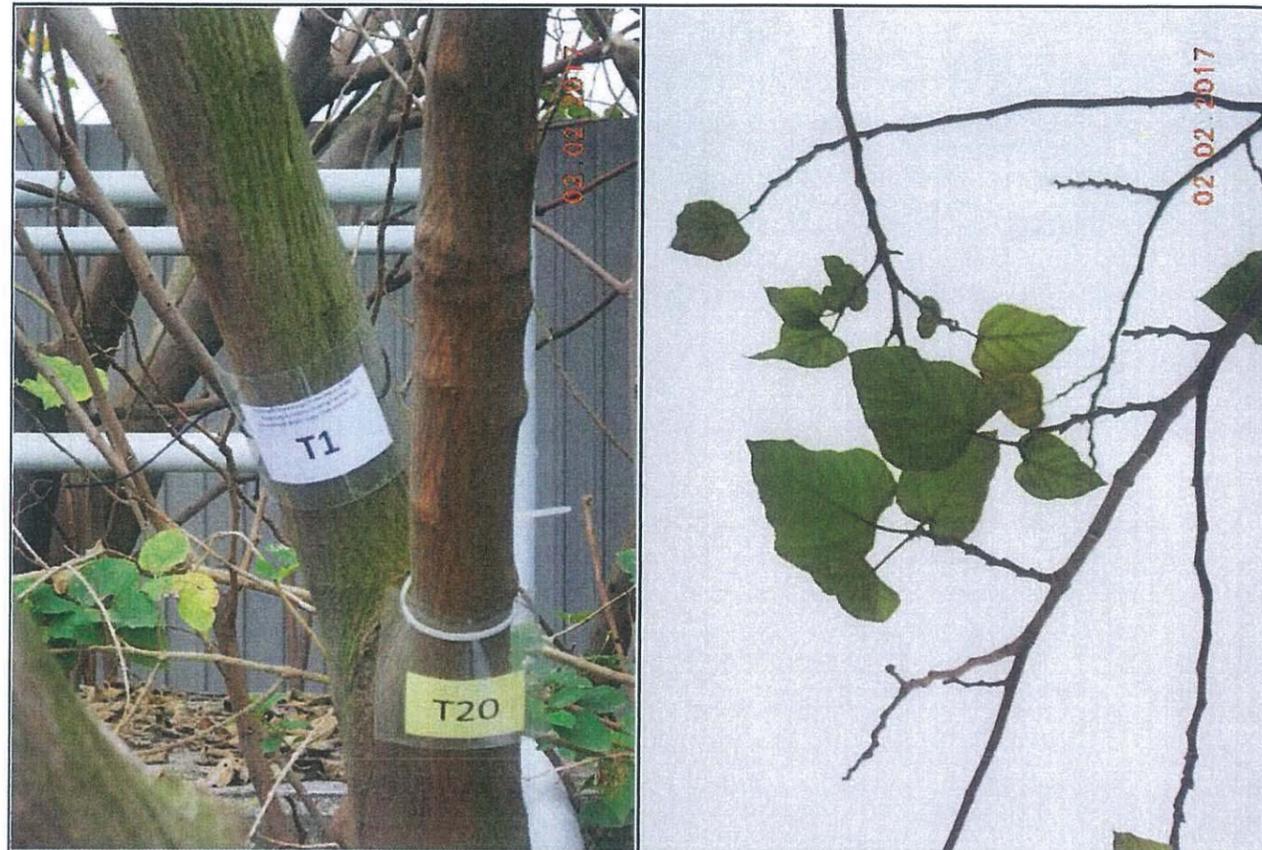
T1	<i>Broussonetia papyrifera</i>	構樹	T1	<i>Broussonetia papyrifera</i>	構樹
Description :	Tree tag		Description :	Feature for identification

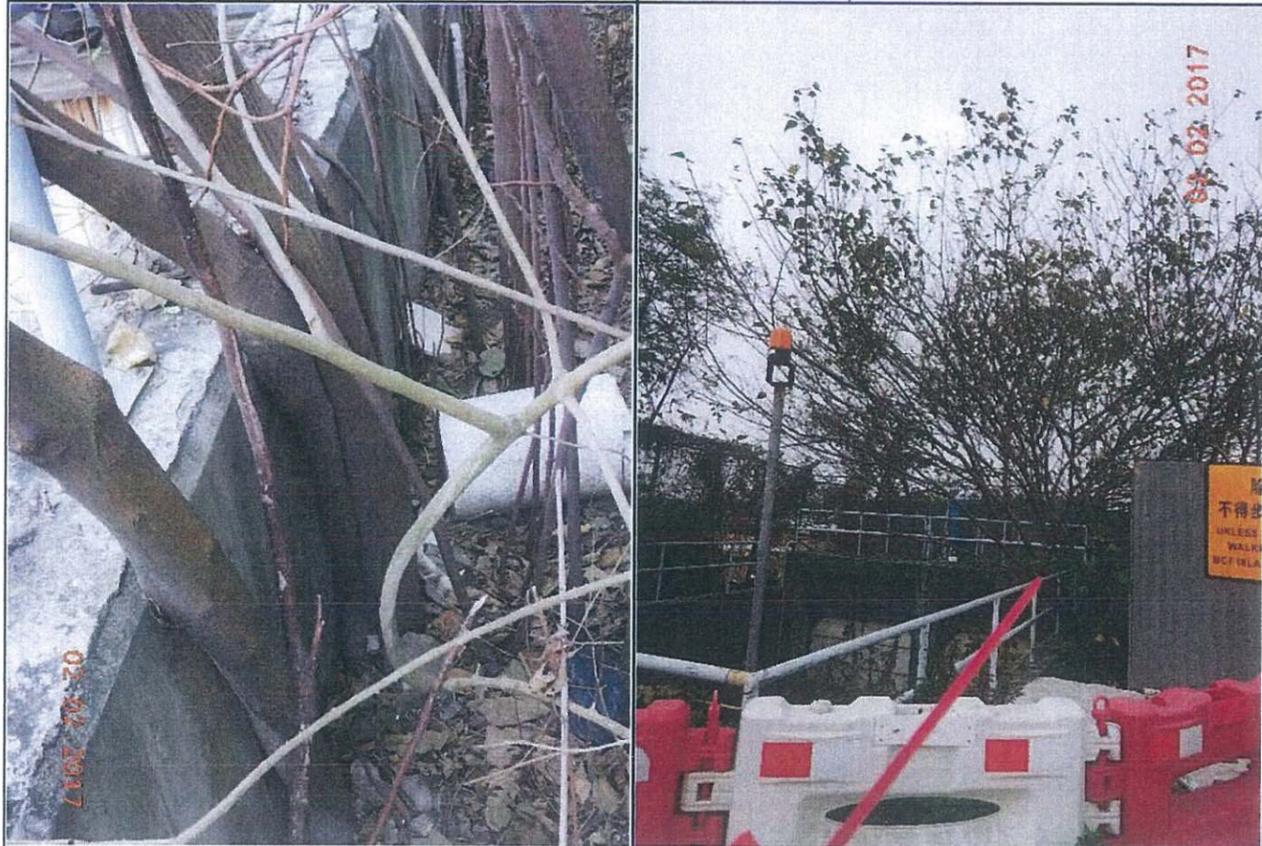
T1	<i>Broussonetia papyrifera</i>	構樹	T1	<i>Broussonetia papyrifera</i>	構樹
Description :	Root collar condition Conflict with structure		Description :	General view

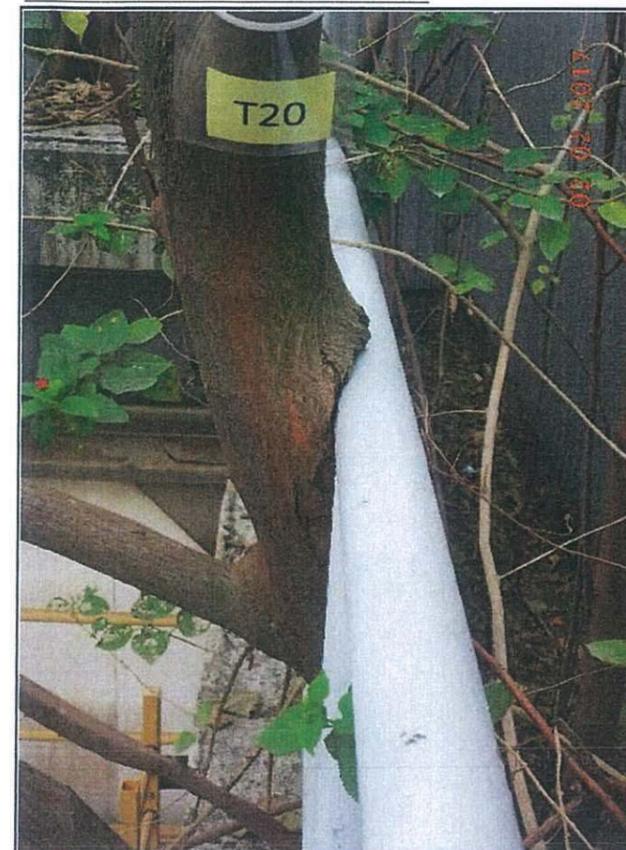
T1	<i>Broussonetia papyrifera</i>	構樹
Description :	Middle trunk in conflict with railing

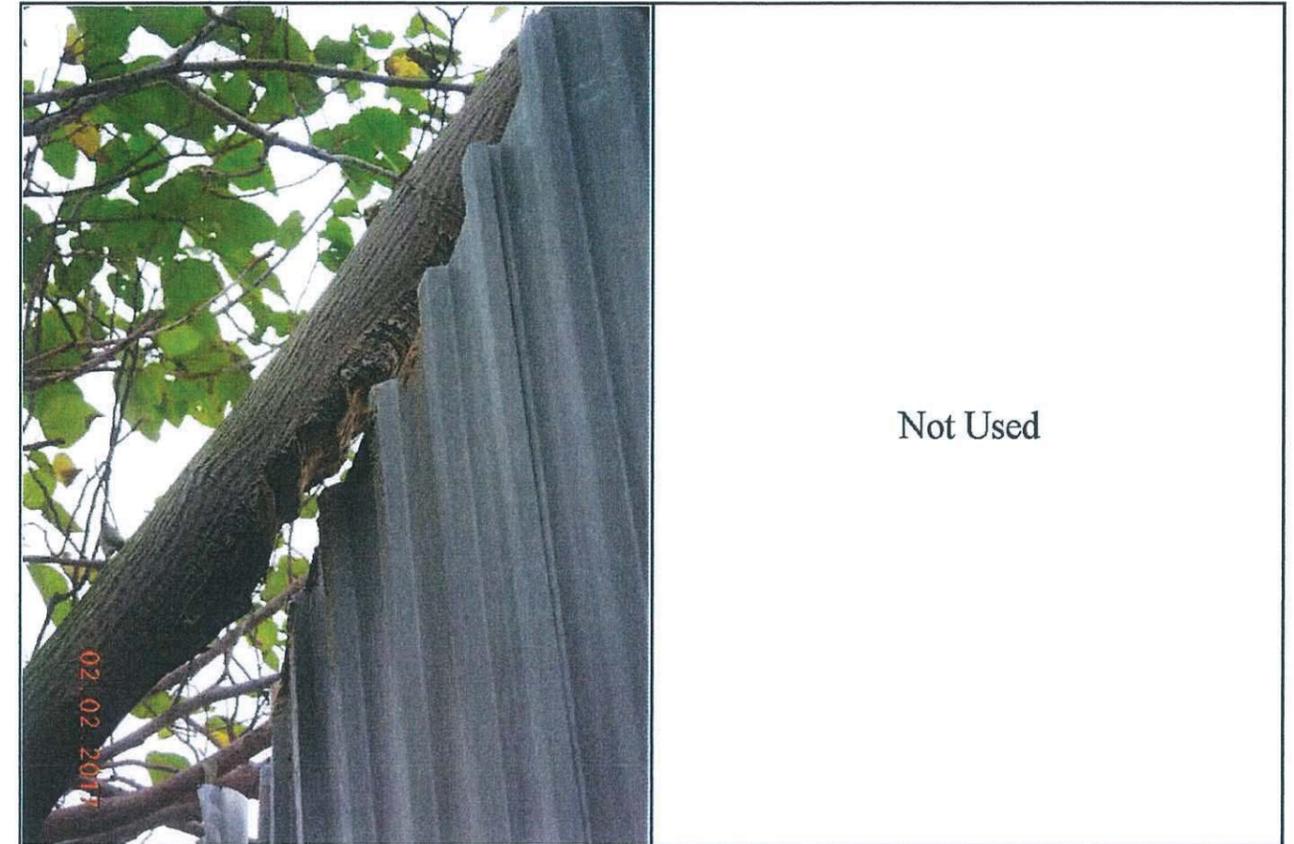
T2	<i>Broussonetia papyrifera</i>	構樹
Description :	Damaged trunk by hoarding	Description :

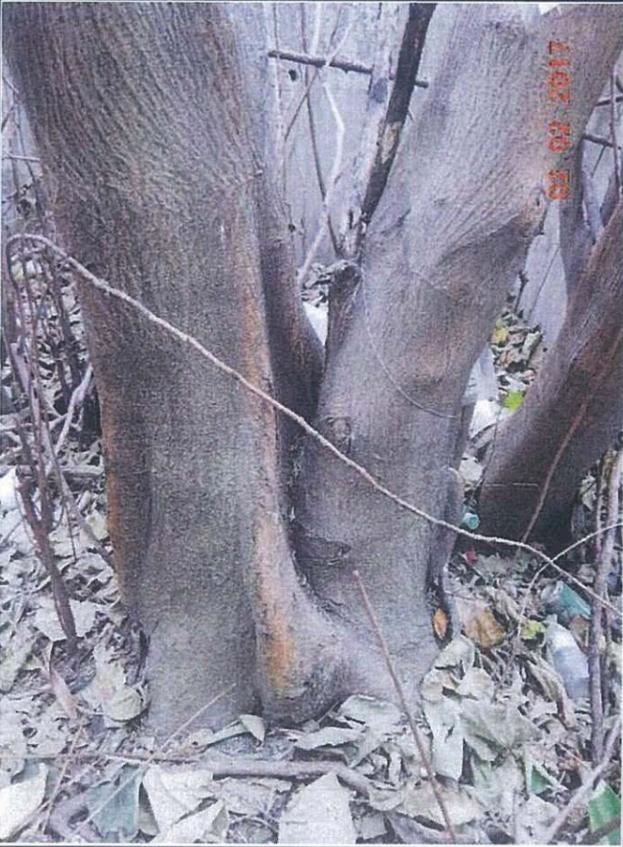
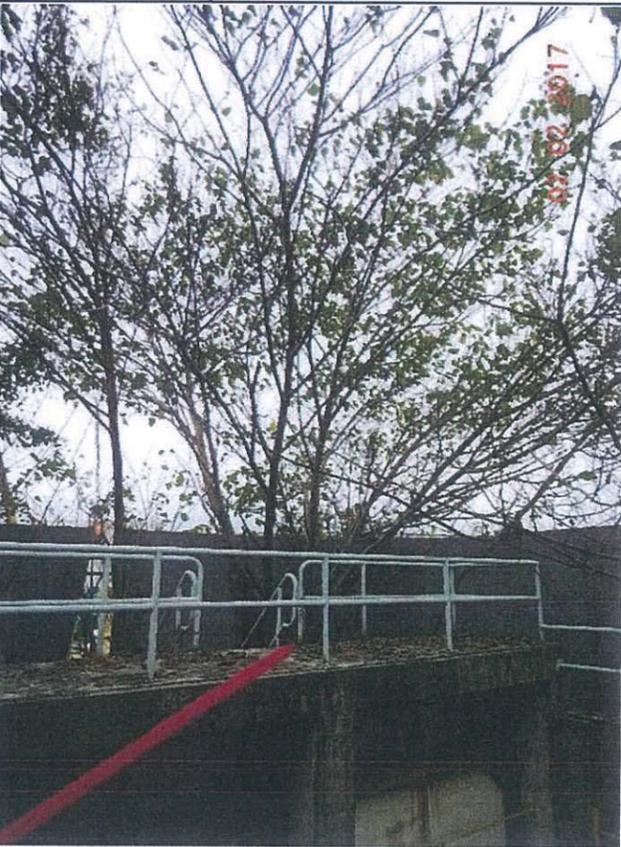
T3 <i>Broussonetia papyrifera</i> 構樹 Description : Root collar condition Included bark	T3 <i>Broussonetia papyrifera</i> 構樹 Description : General view

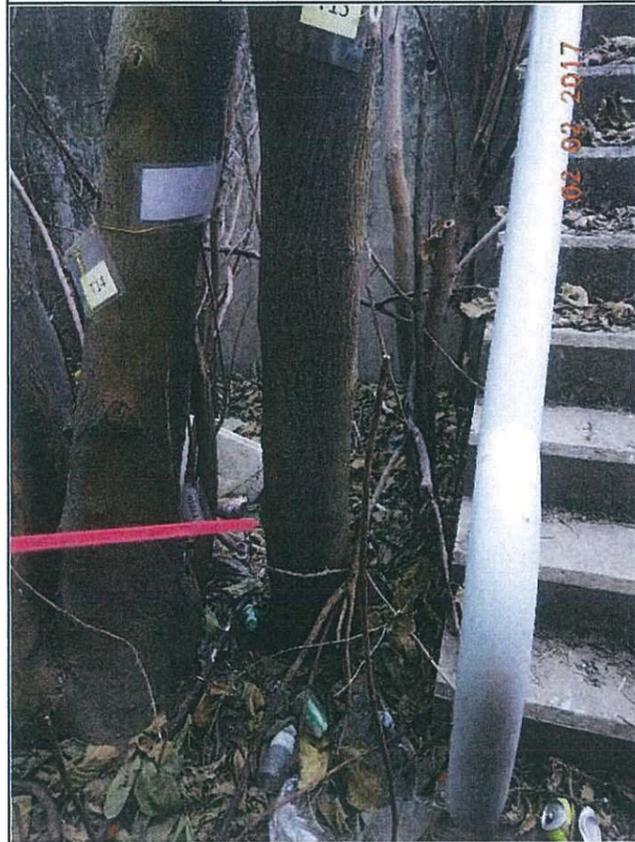
T4 *Broussonetia papyrifera* 構樹
 Description : Root collar condition
 Close to T3 and structure

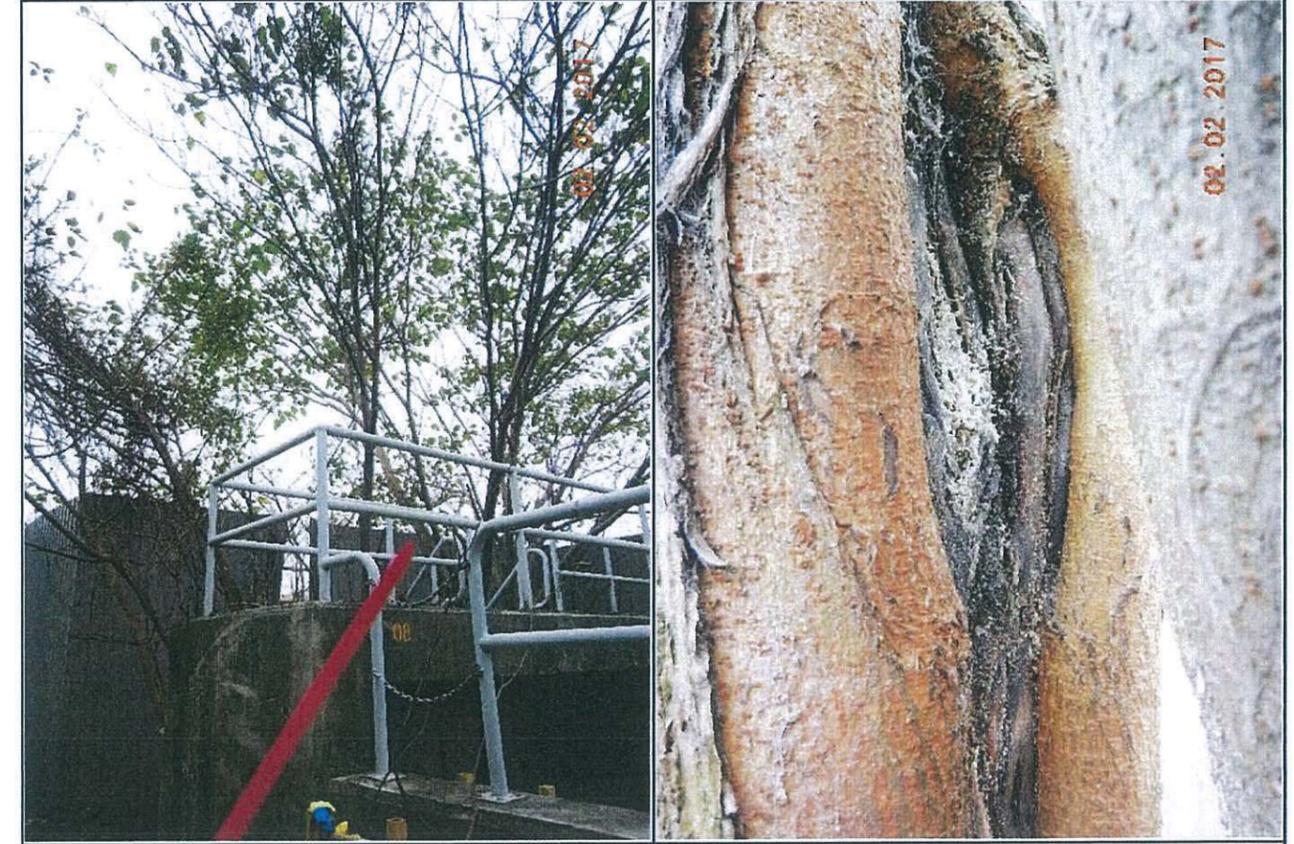
T4 *Broussonetia papyrifera* 構樹
 Description : Sign of wood borers on exposed wood

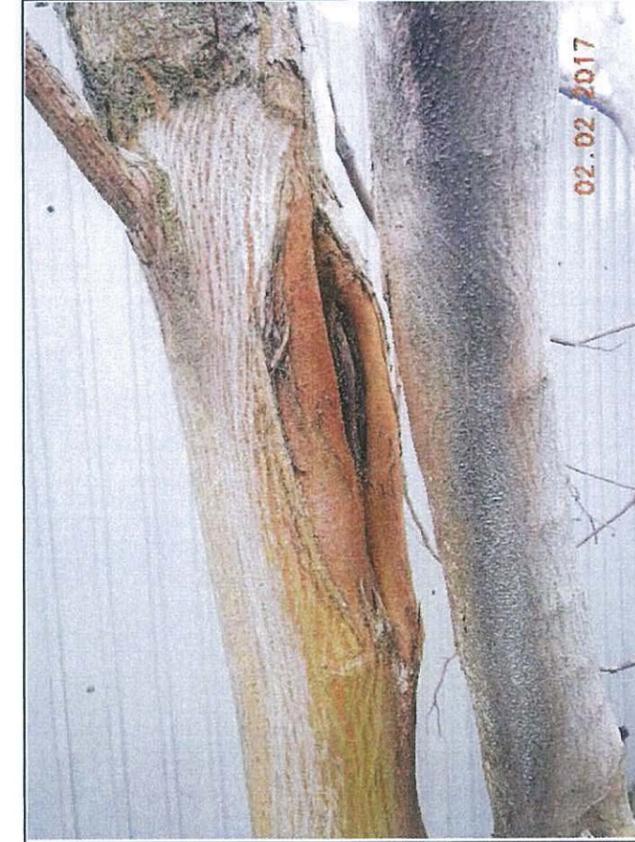
T4 *Broussonetia papyrifera* 構樹
 Description : Damaged by crossed branch with T3

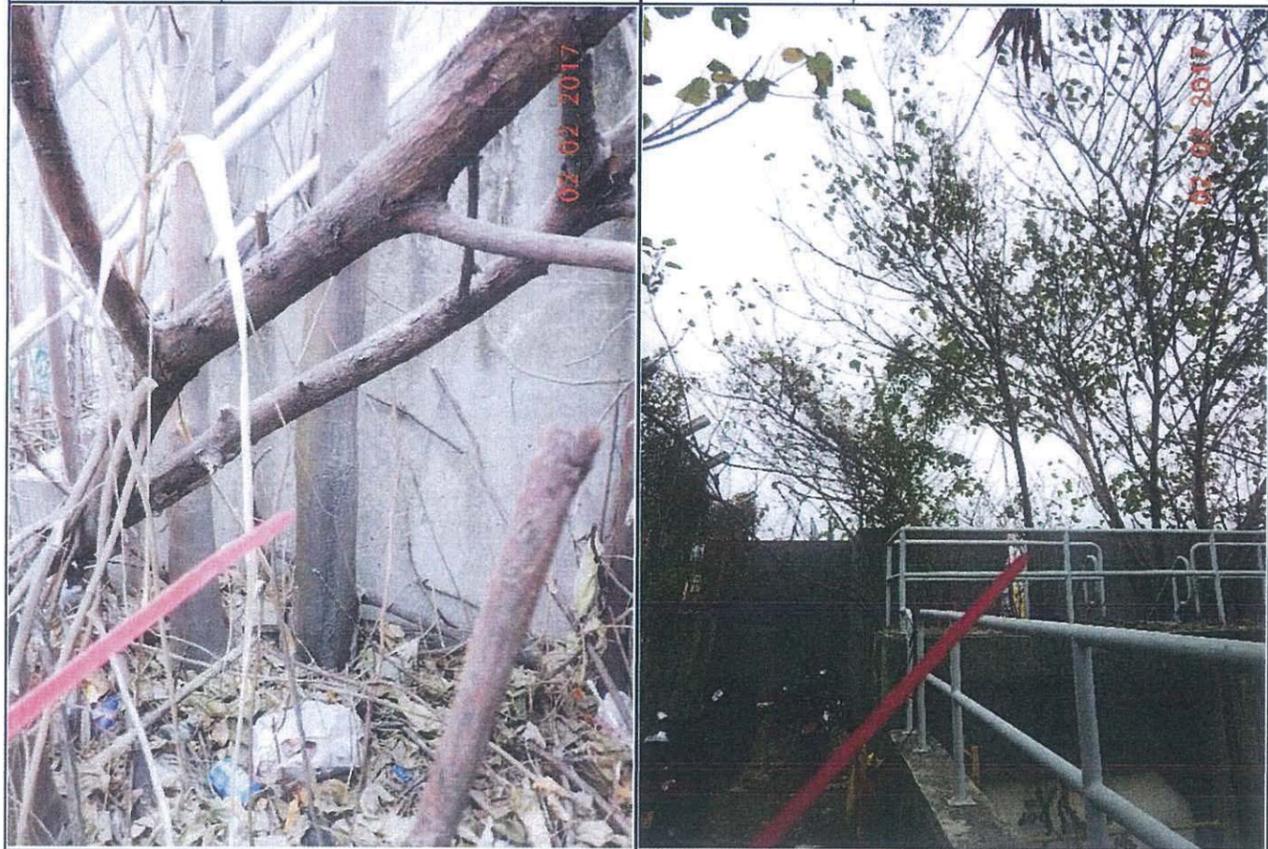
T5	<i>Broussonetia papyrifera</i>	構樹	T5	<i>Broussonetia papyrifera</i>	構樹
Description :	Root collar condition Close to structure		Description :	General view

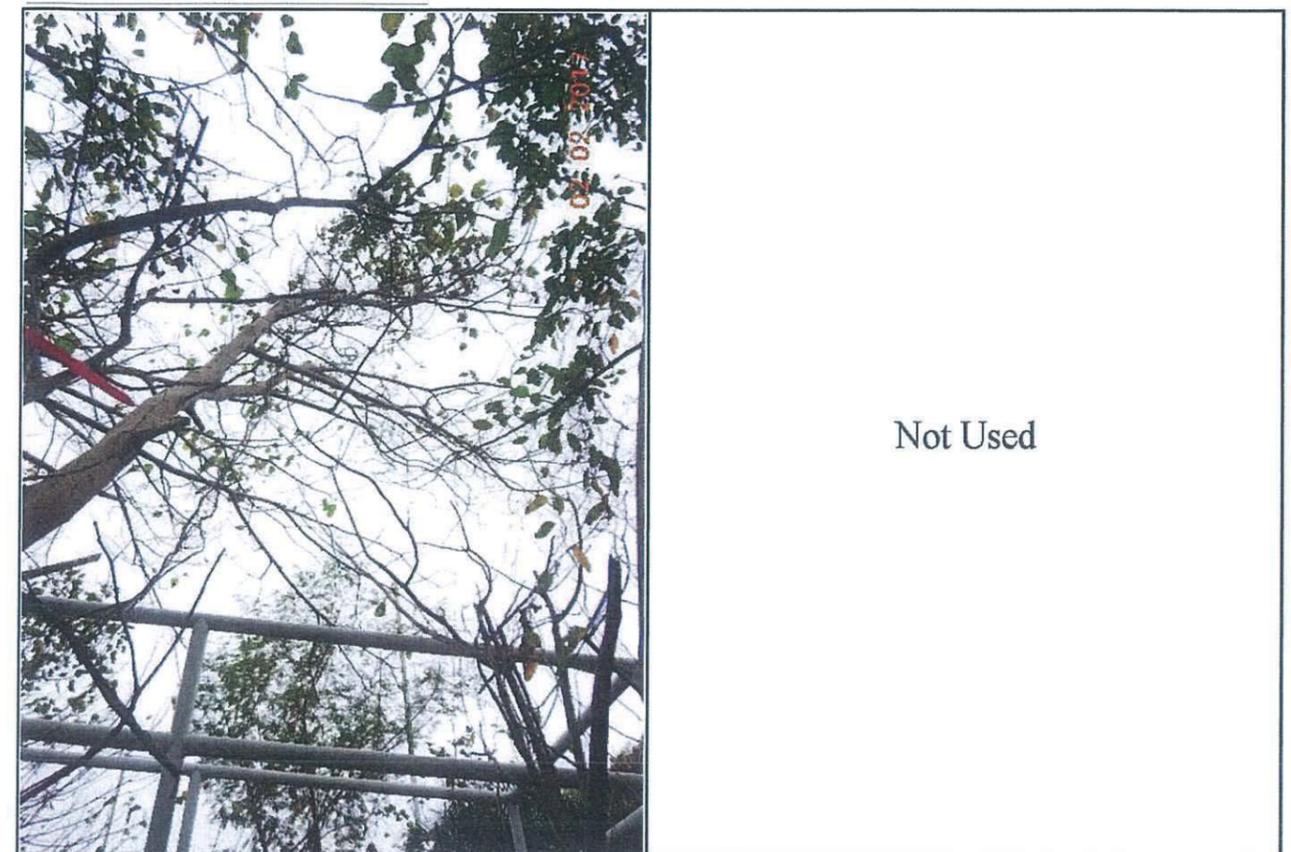
T5	<i>Broussonetia papyrifera</i>	構樹		
Description :	Asymmetric canopy		Description :

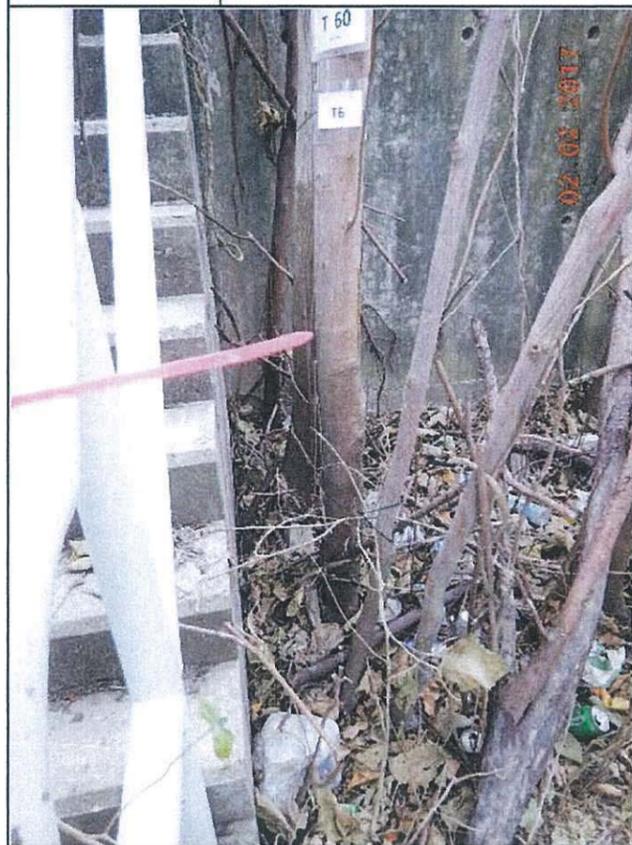
T6 *Broussonetia papyrifera* 構樹
 Description : Root collar condition
 Close to T5 and structure

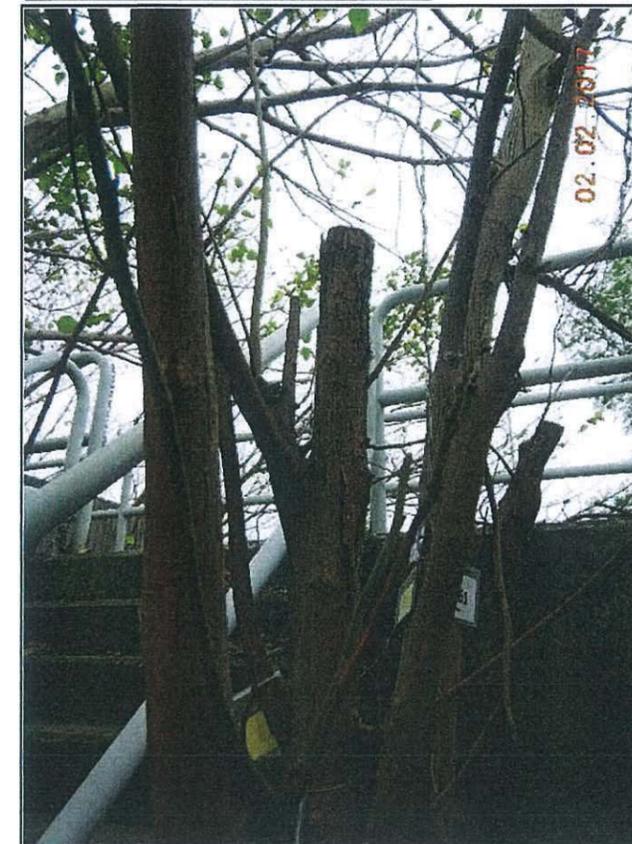
T6 *Broussonetia papyrifera* 構樹
 Description : Topped

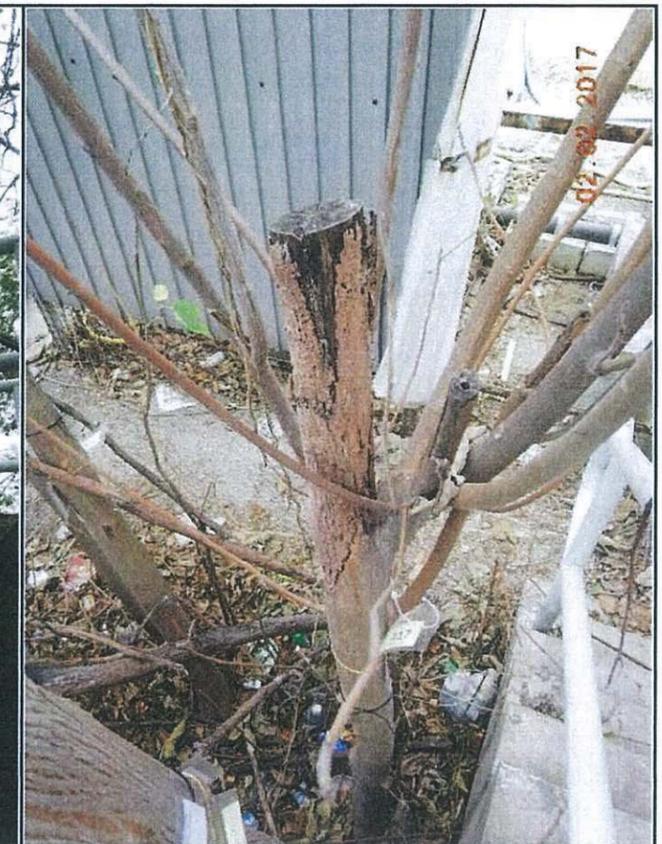
T6 *Broussonetia papyrifera* 構樹
 Description : Exposed dead wood

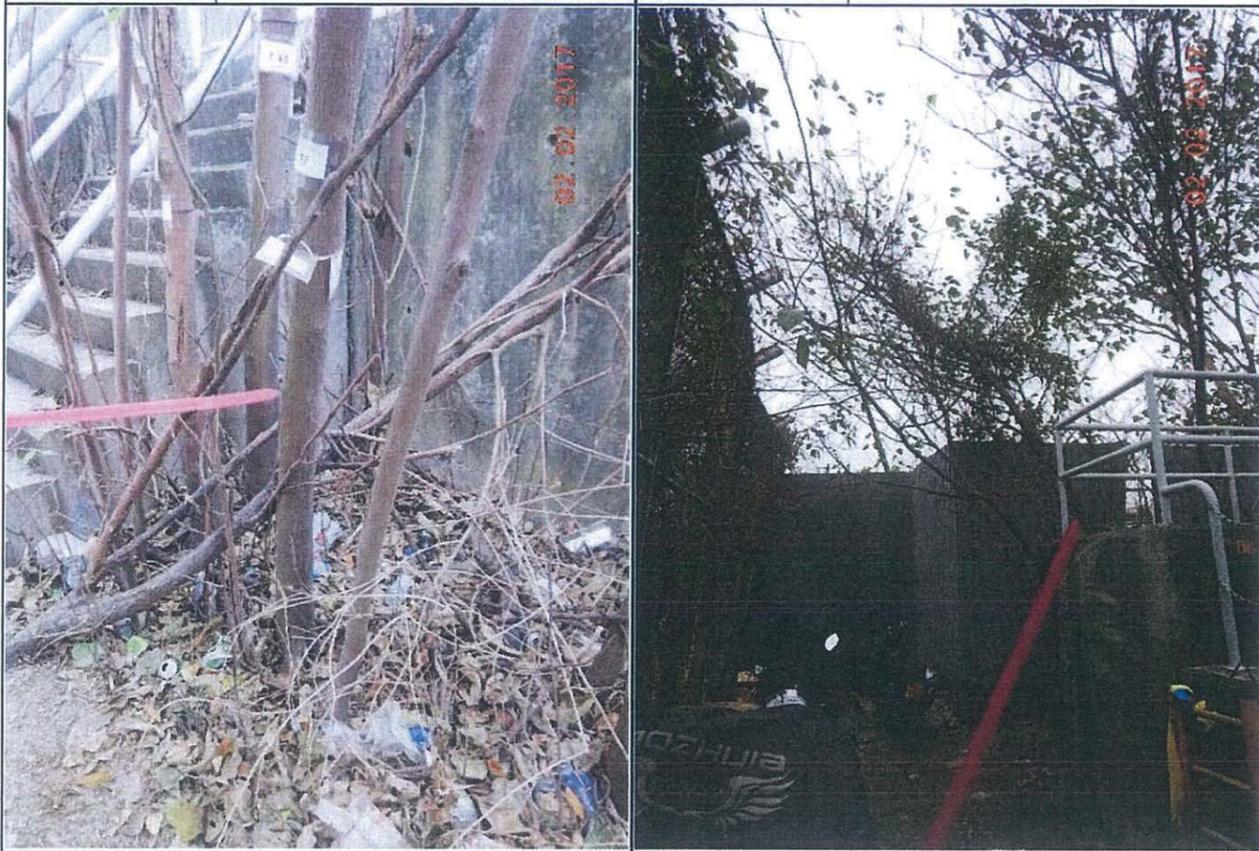
T7	<i>Broussonetia papyrifera</i>	構樹
Description :	Root collar condition Close to T5 and structure	
T7	<i>Broussonetia papyrifera</i>	構樹
Description :	General view

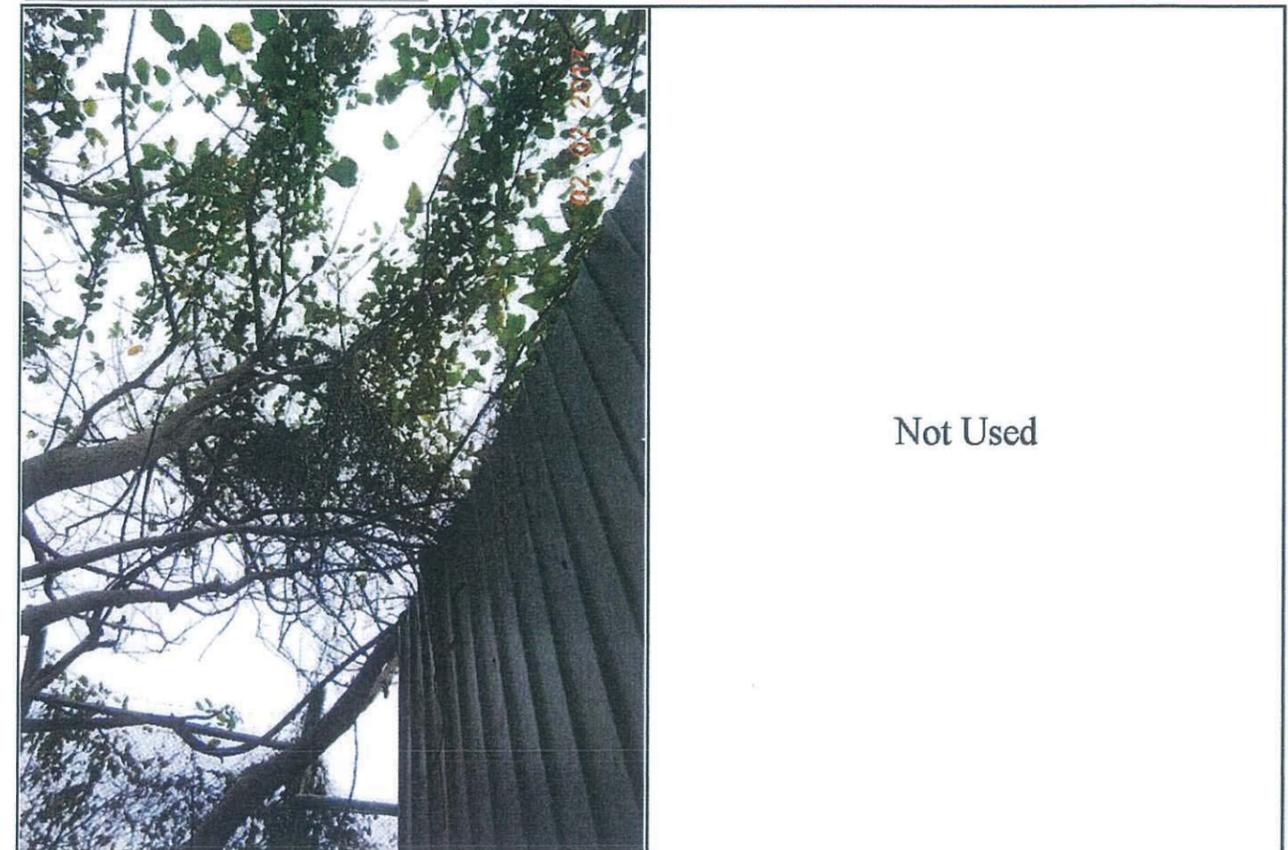
T7	<i>Broussonetia papyrifera</i>	構樹
Description :	Vines on branches	
Description :

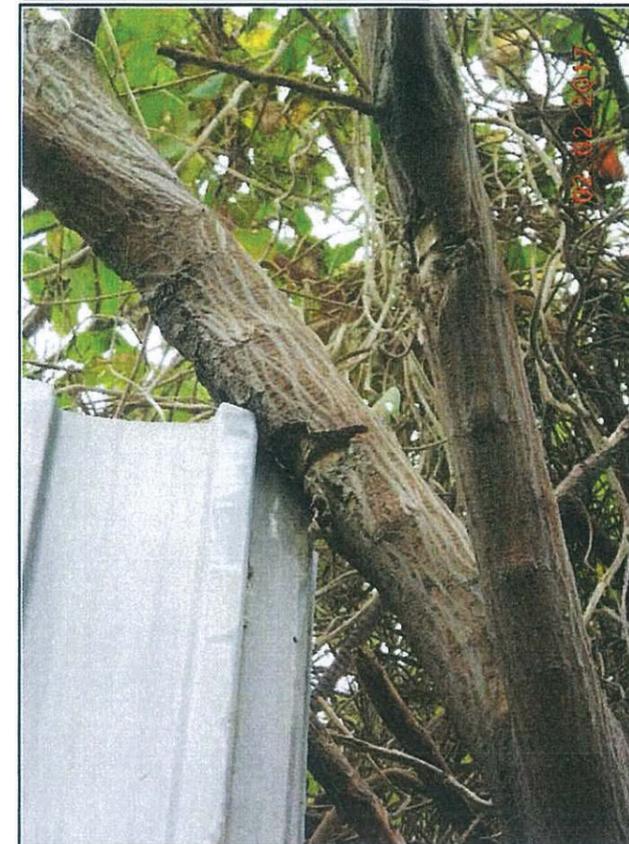
T8 *Broussonetia papyrifera* 構樹
 Description : Damaged trunk by hoarding

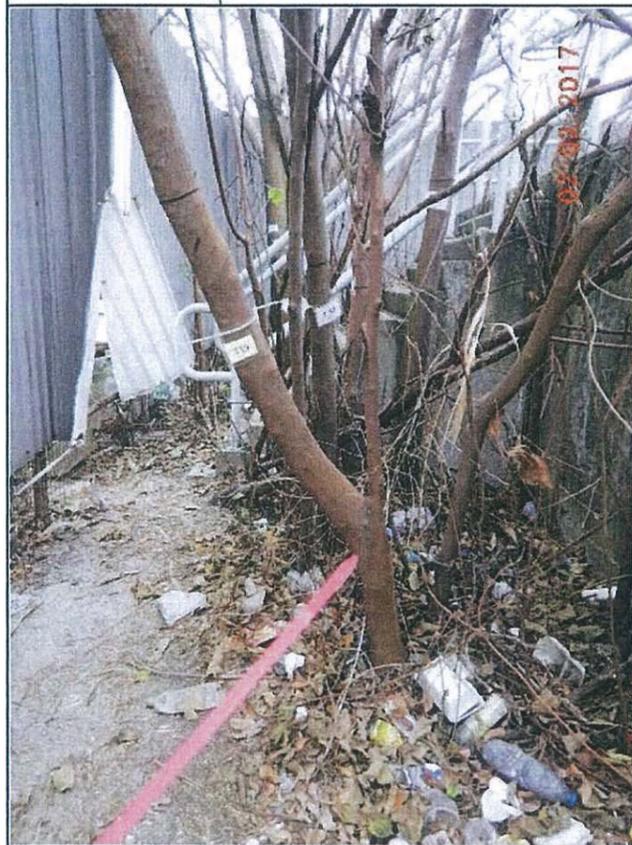
T8 *Broussonetia papyrifera* 構樹
 Description : Root collar condition
 Leaned trunk

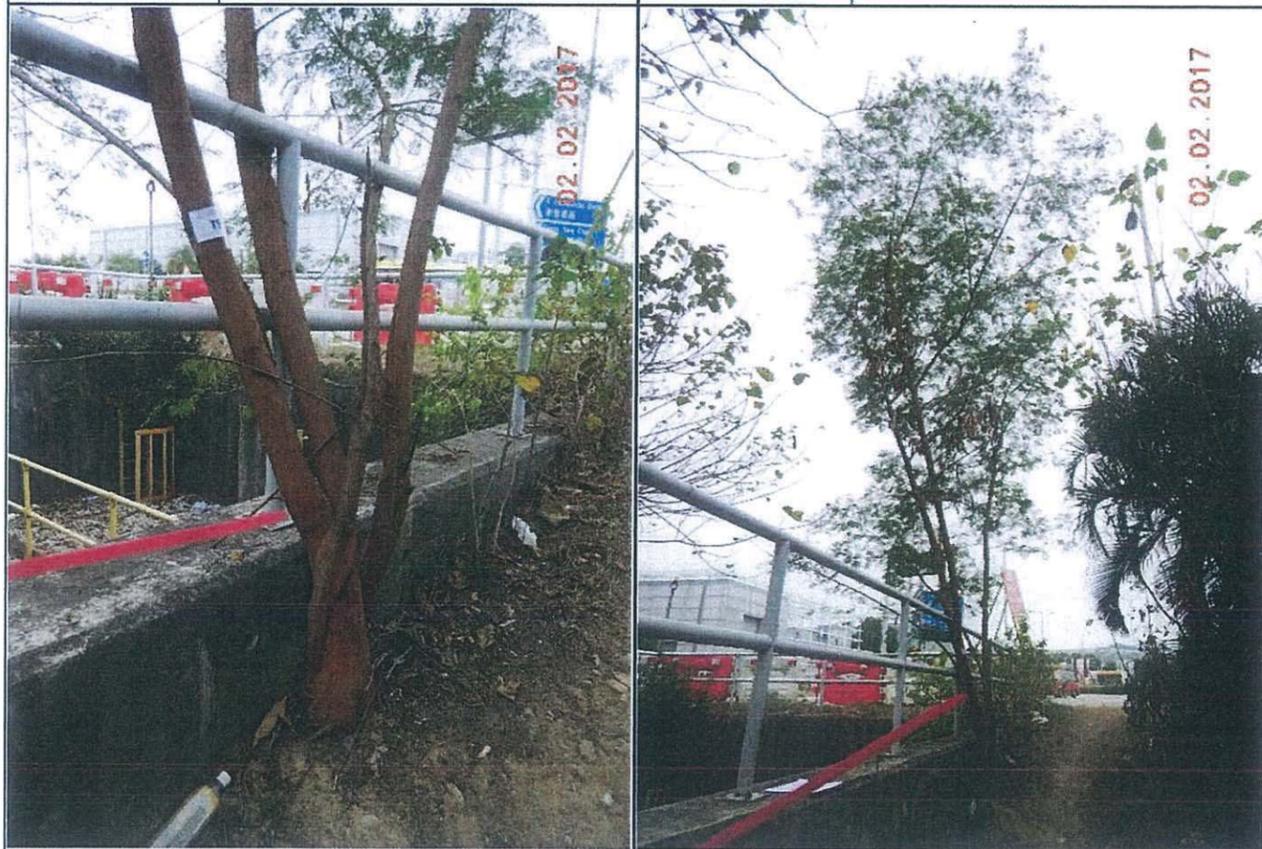
T9	<i>Leucaena leucocephala</i>	銀合歡
Description :	Root collar condition In conflict with structure	
T9	<i>Leucaena leucocephala</i>	銀合歡
Description :	General view

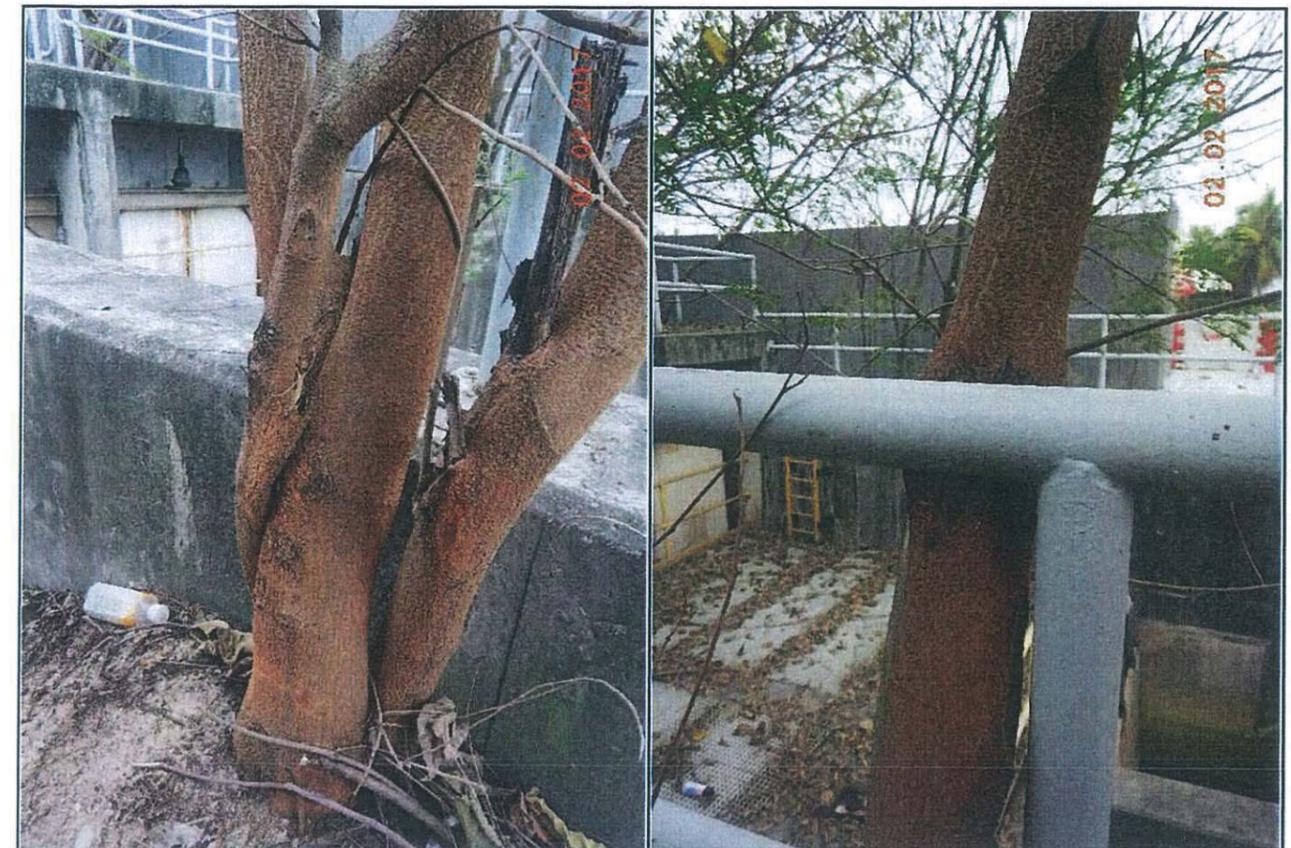
T9	<i>Leucaena leucocephala</i>	銀合歡
Description :	Crossed branches and included bark	
T9	<i>Leucaena leucocephala</i>	銀合歡
Description :	Trunk in conflict with hoarding

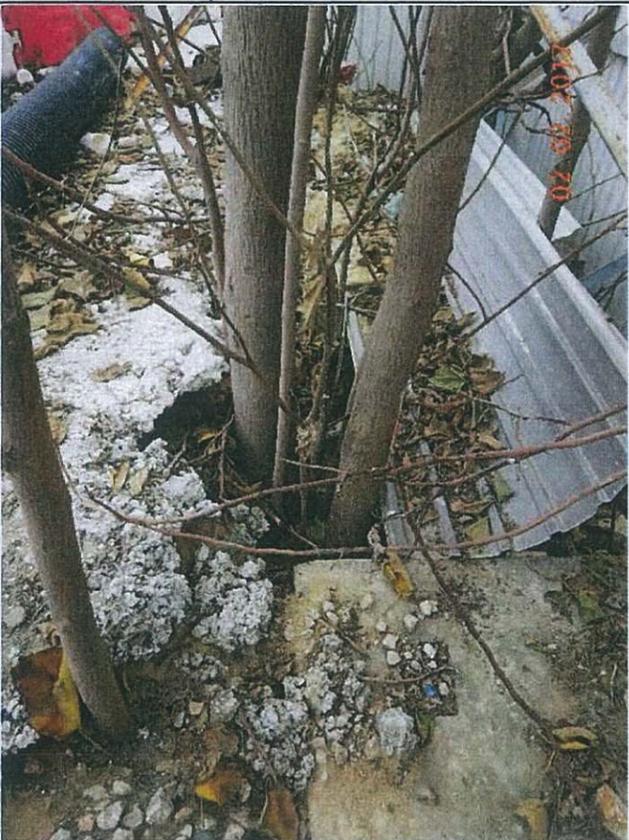
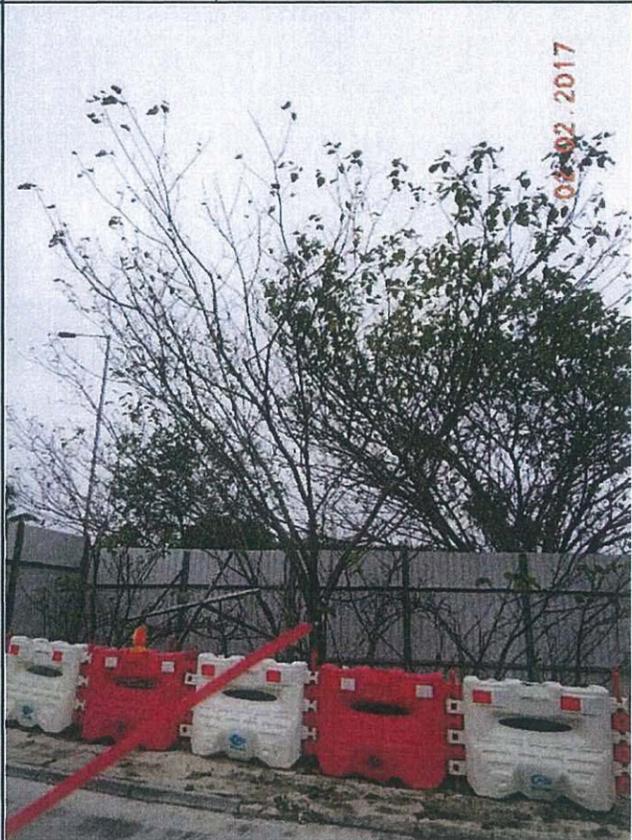
T17 <i>Broussonetia papyrifera</i> 構樹 Description : Root collar condition Increased soil level		T17 <i>Broussonetia papyrifera</i> 構樹 Description : General view

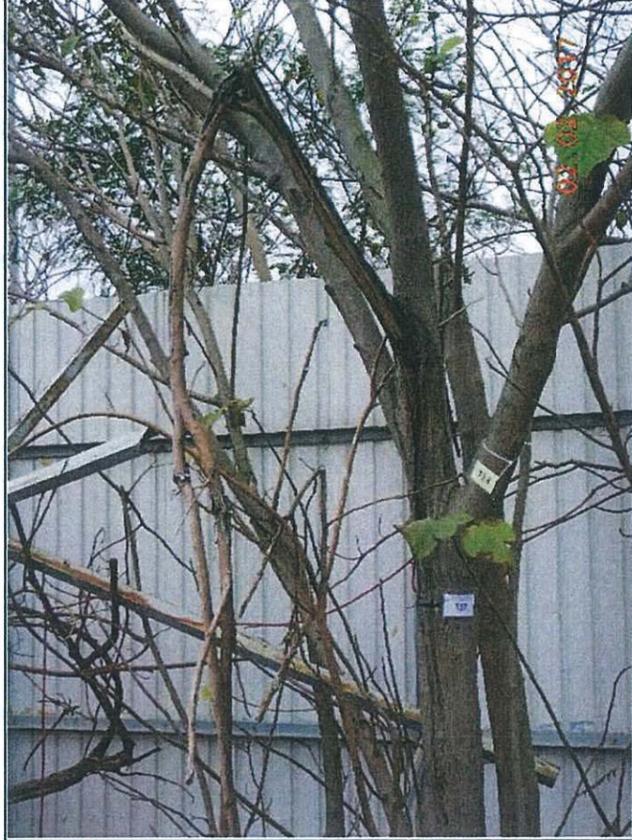
Not Used	
T17 <i>Broussonetia papyrifera</i> 構樹 Description : Minor broken branch		Description :	
Not Used		Not Used	
Description :		Description :
