Contract No. HY/2010/02

**Hong Kong – Zhuhai – Macao Bridge  
Hong Kong Boundary Crossing  
Facilities –  
Reclamation Works****Monthly EM&A Report for April 2013**

Version: Rev. 0 Date: 15 May 2013

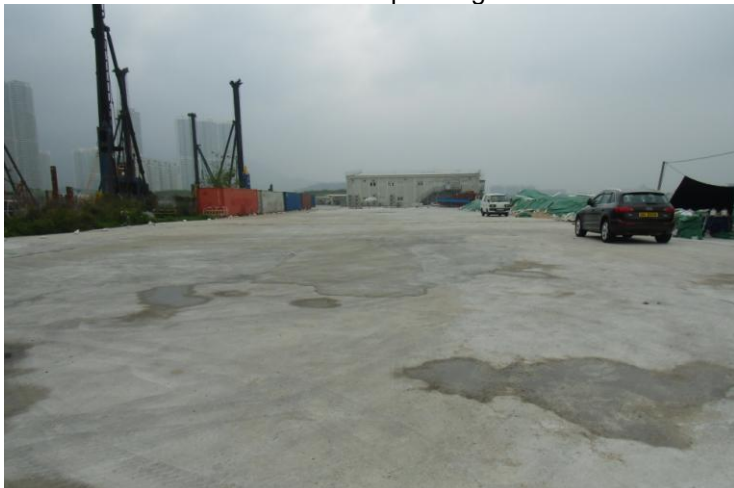
View of Works Area WA2 : Hard paved ground next to monitoring station AMS3A (View A)

2.7.5.10 The Contractor was recommended to continue implementing existing dust mitigation measures.

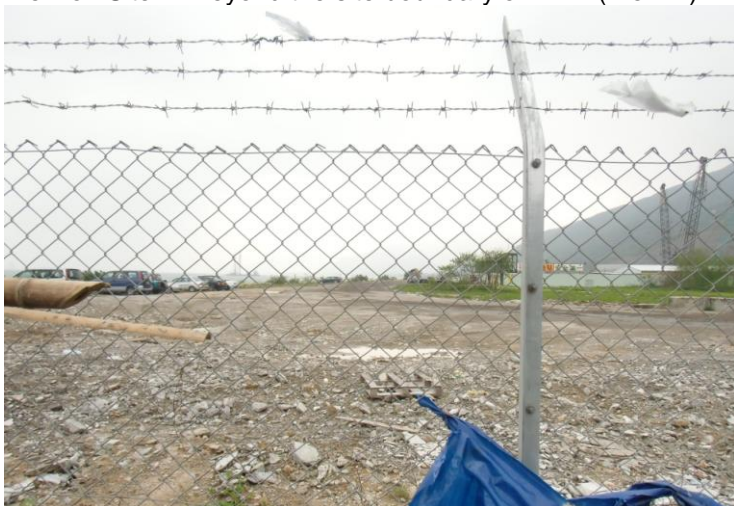
View on Site B: Beyond the site boundary of WA2 (View B)

2.7.5.9 The dust exceedance was therefore considered not to be due to the Project works.

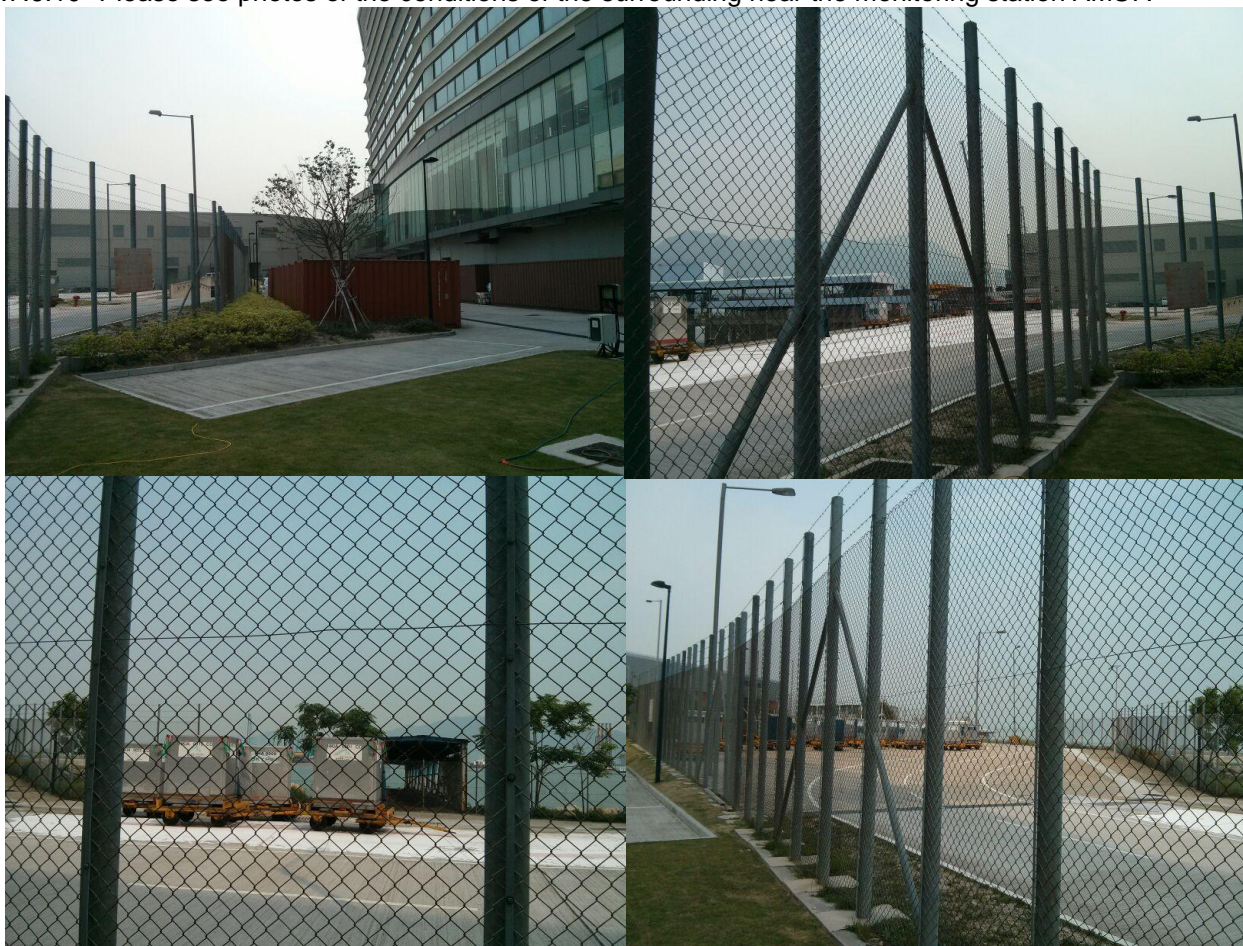
- 2.7.6.5 On the other hand, according to observation made at the monitoring station AMS7, there was no non-project potential cause/activity at the surrounding of monitoring station AMS7 which might potentially contribute to the dust action level exceedance.

2.7.6.10 Please see photos of the conditions of the surrounding near the monitoring station AMS7:

2.7.6.11 The dust exceedance was therefore considered not to be due to the Project works.

2.7.6.12 The Contractor was recommended to continue implementing existing dust mitigation measures.

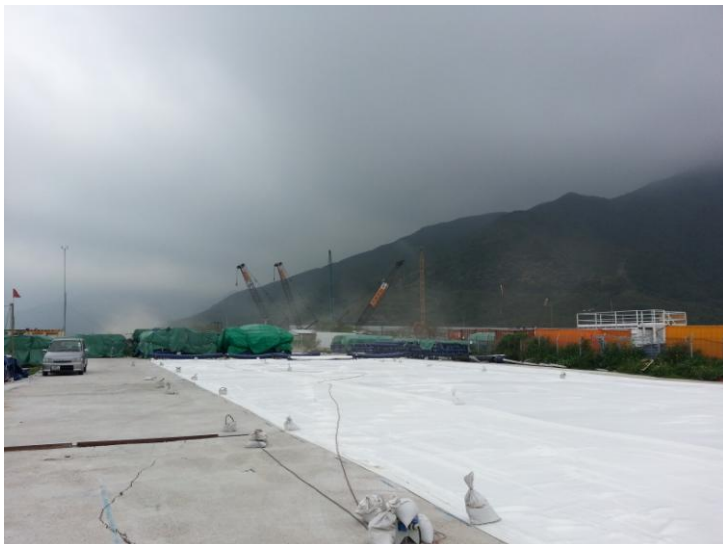
**View of Works Area WA2 : the hard paved ground next to monitoring station AMS3A (View A)**

2.7.7.11 The Contractor was recommended to continue implementing existing dust mitigation measures.

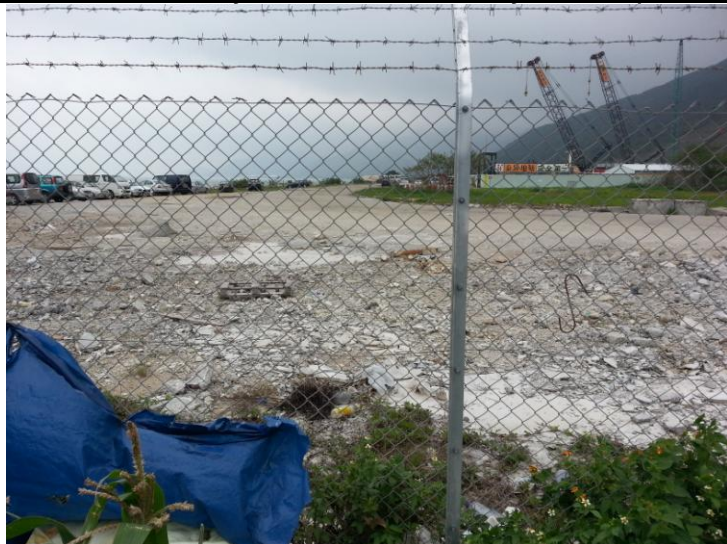
**View on Site B: Beyond the site boundary of WA2 (View B)**

2.7.7.10 The dust exceedance was therefore considered not to be due to the Project works.
