Contract No. HY/2010/02

Hong Kong – Zhuhai – Macao Bridge Hong Kong Boundary Crossing Facilities – Reclamation Works

Monthly EM&A Report for June 2013

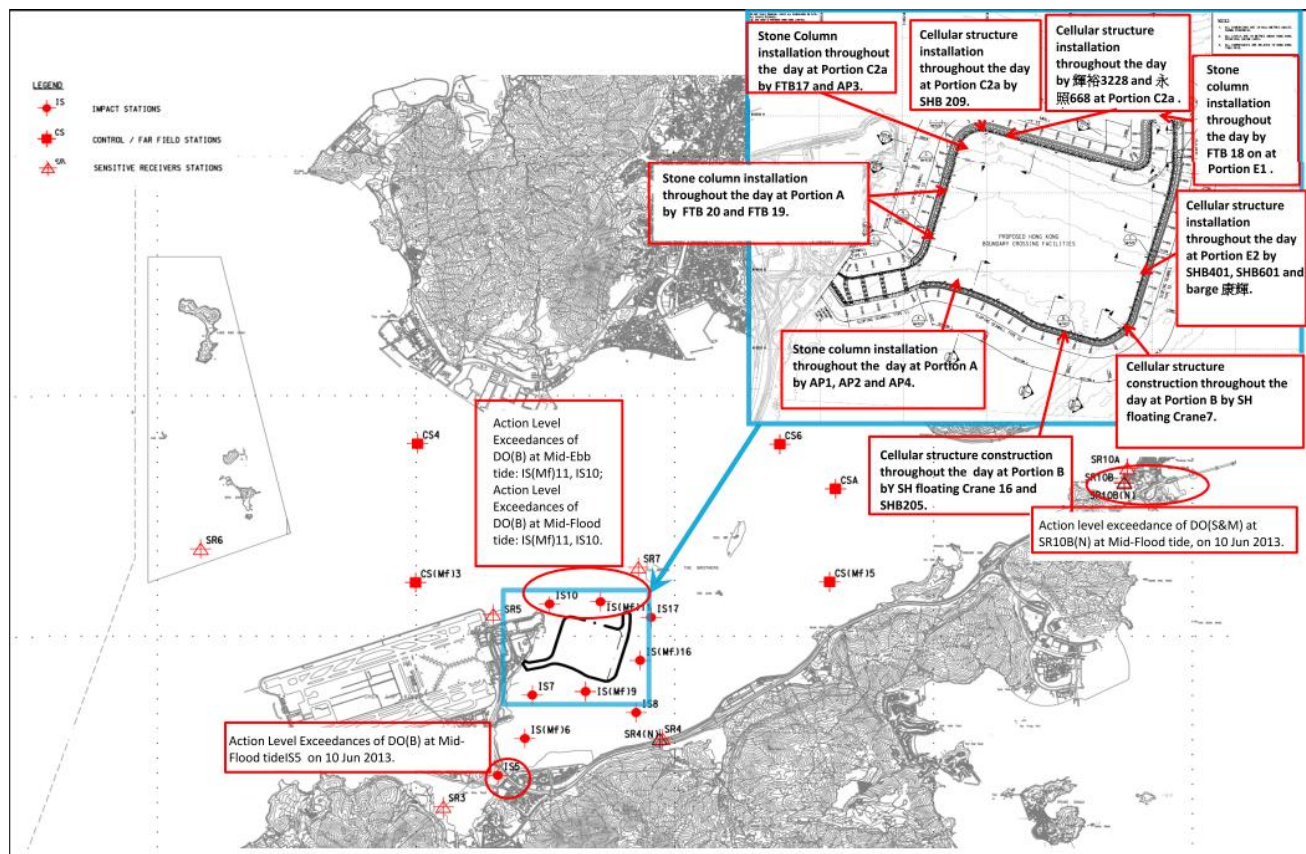
4.7.3.1 For type, location and duration of works carried out on 10 June 2013 please refer to the above layout map.

4.7.3.2 Exceedances were not due to marine based construction works of the Project because:

- 4.7.3.4 During ebb tide, low DO (Bottom) - 4.8mg/L was noted at control station CS(Mf)3 which is considered upstream to monitoring station IS(Mf)11 and IS10, indicating DO (Bottom) at location upstream to active construction works was adversely affected by local effects in the vicinity. As such, the exceedances recorded were likely due to local effects in the vicinity at IS(Mf)11 and IS10 .

- 4.7.3.5 Low DO (Bottom) - 4.4mg/L, 4.2mg/L, 4.0mg/L and 4.0mg/L were noted at monitoring station SR10B(N), CS6, CSA and CS(Mf)5 respectively which are considered upstream to monitoring stations IS(Mf)11 and IS10 during mid flood tide indicating DO (Bottom) at locations upstream to active construction works were adversely affected by local effects in the vicinity. As such, the exceedances recorded were likely due to local effects in the vicinity at IS(Mf)11, IS10 and IS5 during mid flood tide.
