Contract No. HY/2010/02

**Hong Kong – Zhuhai – Macao Bridge
Hong Kong Boundary Crossing
Facilities –
Reclamation Works**

Monthly EM&A Report for July 2014

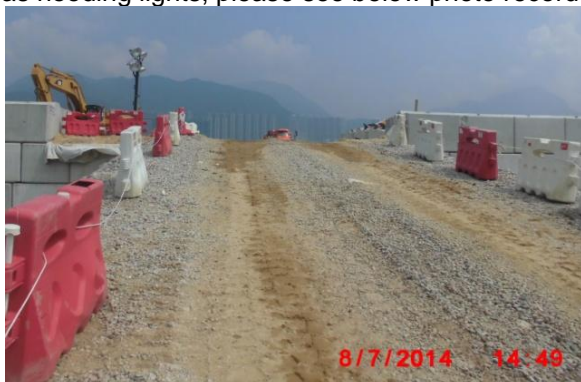
- 6.6.3.2 For the part of the complaint which is related to visual impact:
- After reviewing the available information provided by the complainant, the source of light is likely from lighting system for the construction works conducted at night.

- With referred to the photo record below, there is measure to control night-time lighting and glare such as hooding lights, please see below photo record of hooding of lights.

- In addition, as informed by the Contractor, construction works would be carried out at night in order to be in line with the progress of this project, however, the Contractor has arranged major activities to be performed during the day time to minimize works in the night time.
- As such, the visual impact complaint is likely to be related to the construction works of this Contract.
- As informed by the Contractor, all the night-lighting is movable and would be moved according to the reclamation progress. However, all the night-lighting has been provided with hooding.
- The Contractor was reminded to continue to properly implement existing mitigation measure for visual impact such as provide night-lighting with hooding.
- In addition, the Contractor was recommended to adjust the orientation of light to minimize glare to residence as far as possible.

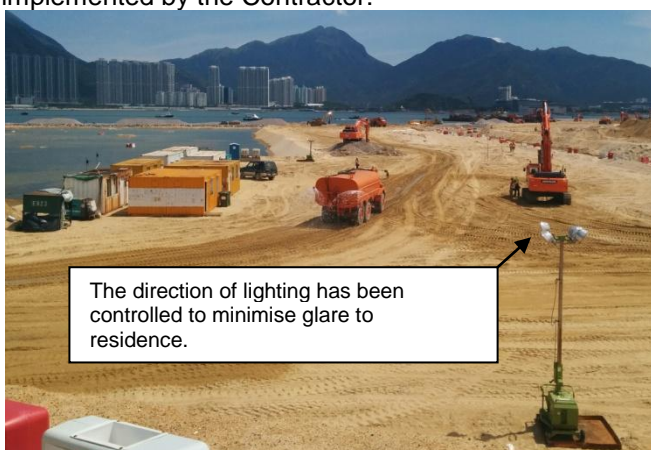
- The Contractor was reminded to continue to properly implement existing mitigation measure for visual impact such as provide night-lighting with hooding.
- In addition, the Contractor was recommended to adjust the orientation of light to minimize glare to residence as far as possible.
- Photo record on 16 July 2014 shows that the recommended mitigation measures has been implemented by the Contractor:

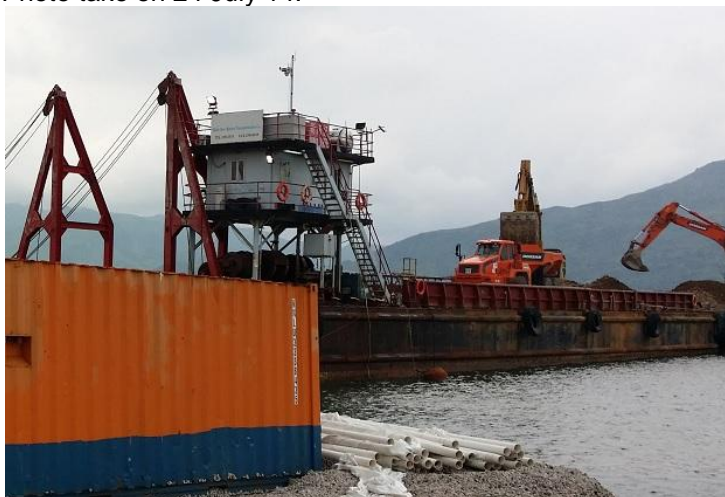
- There is no sufficient information provided by the complainant to make sure that the concerned barges are related to this project.
- Date of the observed impact was not specified by the complainant so the IWQM results available for July 14 for monitoring stations close to the concerned area - IS12, IS13, IS14, IS15 have been reviewed and there were no impact water quality monitoring result that shows the turbidity or suspended solid of sea water were adversely affected.
- In addition, site inspection has been jointly conducted with the Contractor and RSS on 24 and 31 July 2014, but no leakage of soil/sand material from barges causing discoloration of sea water was observed inside or outside the perimeter silt curtain of HKBCF reclamation works. Please see below the photos taken during site inspection for reference.
- Photo take on 24 July 14.

- 6.6.4.3 In addition, site inspection has be jointly conducted with RSS and the Contractor, but no leakage of soil/sand material from barges causing discoloration of sea water was observed inside or outside the perimeter silt curtain of HKBCF reclamation works.

- 6.6.4.4 After investigation, there is no adequate information to conclude the observed impact is related to this Contract.
- 6.6.4.5 Recommendations: The Contractor was advised to ensure the provision of routine maintenance and prohibit overloading of sand material on delivery barges to prevent potential leakage of soil from sand delivery barges causing discoloration of sea water
